The Dirty Dozen

The 12 Most difficult problems I have worked on during the last 45 years of troubleshooting vibration related problems

Nelson Baxter

Presented For The Vibration Institute, Piedmont Chapter, May 2023

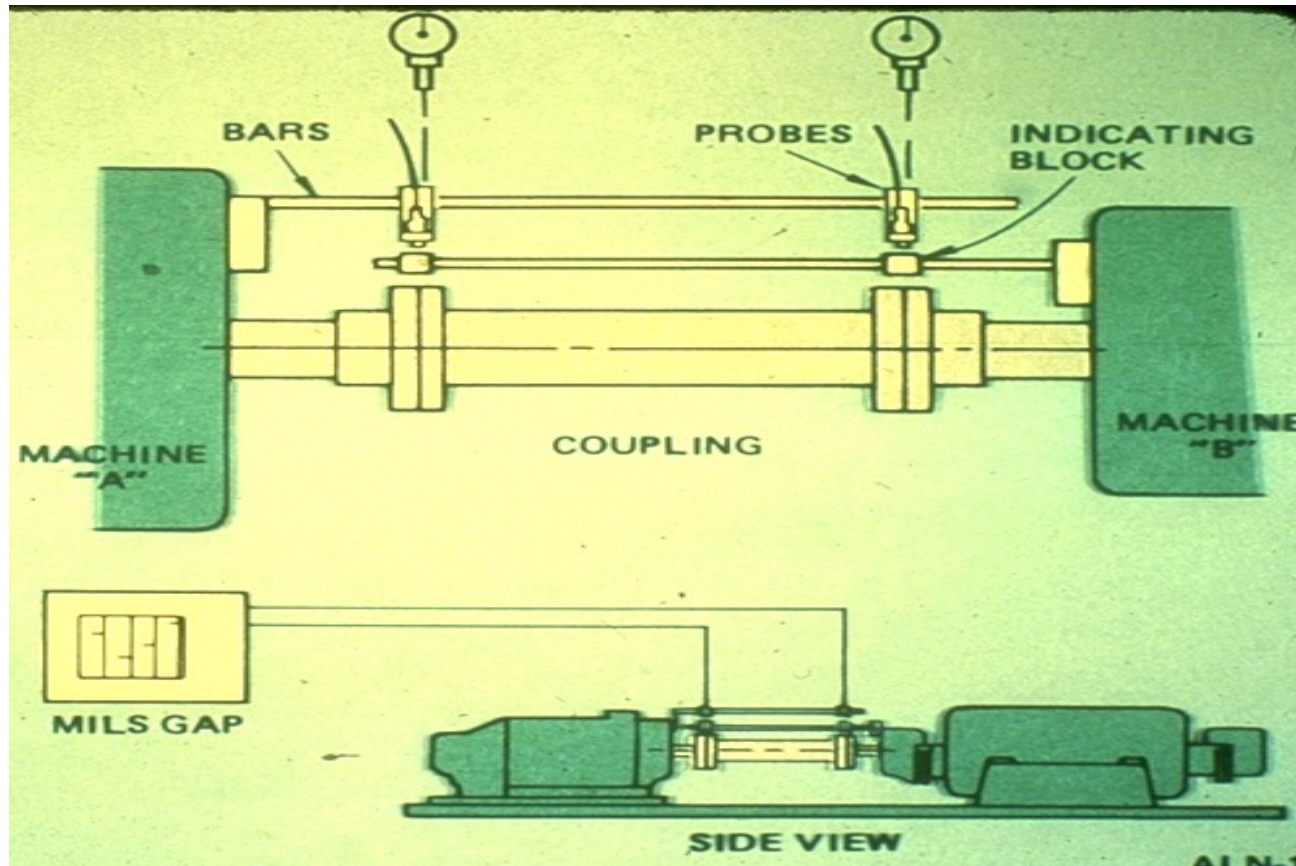
Photo of Dodd Bar Installation

This turbine driven pump was located in a new power plant. After a short amount of operating time, the inboard pump bearing failed along with the inboard pump seals and the coupling. An alignment problem was suspected. In order to study how the alignment moved with load, Dodd bars were installed. DODD Bars consist of brackets with targets mounted on one machines and bars with proximity probes looking at the targets mounted on the other machine.

By monitoring the changes in the DC gap voltages and graphing the results it was possible to measure the amount of vertical and horizontal movement of the turbine relative to the pump.

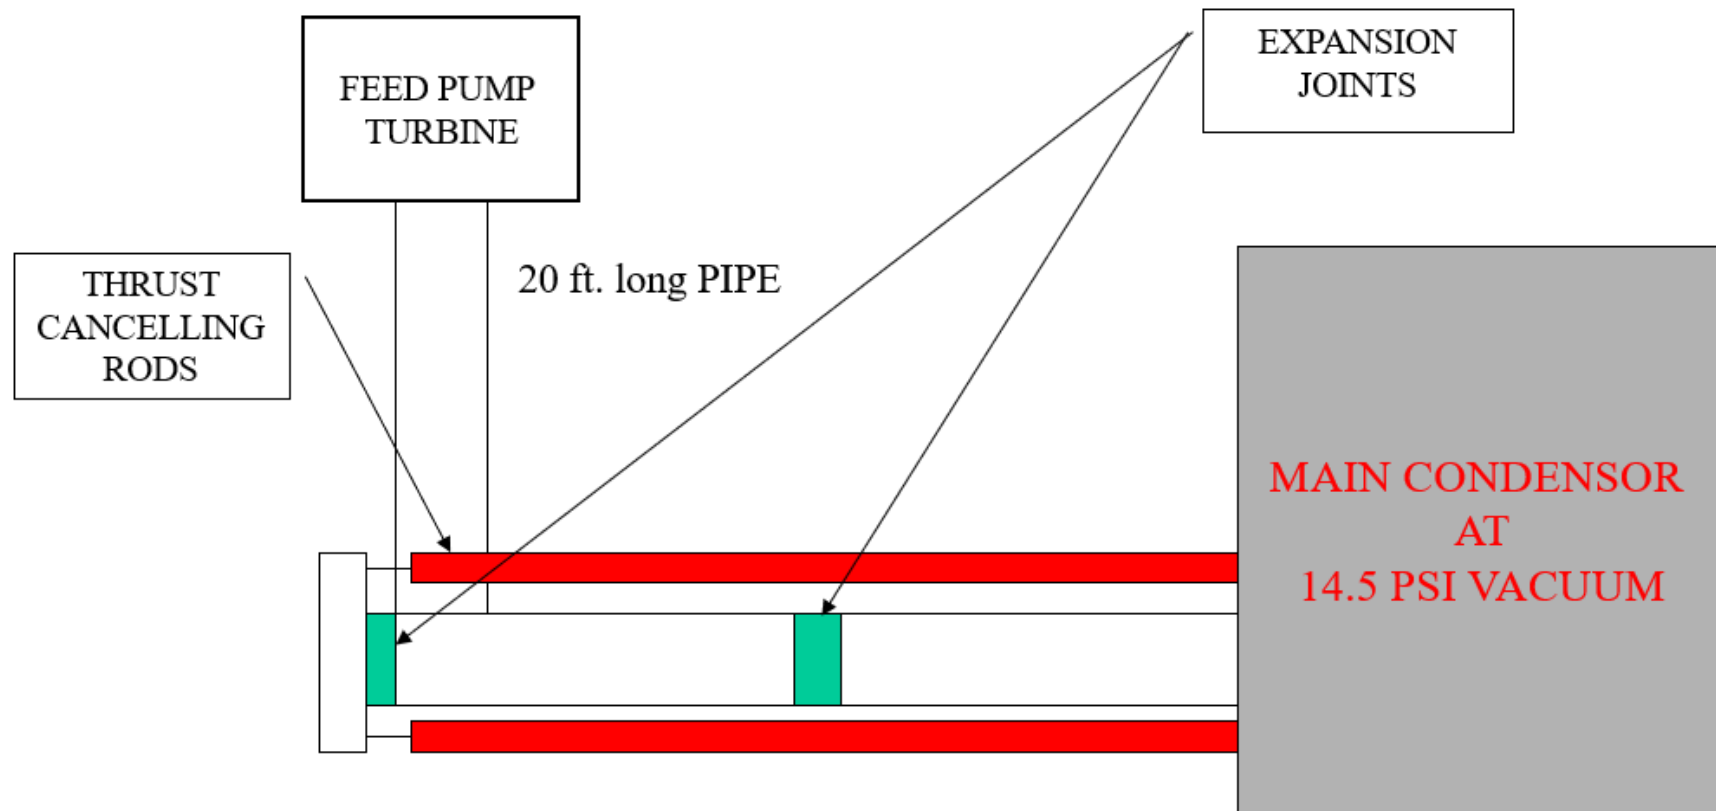
Diagram of feed pump and condenser piping

When Vacuum was broken, the alignment moved over 100 mils.

Examination of thrust cancelling rods showed movement of thrust cancelling rod.

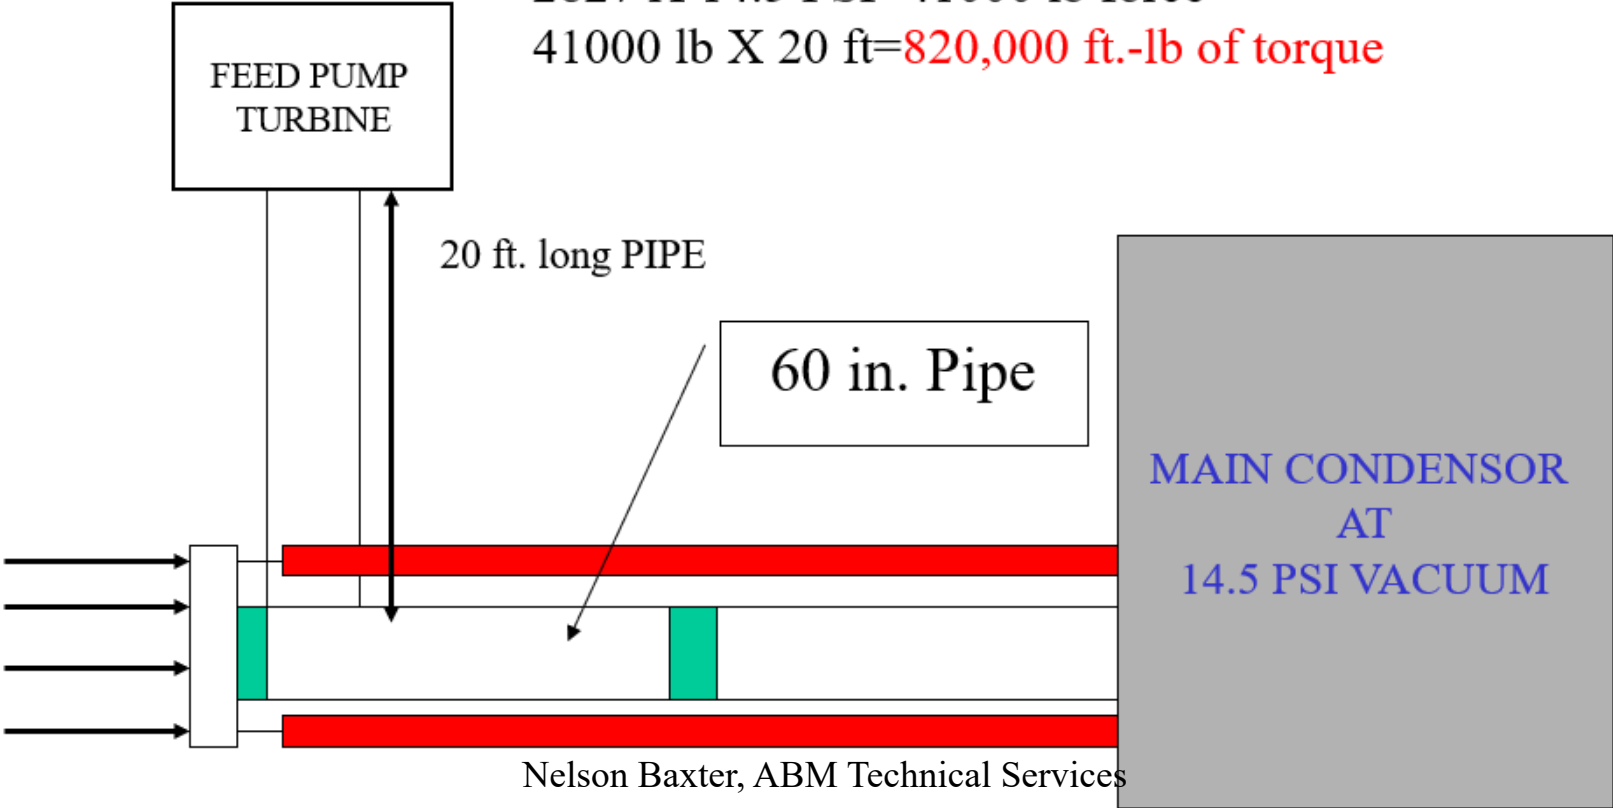
60 " PIPE
AREA = $\text{PI} \times 30 \times 30 = 2827$ square inches
 $2827 \times 14.5 \text{ PSI} = 41000$ lb force
 $41000 \text{ lb} \times 20 \text{ ft} = 820,000 \text{ ft.-lb of torque}$

- This case illustrates how a simple weld failure had a large effect. When the weld on the nut of the original design failed, that prevented the force cancelling rods from doing their job. This resulted in a torque of 820,000 lb-ft being applied to the turbine which caused a very large change in its alignment.

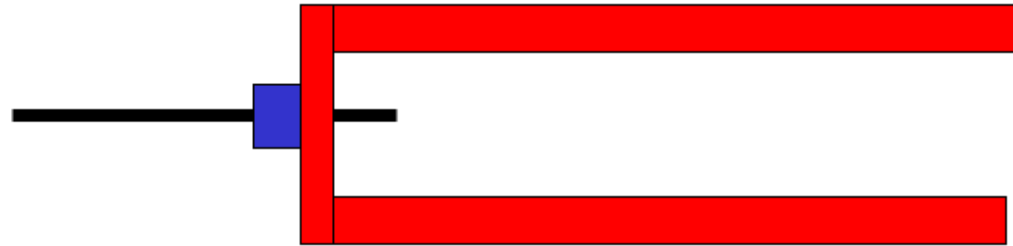
FORCE PUSHES AGAINST END CAP INSTEAD OF
PULLING ON WELD

- PUT NUT ON OUTSIDE OF END CAP

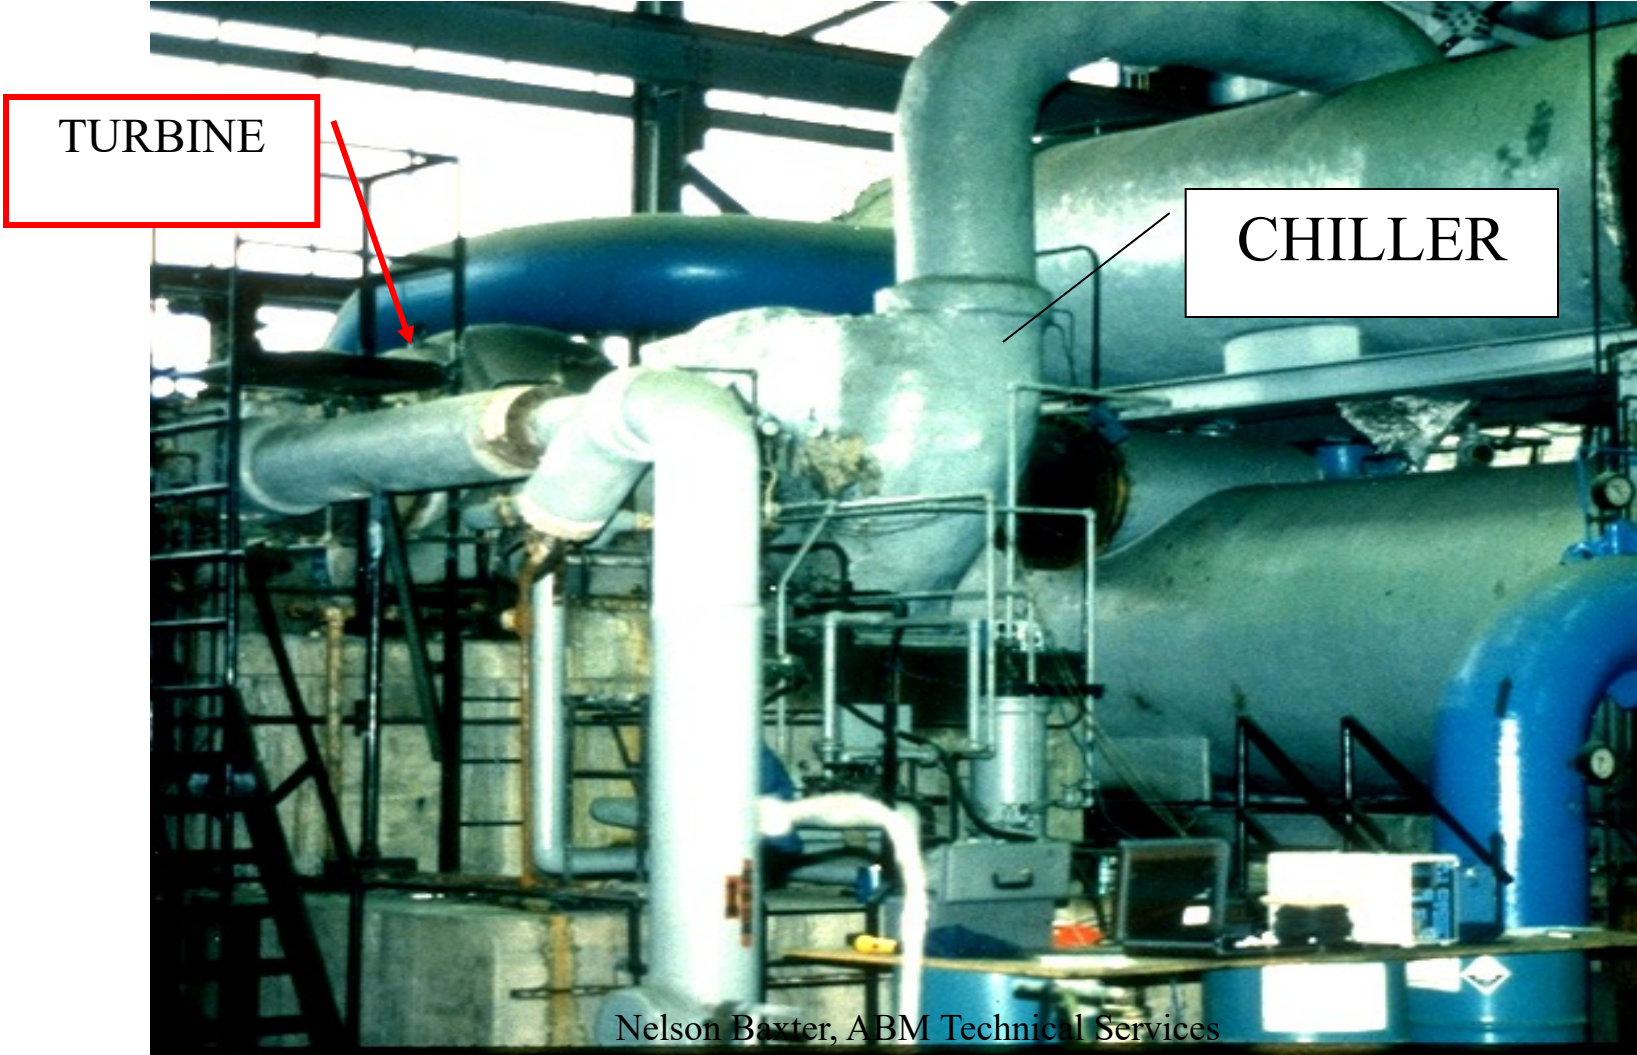
MACHINE SETUP

CHILLER TURBINE WAS DESTROYING BEARINGS

UPPER HALF OF
BEARINGS WERE
FAILING BY FATIGUE

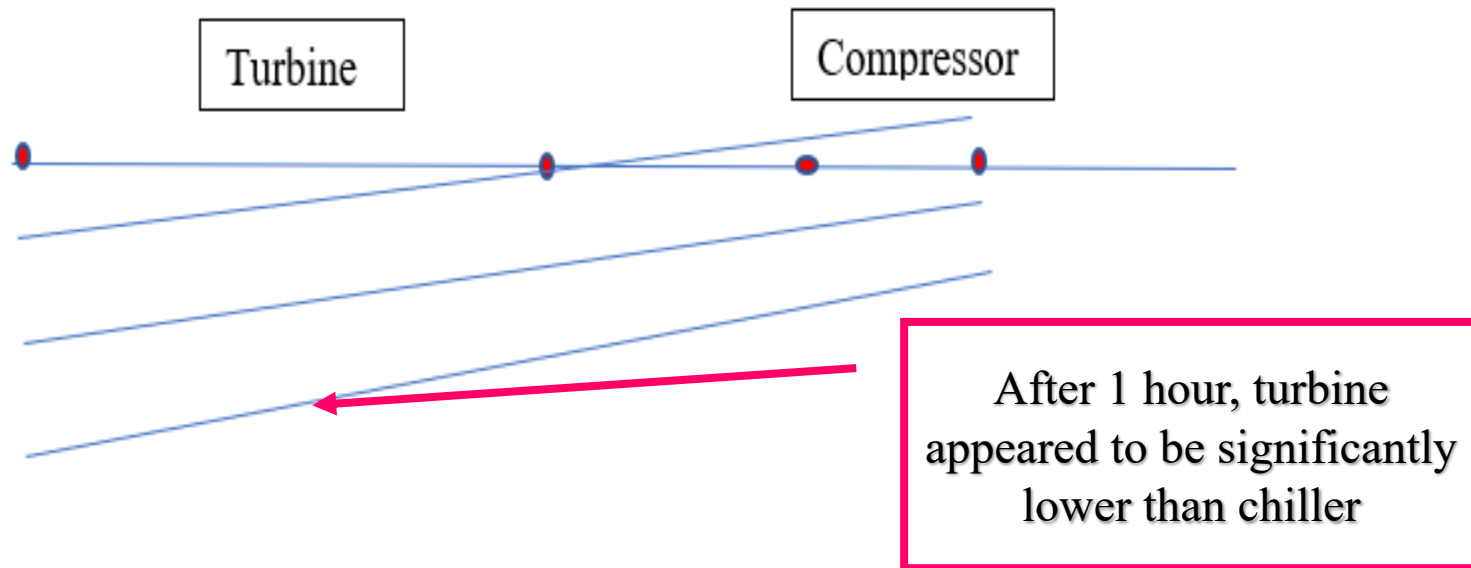
The alignment would vary with time. The plot below shows the movement over a two-hour period following a typical startup. The graph shows that the turbine would appear to drop relative to the compressor. The movement below occurred over the first hour of operation.

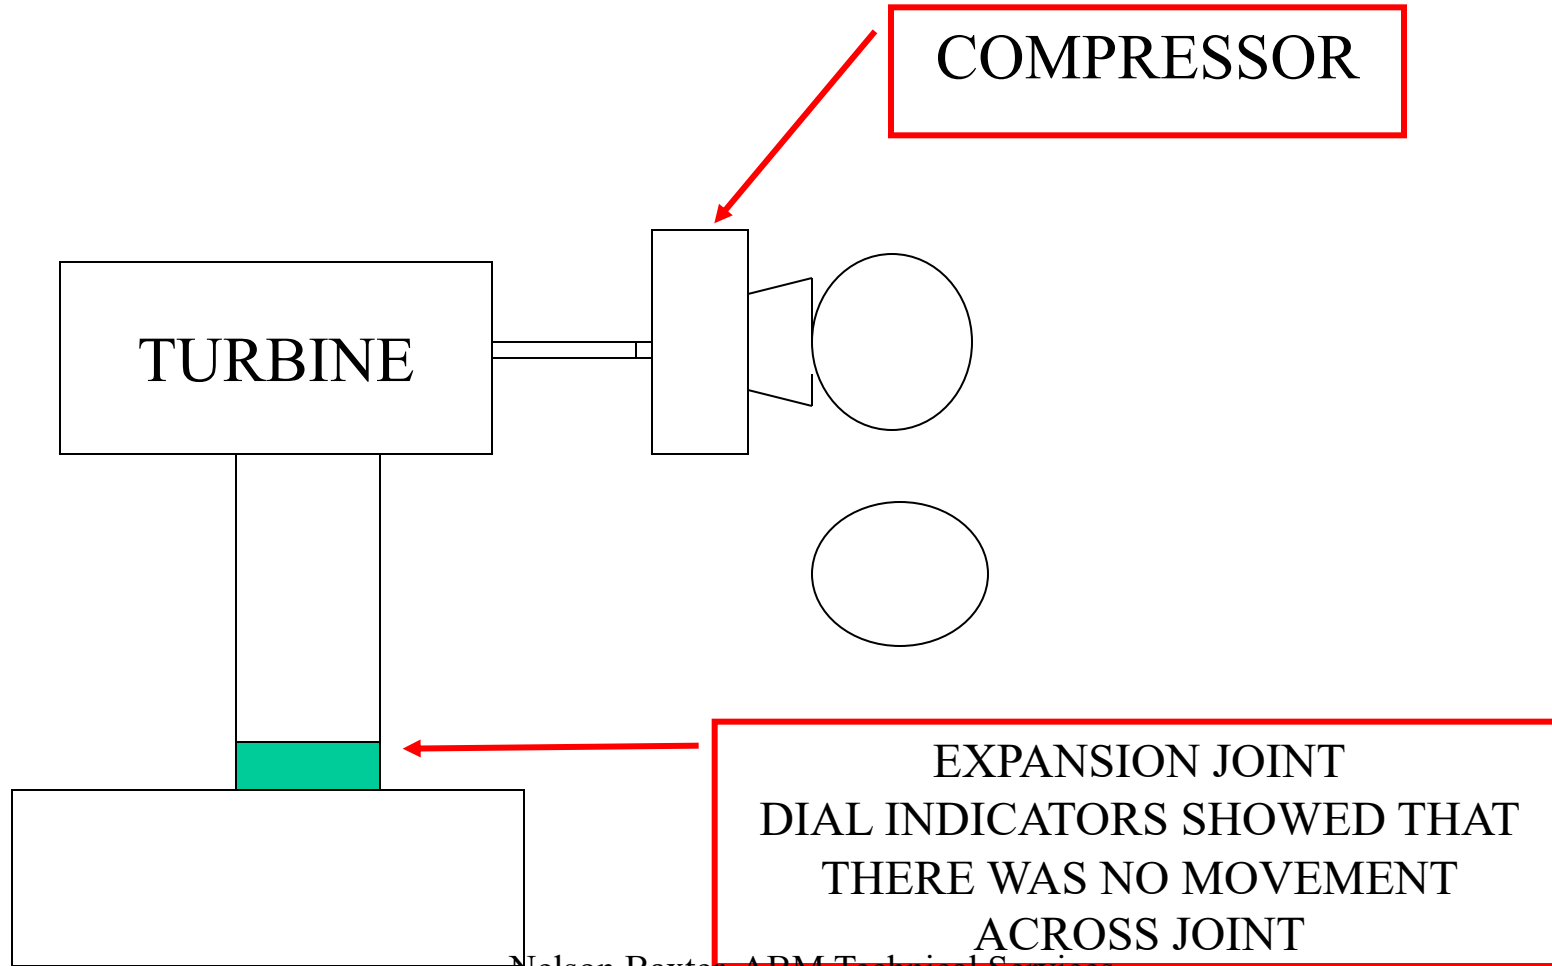
TEST RESULTS

During the time while the alignment changed, there was no movement detected between the turbine and the condenser.

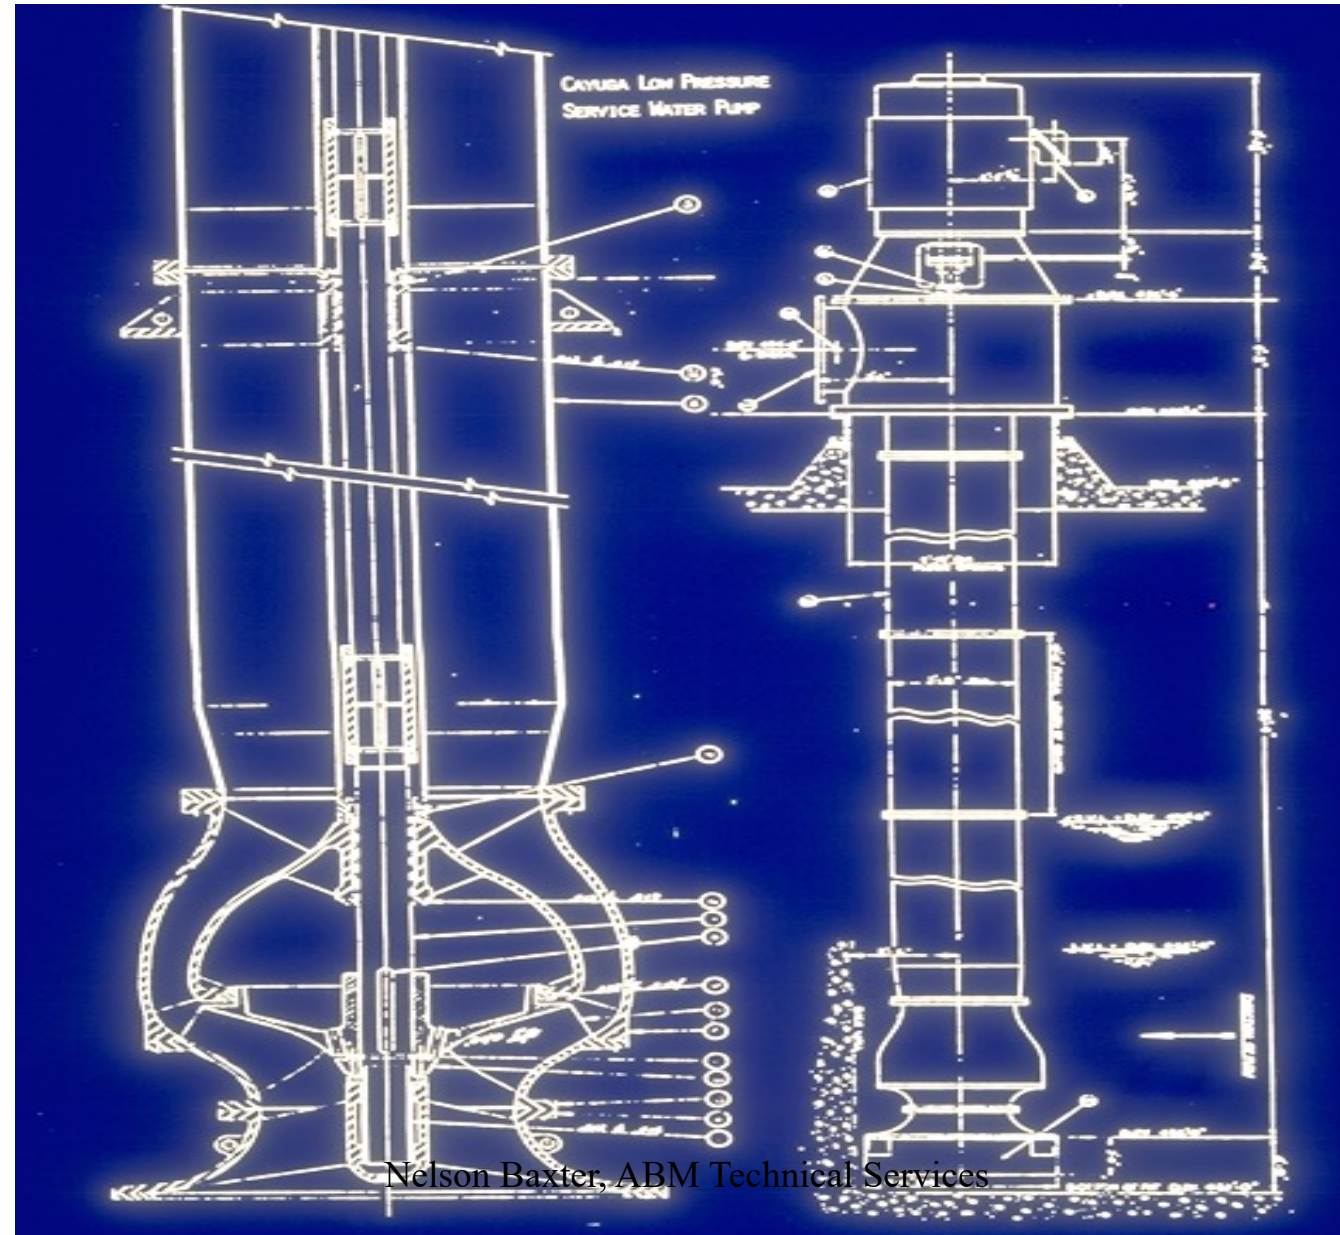
CROSS SECTION OF PUMP

AFTER SIX PUMP SHAFTS HAD BROKEN, TESTS WERE RAN TO DETERMINE CAUSE. THE PUMPS HAD OPERATED FOR MANY YEARS WITH NO PROBLEMS THEN THE SHAFTS STARTED TO BREAK.

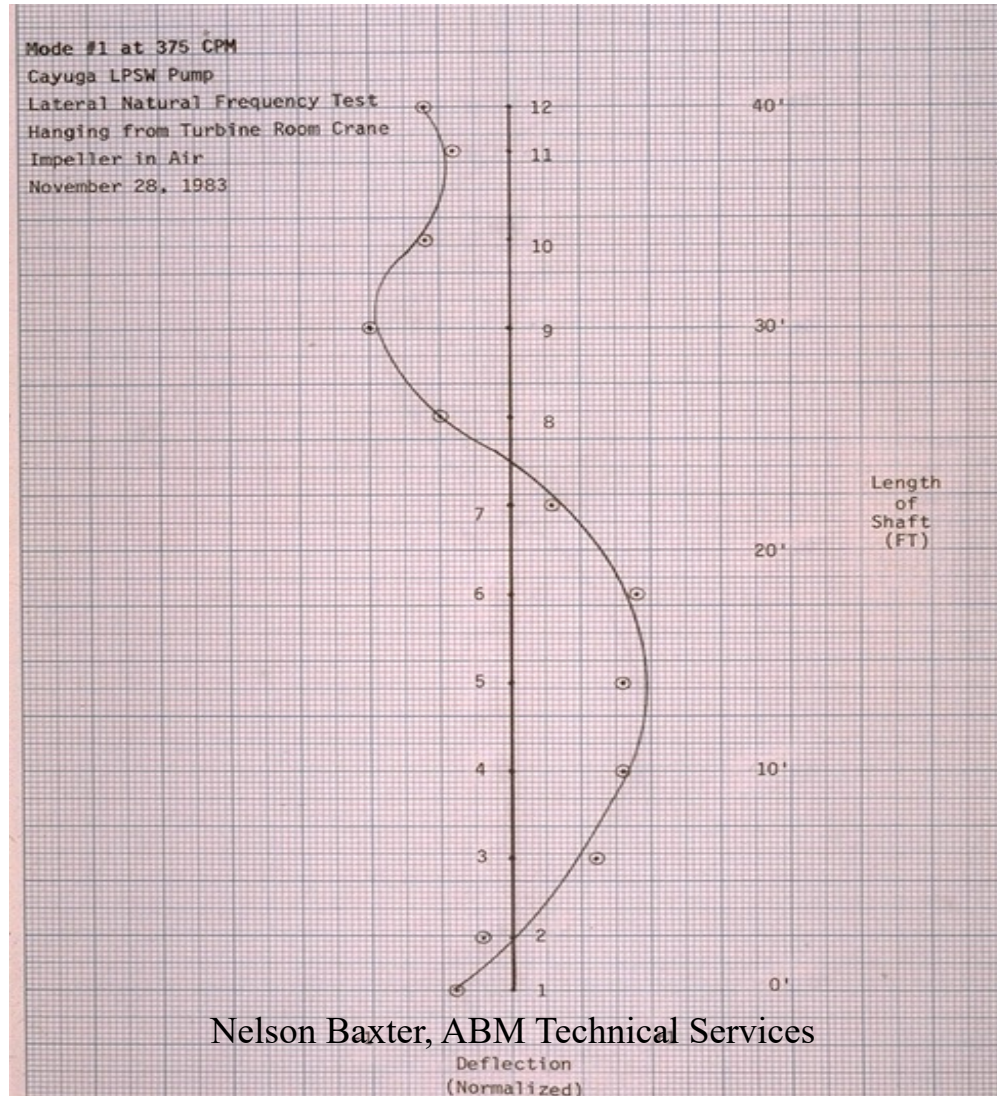
1 St MODE 375 CPM

When the vibration spectra were examined, there was no dominant frequency. What was found was the vibration was broad band in nature and centered around 375 cpm. This frequency matched the first bending mode of the shaft. When synchronous time averaging was applied there was almost no running speed vibration. There was no measurable torsional vibration present. This agreed with the type of breaks that were occurring which did not show any signs of torsional fatigue.

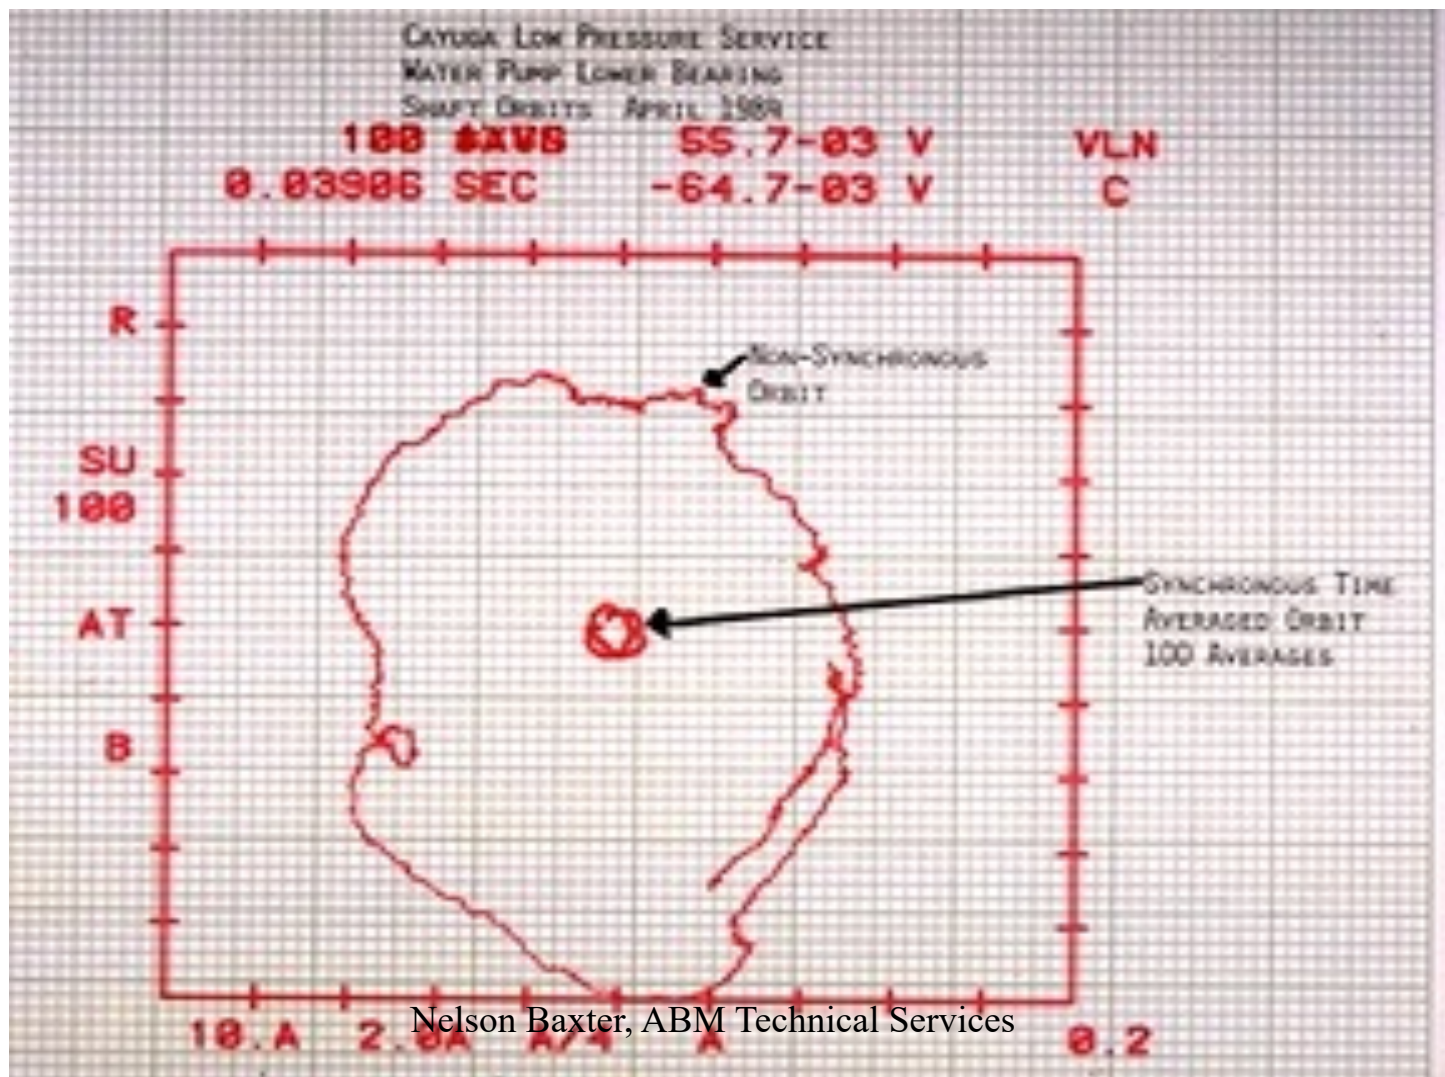
ORBIT

PROX PROBES
INSTALLED 90
DEGREES
APART

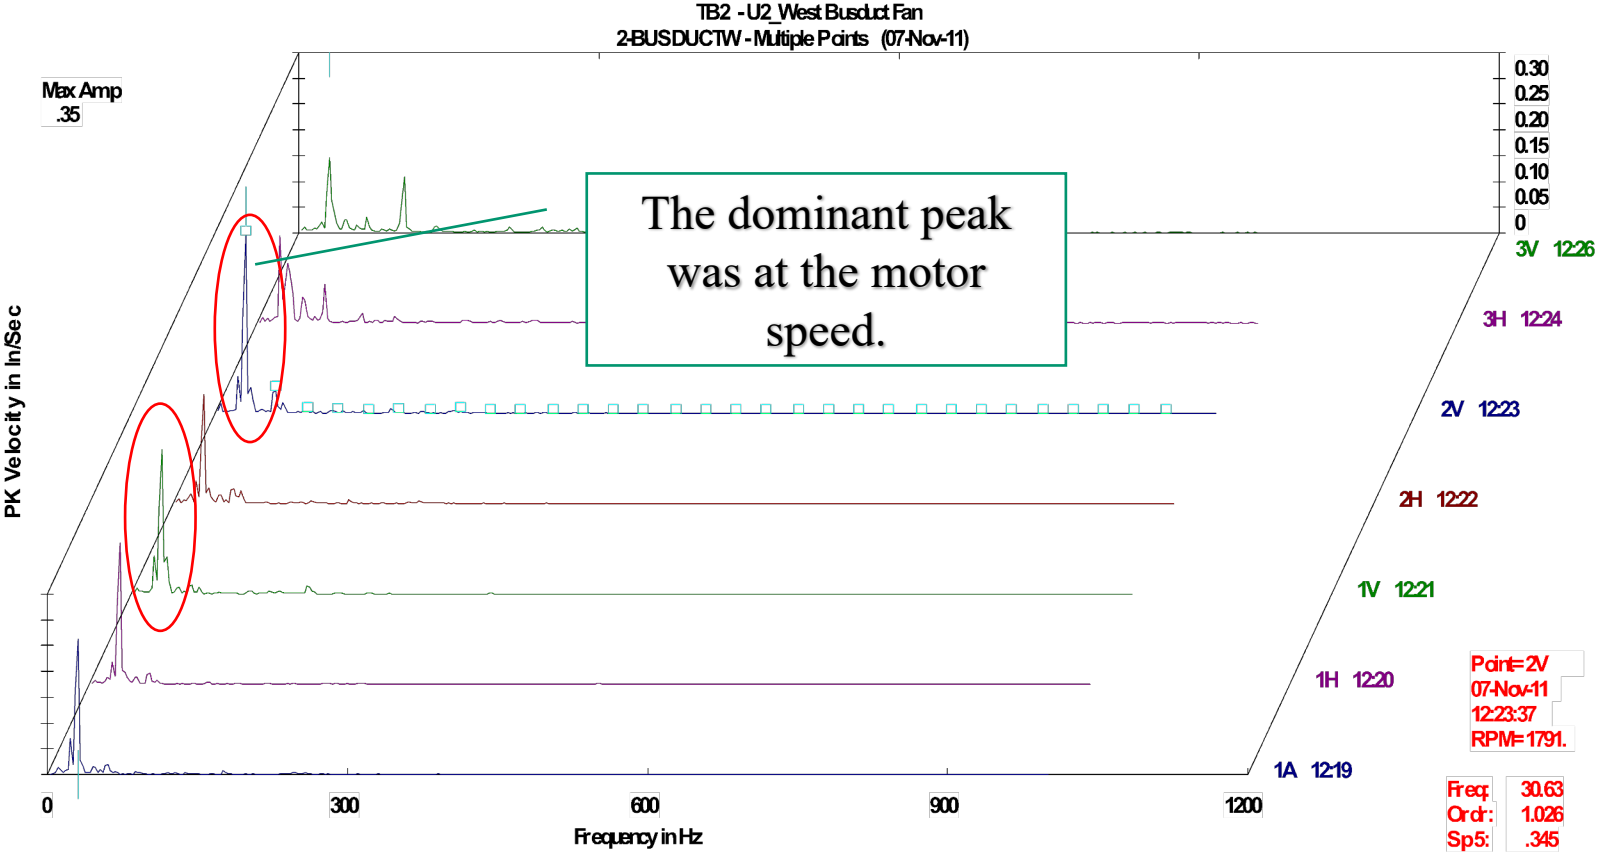
Motor vibration levels were above alarm point. All vibration was at motor speed.

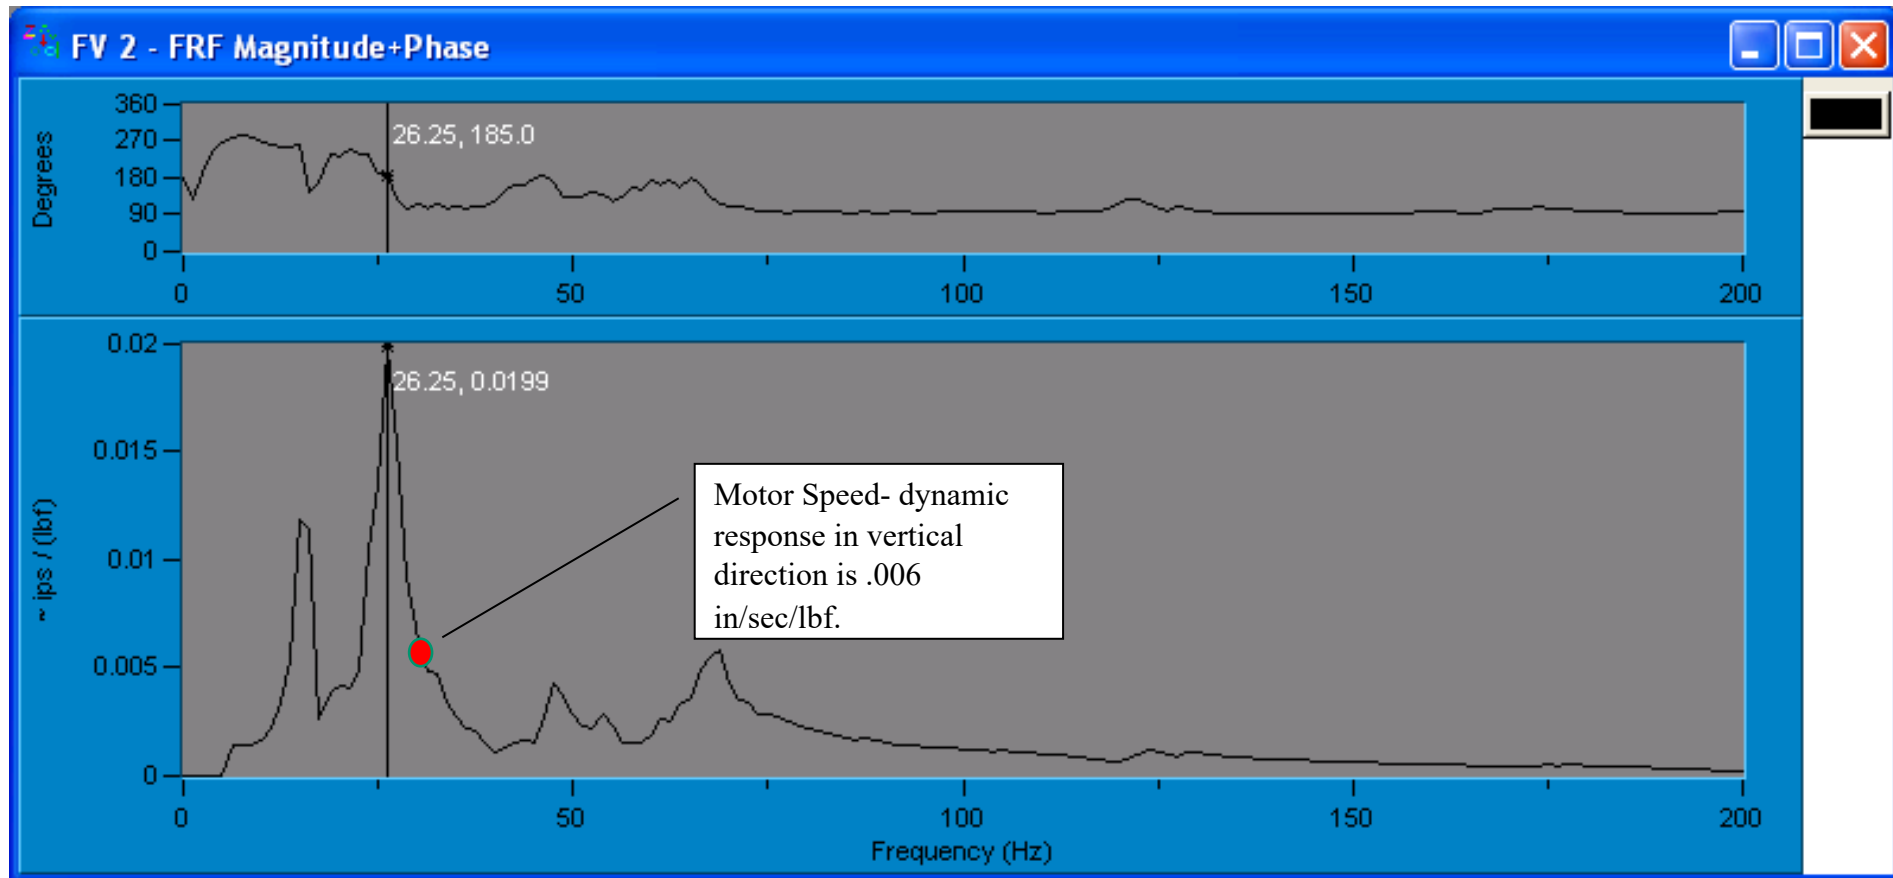
Resonance Test Results showed there was some amplification due to a resonance located around 15% below the operating speed.

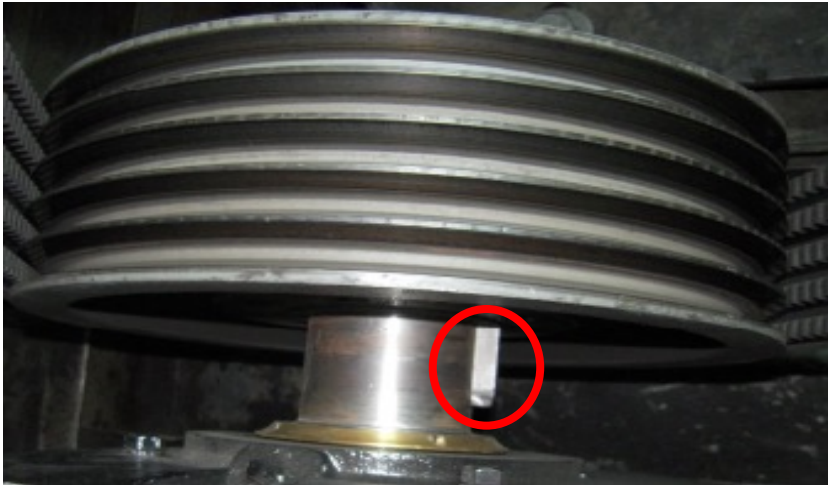
Further Examination showed presence of excess key.

Question: Was excess key enough to cause the vibration levels to be in alarm?

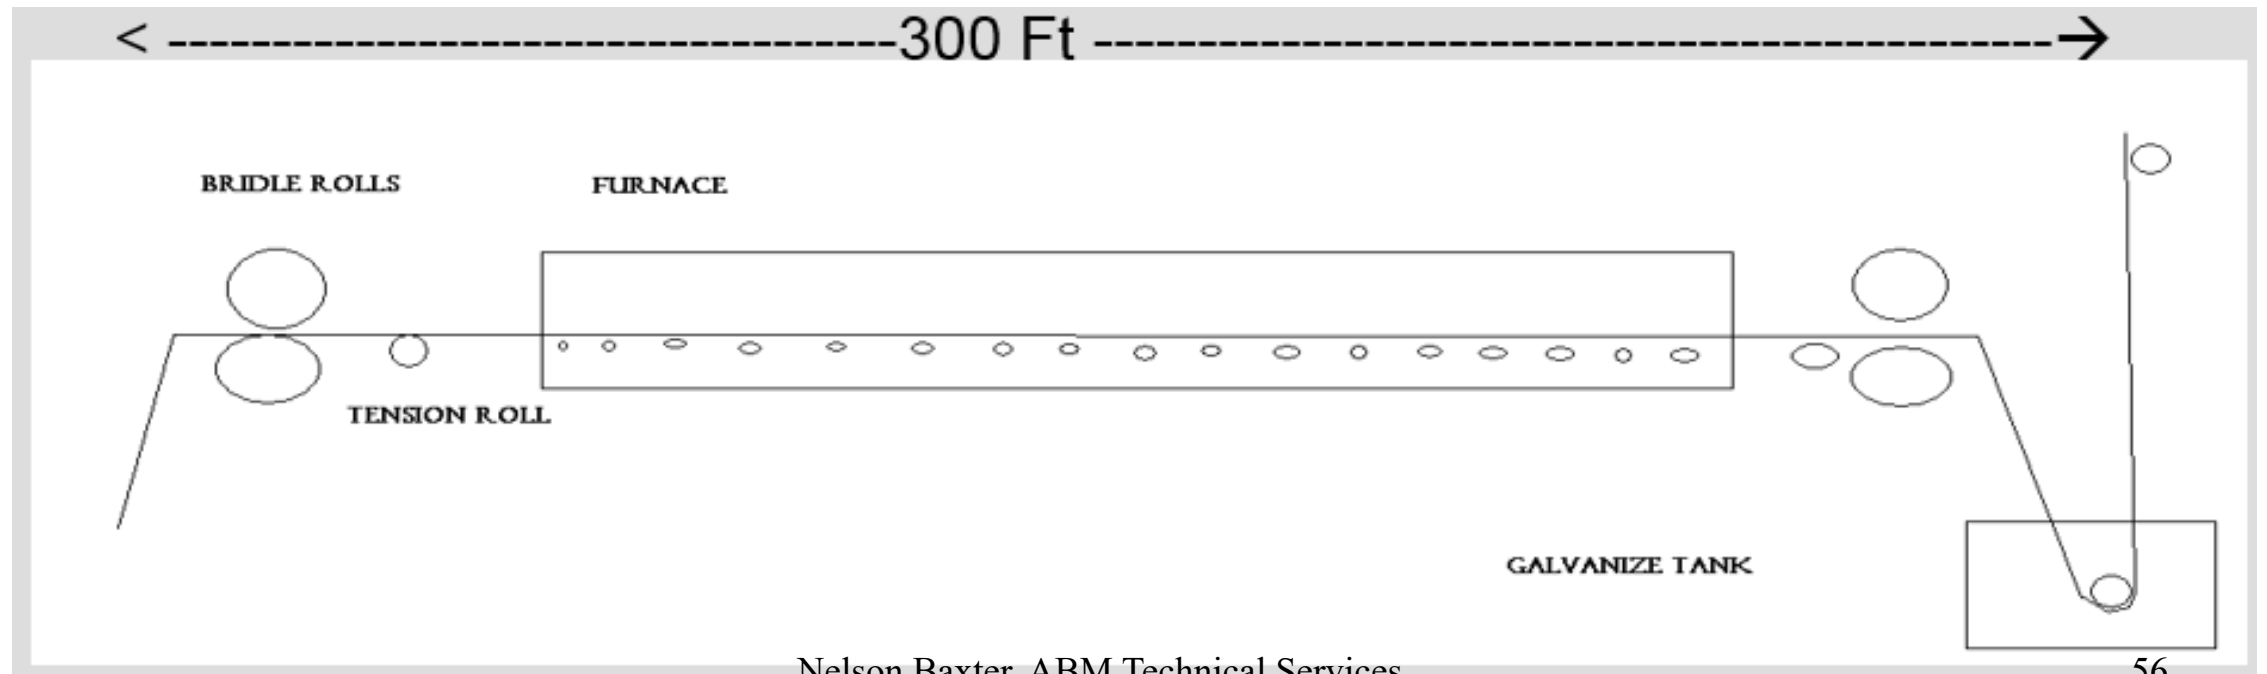
- A steel mill in the Midwestern part of the US had a 7 Hz vibration on its galvanize line. The galvanize line was over 300 ft. in length and this entire large structure would vibrate noticeably at the 7 Hz frequency. Noticeable levels of speed oscillation were seen on the bridle rolls.

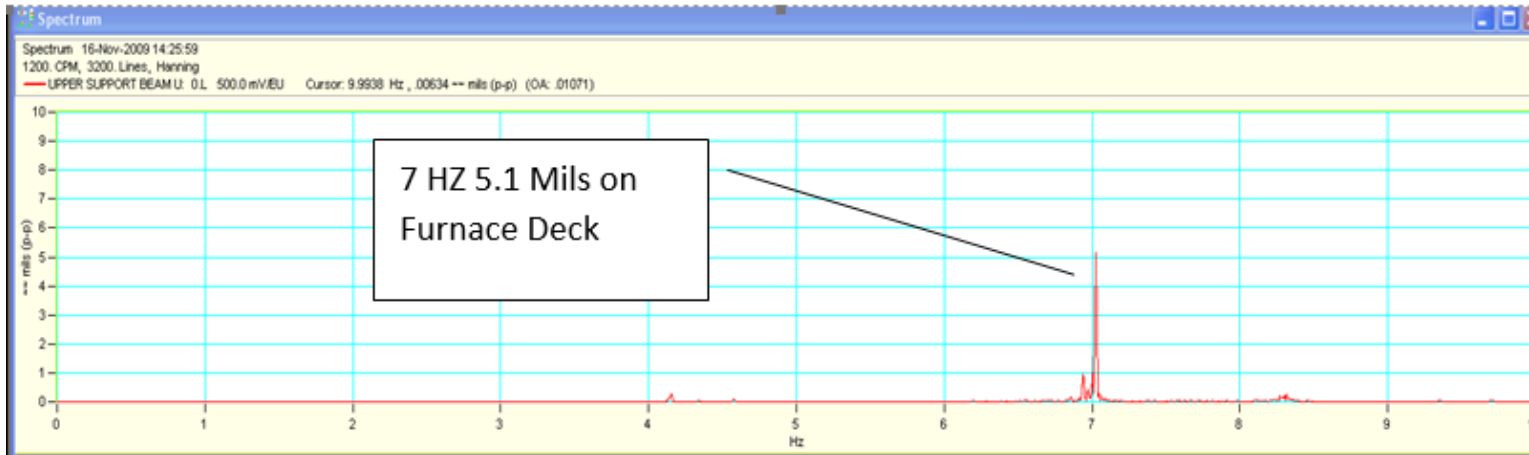
Lateral vibration seen on furnace deck

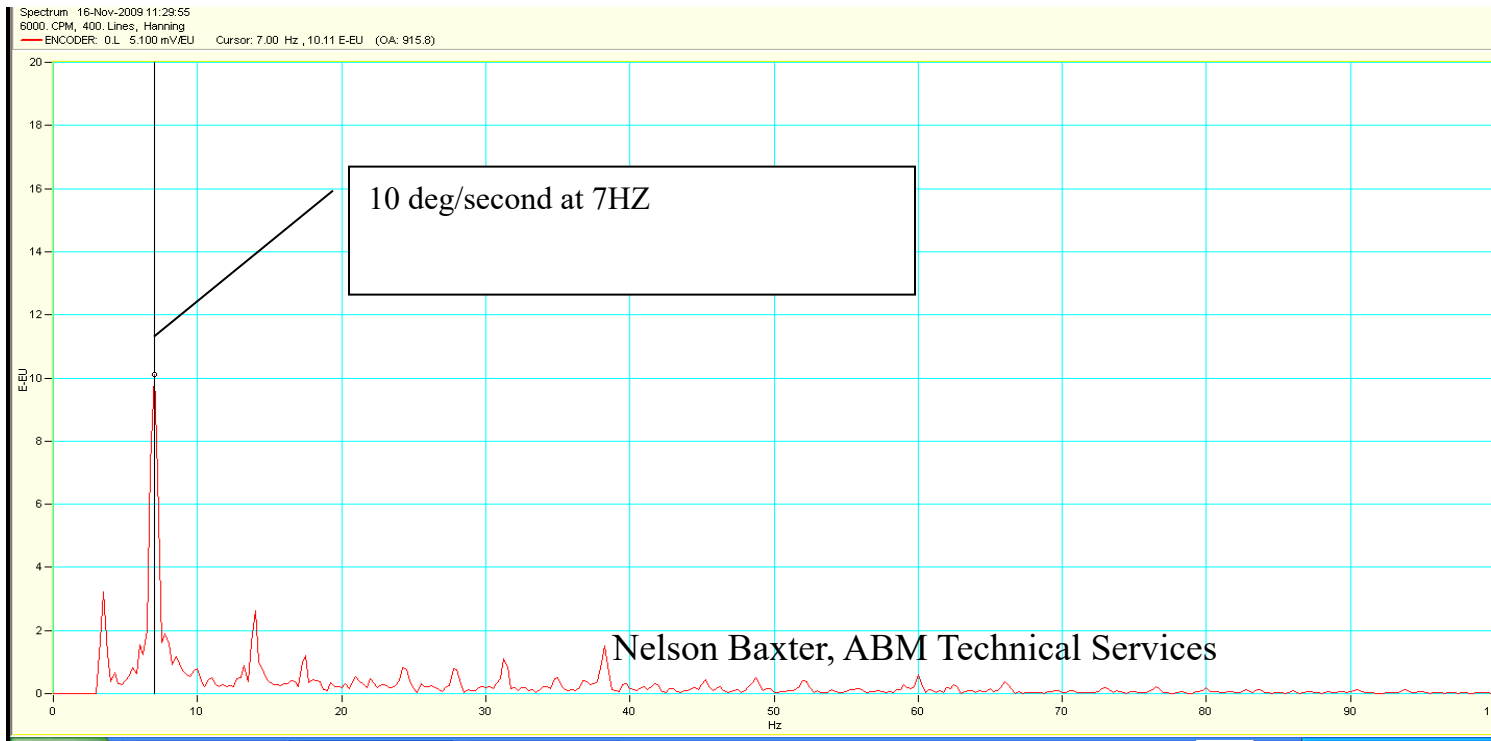
Torsional vibration measured on rolls

The speed on the steel strip was changed and the frequency of the torsional vibration and the lateral vibration exactly tracked the steel strip speed.

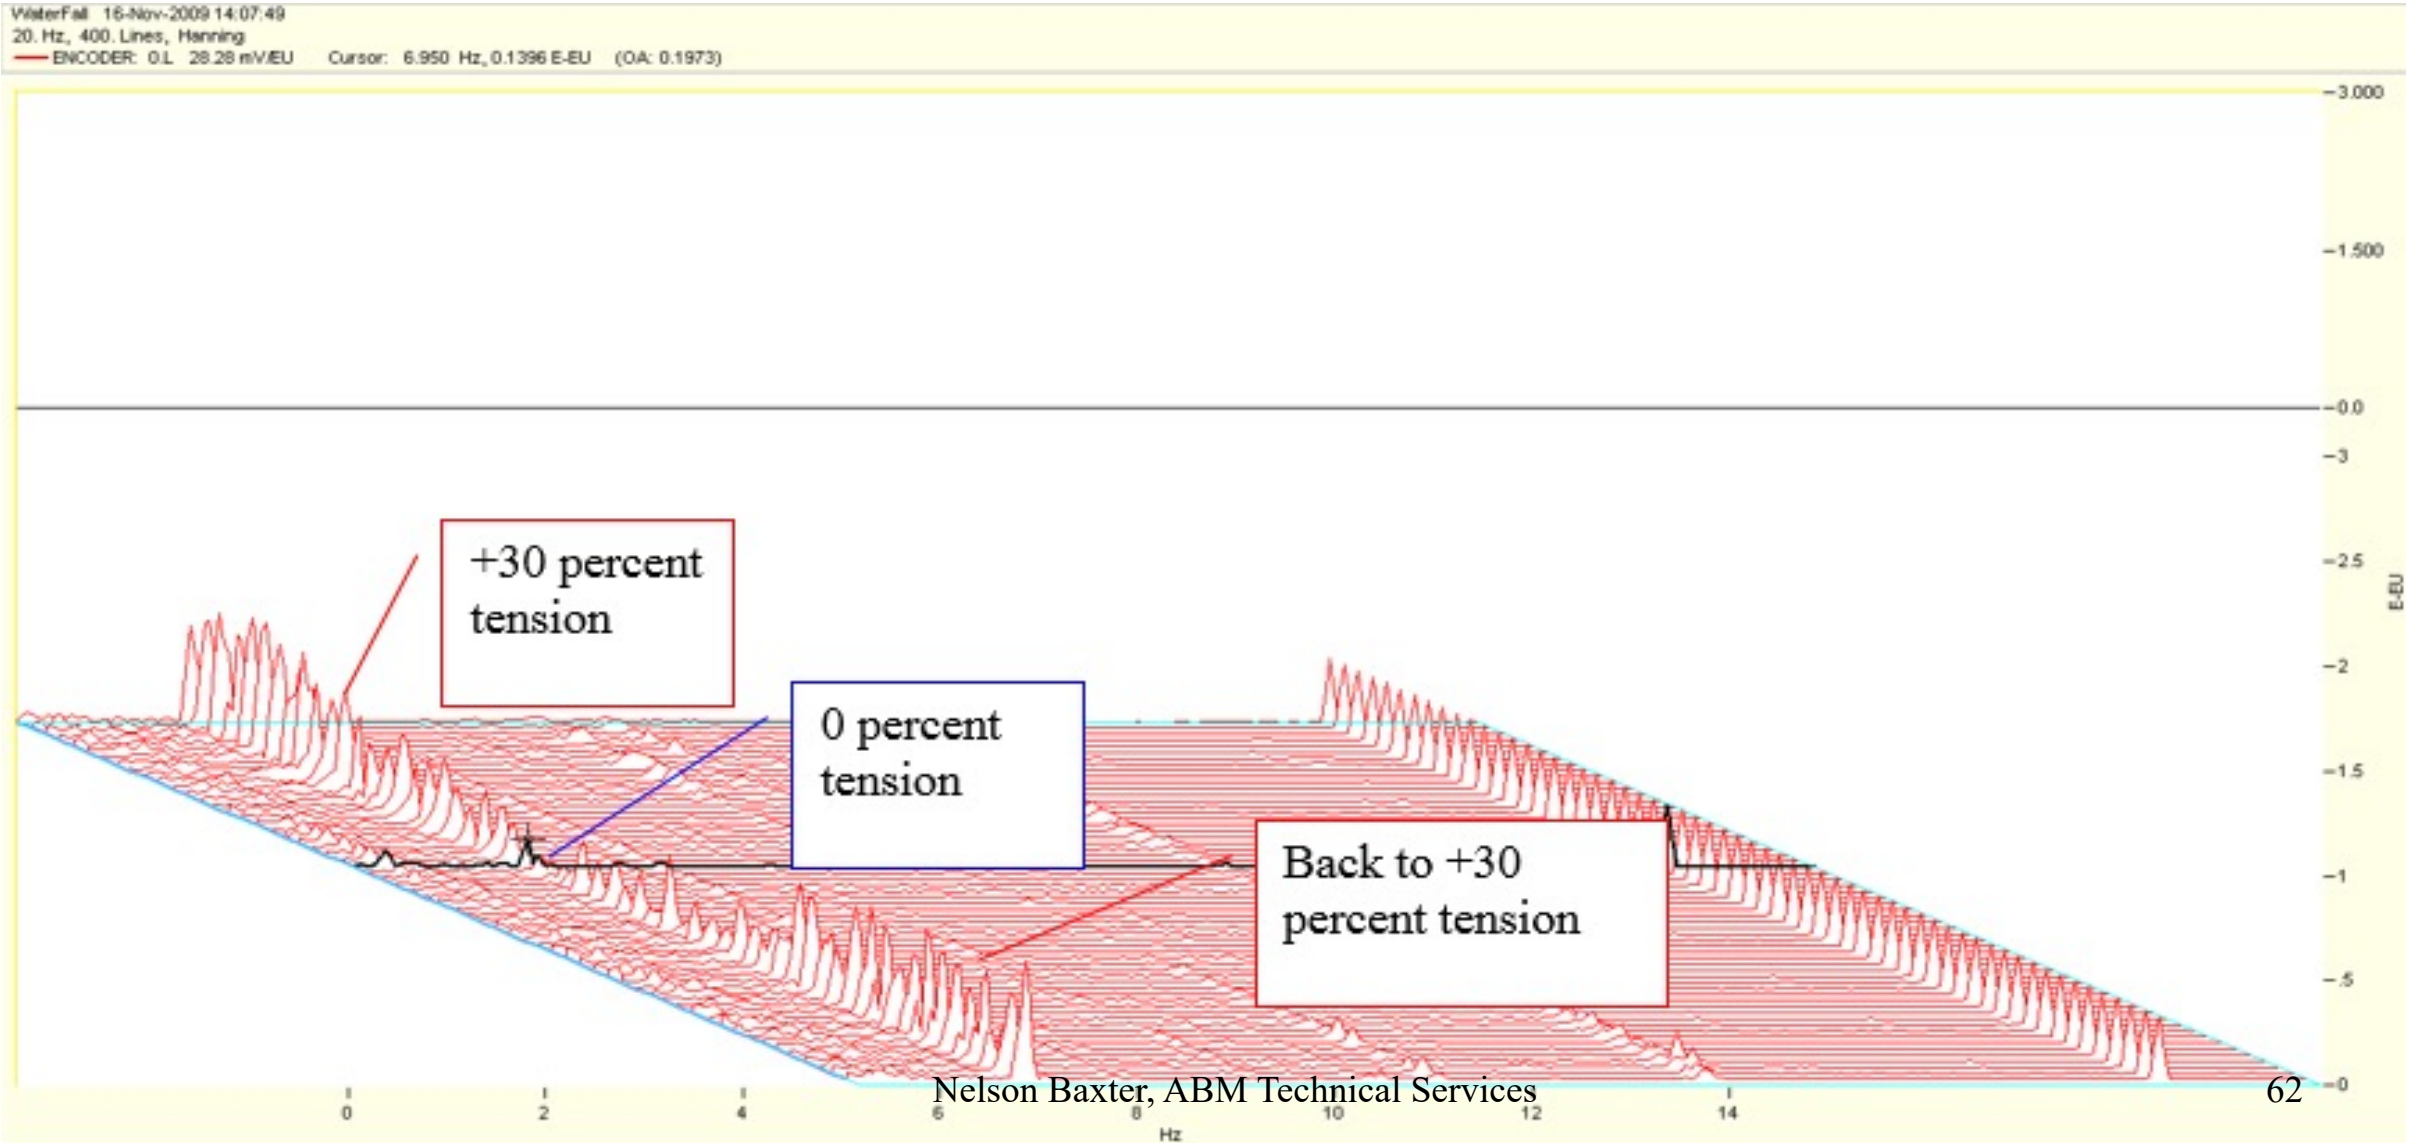
Map Plot of torsional vibration as tension was varied

Both the torsional vibration on the rolls and the structural vibration showed the amplitude of the 7 Hz frequency was directly related to the tension on the steel strip. However, the source of the stimulus that was causing the entire structure to vibrate was still unknown.
