The Dirty Dozen

The 12 Most difficult problems I have worked on during the last 45 years of troubleshooting vibration related problems

Nelson Baxter

Presented For The Vibration Institute, Piedmont Chapter, May 2023

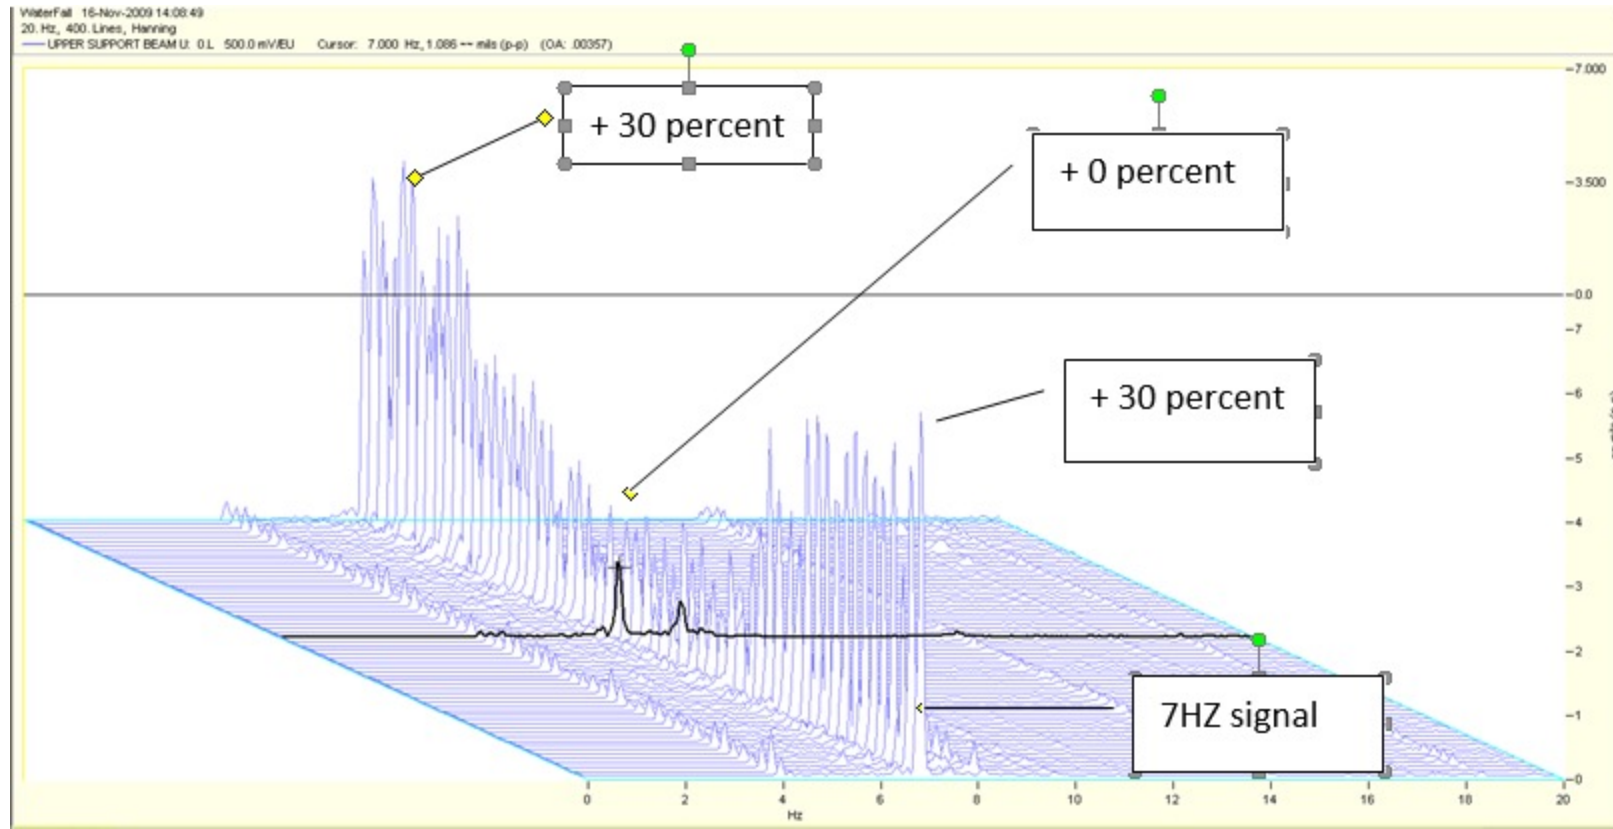
Map plot of lateral vibration as steel strip tension was adjusted.

Both the torsional vibration on the rolls and the structural vibration showed the amplitude of the 7 Hz frequency was directly related to the tension on the steel strip. However, the source of the stimulus that was causing the entire structure to vibrate was still unknown.

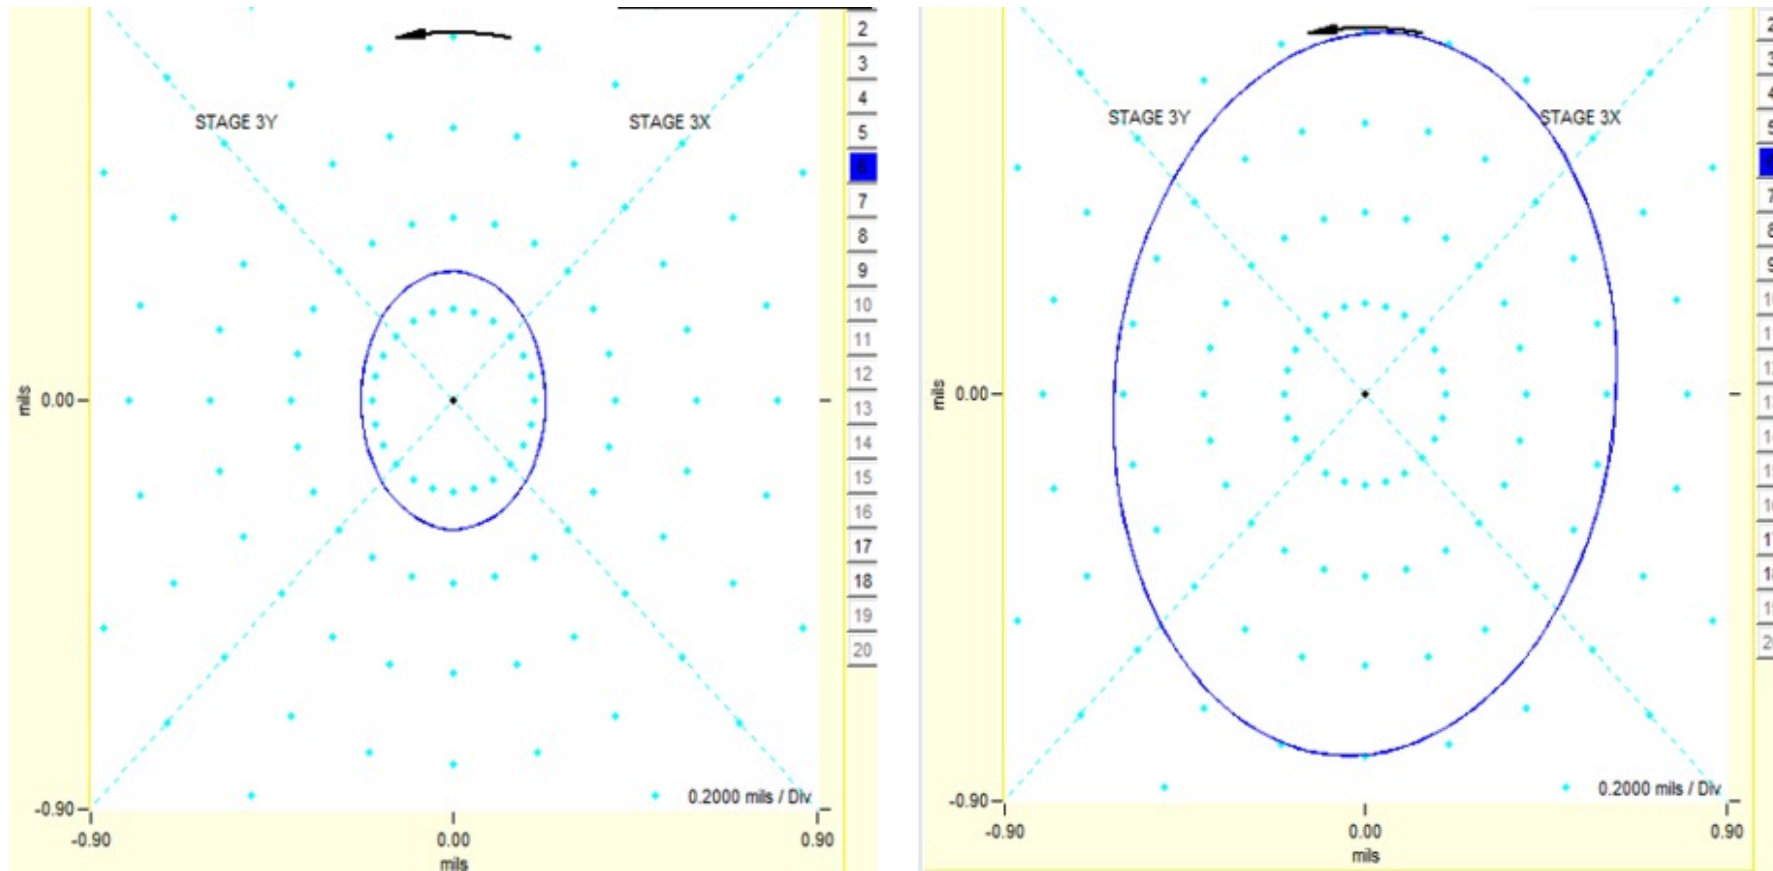
Symptoms of problem: The vibration on both stage 3 proximity probes would slowly increase in amplitude followed by an equally slow decrease. The period of one oscillation was approximately 7 minutes. The peak in the amplitude would get higher each cycle until the compressor finally tripped on high vibration.

Orbits from low to high point in one 7 minute cycle

- The Morton effect occurs as a result of uneven heating of the shaft at the high spot caused by the residual unbalance of the impeller. Because of the high-speed nature of these overhung impellers, the point of the slightly elevated shaft temperature slightly lags the unbalance. This means the unbalance slowly rotates around the shaft casing to come in and out of phase with the unbalance. The heating also tends to slowly increase with each cycle. The solution was to change the bearing design to reduce the amount of shaft heating. This case is a good example of using various test techniques.

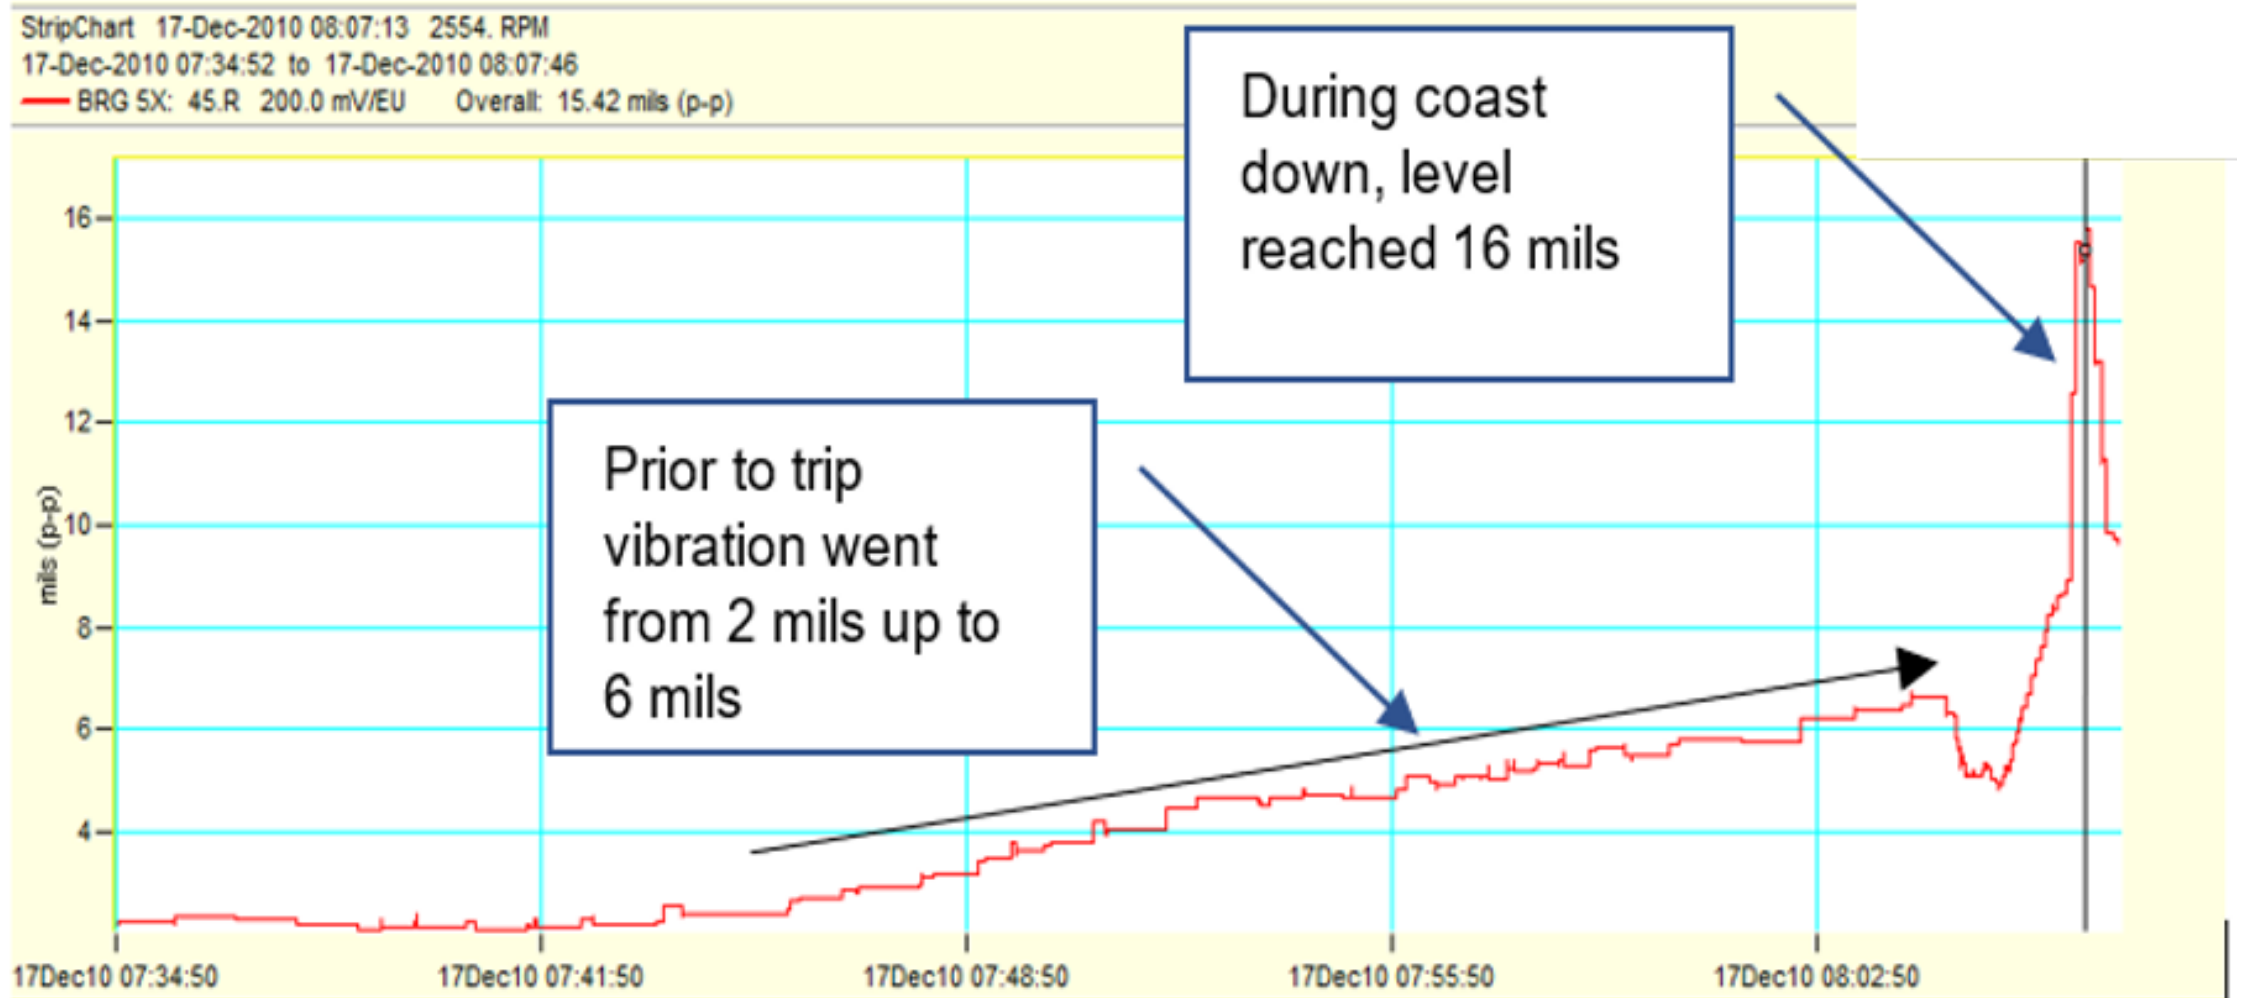
Strip Chart of B LP Rotor overall vibration level

LP Turbine Polar Plot with speed held constant. Rub is increasing vibration and changing phase.

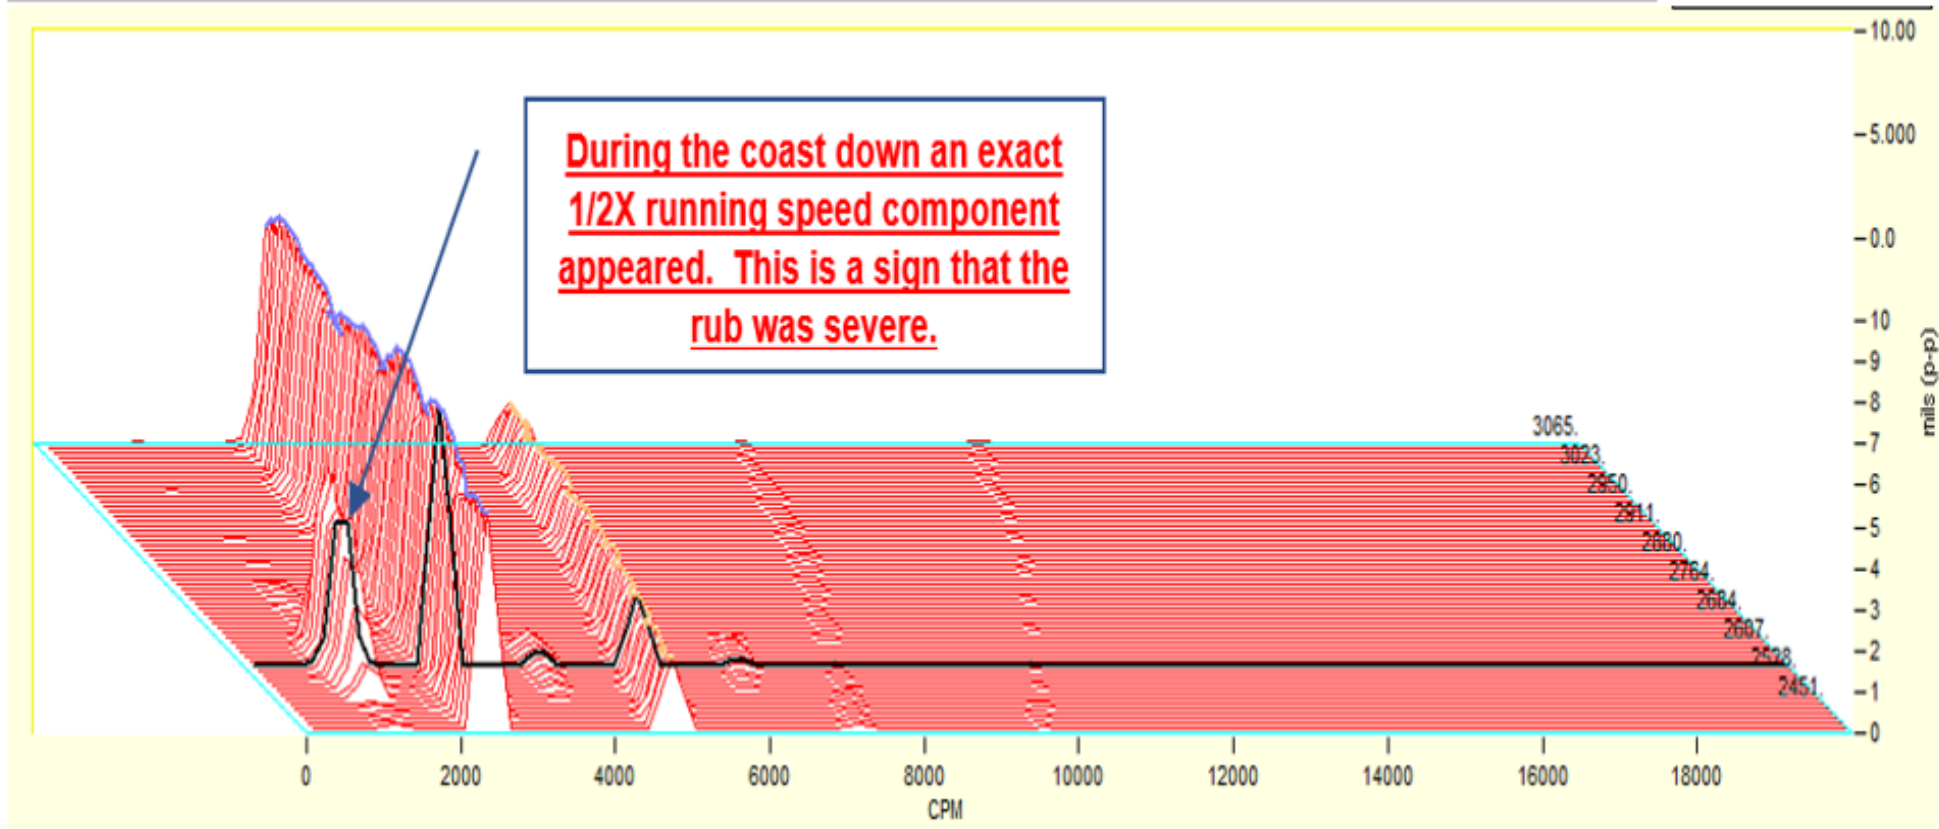
Spectrum with exact 1/2X Running Speed

- Polar Plot showed that at constant speed the amplitude was slowly increasing and the phase was changing.
- The map plot clearly showed the introduction of the $1/2X$ as the critical was traversed.
- The time plot with key phaser mark showed that the vibration was indeed exact $1/2X$
- It was discovered the LP rotor spray system was wired wrong causing the spray to be activated causing thermal distortion and the rub. Once it was fixed, the turbine started without incident.

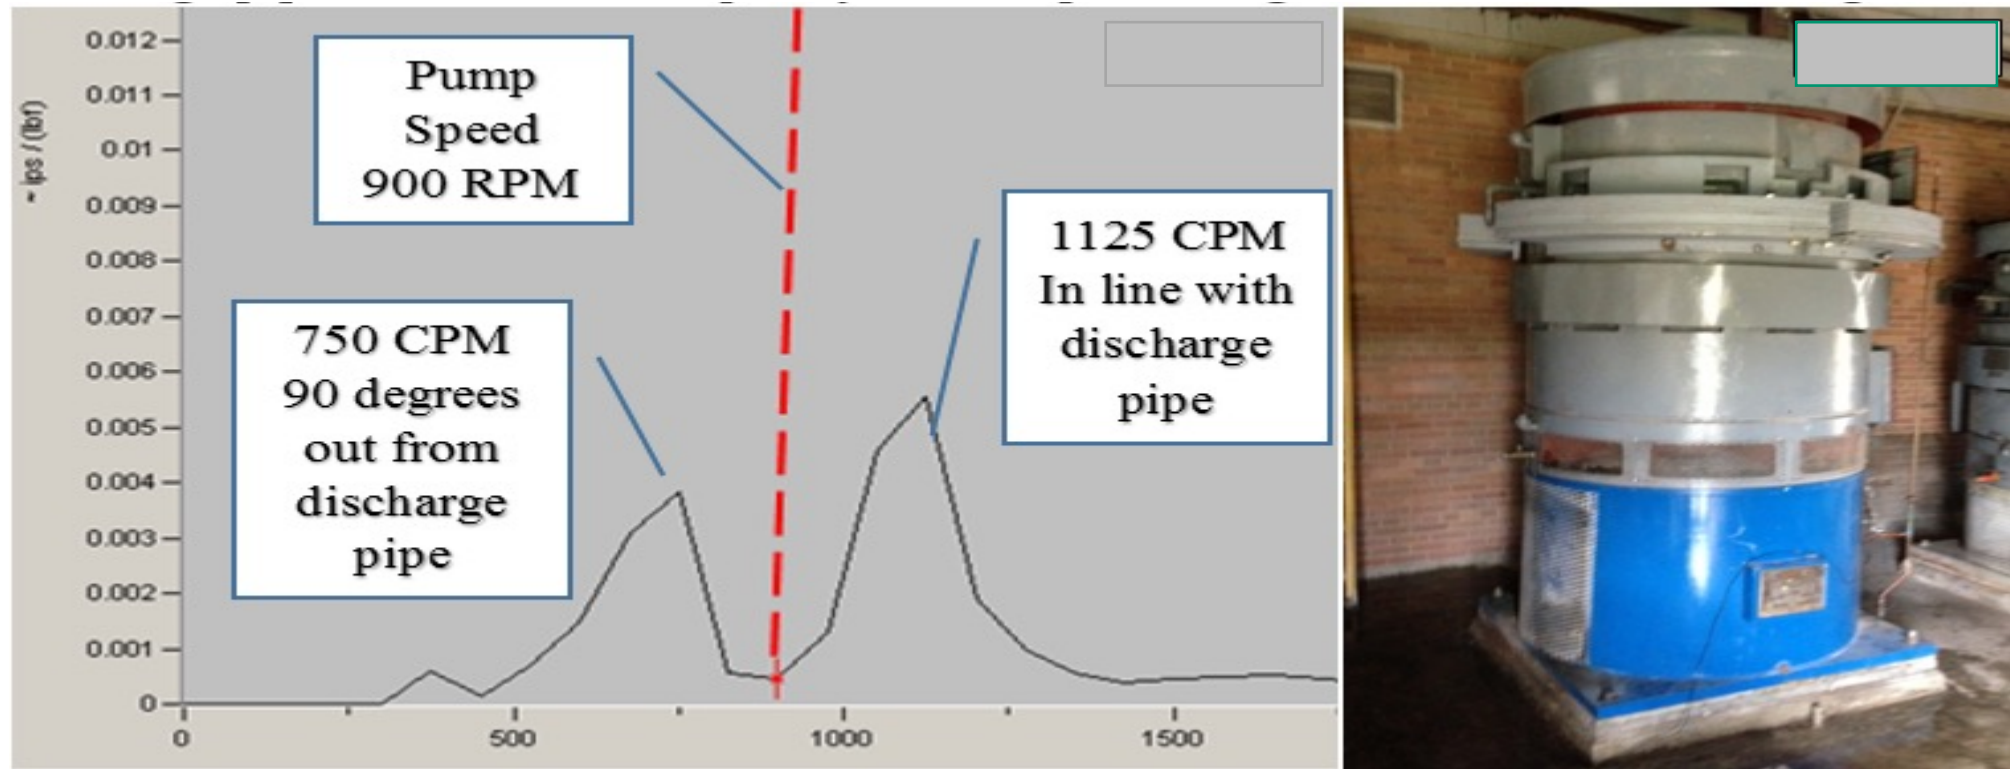
Impact Test Result

As predicted by the impact test, there was an amplified response at 750-800 RPM

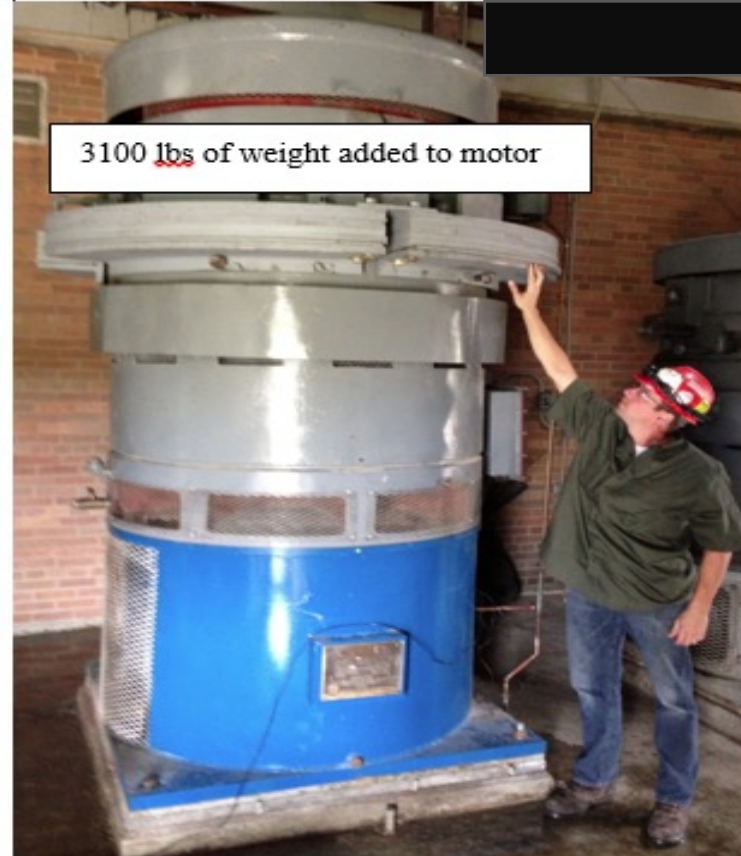
Vertical Pump with Mass added to reduce natural frequency

After installing 3100 lbs at top of motor, impact test was repeated.

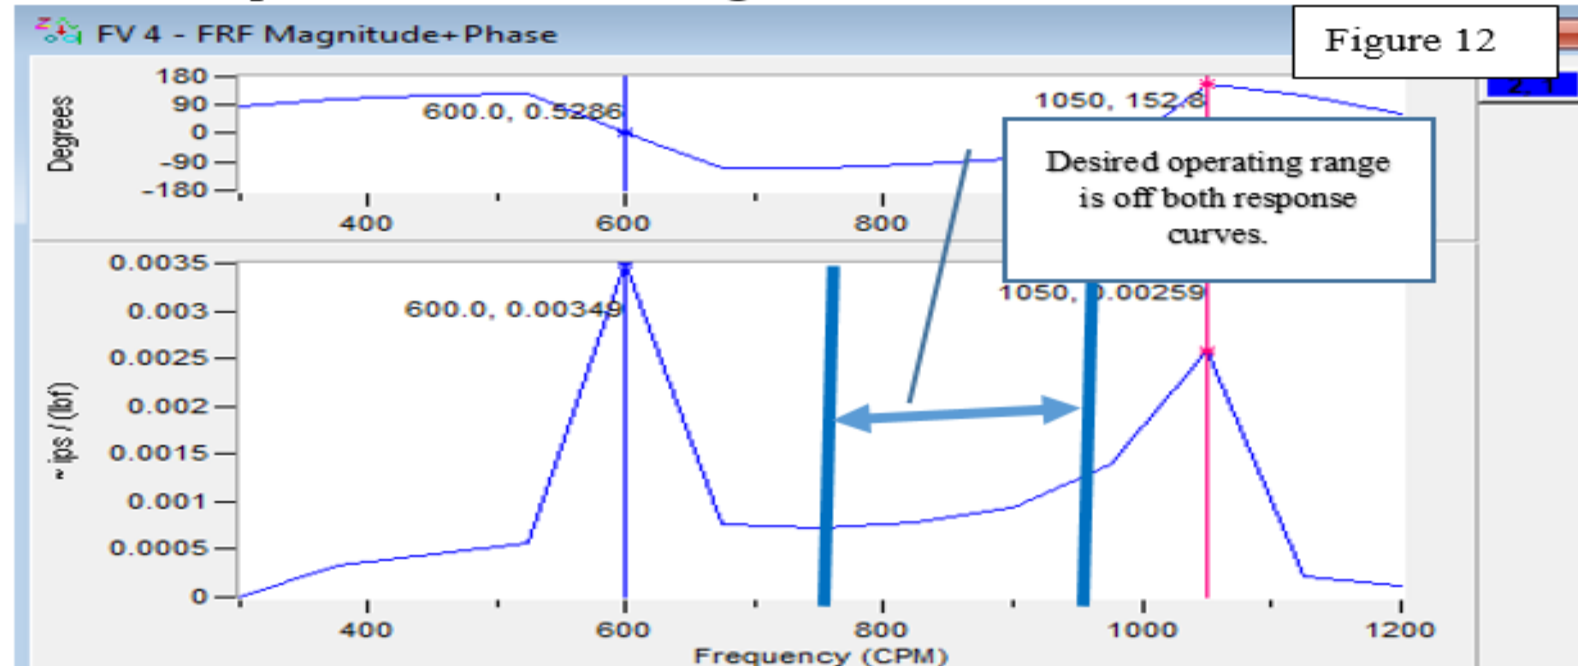
Actual Response Curve Following 21% Mass Increase

| | Before Mass | After Mass | |
|---|---|---|---|
| • In line Natural Frequency | 1125 | 1050 | |

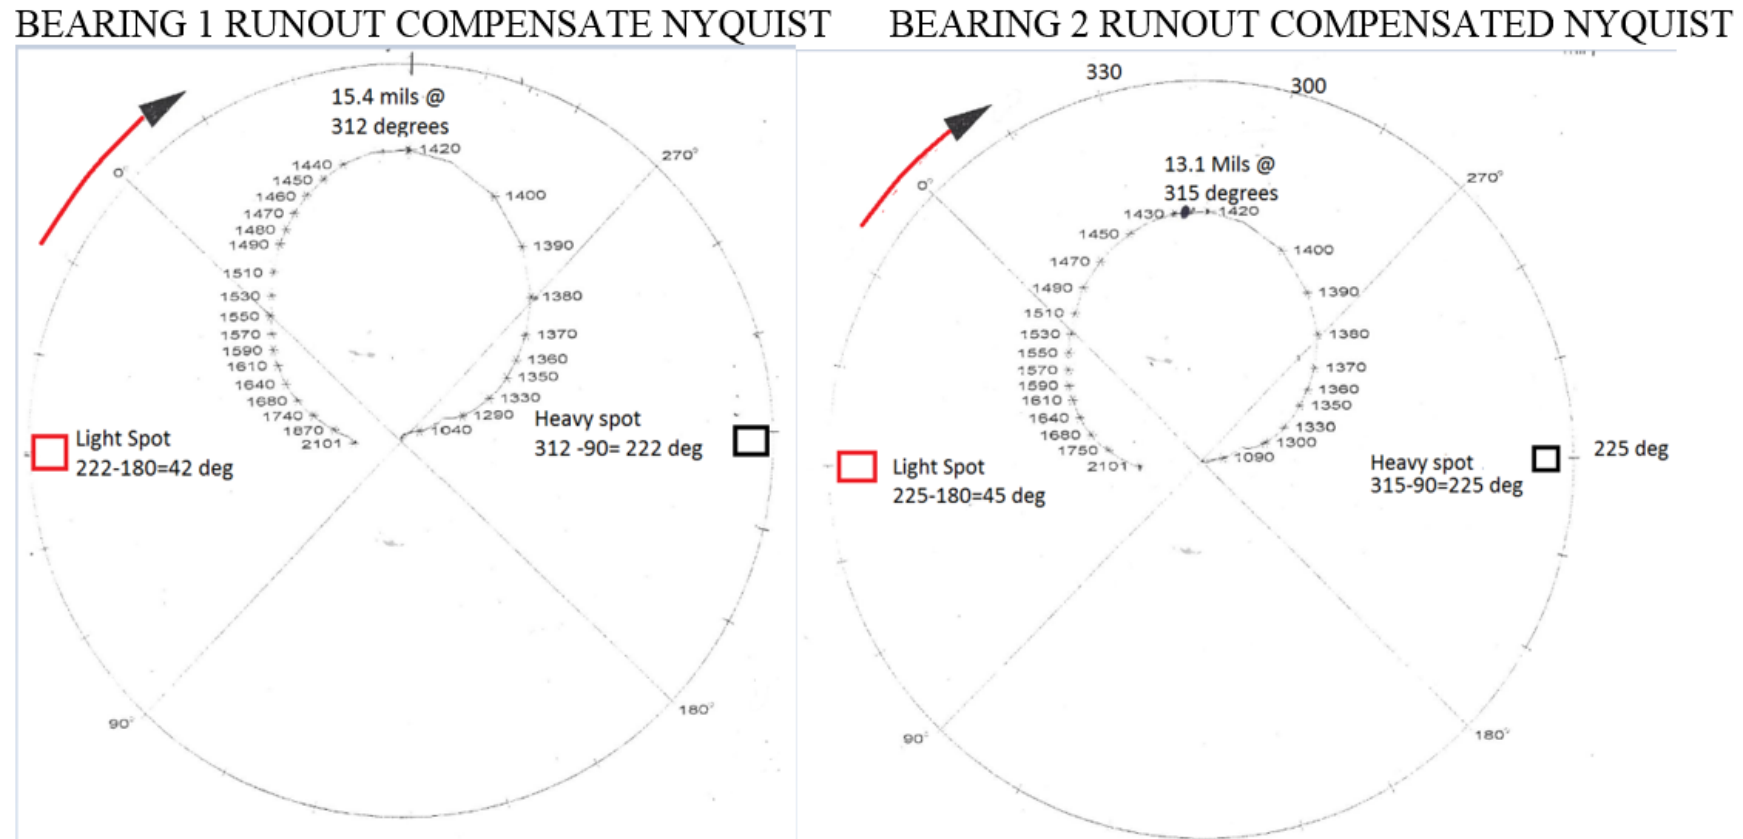
Figure 20 Nyquist plots showing 1st critical speed response

1st Critical Speed Response both bearings in phase 13 & 15 mils

- Vibration response was static in nature(phase angles were nearly identical) as would be expected at the 1st critical.
- Past experience with this rotor design showed that the cause was a bow in the rotor. Since the rotor was bowed, the weight had to be installed in the mid rotor balance plane rather than in the end planes.
- A 90 degree lag at the critical speed was used to estimate the angle.

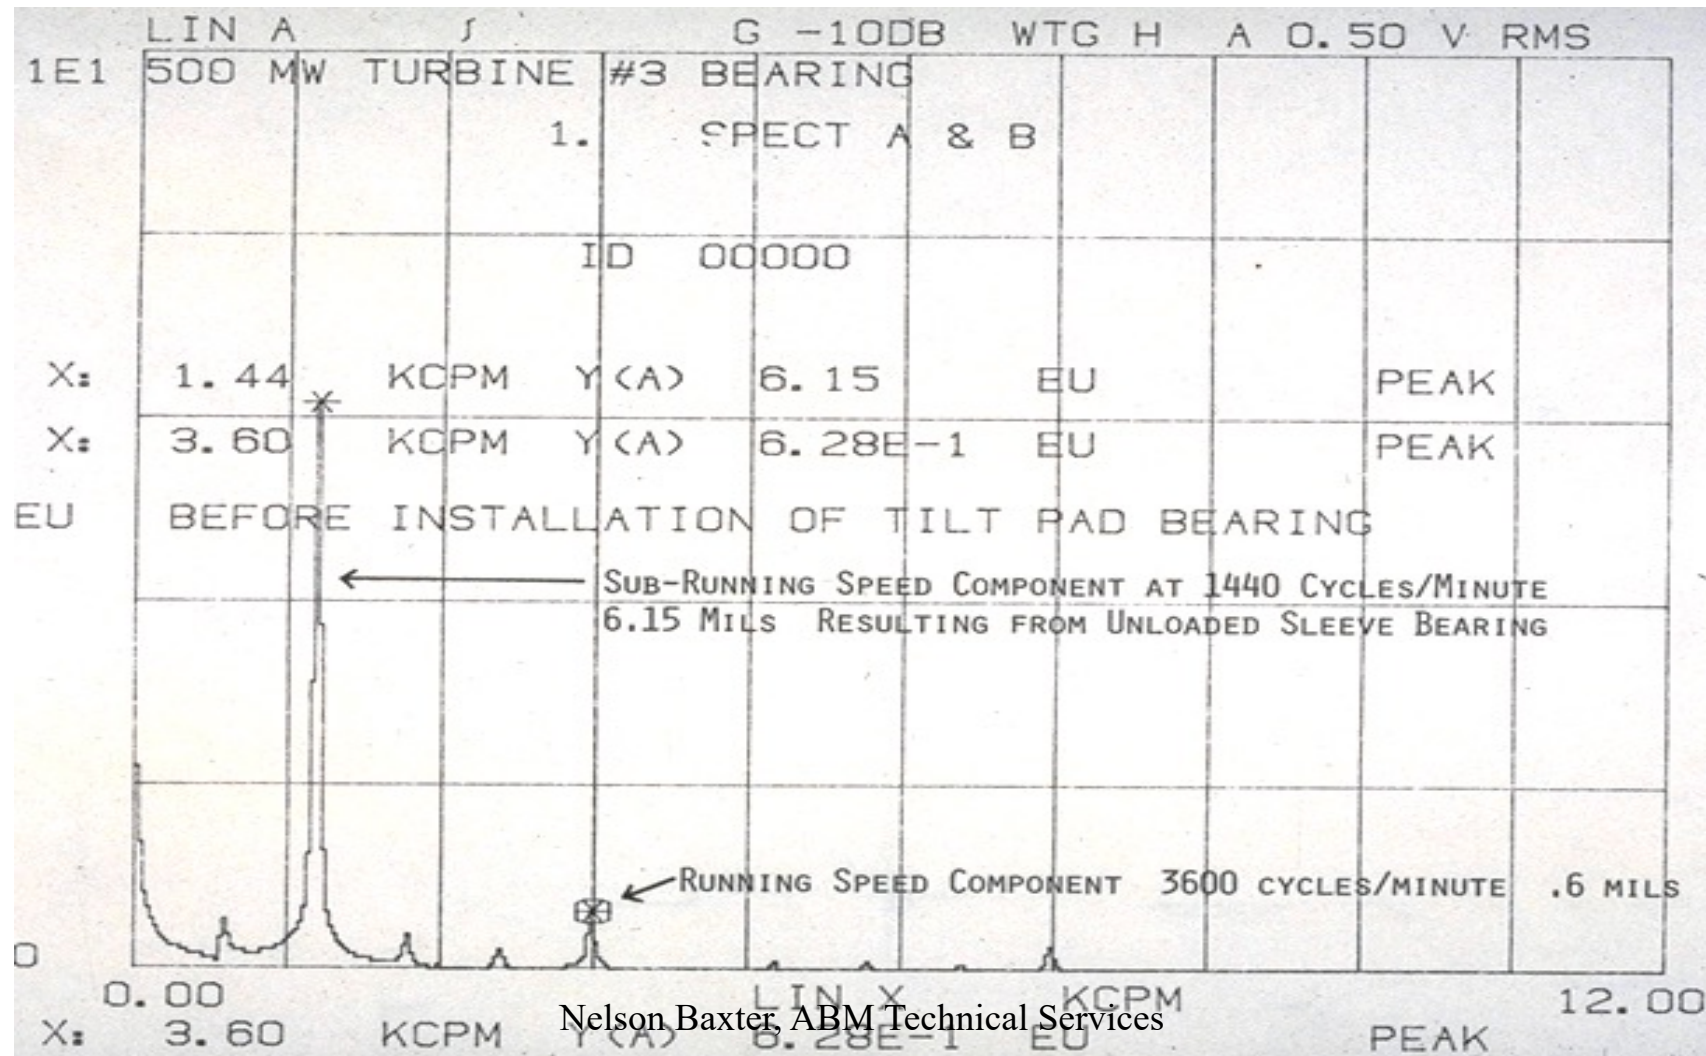
VIBRATION SPECTRUM

As the speed increased, the vibration was ok until the speed reached 2700-2800 RPM. At that point, the vibration would suddenly appear. As the speed increased, the oil whirl spectral component did not increase in frequency with the speed. The frequency of the vibration matched the 1st critical speed of the High-Pressure rotor. Once twice the critical speed was reached, the vibration would appear then as the rotor speed increased, the vibration stayed locked onto the rotor's natural frequency. What was occurring was oil whip. This is a condition where the oil whirl locks onto the rotor's natural frequency.

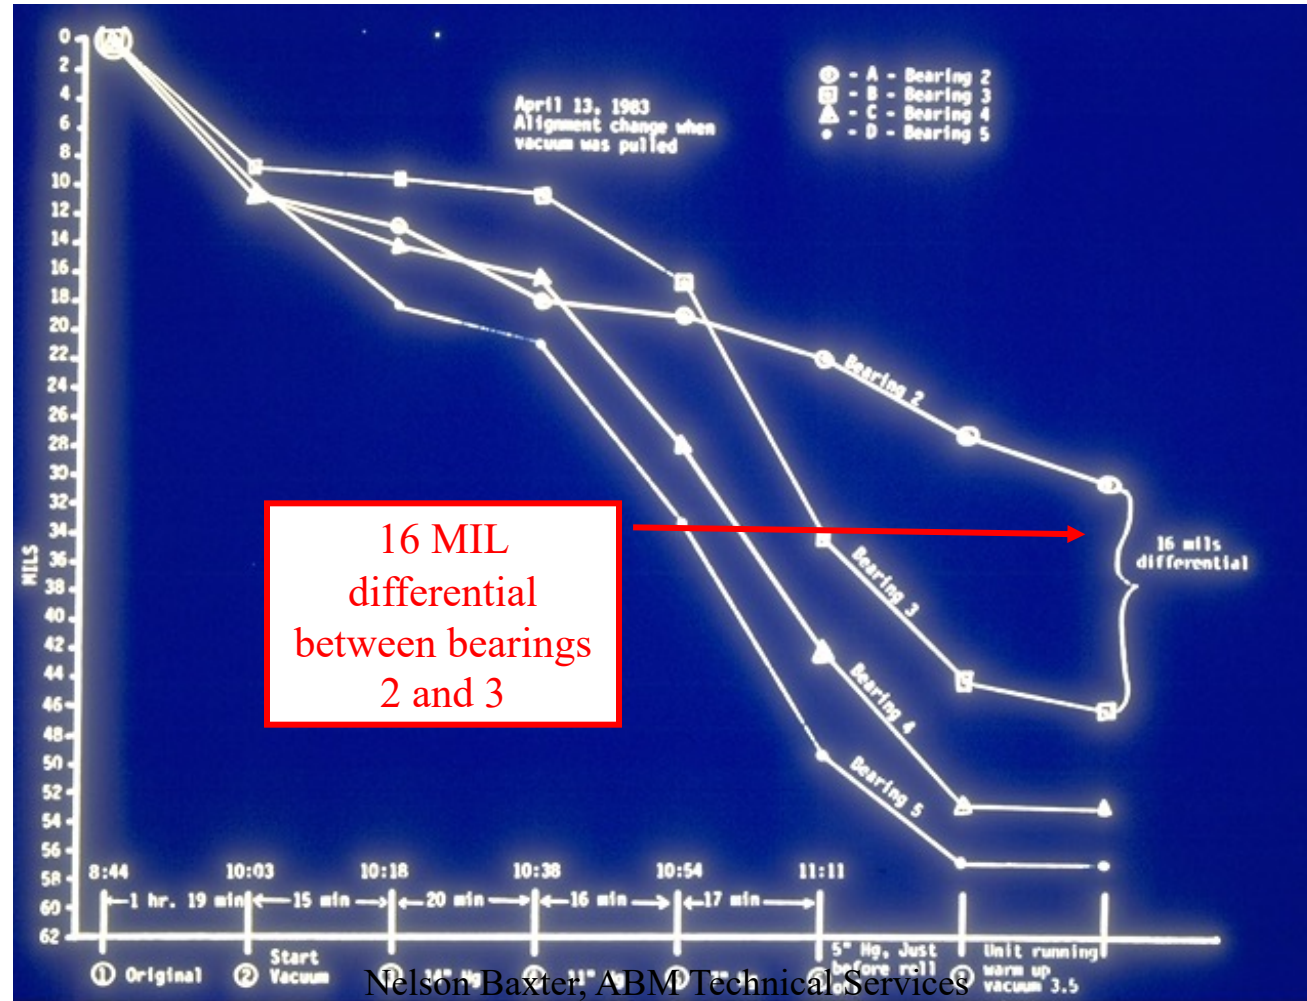
MILS MOVEMENT VERSUS VACUUM

VACUUM DRAW DOWN COMBINED WITH THERMAL DIFFERENTIAL GROWTH UNLOADED BEARING 2 CAUSING IT TO GO UNSTABLE. WHEN BOTH WERE COLD, BEARING WOULD BE STABLE. WHEN BOTH WERE HOT, BEARING WOULD BE STABLE. **THE PROBLEM OCCURRED AFTER A TRIP. THE THINNER LP SECTION WOULD COOL DOWN QUICKER THAN THE THICK HP SECTION. THIS DIFFERENTIAL ADDED TO THE VACUUM DRAW DOWN UNLOADED BEARING CAUSING OIL WHIRL THAT PREGRESSED INTO OIL WHIP.** BEARING METAL TEMPERATURE READINGS CONFIRMED THIS FINDING.

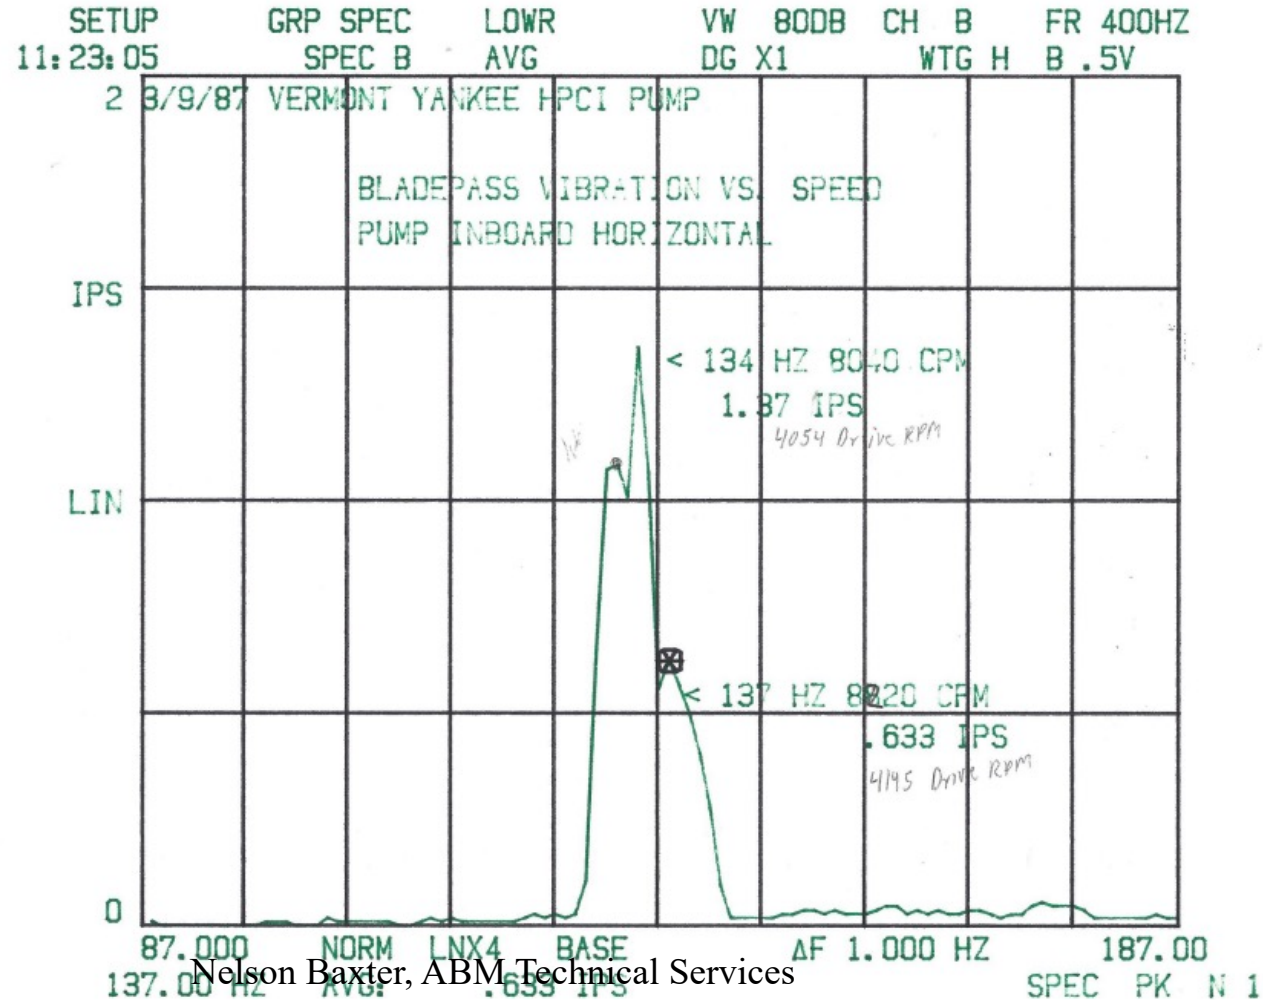
Speed 4020 RPM-Apparent 2X 1.4 in/sec

Vibration was highly speed dependent

The very large horizontal to vertical amplitude ratio plus the sensitivity to speed changes pointed towards a natural frequency problem in the horizontal direction. An impact test was performed and there was a horizontal natural frequency in the 7500-8000 cpm range. Then next figure shows the mode pivoted around the center of the pump case. When operational phase measurements were made the inboard and outboard phase readings were very nearly 180 degrees apart. This confirmed the presence of the pivotal structural mode.
