TRIUMPH DISTRIBUTORS

BULLETIN #T61-2

SUBJECT: AXLE SHAFT UNIVERSAL JOINTS
HERALD MODELS

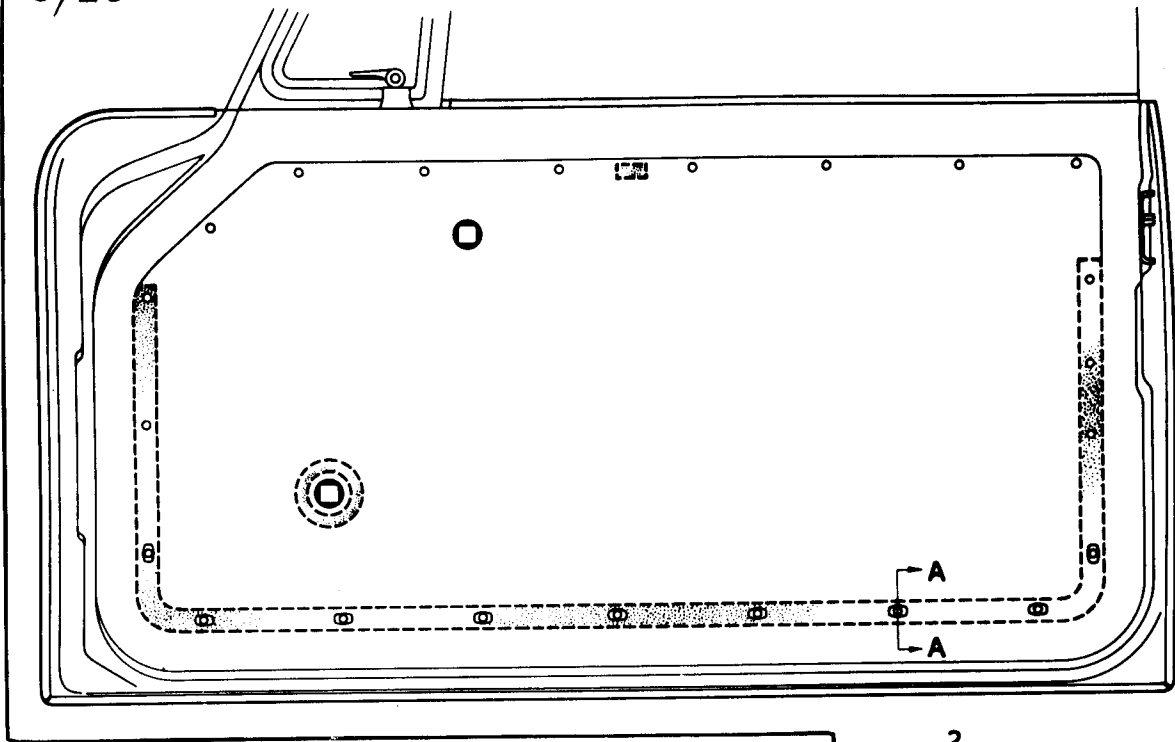
FIG. 1

Apply a continuous strip of sealing compound to the lower and side edges of the curtain. This is shown as a dotted line in Figure 1. The sealing compound must not be stretched or overlapped as it is being applied.
