Genser-Forman Inc. TRIUMPH DISTRIBUTORS

BULLETIN: T-62-9
DATE: AApril 19, 1962
SUBJ: TRIUMPH HERALD
HORNS

BULLETIN #T-62-10
DATE: April 18, 1962
SUBJ: CARBURETOR
HERALD 1200

BULLETIN: # T-62-13
DATE: April 19, 1962
SUBJ: ENGINE RESTRICTOR
BRACKET - TR-4

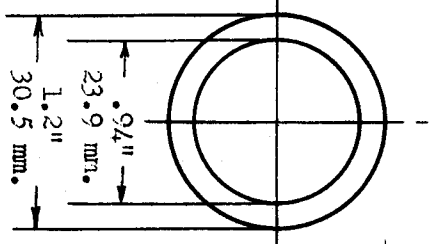
BOSS TAPPING DETAILS.

This method of securing plunger may be incorporated on Part Number 205628 and 304737 when serviced for complaint of circlip not holding in position.

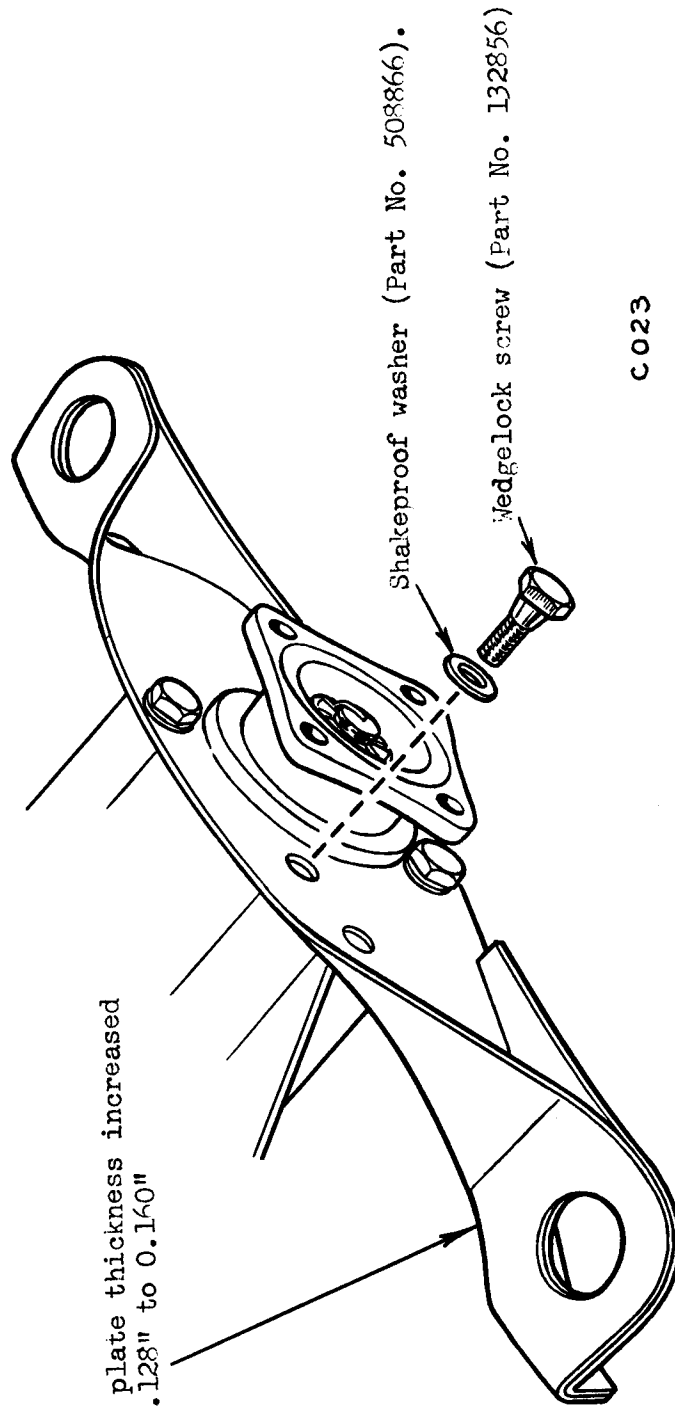
Bearer plate thickness increased
from 0.128" to 0.160"

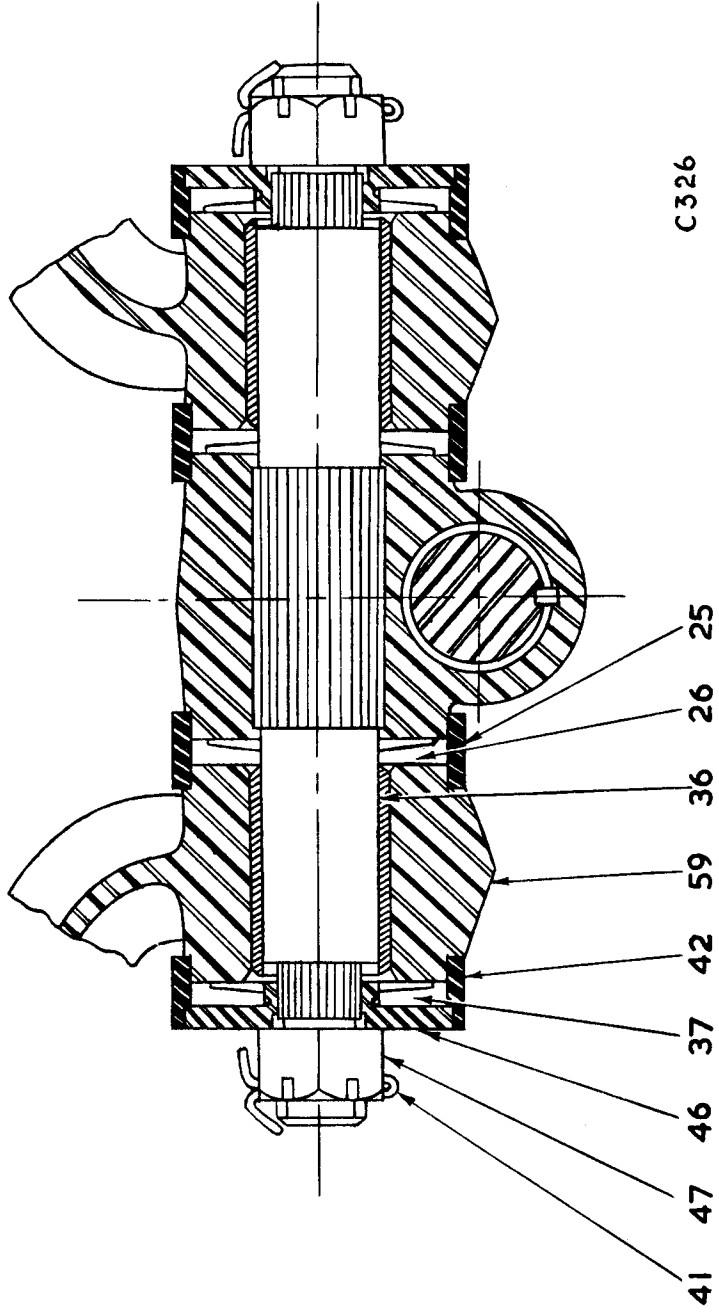
- 25. Rubber seal.
- 26. Thrust washer.
- 36. Bush.
- 37. Thrust washer.
- 41. Split pin.
- 42. Rubber seal.
- 46. Washer.
- 47. Slotted nut.
- 59. Lower wishbone.
