## SUMMARY REPORT:

Service Life Assessment of Low-Slope Unpainted 55%Al-Zn Alloy-Coated Steel Standing Seam Metal Roof Systems

Ron Dutton, Ron Dutton Consulting Services LLC

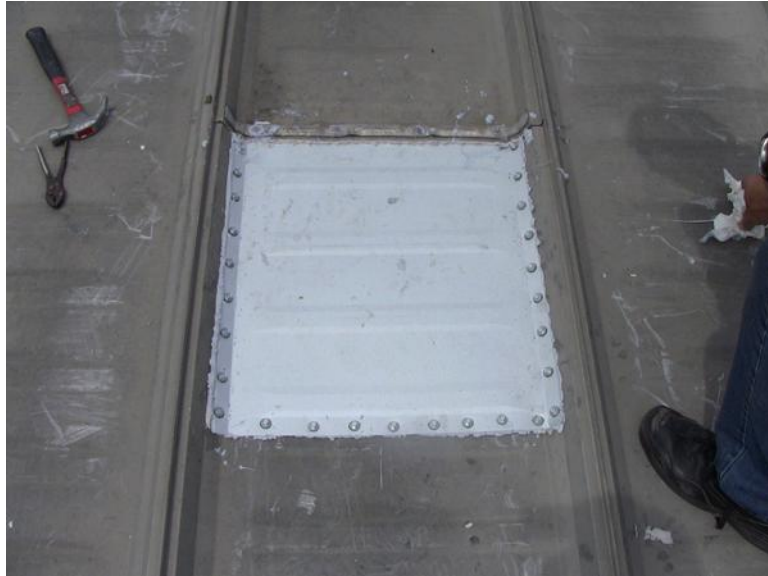
Following the extraction of the specimen, field patching needs to be skillfully accomplished with new 55% Al-Zn alloy-coated material and sealed with butyl polymer tape. Figure 9 shows the specimen area from an actual site after the sample extractions and field patching of the area were accomplished.

Figure 9 – Completed patch after removal of exposed sample.

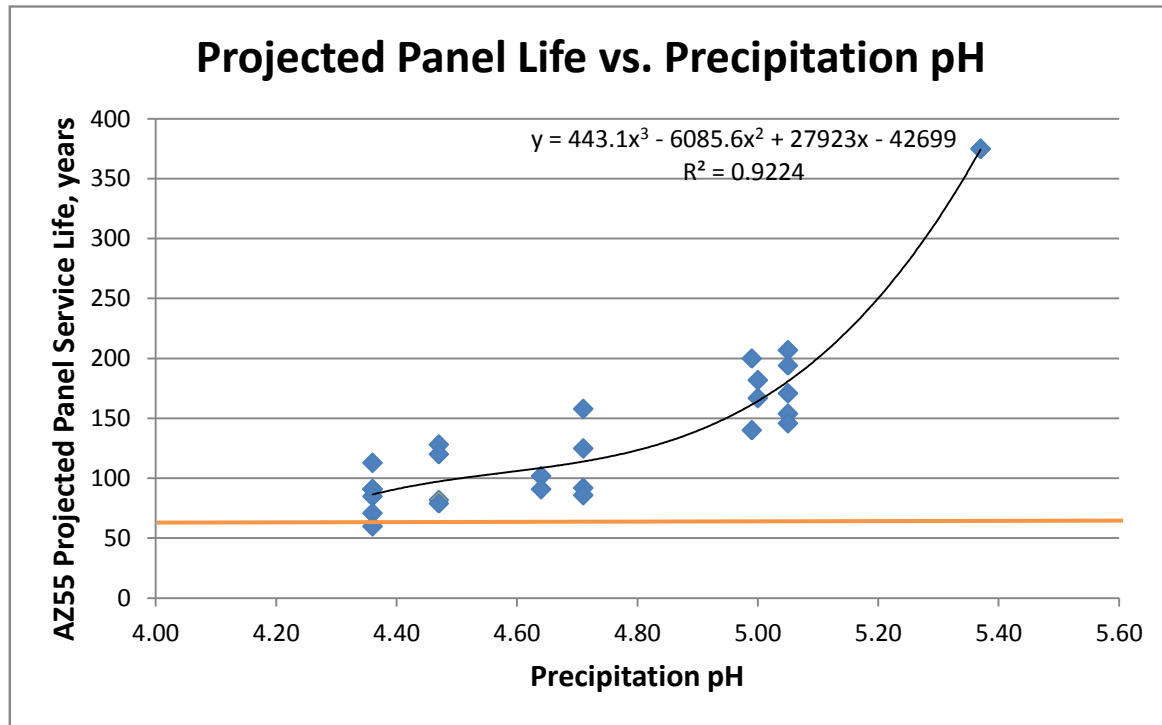
Using the calculated corrosion rates from Table II, the projected 55% Al-Zn alloy-coated steel panel service life is plotted in Figure 24 as a function of the precipitation pH associated with each building's location. It should be remembered here that the definition for panel service life was stated as the time required for total coating mass loss to occur due to corrosion of the top coating surface. Thus, it is a conservative definition because it does not include the additional years required, after the coating has

As seen in Figure 24, there is a very good correlation between the precipitation pH and the projected 55% Al-Zn alloy-coated steel panel service life, a finding which helps to explain the wide range of service life values calculated from the corrosion rates determined in this study. That is, the wide range in precipitation pH for the different building locations accounts for the wide range of projected service life values and is consistent with the expectation that more aggressive environments (lower pH) are more corrosive to materials of construction exposed to those atmospheric conditions.

Figure 24 – Strong correlation between projected service life for 55%Al-Zn alloy-coated steel SSR panels and precipitation pH.

The reference line at 60 years in Figure 24 is significant in that it represents an “assumed building service life” as described in LEED, version 4 [22]. Thus the data from this project support the proposition that a 55% Al-Zn alloy-coated steel SSR system, installed today on new or retrofit low-slope roof systems in a wide range of environments, would not require replacement during the building’s entire service life, a significant advantage compared to other roof systems that require one or more full replacements within this 60-year period. Periodic roof inspections and maintenance associated with roof ancillaries are advised, to minimize any detrimental effects to the roof system and maximize roof system life.

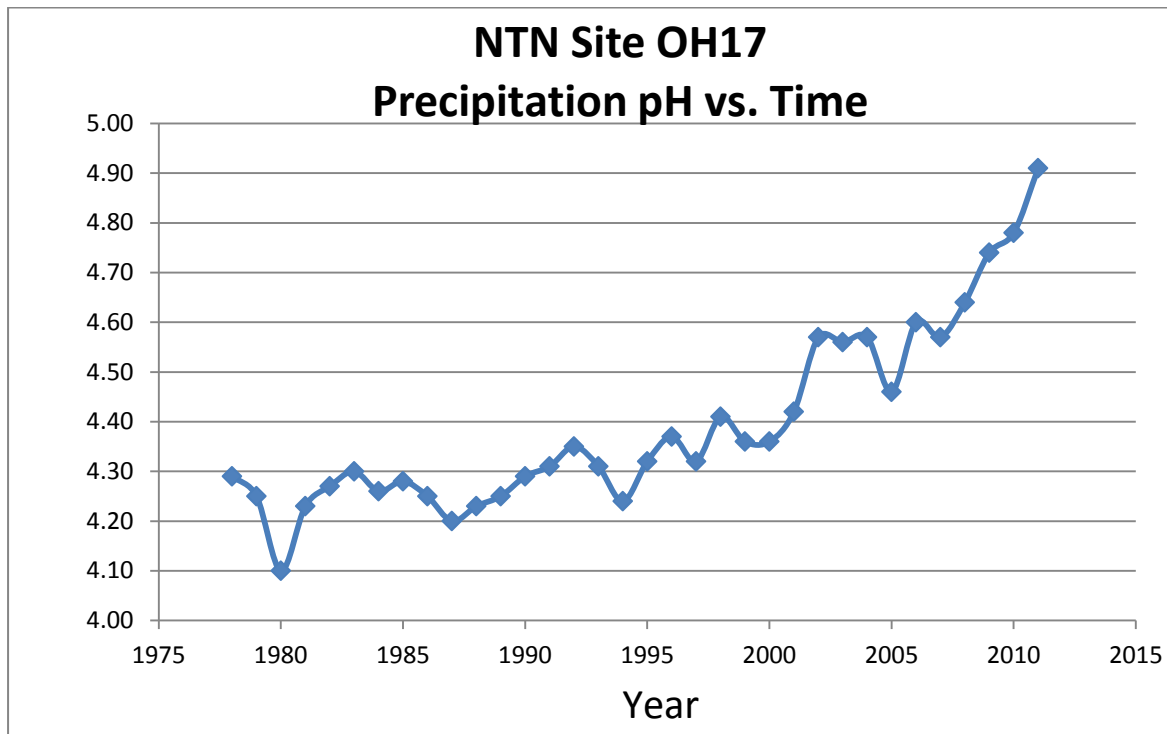
This improved performance is due to the significant improvement in climate experienced in the U.S. over the last 30 years due to industry's compliance with government regulatory air quality requirements. The data shown in Figure 25 are an example of the improvement in precipitation pH that has resulted from these efforts. In this figure, the change in precipitation pH is plotted vs. time for a site located in Ohio near three of the building locations in this study. The pH has improved from a value of about 4.4 in 1999 to a value of 4.8 in 2010. Thus if the current-day pH values are used in the service life equation shown in Figure 24, the projected panel service life can be calculated for a building that would be constructed today using best practices. Thus, in the case of this location in Ohio, the projected panel service life, calculated from the equation in Figure 24, improves from a value of about 90 years (pH of 4.4) to a value of about 122 years (pH of 4.8). That is to say, the 55%Al-Zn alloy-coated steel panel service lives reported in this study, while significant in their own right, represent conservative estimates of the service lives to be expected on buildings erected today with this material.

Figure 25 – Improvement in precipitation pH over the last 30 years near one of the building sites in Ohio [17].

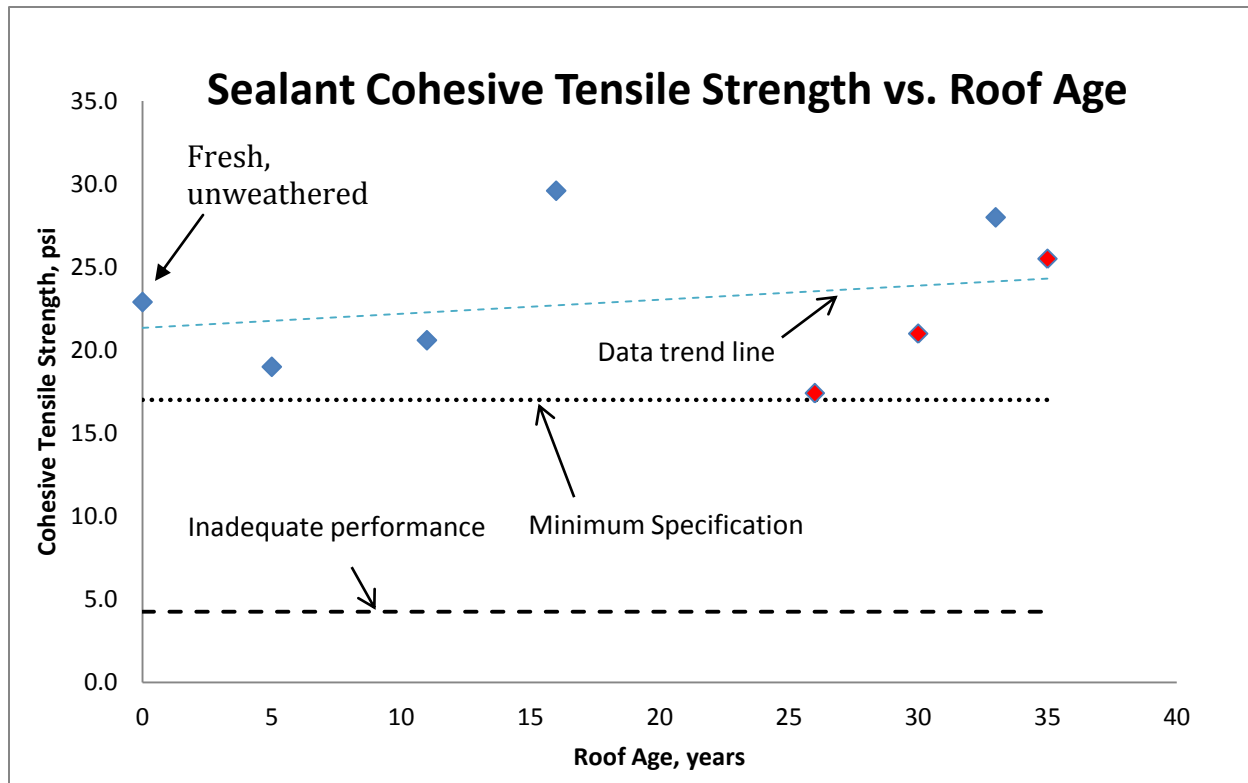
Cohesive tensile strength can be thought of as a measure of the ability of a sealant to maintain internal integrity and resist shearing in order to effectively seal the joint. The cohesive tensile strength of the butyl sealant samples obtained in this study is plotted as a function of the age of the roof in Figure 26. The inadequate performance value was assumed to be at  $\frac{1}{4}$  of the minimum specification limit of 17 psi, or at 4.25 psi, and is plotted as such. At this low level of cohesive tensile strength, it was speculated that the sealant would have undergone significant decomposition, or de-polymerization, with the result being that the sealant would behave more like a low-viscosity liquid that would easily flow out of the joint, thus rendering the joint unacceptable.

The plot in Figure 26 shows that, even for those sealant samples exhibiting some degree of de-polymerization, the cohesive tensile strength continues to maintain consistent levels above the minimum specification and well above the inadequate performance level. Based on the data in Figure 26, there is no evidence of deterioration of this property through 35 years of service on these roofs.

Figure 26 – Cohesive tensile strength of butyl sealant vs. roof age. Sealant samples from New England roofs. Red symbols indicate samples exhibited some degree of de-polymerization.

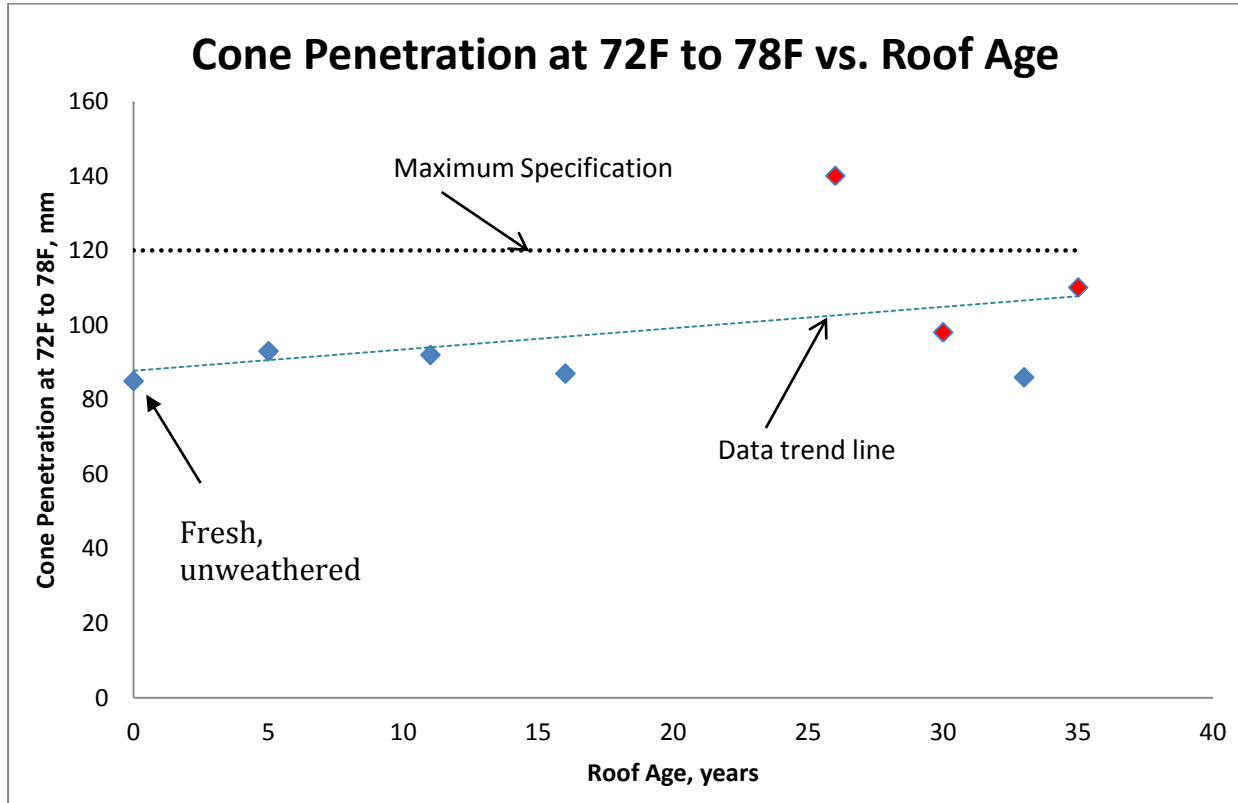
The cone penetration data are plotted vs. roof age in Figure 27. Higher cone penetration values indicate the sealant exhibits an increased tendency to flow. The maximum specification at 120 is a value selected for qualifying butyl sealants for initial use. All but one of the data points are under this maximum value. The sealant samples from the 26-, 30- and 35-year roofs, noted with red symbols, showed evidence in laboratory analysis of some degree of de-polymerization. This condition was noted in the cone penetration testing done at 120F in which the materials exhibited a level of softness that prevented valid test results from being obtained. Notwithstanding these laboratory observations, the behavior of these sealants in the actual roof systems was judged to be entirely adequate and without issue, providing a weather tight seal.

The cone penetration data trend line in Figure 27 shows a slight upward trend toward the maximum specification line and would mathematically intersect that line at approximately 57 years. However, the amount of scatter in this limited data set is significant (correlation coefficient less than 0.20), so it is unwise to draw a firm conclusion from such an intersection. However, it is also unclear whether a cone penetration value of 120 is indicative of inadequate performance. What is clear, is that the 26-, 30- and 35-year roofs in New England continue to perform well, and that the roofs in AZ, NM and CO exhibit excellent cone penetration values, and field performance, after up to 33 years (Table III). Thus, the likelihood of butyl sealants achieving a failure mode prior to about 60 years of service is deemed to be nil.

Figure 27 – Cone penetration values of butyl sealant vs. roof age. Sealant samples from New England roofs. Red symbols indicate samples exhibited some degree of de-polymerization.
