Inspection report for the property at

Precision Building Inspection LLC

This is a 30 year old park model with deck and screen room added to one side and master suite added to other. For age the subject appears to be in above average condition and very well suited for the area.

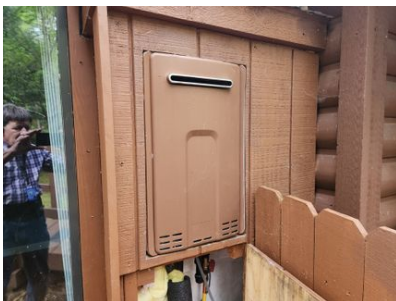
The water temperature tested slightly below the recommended 120 degrees F. Adjust the water temperature as needed.

Exterior tankless water heater
