2023
STRUCTURAL INSPECTION REPORT
MARINERS POINT
Lakeside Decks
STRUCTURE TAG NO.: LAKESIDE DECKS

Previous Inspection Date: N/A
Globex Job No.: G-6970

Date Of Inspection: 4/26/2023, 5/17/2023 and 5/18/2023
Report Issued Date: 06/09/2023
Inspected By: B. Gerst, J. Myers

A structural condition based inspection of the wooden exterior decks and their support columns on the lake side of Buildings 1 – 5 was performed from the ground level and a 20' and 28' extension ladder.

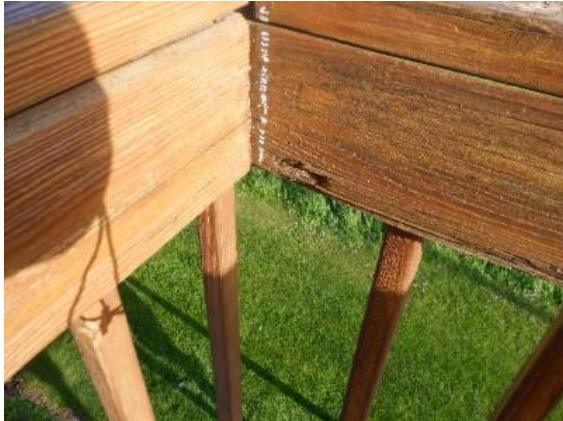
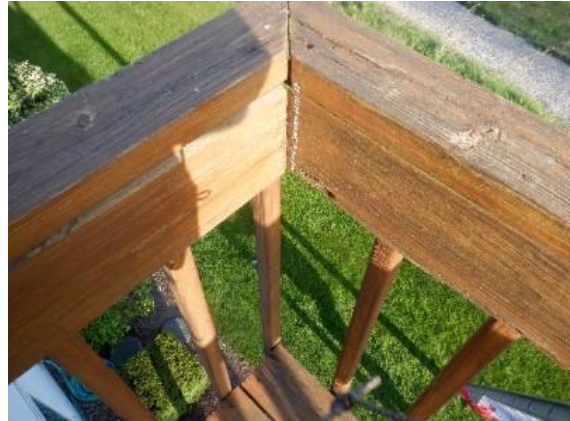
Image(s) For Finding No.1

1. At the topside of unit 136 deck, at the West corner of the North guardrail, the 2x6 is starting to separate.

1. Remove the existing fasteners and secure the guard rail connection with the proper length and type of exterior screws for decks.
Repair Priority: P3

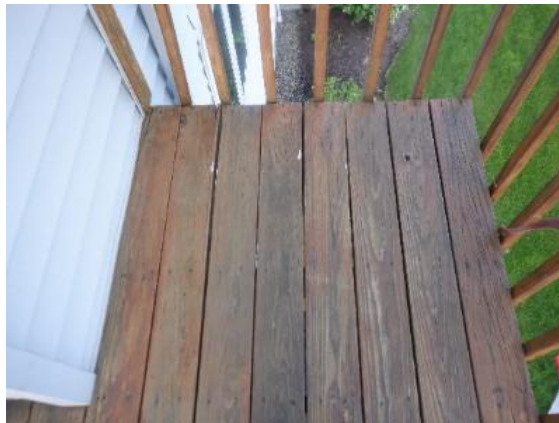
Image(s) For Finding No.2

2. At the topside of unit 136 deck, there are 3 loose deck boards on the West side.

2. Remove the existing fasteners and secure the deck boards with the proper length and type of exterior screws for decks.
Repair Priority: P3

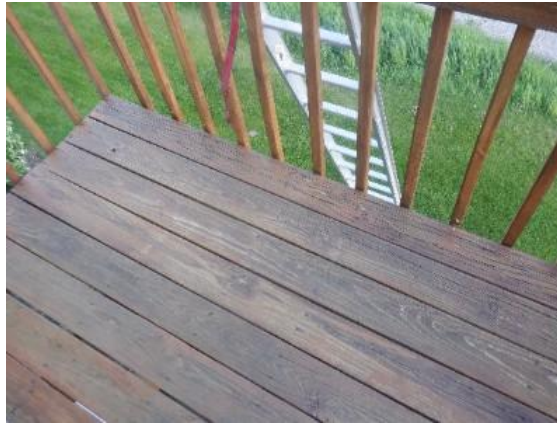
Image(s) For Finding No.3

3. At the topside of unit 136 deck, there are 3 loose balusters on the North side.

3. Remove the existing fasteners and secure the balusters with the proper length and type of exterior screws for decks.
Repair Priority: P2

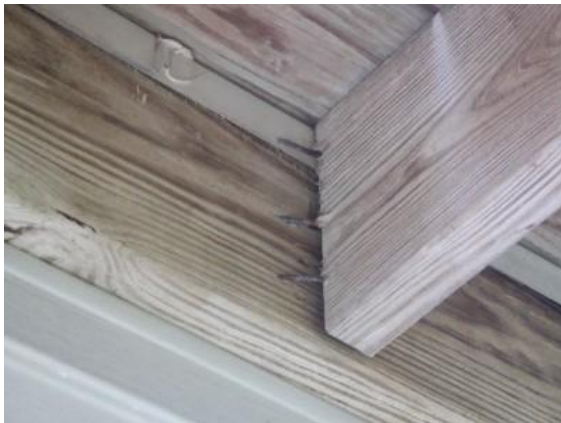
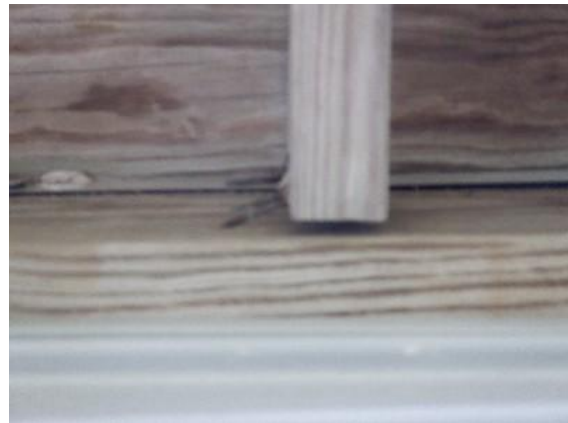
Image(s) For Finding No.4

4. At the underside of unit 136 deck, at the 1st joist from West, the joist has been toe nailed. However, the nails missed the ledger board.

4. Secure the joist to the ledger board with the proper size nails for the joist.
Repair Priority: P2

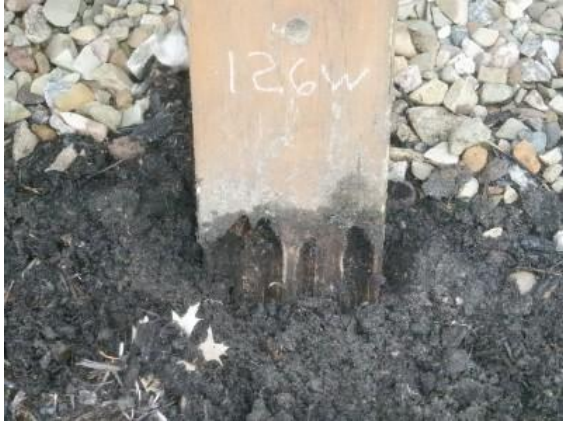
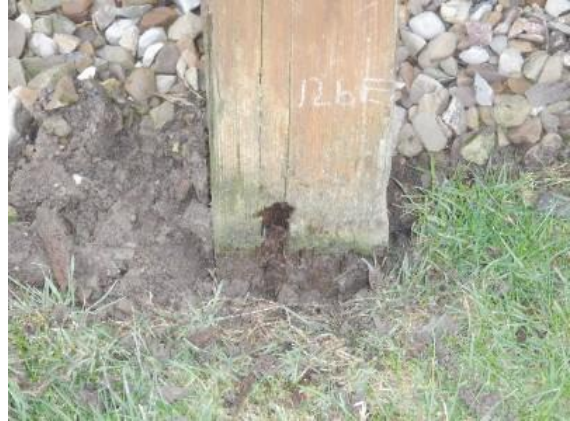
Image(s) For Finding No.6

6. At the underside of unit 126 deck, both the East and West support (6" x 6"x 10' lg.) columns are decayed at ground level with approximately 40% section loss.

Please note finding nos. 6, 93, and 126, are recommended to have further engineering performed.

6. Further engineering is recommended to develop a repair procedure to raise the concrete footing.
Repair Priority: P3

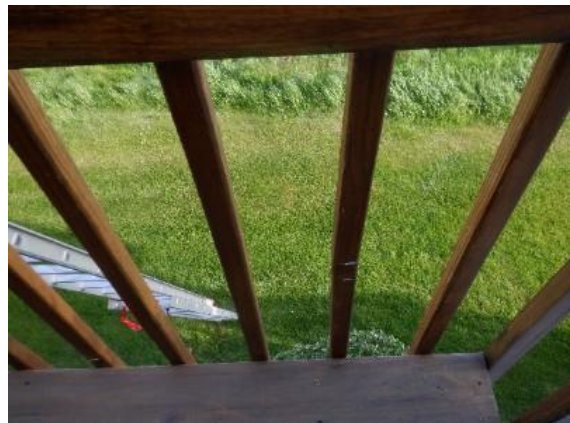
Image(s) For Finding No.7

7. At the topside of unit 135 deck, on North side, there is 1 loose baluster and 1 cracked baluster.

7. Replace the cracked baluster in kind with pressure treated lumber and secure the new and loose baluster with the proper length and type of exterior screws for decks.
Repair Priority: P2

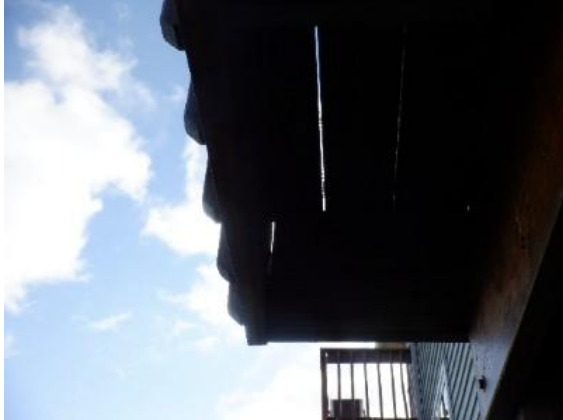
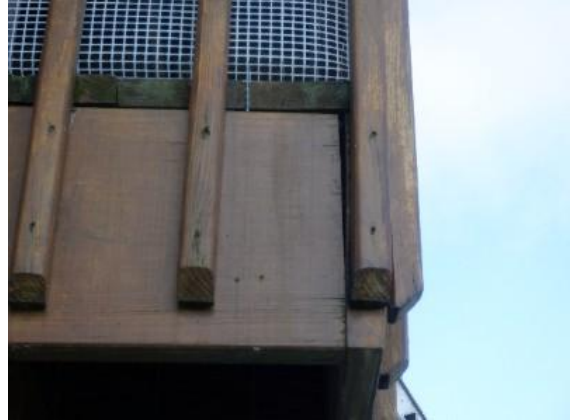
Image(s) For Finding No.10

10. At the underside of unit 125 deck, at the N.E. corner, the rim joist is end nailed and separating.

10. Remove the existing fasteners and secure the rim joist connections with the proper length and type of exterior screws for decks.
Repair Priority: P3

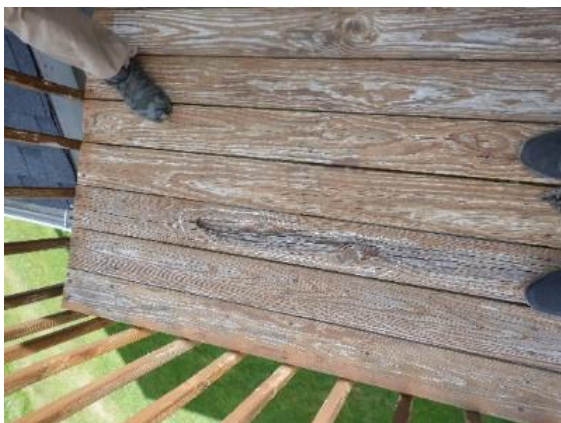
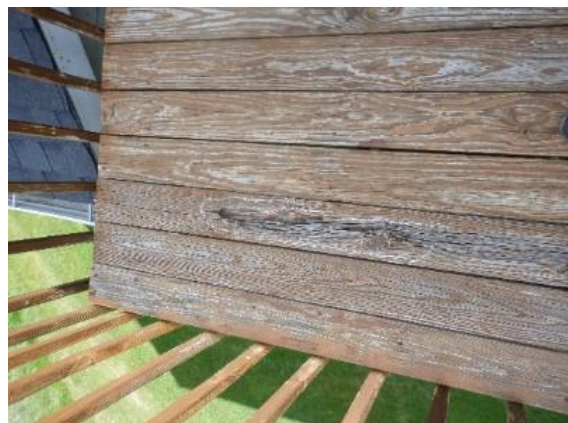
Image(s) For Finding No.13

13. At the topside of unit 134 West third floor deck, there is 1 loose and 1 deteriorated deck board

13. Replace the deteriorated deck board in kind with pressure treated lumber and secure the new and existing loose deck boards with the proper length and type of exterior screws for decks.

Repair Priority: P2

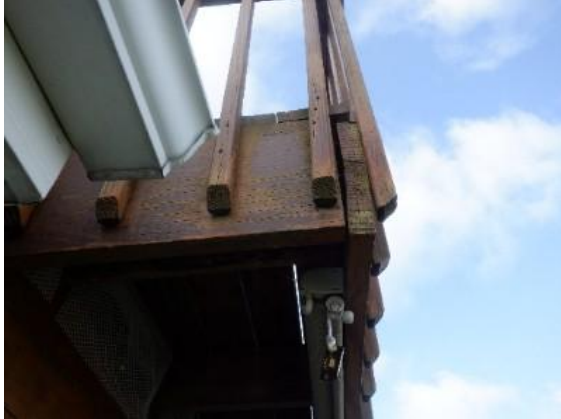
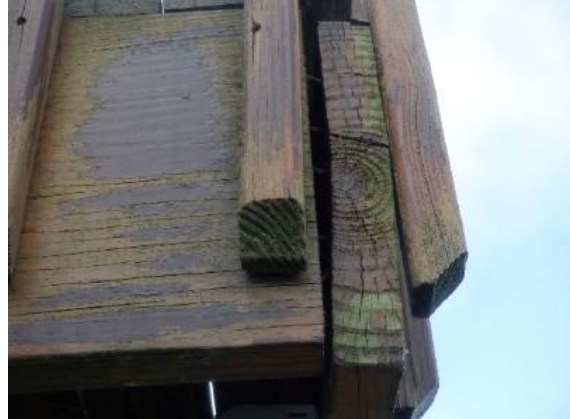
Image(s) For Finding No.14

14. At the underside of unit 134 West third floor deck, the North rim joist is end nailed and separated at the East end and partially separated at the West end.

14. Remove the existing fasteners and secure the rim joist connections with the proper length and type of exterior screws for decks.
Repair Priority: P2

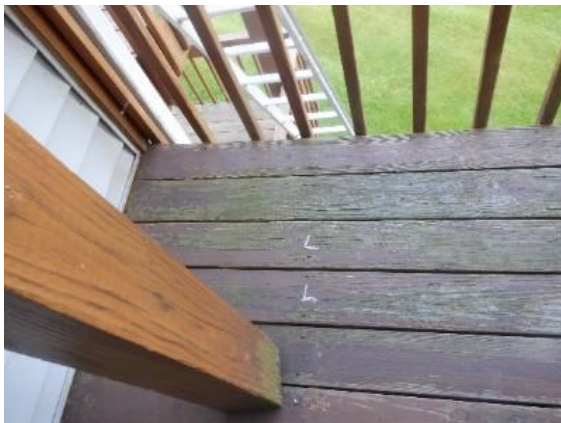
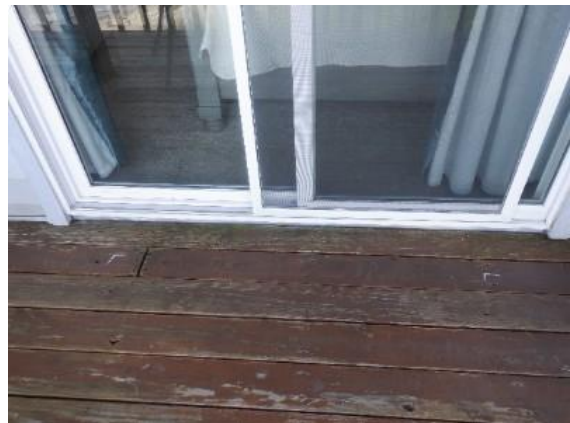
Image(s) For Finding No.15

15. At the topside of unit 134 West deck, there are 4 deck boards loose.

15. Remove the existing fasteners and secure the deck boards with the proper size and type exterior screws for decks.
Repair Priority: P3

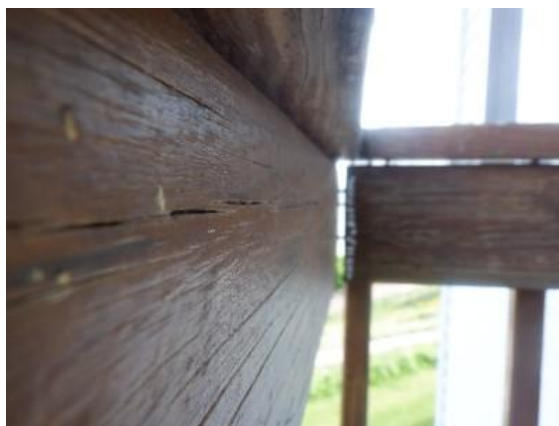
Image(s) For Finding No.16

16. At the topside of unit 134 West deck, at the N.E. guardrail connection, the 2x6's are end nailed and separating.

16. Remove the existing fasteners and secure the guardrail connection with the proper size and type exterior screws for decks
Repair Priority: P2

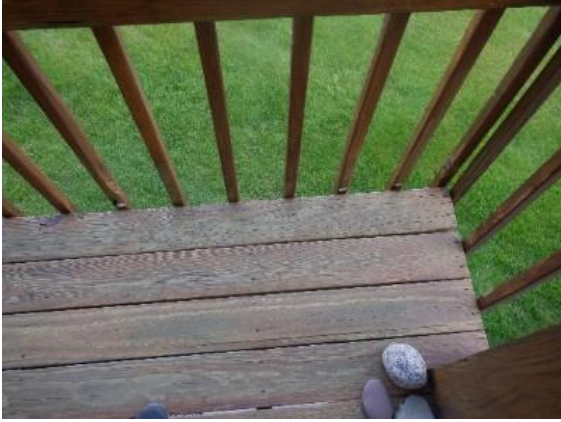
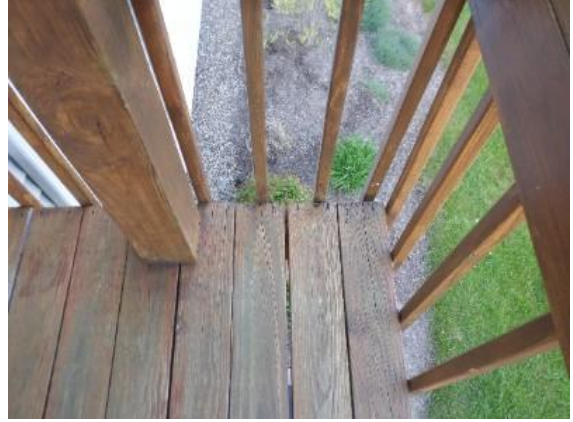
Image(s) For Finding No.22

22. At the topside of unit 124 West deck, there is 1 deck board loose and 4 balusters loose.

22. Remove the existing fasteners and secure the deck board and baluster connections with the proper size and type exterior screws for decks.
Repair Priority: P2

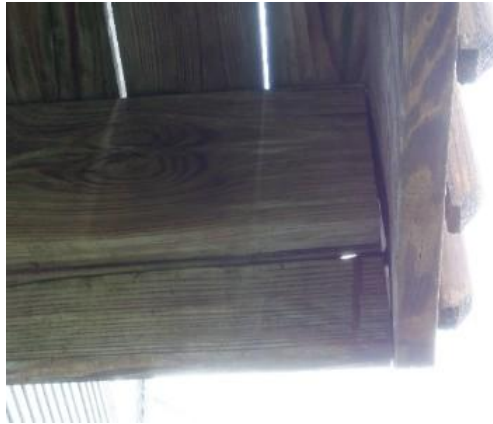
Image(s) For Finding No.23

23. At the underside of unit 124 West deck, the West rim joist is split/cracked and separating.

23. Temporarily shore the deck and replace the rim joist in kind with pressure treated lumber.
Repair Priority: P2

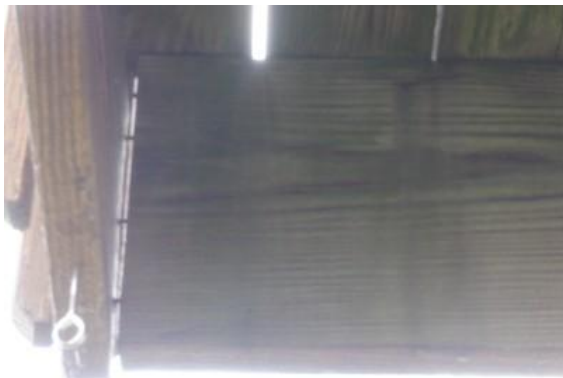
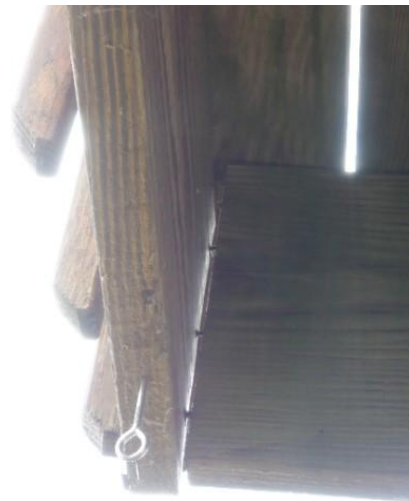
Image(s) For Finding No.24

24. At the underside of unit 124 West deck, at N.E. corner, the rim joist is end nailed and separating.

24. Remove the existing fasteners and secure the rim joist connection with the proper size and type exterior screws for decks.
Repair Priority: P2

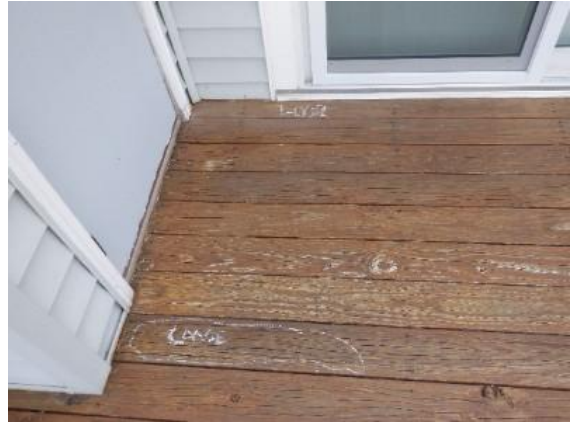
Image(s) For Finding No.25

25. At the topside of unit 133 deck, there are 3 deck boards loose.

25. Remove the existing fasteners and secure the deck boards with proper size and type of exterior screws for decks.
Repair Priority: P3

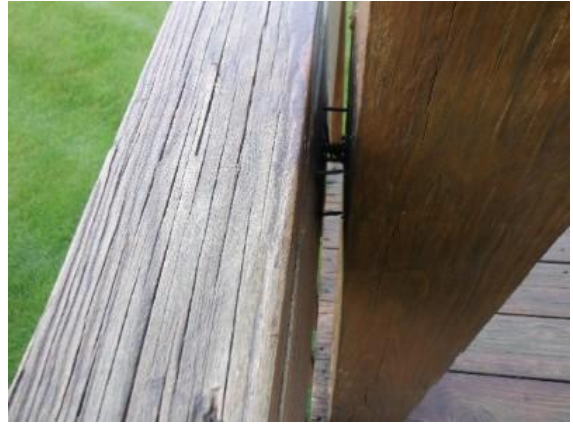
Image(s) For Finding No.27

27. At the topside of unit 123 deck, the West guardrail separated from the column and is loose.

27. Remove the existing fasteners and secure the rim joist connection with the proper size and type exterior screws for decks. Repair Priority: P2

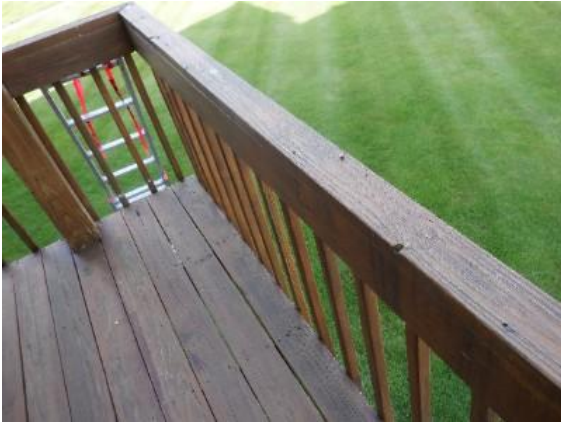
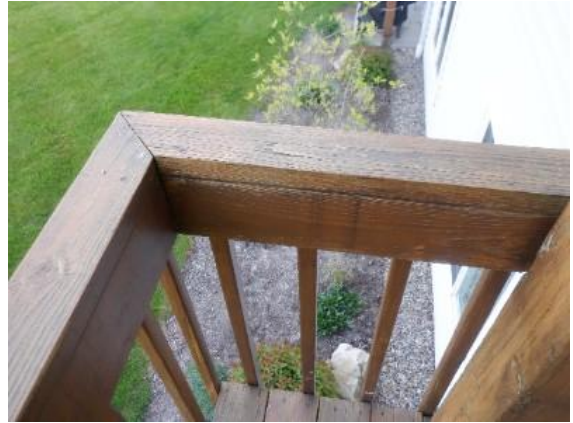
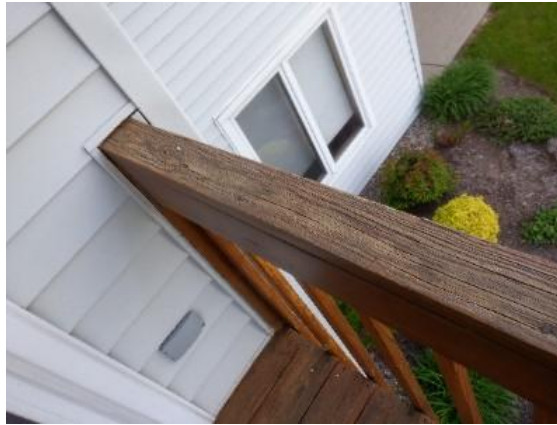
Image(s) For Finding No.28

28. At the topside of unit 123 deck, the guardrail 2x4 is loose all around.

28. Secure the loose guardrail 2x4 with proper size and type exterior screws for decks.
Repair Priority: P2

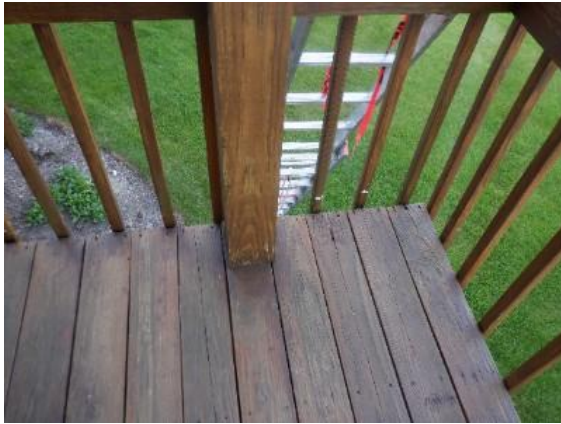
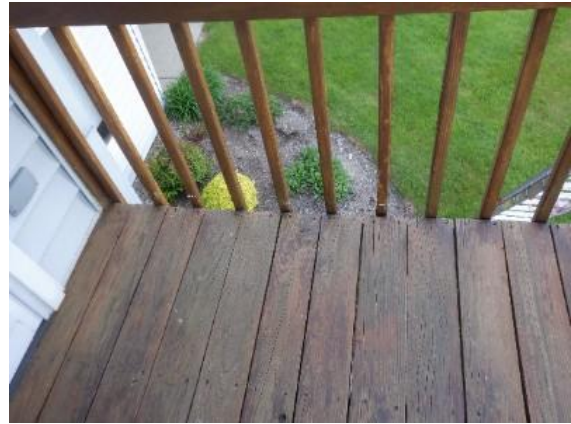
Image(s) For Finding No.29

29. At the topside of unit 123 deck, at the West guardrail, there are 4 loose balusters.

29. Remove the existing fasteners and secure the baluster connections with the proper size and type exterior screws for decks. Repair Priority: P2

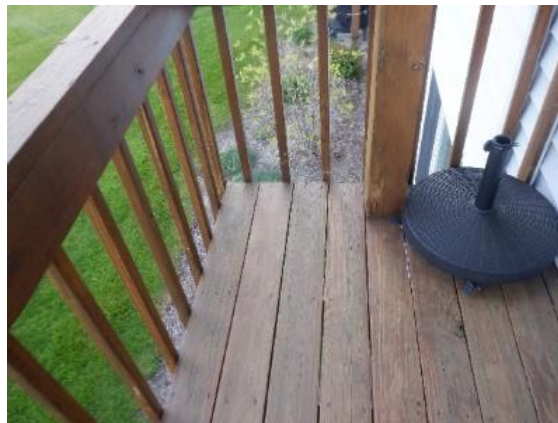
Image(s) For Finding No.30

30. At the topside of unit 123 deck, at the East guardrail, there 1 loose baluster.

30. Remove the existing fasteners and secure the baluster connections with the proper size and type exterior screws for decks. Repair Priority: P2

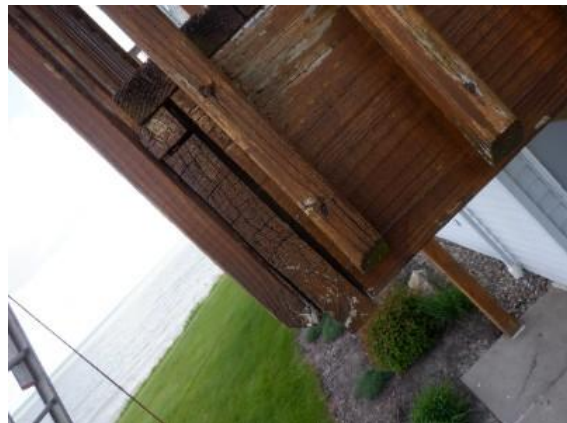
Image(s) For Finding No.32

32. At the underside of unit 123 deck, the N.W. rim joist connection is end nailed, separating and the West rim joist is cracked.

32. Replace the damaged rim joist in kind with pressure treated lumber and secure to columns with proper size and type of exterior screws for decks. Repair Priority: P2

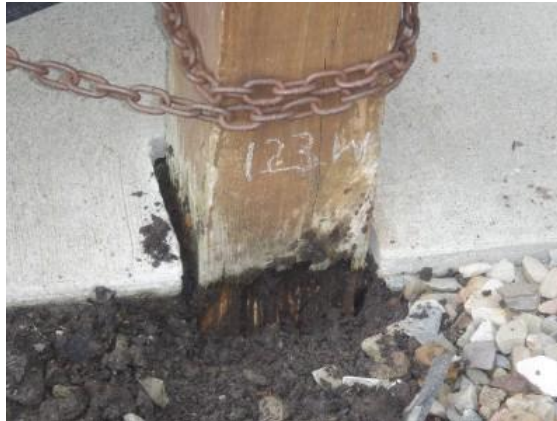
Image(s) For Finding No.33

33. At the underside of unit 123 deck, the West support column is starting to decay below ground level.

33. Monitor the condition of the column until the next inspection.
Repair Priority: P5

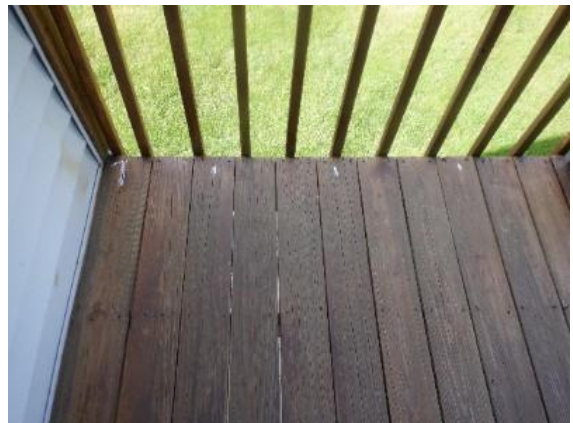
Image(s) For Finding No.38

38. At the topside of unit 121 deck, there are 6 loose deck boards on the West side.

38. Remove the existing fasteners and secure the deck boards with the proper size and type exterior screws for decks. Repair Priority: P3

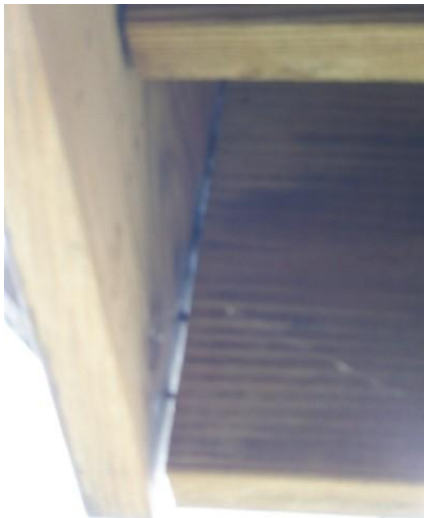
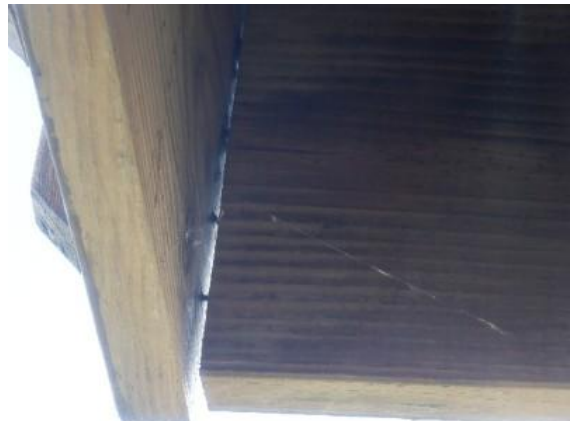
Image(s) For Finding No.43

43. At the underside of unit 236 deck, the rim joist connections are end nailed and separating.

43. Remove the existing fasteners and secure the rim joist connections with the proper size and type exterior screws for decks.

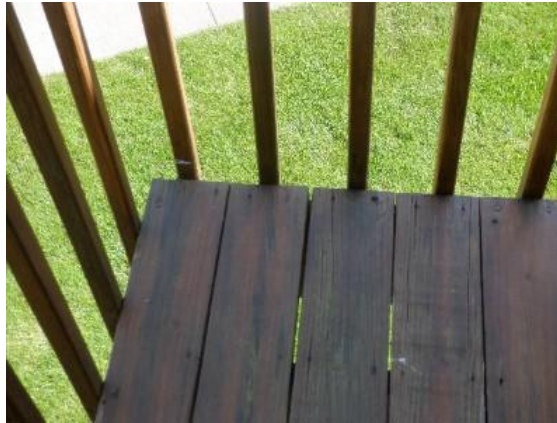
Image(s) For Finding No.44

44. At the topside of unit 226 deck, the North and South guardrails are not connected to the building and are wobbly.

44. Install new Southern pine 4x4 pressure treated guard post at each end of the guardrail per Simpson guard post to decking from hold down and fastener details or equal.
Repair Priority: P2

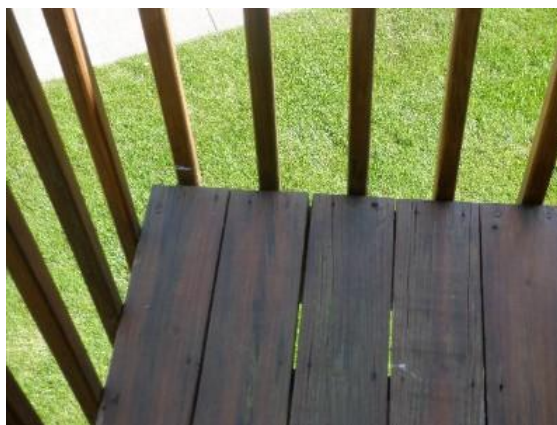
Image(s) For Finding No.45

45. At the topside of unit 226 deck, at the N.W. corner, there is 1 loose baluster.

45. Remove the existing fasteners and secure the baluster connection with the proper size and type exterior screws for decks.
Repair Priority: P2

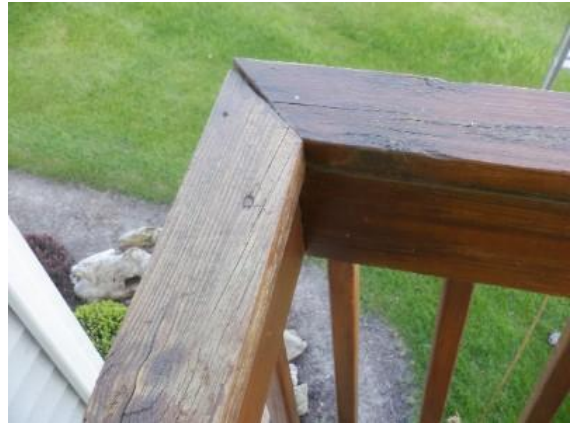
Image(s) For Finding No.46

46. At the topside of unit 226 deck, at the N.W. corner, the guardrail 2x4 is loose.

46. Remove the existing fasteners and secure the guardrail connection with the proper size and type exterior screws for decks. Repair Priority: P2

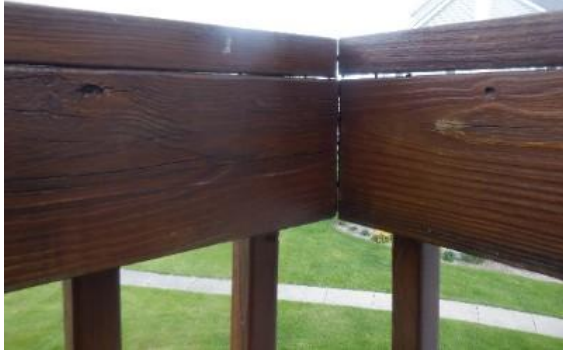
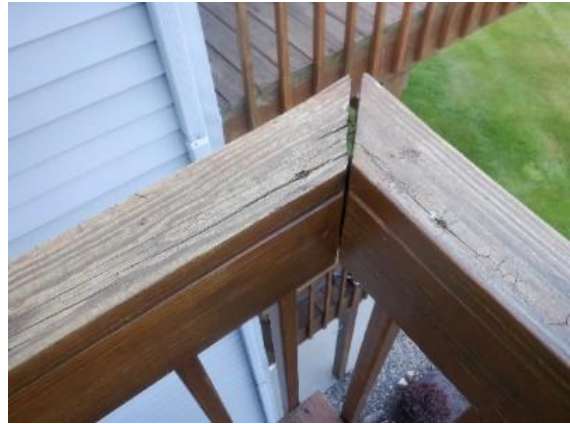
Image(s) For Finding No.50

50. At the topside of unit 235 deck, the guardrail 2x4 is loose and deteriorated with connections separating.

50. Replace the loose and deteriorated guardrail 2x4 in kind with pressure treated lumber.
Repair Priority: P2

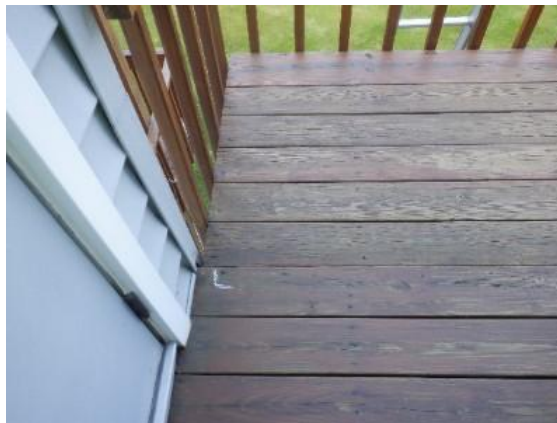
Image(s) For Finding No.51

51. At the topside of unit 235 deck, there is 1 deck board loose

51. Remove the fasteners and secure the deck board with proper size and type of exterior screw for decks.
Repair Priority: P3

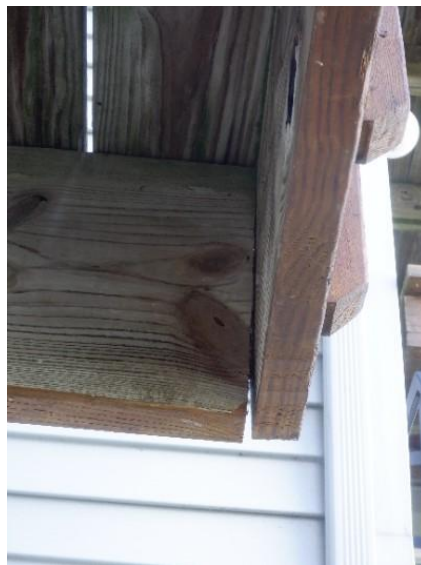
Image(s) For Finding No.55

55. At the underside of unit 225 deck, the N.W. corner of the rim joist is end nailed and separating

55. Remove the existing fasteners and secure the rim joist connection with the proper size and type exterior screws for decks.
Repair Priority: P3

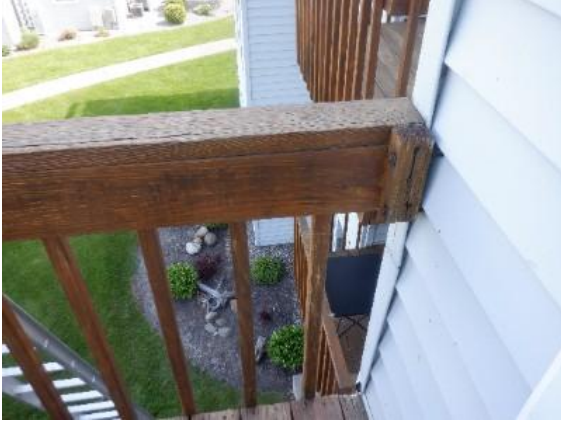
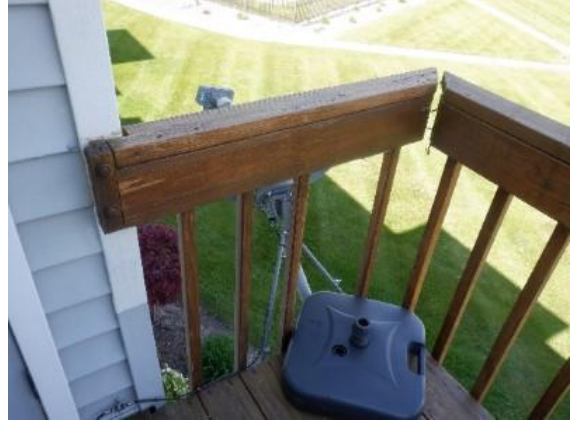
Image(s) For Finding No.56

56. At the topside of unit 234 deck, the North and South guardrails are connected to the building with wooden cleats which are deteriorated and loose with lag screws which have pulled out.

56. Install new Southern pine 4x4 pressure treated guard post at each end of the guardrail per Simpson guard post to decking from hold down and fastener details or equal.

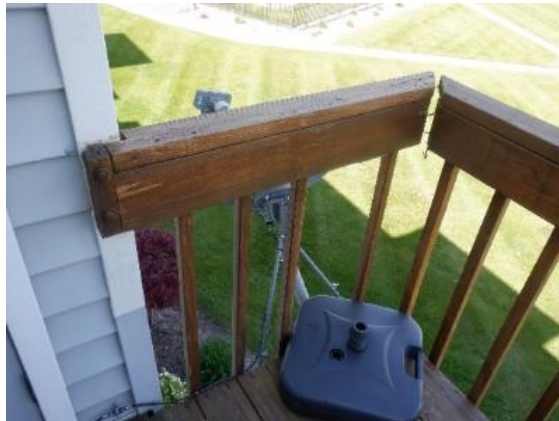
Image(s) For Finding No.57

57. At the topside of unit 234 deck, at the S.W. corner of the guardrail, the 2x6 and 2x4 are deteriorated with nails and screws that have pulled out and the connection is separated.

57. Replace the deteriorated guardrail in kind using pressure treated lumber. POSTS Repair Priority: P1

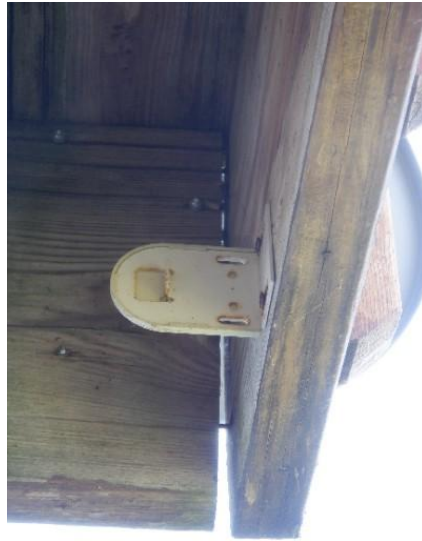
Image(s) For Finding No.58

58. At the underside of unit 234 deck, at the S.W. corner, the rim joist connection is end nailed and separated.

58. Remove the existing fasteners and secure the rim joist connection with the proper size and type exterior screws for decks. Repair Priority: P2

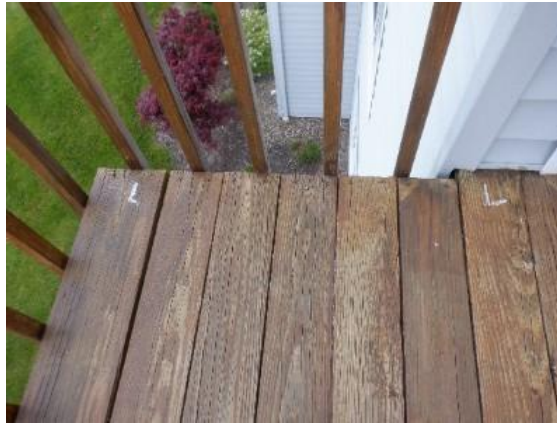
Image(s) For Finding No.62

62. At the topside of unit 233 deck, there are 2 loose deck boards at the north side.

62. Remove the existing fasteners and secure the deck boards with the proper size and type exterior screws for decks.
Repair Priority: P3

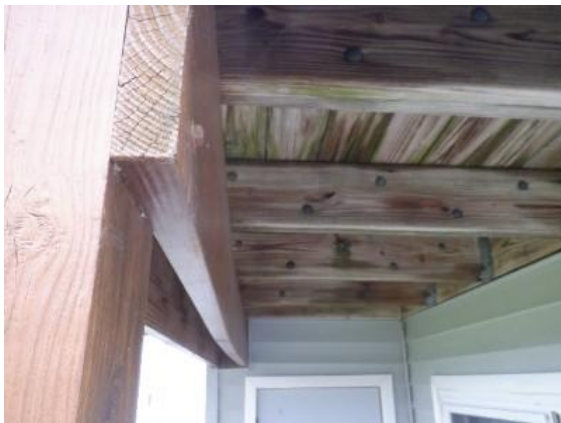
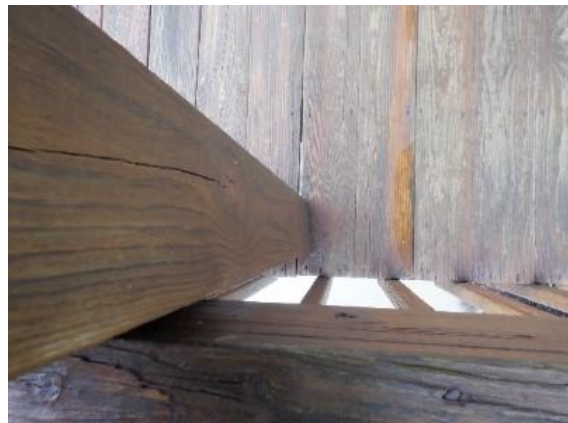
Image(s) For Finding No.64

64. At the underside of unit 233, the support column is twisted.

64. For the record only. No action required.

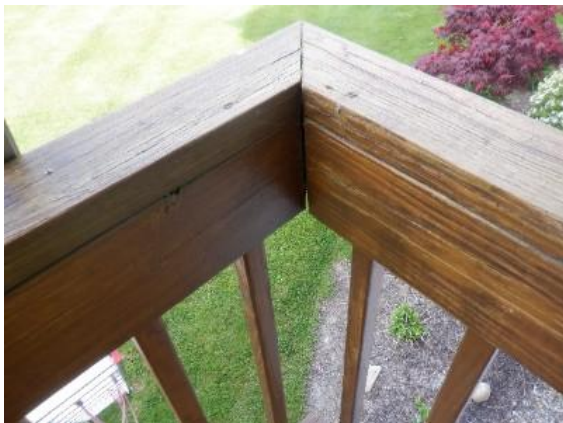
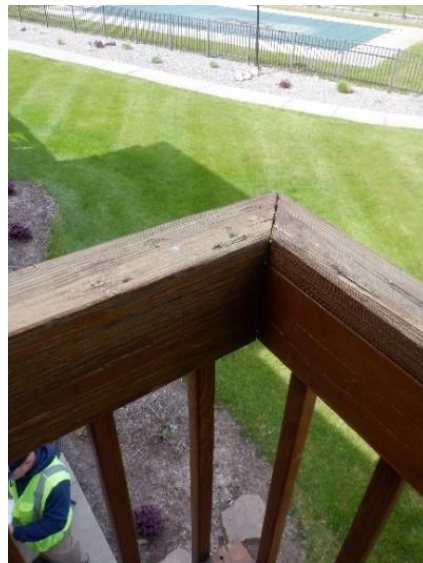
Image(s) For Finding No.66

66. At the topside of unit 223 deck, at both guardrail corner connections, the 2x6 and 2x4 are toe nailed and separating.

66. Remove the existing fasteners and secure the guardrail connection with the proper size and type exterior screws for decks.
Repair Priority: P2

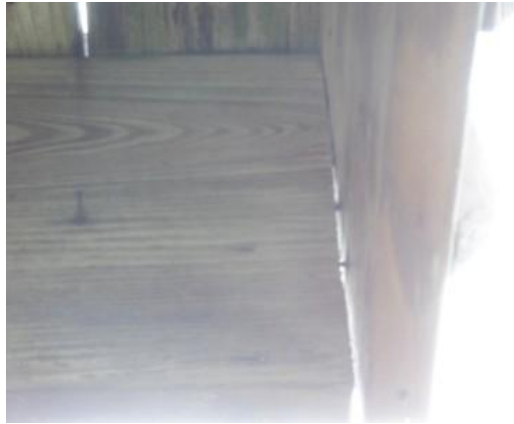
Image(s) For Finding No.67

67. At the underside of unit 223 deck, the S.W rim joist corner connection is end nailed and separating.

67. Remove the existing fasteners and secure the rim joist connection with the proper size and type exterior screws for decks.
Repair Priority: P2

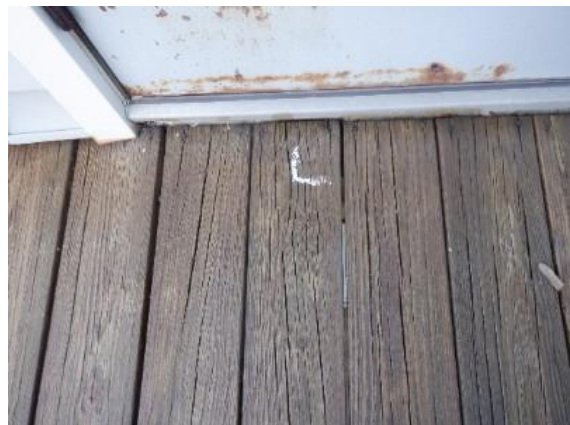
Image(s) For Finding No.68

68. At the topside of unit 232 deck, there are 2 loose deck boards and 1 deteriorated deck board.

68. Replace the deteriorated deck board in kind with pressure treated lumber and secure the new and existing loose deck boards with the proper size and type exterior screws for decks.
Repair Priority: P3

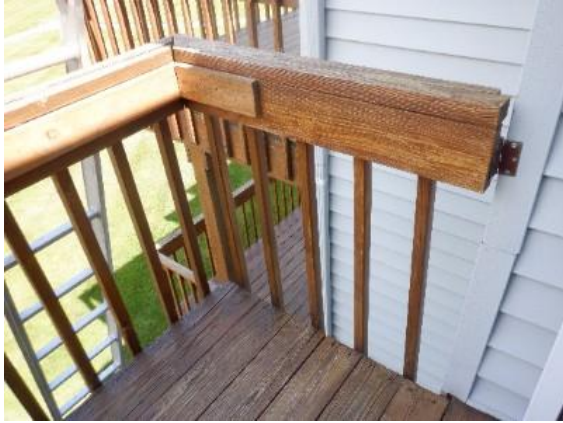
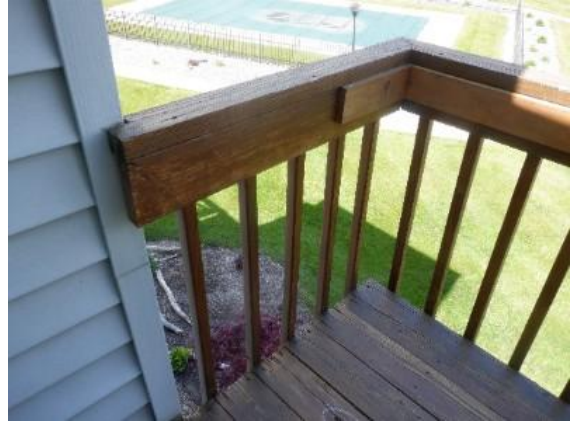
Image(s) For Finding No.69

69. At the topside of unit 232 deck, the North and South guardrails are not supported with a post at the building side and wobbly.

69. Install new Southern pine 4x4 pressure treated guard post at each end of the guardrail per Simpson guard post to decking from hold down and fastener details or equal.
Repair Priority: P2

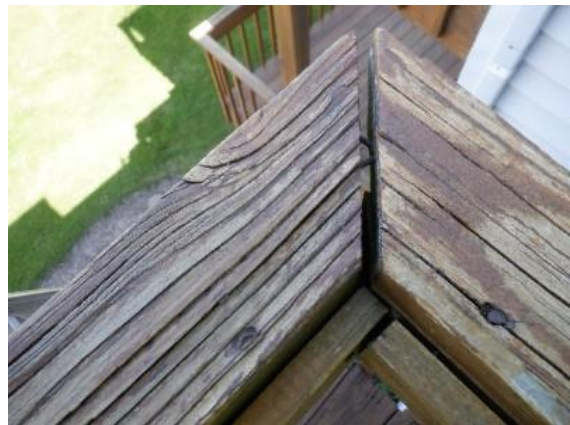
Image(s) For Finding No.70

70. At the topside of unit 232 deck, the guardrail 2x4 is deteriorated and separating at the connections.

70. Replace the deteriorated 2x4 guardrail in kind with pressure treated lumber.
Repair Priority: P3

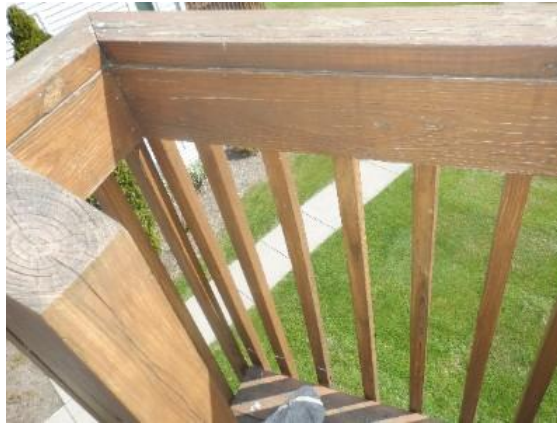
Image(s) For Finding No.73

73. At the topside of unit 222 deck, at the S.W. corner guardrail connection, the 2x6 and 2x4 are both separated.

73. Remove the existing fasteners and secure the guardrail connection with the proper size and type exterior screws for decks. Repair Priority: P3

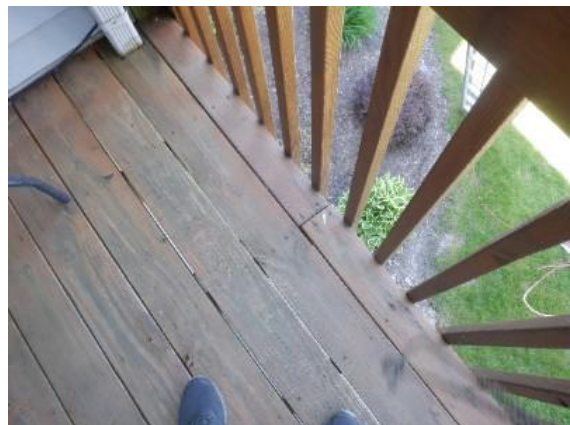
Image(s) For Finding No.81

81. At the topside of unit 327 deck, there is 1 loose deck board.

81. Remove the existing fasteners and secure the deck board with the proper size and type exterior screws for decks. Repair Priority: P3

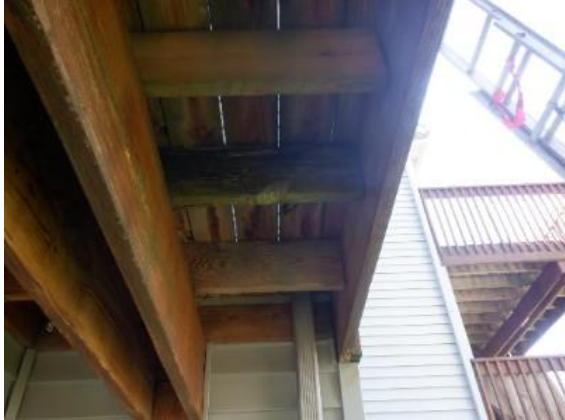
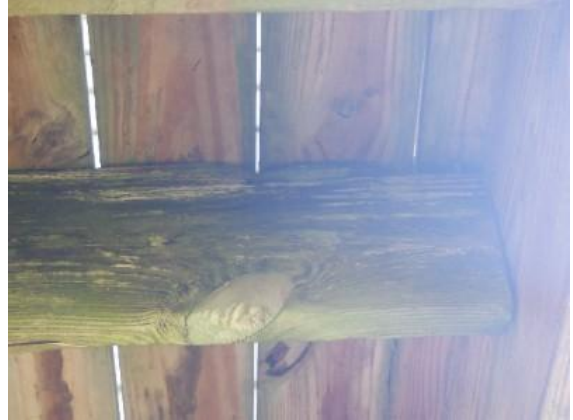
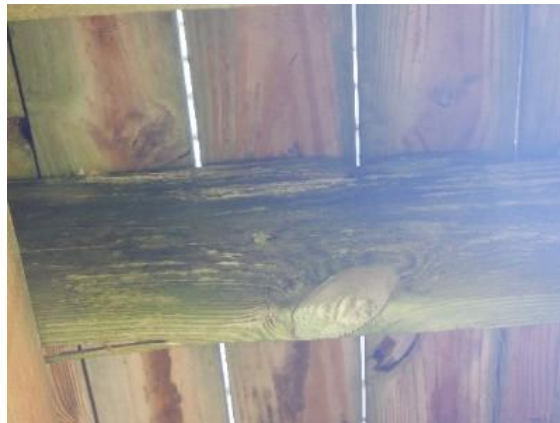
Image(s) For Finding No.82

82. At the underside of unit 327 deck, 2nd joist from South is soft and decayed at the top.

82. Replace the damaged joist in kind with pressure treated lumber and deck joist flashing tape added. Secure with proper size and type of exterior screws for decks. Repair Priority: P3

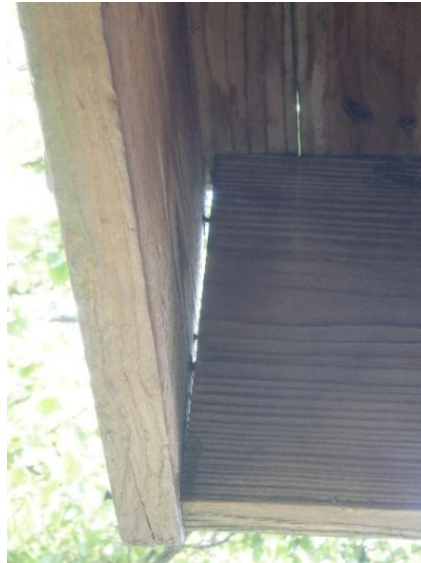
Image(s) For Finding No.83

83. At the underside of unit 327 deck, the rim joist corner connection is end nailed and separating.

83. Remove the existing fasteners and secure the rim joist connection with the proper size and type exterior screws for decks. Repair Priority: P2

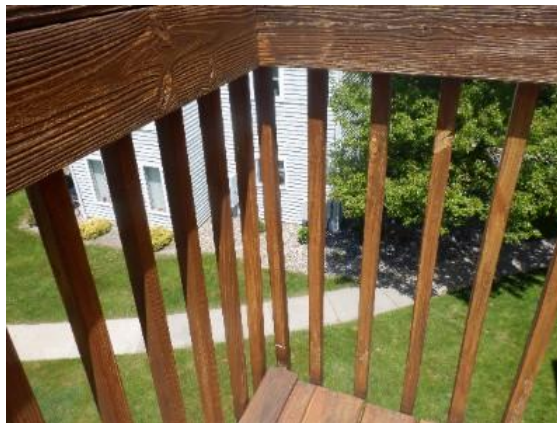
Image(s) For Finding No.84

84. At the topside of unit 336 deck, at the N.W. corner of the guardrail, there is 1 loose baluster.

84. Remove the existing fasteners and secure the baluster connection with the proper size and type exterior screws for decks. Repair Priority: P2

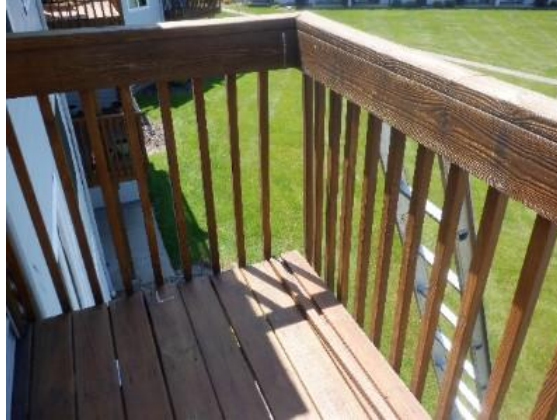
Image(s) For Finding No.85

85. At the topside of unit 336 deck, at the S.W. corner of guardrail, there is 1 baluster missing and laying on deck.

85. Replace the missing baluster in kind with pressure treated lumber and secure with proper size and type exterior screws for decks.

Repair Priority: P2

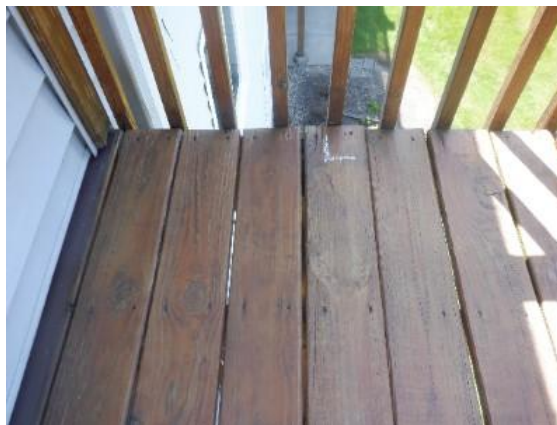
Image(s) For Finding No.86

86. At the topside of unit 336 deck, there is 1 loose deck board.

86. Remove the existing fasteners and secure the deck board with the proper size and type exterior screws for decks.

Repair Priority: P3

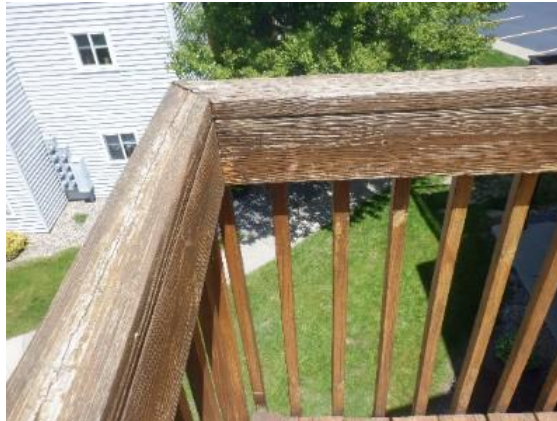
Image(s) For Finding No.87

87. At the topside of unit 336 deck, the guardrail 2x4 is weathered and splintered.

87. Replace the deteriorated 2x4 guardrail in kind using pressure treated lumber.
Repair Priority: P3

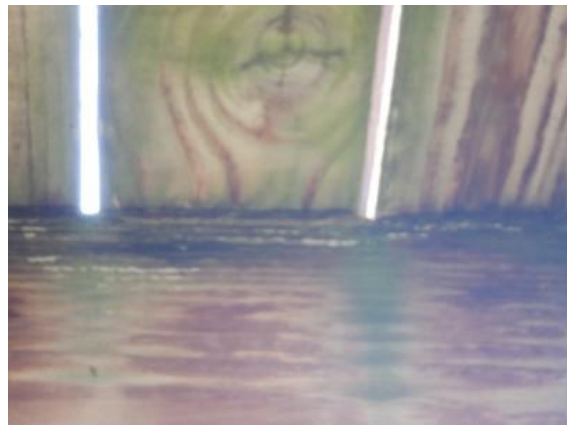
Image(s) For Finding No.88

88. At the underside of unit 336 deck, the South rim joist and 2 joists North are soft and decayed at the top.

88. Replace the deteriorated joists in kind with pressure treated lumber and deck joint flashing tape added. Secure with proper size and type of exterior screws for decks.
Repair Priority: P3

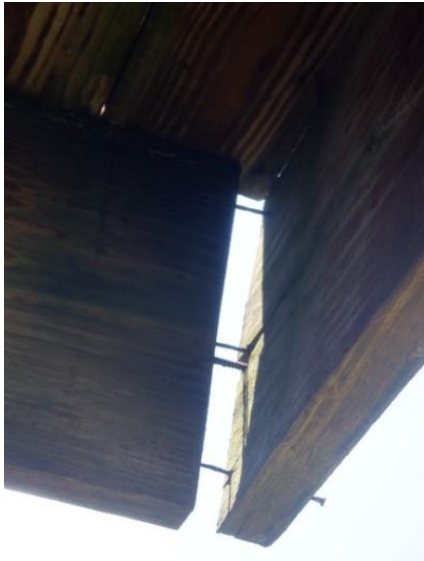
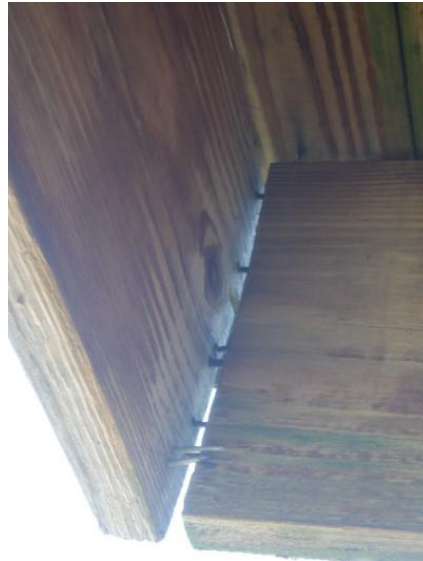
Image(s) For Finding No.89

89. At the underside of unit 336 deck, the rim joist corner connections are end nailed and separating.

89. Remove the existing fasteners and secure the rim joist connections with the proper size and type exterior screws for decks. Repair Priority: P2

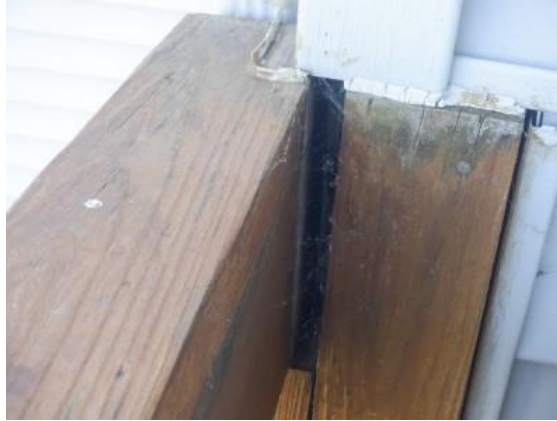
Image(s) For Finding No.91

91. At the topside of unit 326 deck, the North guardrail is loose at the building side post.

91. Secure the guardrail with proper size and type of exterior screws for decks.
Repair Priority: P2

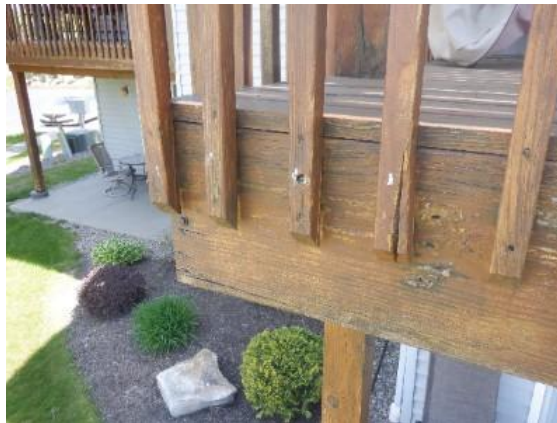
Image(s) For Finding No.92

92. At the topside of unit 326 deck, on West guardrail, there are 4 balusters loose

92. Remove the existing fasteners and secure the baluster connections with the proper size and type exterior screws for decks.
Repair Priority: P2

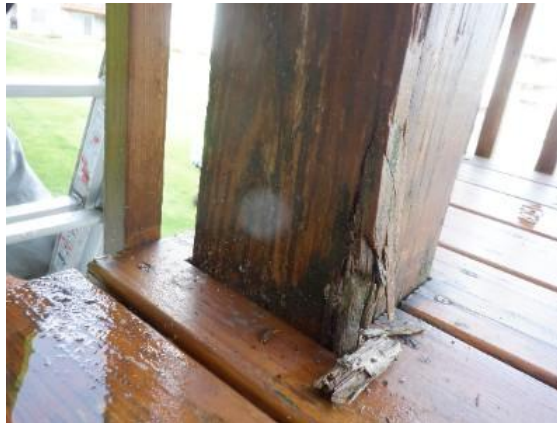
Image(s) For Finding No.93

93. At the underside of unit 326 deck, the West support column is decayed at the deck elevation.

93. Temporarily shore the decks above and replace the decayed support column in kind with Simpson DJTZ connectors added at the beam connections. Since the column is being replaced, further engineering is recommended to develop a repair procedure to raise the concrete footer.

Repair Priority: P3

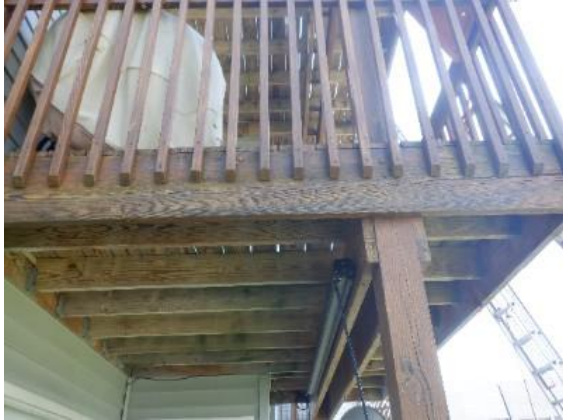
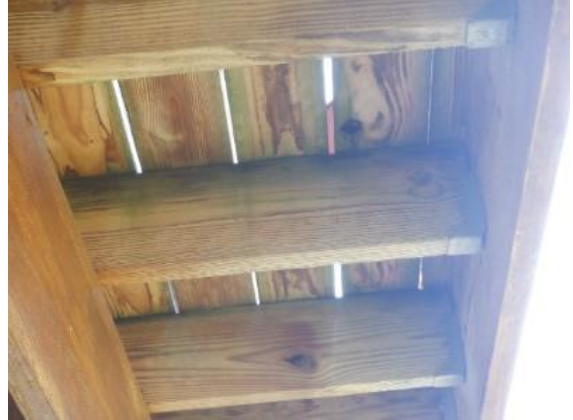
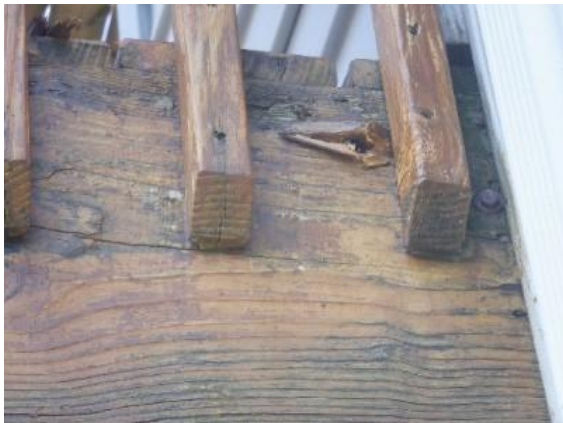
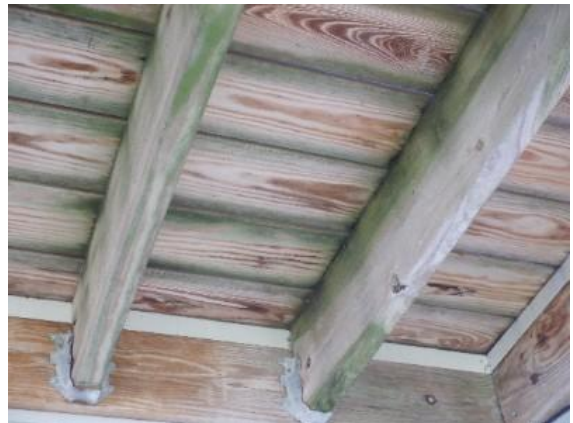
Image(s) For Finding No.94

94. At the underside of unit 326 deck, all joists including the North and South end joists are soft and decayed at the top and the North is cracked.

94. Replace the deteriorated joists in kind with pressure treated lumber and deck joist flashing tape added. Secure with proper size type of exterior screws for decks. Repair Priority: P2
