2023
STRUCTURAL INSPECTION REPORT
MARINERS POINT
Lakeside Decks
STRUCTURE TAG NO.: LAKESIDE DECKS

Previous Inspection Date: N/A
Globex Job No.: G-6970

Date Of Inspection: 4/26/2023, 5/17/2023 and 5/18/2023
Report Issued Date: 06/09/2023
Inspected By: B. Gerst, J. Myers

A structural condition based inspection of the wooden exterior decks and their support columns on the lake side of Buildings 1 – 5 was performed from the ground level and a 20' and 28' extension ladder.

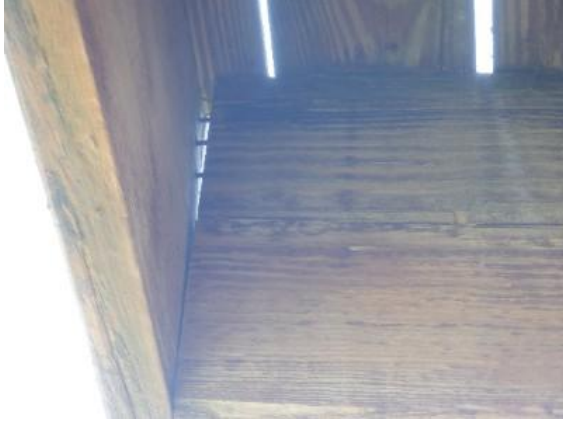
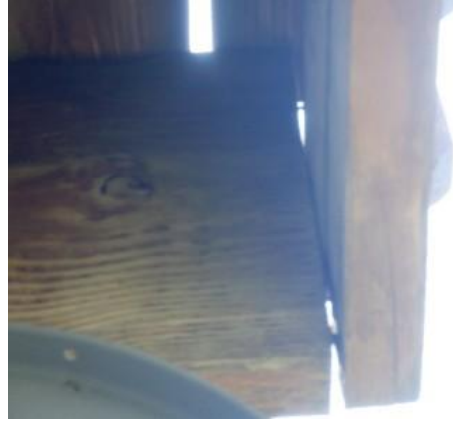
Image(s) For Finding No.95

95. At the underside of unit 326 deck, the West rim joist has multiple screws and nails at both end connections and the joist is cracked and splintered as a result.

95. Replace the damaged rim joist in kind with pressure treated lumber and deck joist flashing tape added. Secure with proper size type of exterior screws for decks. Repair Priority: P2

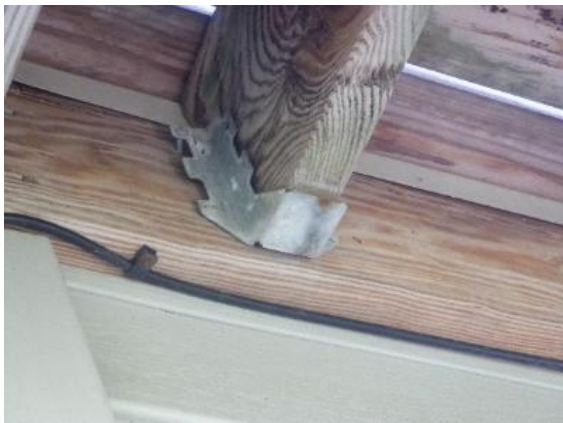
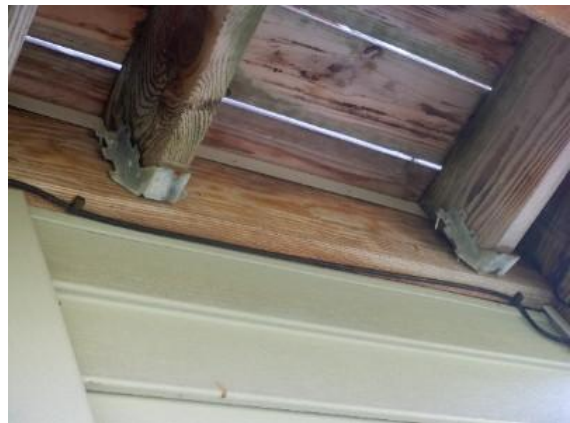
Image(s) For Finding No.96

96. At the underside of of unit 326 deck, at the first and second joist from the South on the building side, the joist hanger nails are pulling out.

96. Remove the loose fasteners and secure with the proper size and type of exterior screws for decks. Repair Priority: P1

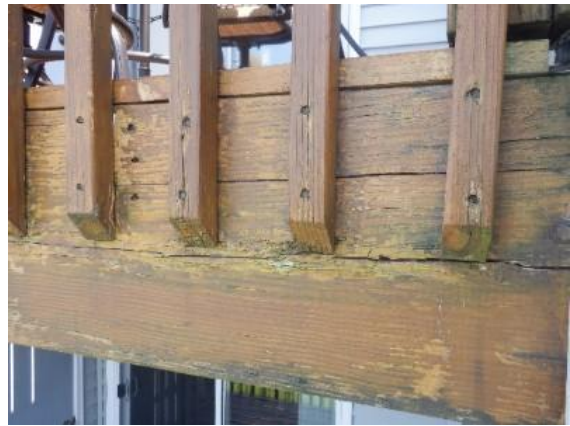
Image(s) For Finding No.98

98. At the underside of unit 335 deck, the West rim joist is cracked at mid depth almost full length.

98. Replace the damaged rim joist in kind with pressure treated lumber and deck joist flashing tape added.
Repair Priority: P2

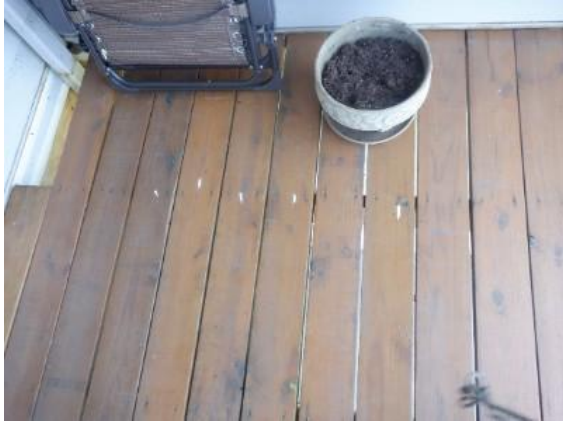
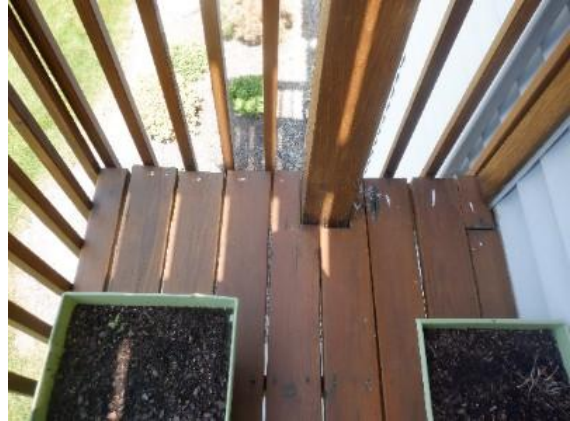
Image(s) For Finding No.99

99. At the topside of unit 325 deck, there are 13 loose deck boards and 1 missing.

99. Replace the missing deck board in kind with pressure treated lumber and secure the new and existing loose deck boards with the proper size and type exterior screws for decks.
Repair Priority: P2

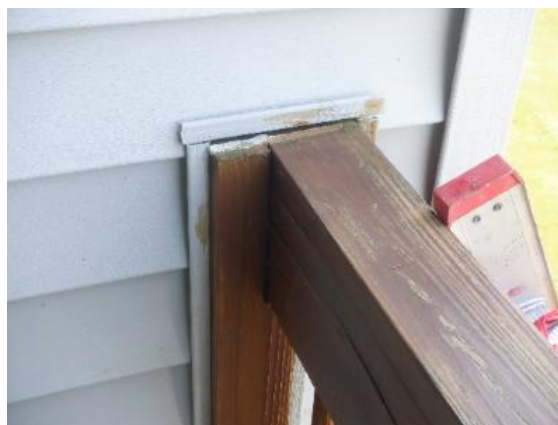
Image(s) For Finding No.100

100. At the topside of unit 325 deck, the South guardrail to building connection is loose.

100. Remove the existing fasteners and secure the guardrail connection with the proper size and type exterior screws for decks.
Repair Priority: P2

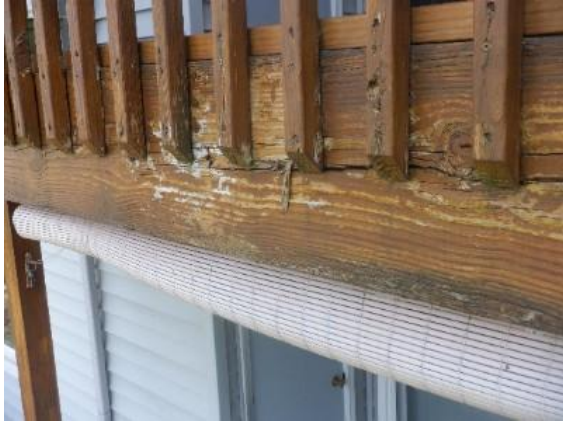
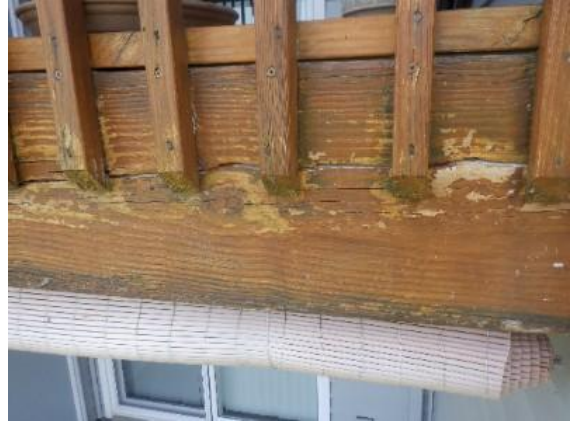
Image(s) For Finding No.101

101. At the underside of unit 325 deck, the West rim joist is cracked, soft and decayed. Also, the N.W. corner connection is end nailed, lag bolted and is separating.

101. Replace the damaged rim joist in kind with pressure treated lumber and deck joist flashing tape added. Secure with proper size type of exterior screws for decks. Repair Priority: P2

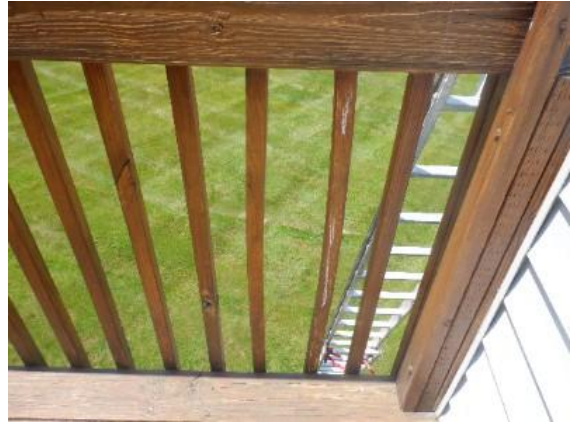
Image(s) For Finding No.103

103. At the topside of unit 334 deck, there are 6 loose balusters.

103. Remove the existing fasteners and secure the baluster connections with the proper size and type exterior screws for decks.
Repair Priority: P2

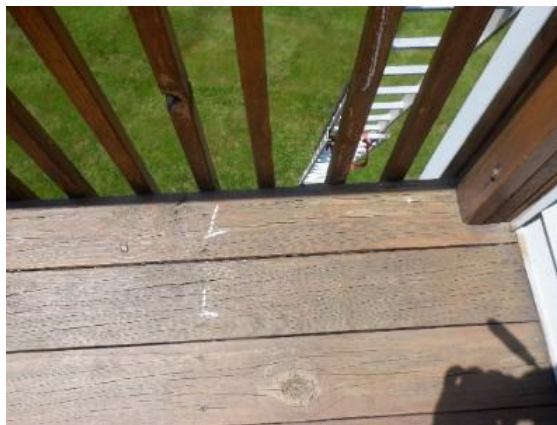
Image(s) For Finding No.104

104. At the topside of unit 334 deck, there are 2 loose deck boards.

104. Remove the existing fasteners and secure the deck boards with the proper size and type exterior screws for decks.
Repair Priority: P3

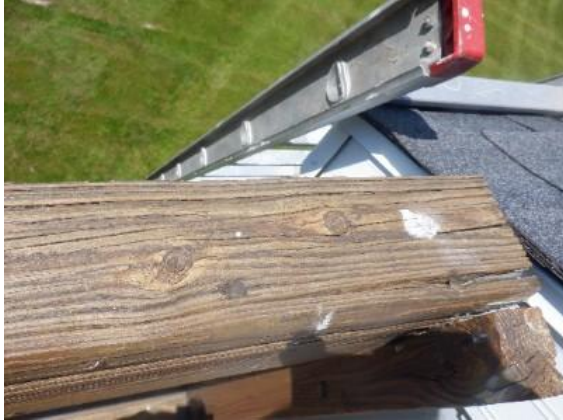
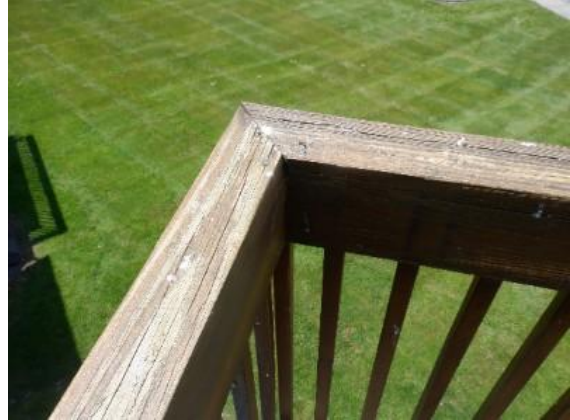
Image(s) For Finding No.105

105. At the topside of unit 334 deck, the guardrail 2x4 is weathered and splintered.

105. Replace the damaged 2x4 guardrail in kind with pressure treated lumber. Secure with proper size type of exterior screws for decks.
Repair Priority: P2

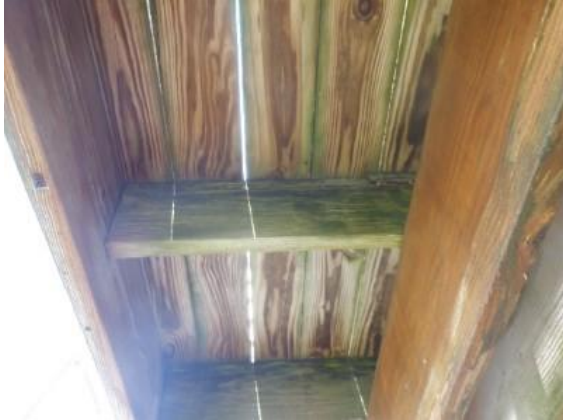
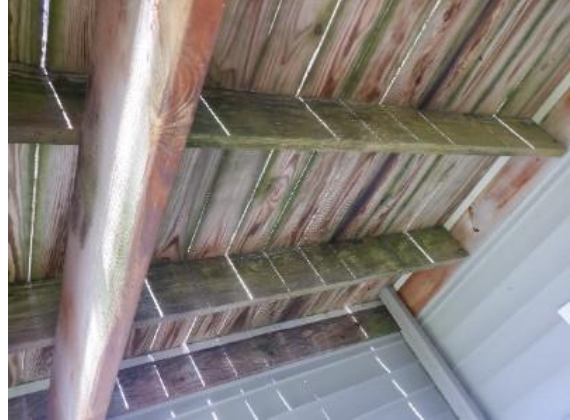
Image(s) For Finding No.107

107. At the underside of unit 334 deck, the fifth and sixth joists from the South, are soft and decayed at the top.

107. Replace the deteriorated joists in kind with pressure treated lumber and deck joist flashing tape added. Secure with proper size type of exterior screws for decks. Repair Priority: P2

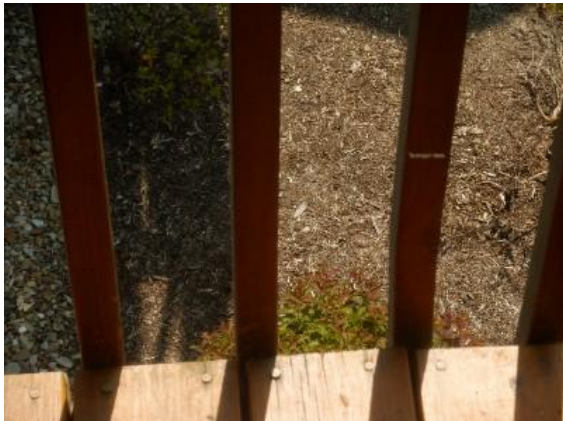
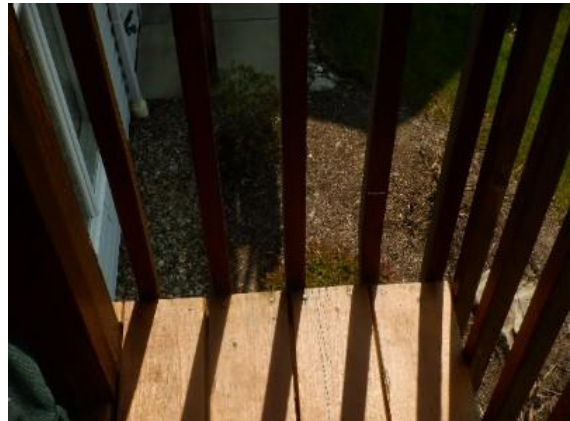
Image(s) For Finding No.108

108. At the topside of unit 324 deck, at South guardrail, there is 1 loose baluster

108. Remove the existing fasteners and secure the baluster connection with the proper size and type exterior screws for decks. Repair Priority: P2

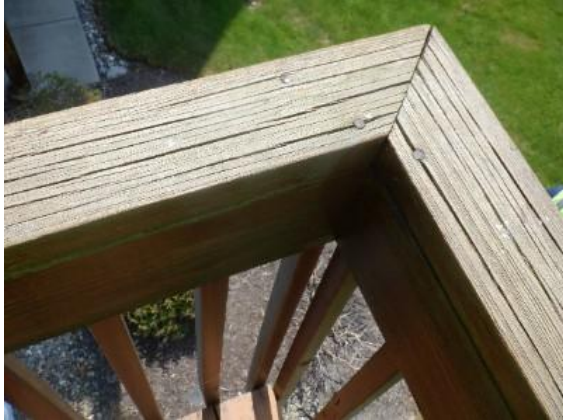
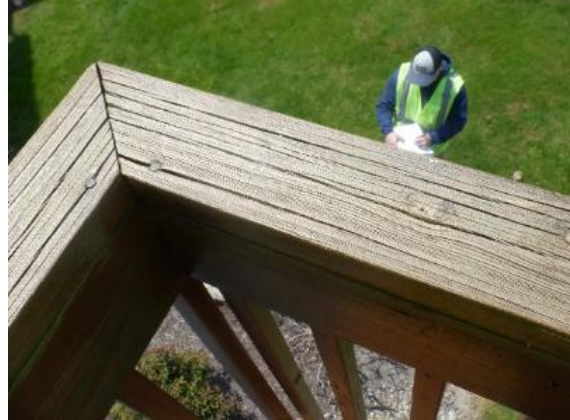
Image(s) For Finding No.109

109. At topside of unit 324 deck, the guardrail 2x4 is weathered and splintered all around.

109. Replace the deteriorated 2x4 guardrail in kind with pressure treated lumber. Secure with proper size type of exterior screws for decks.
Repair Priority: P3

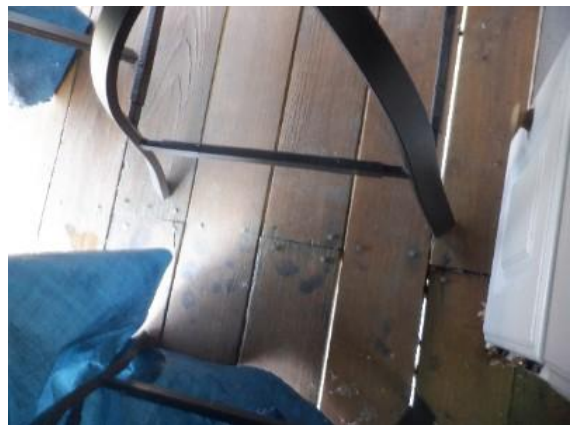
Image(s) For Finding No.110

110. At the topside of unit 324 deck, all deck boards are loose at seams.

110. The deck boards are loose due to the deteriorated joists below. After the joist below are replaced, secure the deck boards with proper size and type exterior screws for decks.
Repair Priority: P2

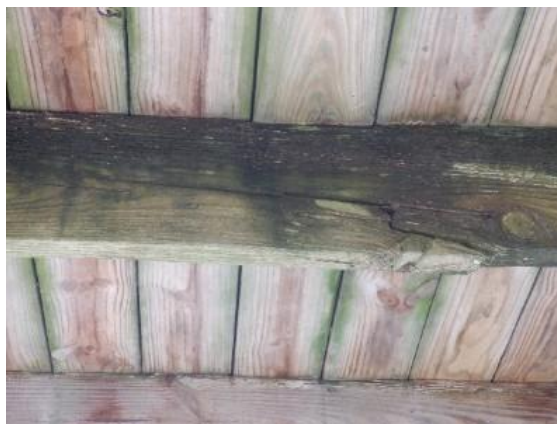
Image(s) For Finding No.111

111. At the underside of unit 324 deck, the third thru sixth joists from the South are soft and decayed at the top and the fifth joist is cracked and sagging.

111. Replace the deteriorated joists in kind with pressure treated lumber and deck joist flashing tape added.
Repair Priority: P1

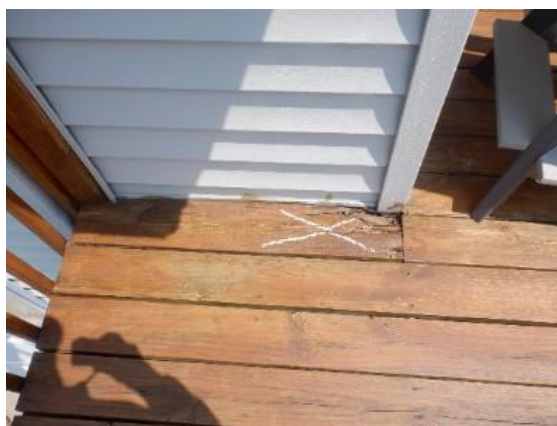
Image(s) For Finding No.112

112. At the topside of unit 333 deck, at the North corner, there is 1 deck board deteriorated.

112. Due to the extent of damage noted in the findings for unit 333 deck, it is recommended that this deck be replaced with a new deck in accordance with OBC-latest edition requirements with pressure treated lumber and deck joist flashing tape added.
Repair Priority: P2

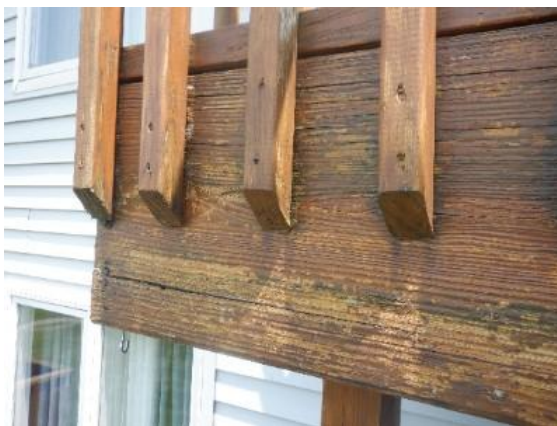
Image(s) For Finding No.113

113. At the underside of unit 333 deck, the N.W. corner connection of rim joist has been end nailed and lagged, as a result the rim joist is cracked.

113. Due to the extent of damage noted in the findings for unit 333 deck, it is recommended that this deck be replaced with a new deck in accordance with OBC-latest edition requirements with pressure treated lumber and deck joist flashing tape added.
Repair Priority: P2

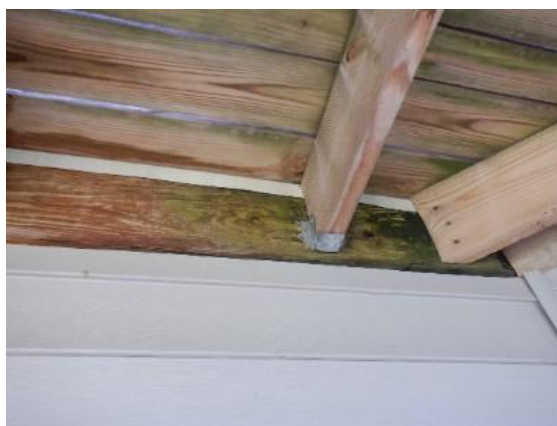
Image(s) For Finding No.116

116. At the underside of unit 333 deck, the 2x4 joist hangers were used for 2x8 joists.

116. Due to the extent of damage noted in the findings for unit 333 deck, it is recommended that this deck be replaced with a new deck in accordance with OBC-latest edition requirements with pressure treated lumber and deck joist flashing tape added.
Repair Priority: P2

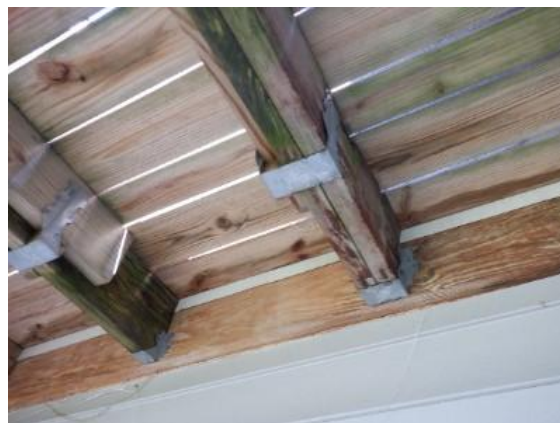
Image(s) For Finding No.117

117. At the underside of unit 333 deck, 4.5" wide hanger brackets were used during a prior reinforcement attempt to allow the decayed joists to remain. However, the decayed joists are still carrying the load.

117. Due to the extent of damage noted in the findings for unit 333 deck, it is recommended that this deck be replaced with a new deck in accordance with OBC-latest edition requirements with pressure treated lumber and deck joist flashing tape added.
Repair Priority: P2

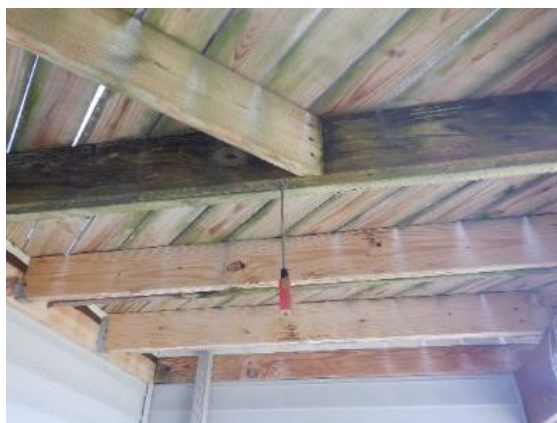
Image(s) For Finding No.118

118. At the underside of unit 333 deck, new joists were added in an attempt to reinforce the deck. However, the new joists are tied into the decayed joists.

118. Due to the extent of damage noted in the findings for unit 333 deck, it is recommended that this deck be replaced with a new deck in accordance with OBC-latest edition requirements with pressure treated lumber and deck joist flashing tape added.
Repair Priority: P2

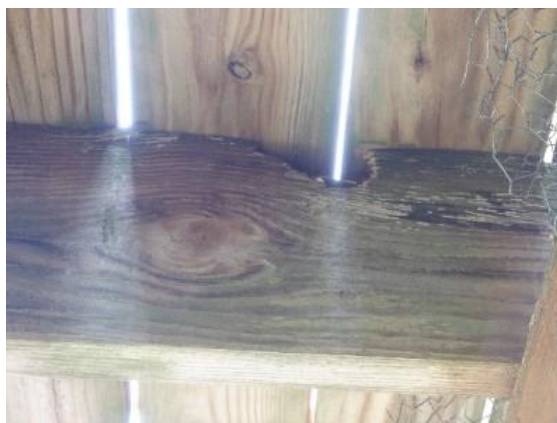
Image(s) For Finding No.120

120. At the underside of unit 333 deck, the third joist from the North is soft and decayed at the top.

120. Due to the extent of damage noted in the findings for unit 333 deck, it is recommended that this deck be replaced with a new deck in accordance with OBC-latest edition requirements with pressure treated lumber and deck joist flashing tape added.
Repair Priority: P2

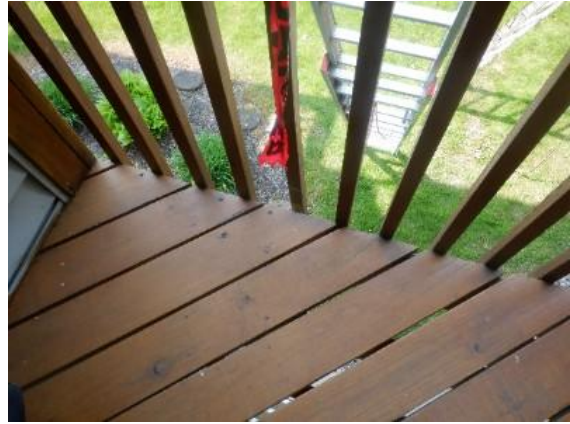
Image(s) For Finding No.121

121. At the topside of unit 323 deck, there is 1 loose baluster.

121. Remove the existing fasteners and secure the baluster connection with the proper size and type exterior screws for decks. Repair Priority: P2

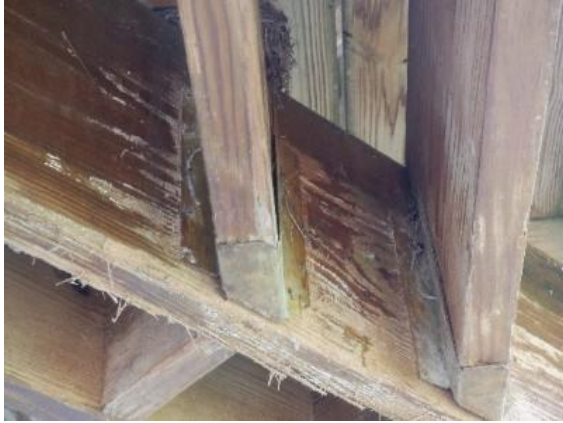
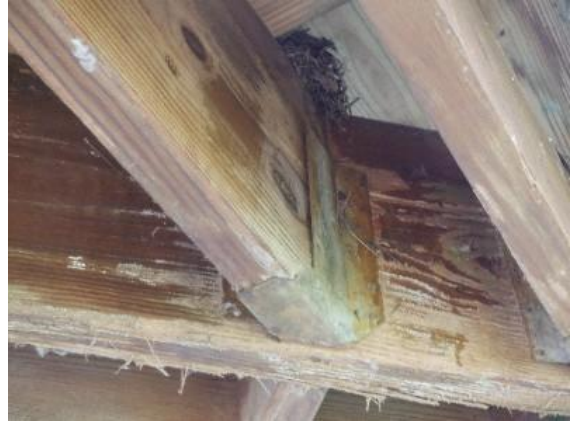
Image(s) For Finding No.123

123. At the underside of unit 323 deck, at the main 2x12 beam splice, there is 1 beam hanger that is not fully nailed.

123. Secure the hanger bracket to the beam in accordance with manufacturer's requirements. Due to the limited clearance, a right angle drill will be required.
Repair Priority: P3

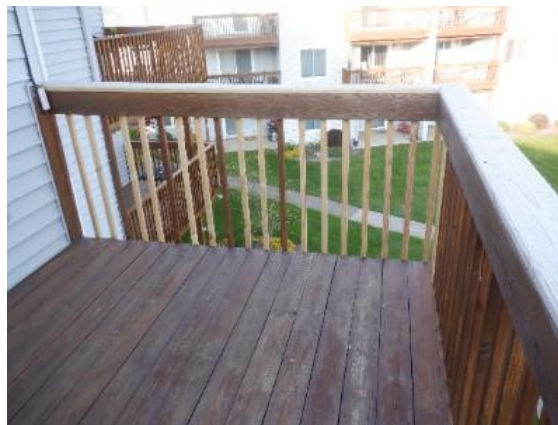
Image(s) For Finding No.124

124. At the topside of unit 332 deck, the recently added guardrail 2x4 and balusters need sealant.

124. Prepare and apply a protective sealant in accordance with the manufacturer's recommendations.
Repair Priority: P4

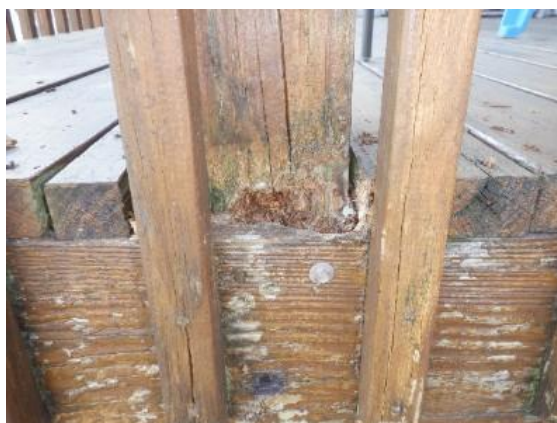
Image(s) For Finding No.126

126. At the underside of unit 332 deck, the South support column is soft and decayed with approximately 40% section loss behind the recently installed rim joist. Note the rim joist was installed with 2 lag screws and a thru bolt. At the topside of unit 322 deck, the same South support column is soft and decayed with approximately 50% section loss at deck level.

126. Temporarily shore the decks and replace the deteriorated column in kind with pressure treated lumber and with Simpson DJTZ connections added at the beam connections. Since the column is being replaced, further engineering is recommended to develop a repair procedure to raise the concrete footer. Repair Priority: P3

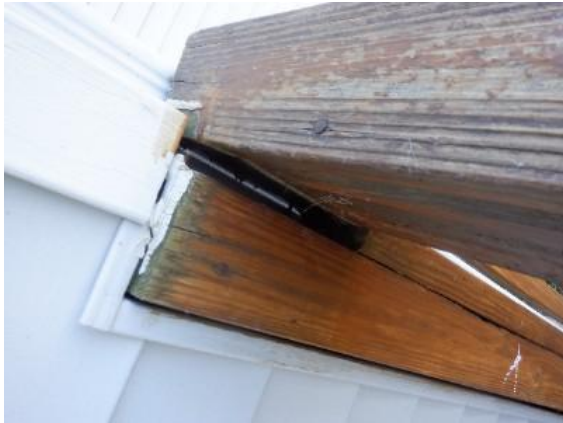
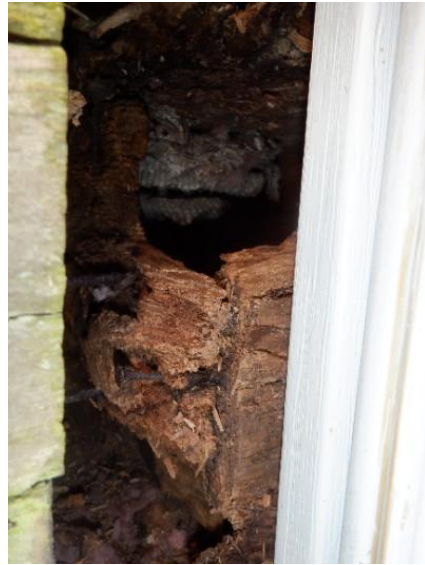
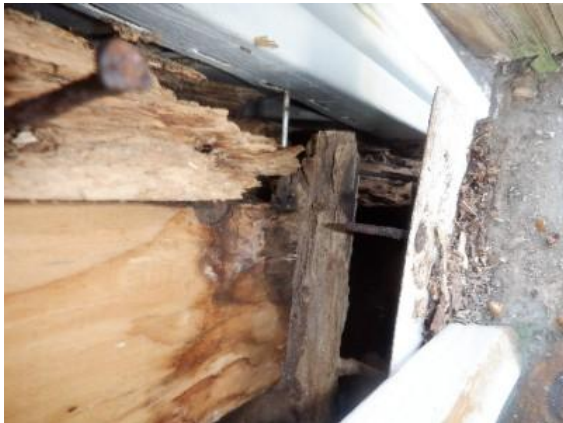
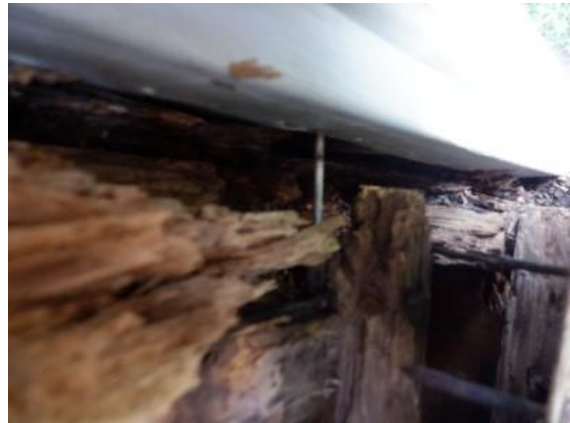
Image(s) For Finding No.127

127. At the topside of unit 322 deck, the South guardrail to building connection is loose because the building framing is deteriorated.

127. Due to the extent of damage noted in the findings for unit 322 deck, it is recommended that this deck be replaced with a new deck in accordance with OBC-latest edition requirements with pressure treated lumber and deck joist flashing tape added.

Repair Priority: P1

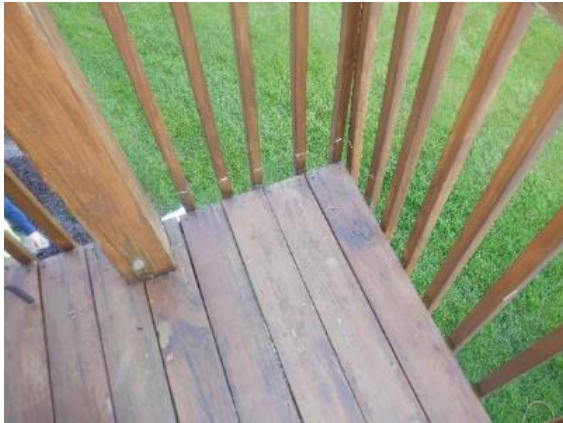
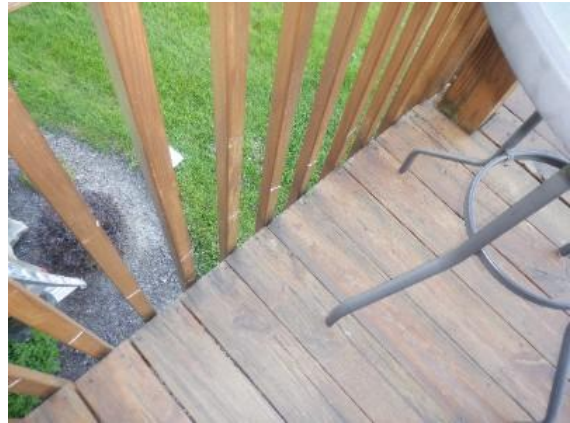
Image(s) For Finding No.128

128. At the topside of unit 322 deck, at the South guardrail, all balusters are loose.

128. Due to the extent of damage noted in the findings for unit 322 deck, it is recommended that this deck be replaced with a new deck in accordance with OBC-latest edition requirements with pressure treated lumber and deck joist flashing tape added.
Repair Priority: P1

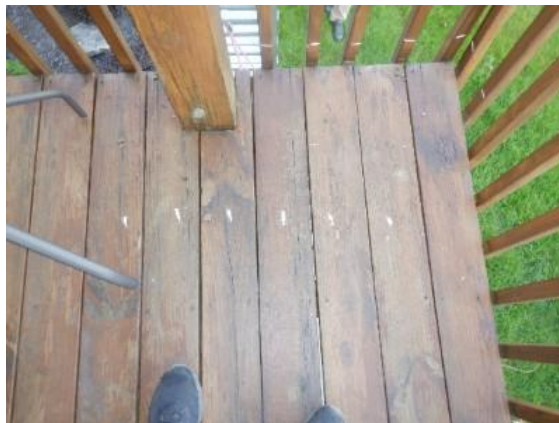
Image(s) For Finding No.129

129. At the topside of unit 322 deck, there are 6 loose deck boards.

129. Due to the extent of damage noted in the findings for unit 322 deck, it is recommended that this deck be replaced with a new deck in accordance with OBC-latest edition requirements with pressure treated lumber and deck joist flashing tape added.
Repair Priority: P1

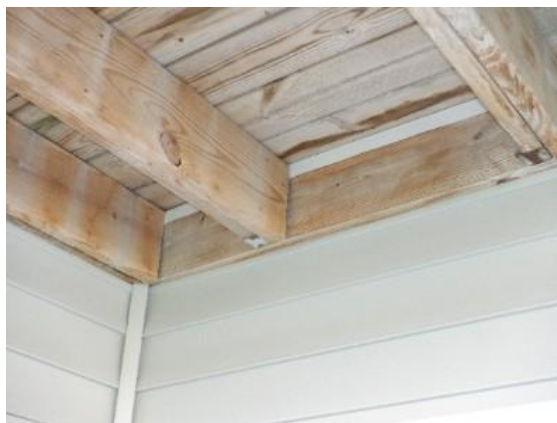
Image(s) For Finding No.130

130. At the underside of unit 322 deck, new joists were added next to decayed joists. However, the new joists are not connected to the ledger board and only screwed to the decayed joist.

130. Due to the extent of damage noted in the findings for unit 322 deck, it is recommended that this deck be replaced with a new deck in accordance with OBC-latest edition requirements with pressure treated lumber and deck joist flashing tape added.
Repair Priority: P1

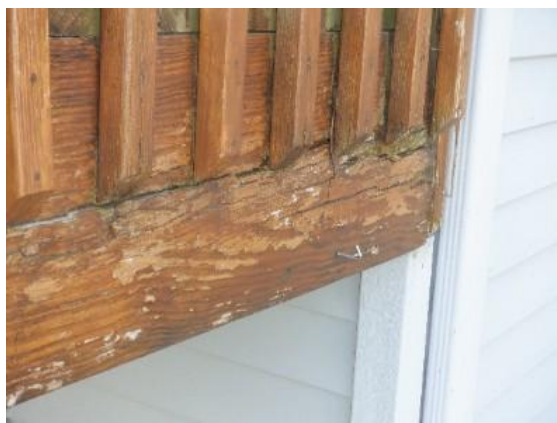
Image(s) For Finding No.131

131. At the underside of unit 322 deck, the South rim joist is completely decayed. The South end of ledger board is decayed and building framing in the wall is decayed from precipitation infiltrating the wall.

131. Due to the extent of damage noted in the findings for unit 322 deck, it is recommended that this deck be replaced with a new deck in accordance with OBC-latest edition requirements with pressure treated lumber and deck joist flashing tape added.
Repair Priority: P1

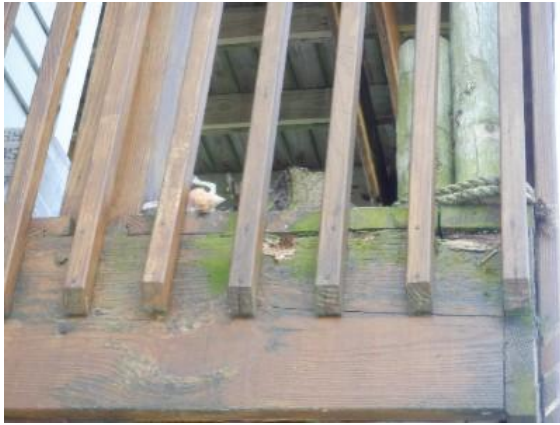
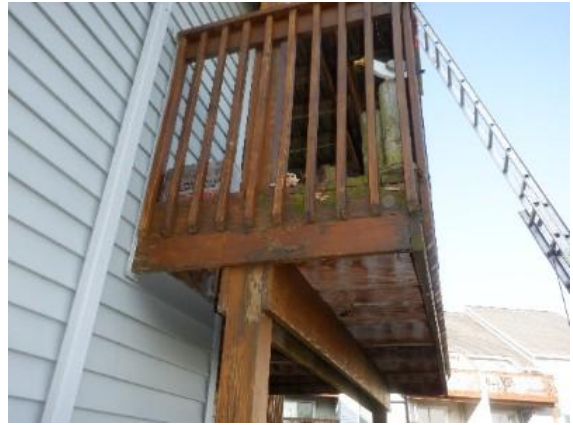
Image(s) For Finding No.132

132. At the underside of unit 322 deck, the North rim joist is soft and decayed at the top.

132. Due to the extent of damage noted in the findings for unit 322 deck, it is recommended that this deck be replaced with a new deck in accordance with OBC-latest edition requirements with pressure treated lumber and deck joist flashing tape added.
Repair Priority: P1

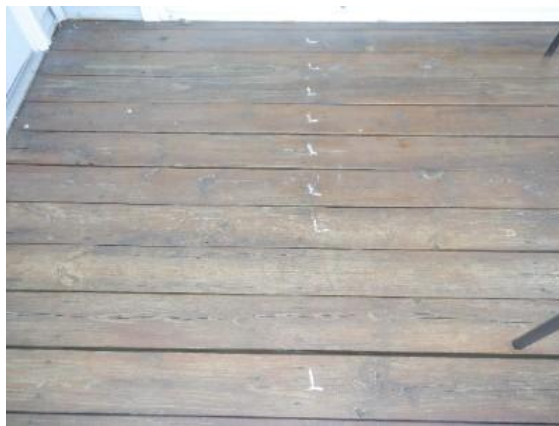
Image(s) For Finding No.133

133. At the topside of unit 331 deck, there are 8 loose deck boards.

133. Remove the existing fasteners and secure the deck boards with the proper size and type exterior screws for decks.
Repair Priority: P3

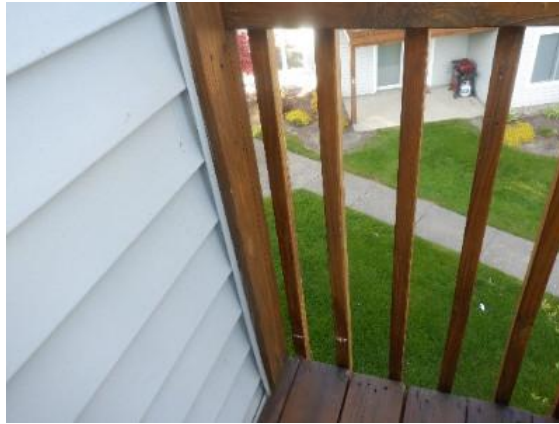
Image(s) For Finding No.134

134. At the topside of unit 331 deck, at the South guardrail, there are 2 loose balusters.

134. Remove the existing fasteners and secure the baluster connection with the proper size and type exterior screws for decks. Repair Priority: P2

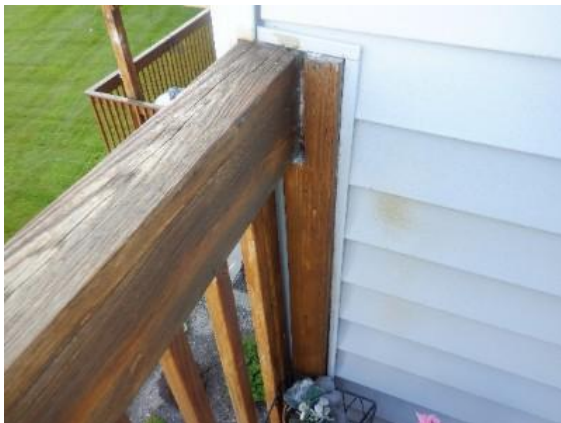
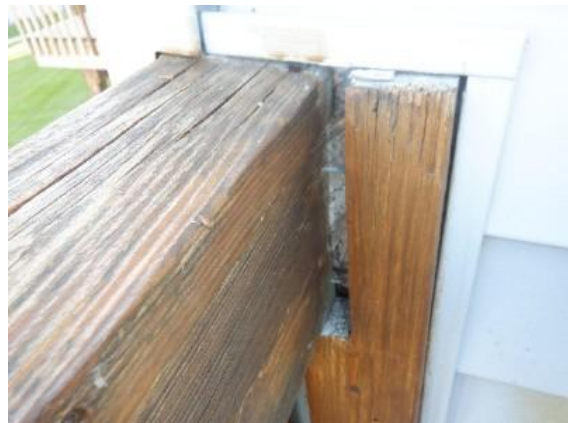
Image(s) For Finding No.135

135. At the topside of unit 331 deck, at the North guardrail to building connection the toe nails are pulled out and the OSB behind is exposed.

135. Install proper flashing and caulking to protect the building structure. Remove the existing fasteners and secure the guardrail connection with the proper size and type exterior screws for decks. Repair Priority: P2

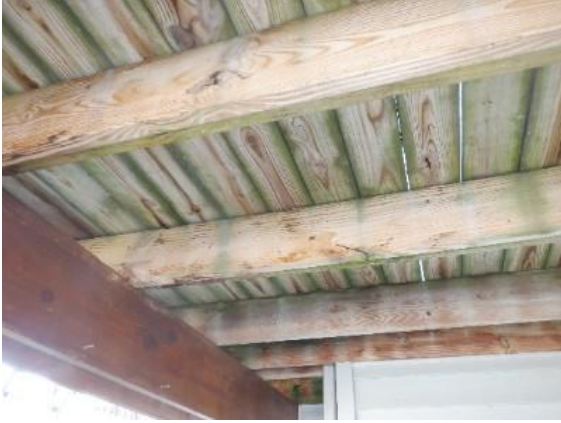
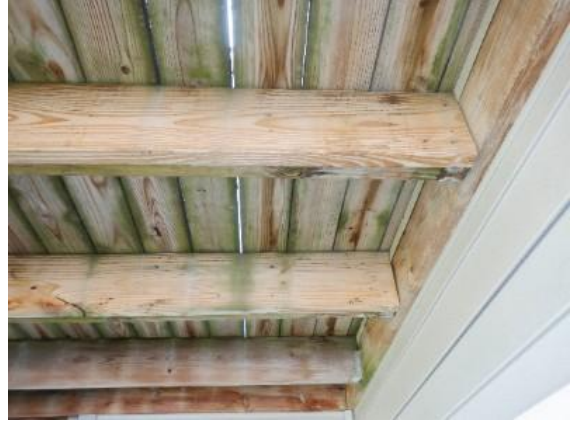
Image(s) For Finding No.136

136. At the underside of unit 331 deck, 2 new joists were added next to the decayed joists. However, the new joists are screwed into the old joists and only connected to the ledger with 1 toe screw.

136. Remove the deteriorated joists, add deck joist flashing tape to the new joists and secure to the ledger board with proper hangers and proper size and type exterior screws for decks.
Repair Priority: P2

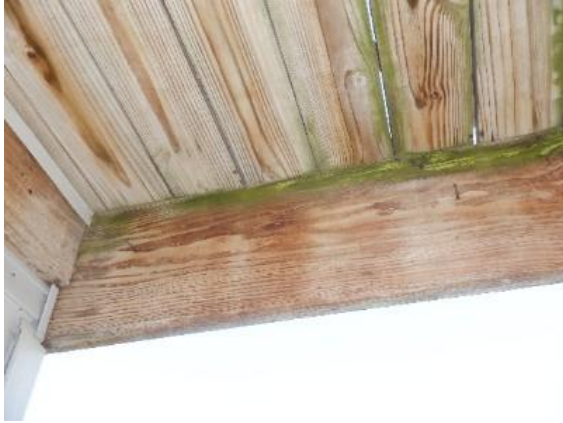
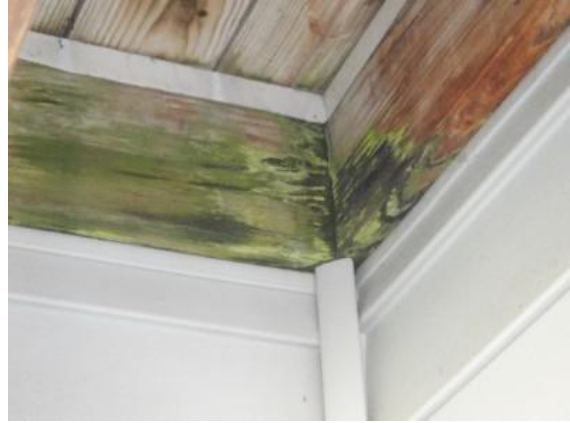
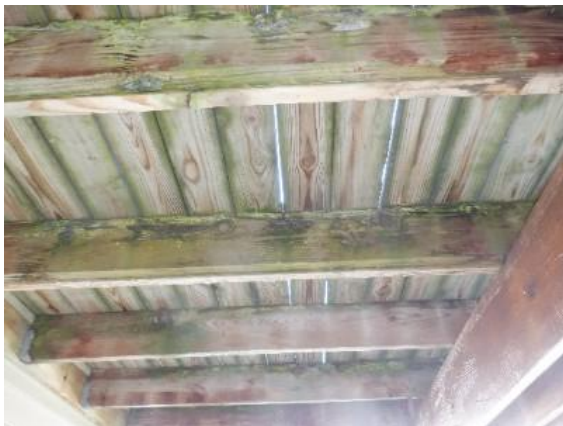
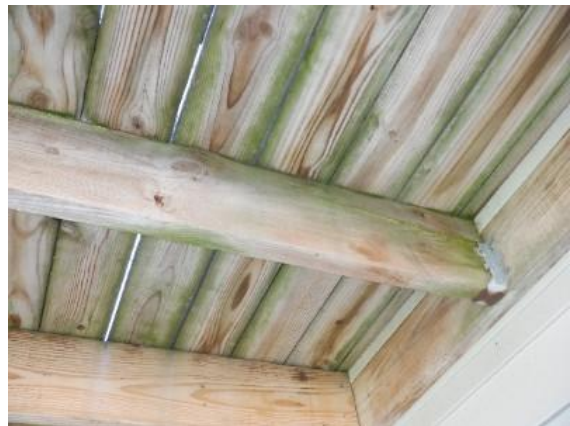
Image(s) For Finding No.137

137. At the underside of unit 331 deck, there are 4 joists which are soft and decayed at the top.

137. Replace the deteriorated joists in kind with pressure treated lumber and deck joist flashing tape added. Secure the new joists to ledger board with proper size and type of exterior screws for decks.
Repair Priority: P2

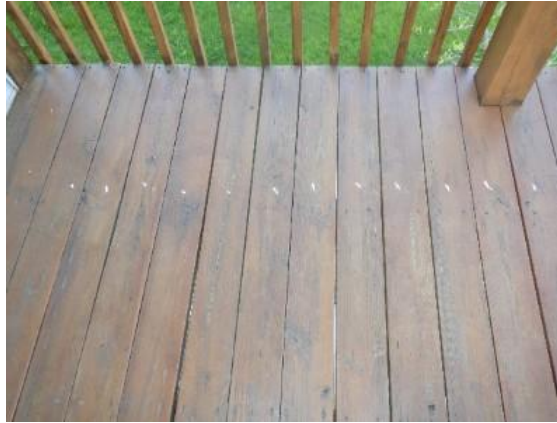
Image(s) For Finding No.138

138. At the topside of unit 321 deck, there are 12 loose deck boards.

138. Remove the existing fasteners and secure the deck boards with the proper size and type exterior screws for decks.
Repair Priority: P3

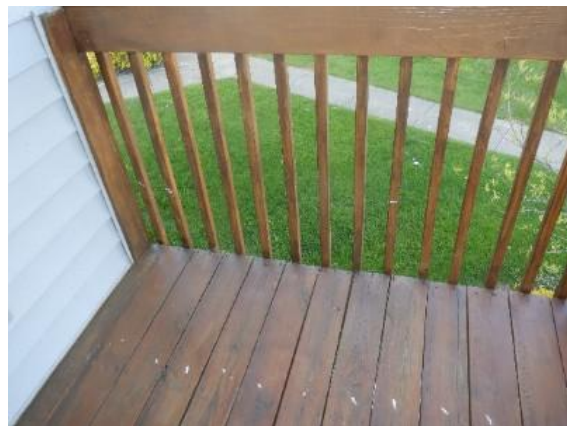
Image(s) For Finding No.139

139. At the topside of unit 321 deck, there are 4 loose balusters.

139. Remove the existing fasteners and secure the baluster connections with the proper size and type exterior screws for decks.
Repair Priority: P2

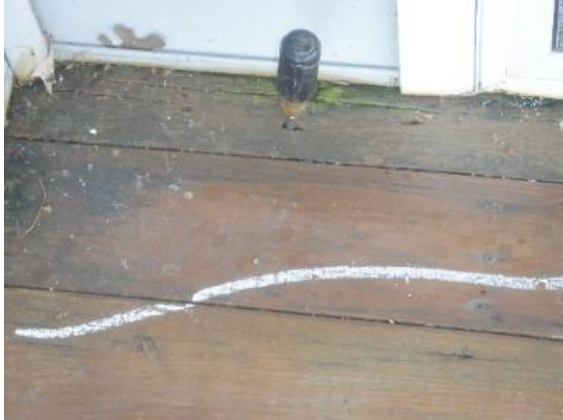
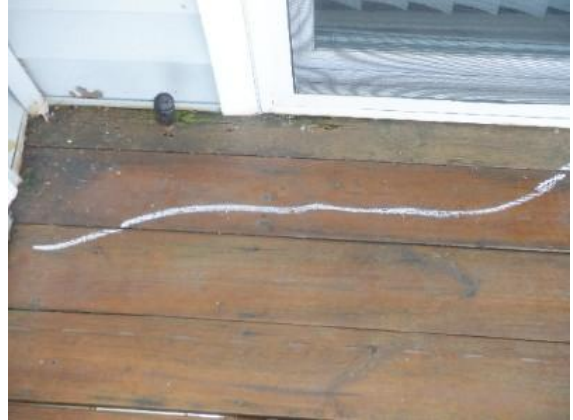
Image(s) For Finding No.140

140. At the topside of unit 321 deck, there are 2 deteriorated deck boards.

140. Replace the deteriorated deck boards in kind with pressure treated lumber and secure with the proper size and type exterior screws for decks.
Repair Priority: P2

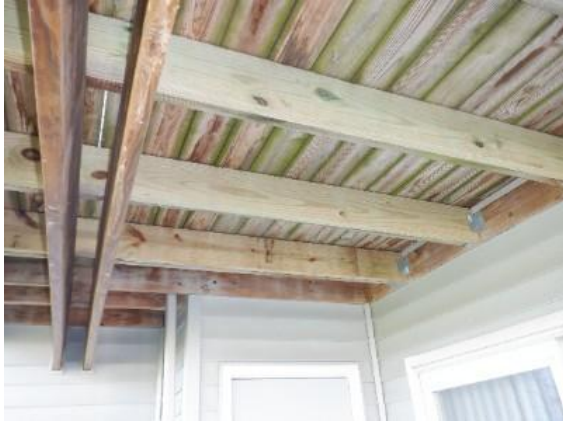
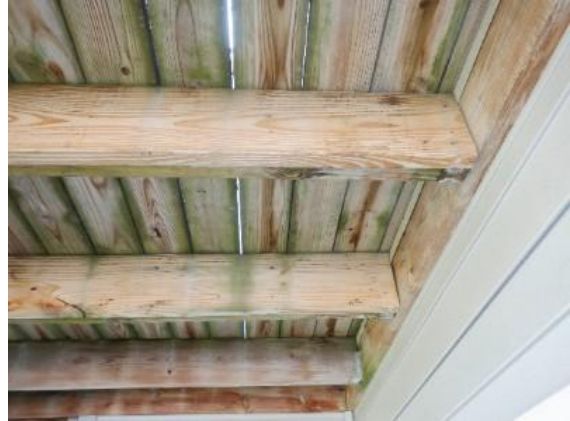
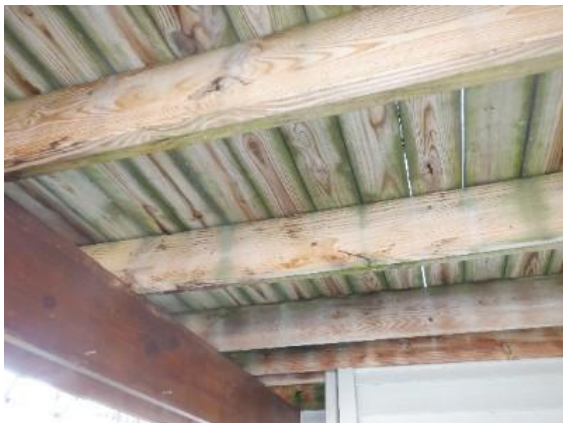
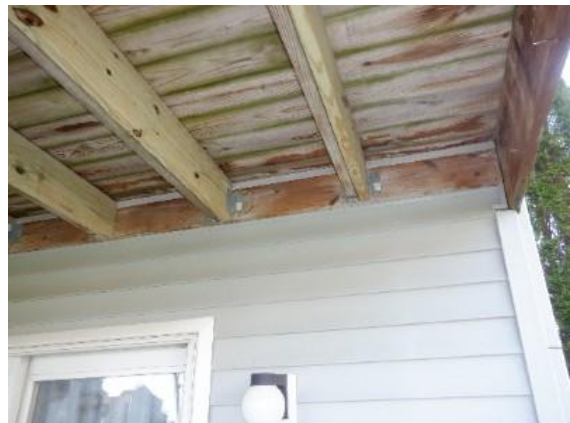
Image(s) For Finding No.141

141. At the underside unit 321 deck, 6 new joists were added next to the decayed joists. However, 5 of them are connected to the ledger with corner brackets and 1 is toe screwed to the ledger instead of using hanger brackets.

141. Remove the deteriorated joist and secure the new joist with proper size hangers and fasteners.
Repair Priority: P3

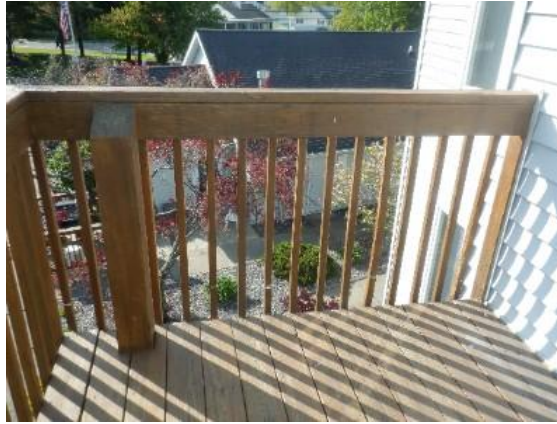
Image(s) For Finding No.142

142. At the topside of unit 436 deck, the South guardrail has 4 balusters loose.

142. Remove the existing fasteners and secure the baluster connections with the proper size and type exterior screws for decks. Repair Priority: P2

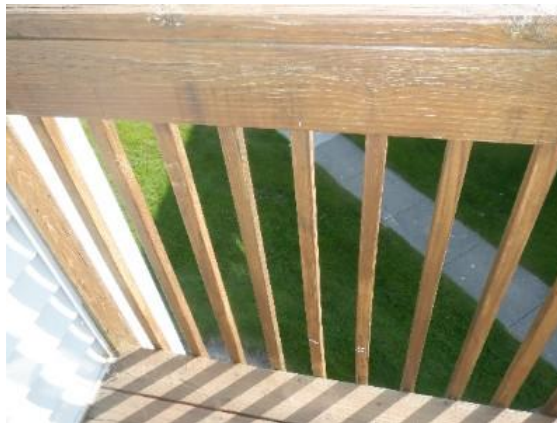
Image(s) For Finding No.143

143. At the topside of unit 436 deck, the East guardrail at North end has 2 balusters loose.

143. Remove the existing fasteners and secure the baluster connections with the proper size and type exterior screws for decks. Repair Priority: P2

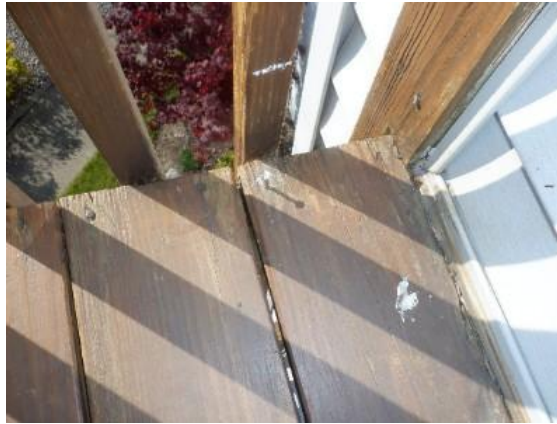
Image(s) For Finding No.144

144. At the topside of unit 436 deck, there is 1 deck board with popped nails on South end.

144. Remove the existing fasteners and secure the deck board with the proper size and type exterior screws for decks.
Repair Priority: P3

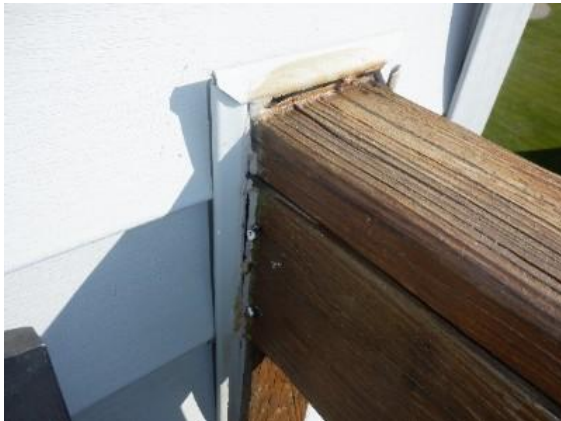
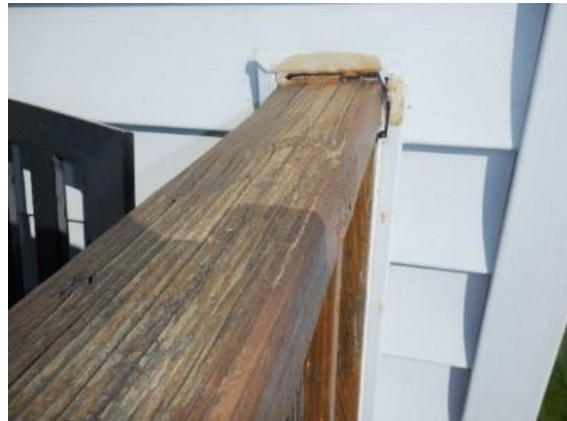
Image(s) For Finding No.145

145. At the topside of unit 436 deck, the East guardrail at the North end building connection is loose.

145. Remove the existing fasteners and secure the guardrail connection with the proper size and type exterior screws for decks. Removal of siding and J-channel may be required.
Repair Priority: P2

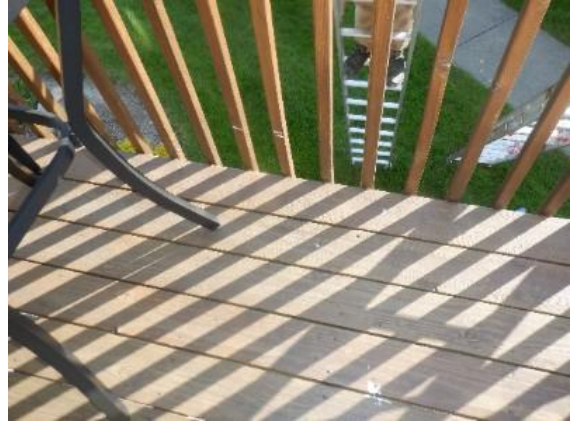
Image(s) For Finding No.147

147. At the topside of unit 426 deck, there are 7 balusters loose on the East side.

147. Remove the existing fasteners and secure the baluster connections with the proper size and type exterior screws for decks. Repair Priority: P2

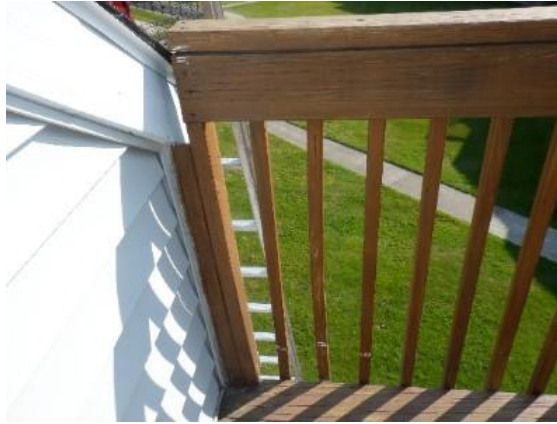
Image(s) For Finding No.149

149. At the topside of unit 435 deck, at the East guardrail North end, there are 3 loose balusters.

149. Remove the existing fasteners and secure the baluster connections with the proper size and type exterior screws for decks. Repair Priority: P2

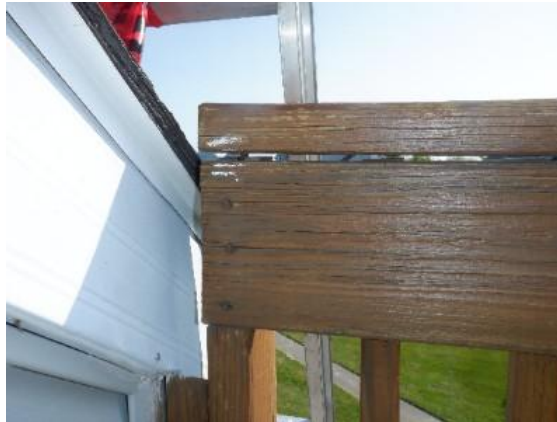
Image(s) For Finding No.150

150. At the topside of unit 435 deck, at the East guardrail North end, the 2x4 is loose.

150. Remove the existing fasteners and secure the guardrail connection with the proper size and type exterior screws for decks. Repair Priority: P3

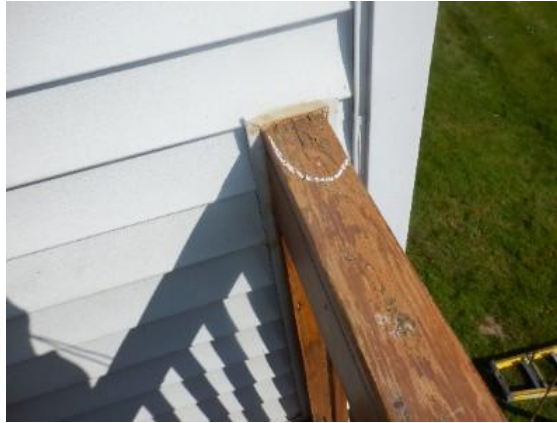
Image(s) For Finding No.152

152. At the topside of unit 425 deck, at the East guardrail North end, the 2x4 is starting to deteriorate.

152. Replace the deteriorated 2x4 guardrail in kind with pressure treated lumber. Secure with proper size and type of exterior screws for decks.
Repair Priority: P2

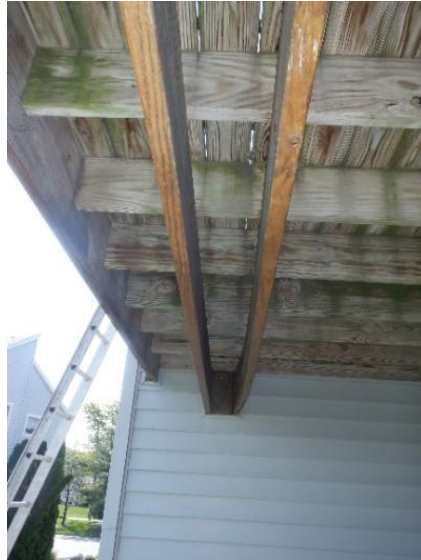
Image(s) For Finding No.155

155. At the underside of unit 434 deck, the West 2x12 beam is bowed.

155. For the record only. No action required.

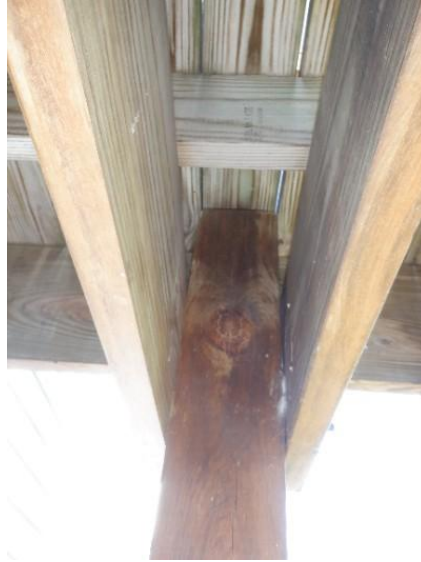
Image(s) For Finding No.156

156. At the underside of unit 434 deck, at the East 2x12 beam to North post connection, the top of the connection is separated.

156. Secure the beam to post connection with Simpson DJTZ connectors in accordance with the manufactures recommendations.
Repair Priority: P2

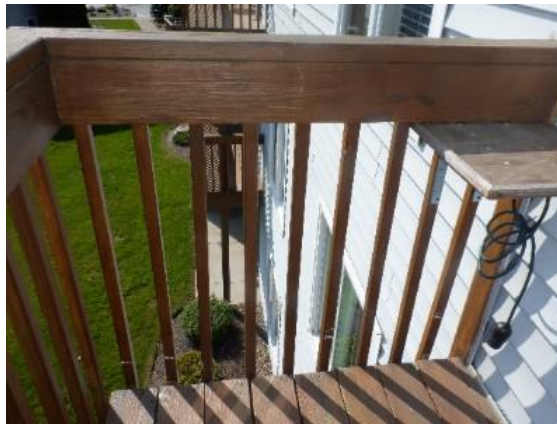
Image(s) For Finding No.159

159. At the topside of unit 433 deck, at the South guardrail, there are 4 loose balusters.

159. Remove the existing fasteners and secure the baluster connections with the proper size and type exterior screws for decks. Repair Priority: P2

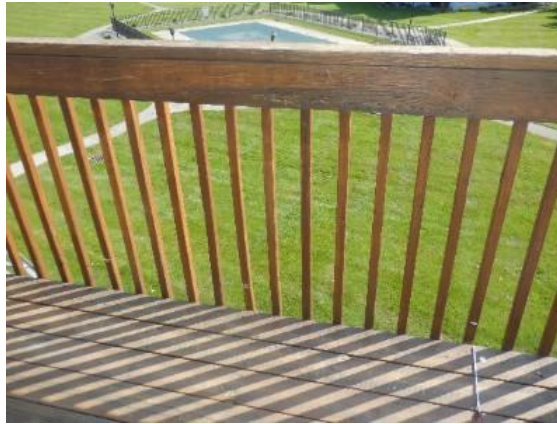
Image(s) For Finding No.160

160. At the topside of unit 433 deck, at the East guardrail, there are 3 loose balusters.

160. Remove the existing fasteners and secure the baluster connections with the proper size and type exterior screws for decks. Repair Priority: P2
