2023
STRUCTURAL INSPECTION REPORT
MARINERS POINT
Lakeside Decks
STRUCTURE TAG NO.: LAKESIDE DECKS

Previous Inspection Date: N/A
Globex Job No.: G-6970

Date Of Inspection: 4/26/2023, 5/17/2023 and 5/18/2023
Report Issued Date: 06/09/2023
Inspected By: B. Gerst, J. Myers

A structural condition based inspection of the wooden exterior decks and their support columns on the lake side of Buildings 1 – 5 was performed from the ground level and a 20' and 28' extension ladder.

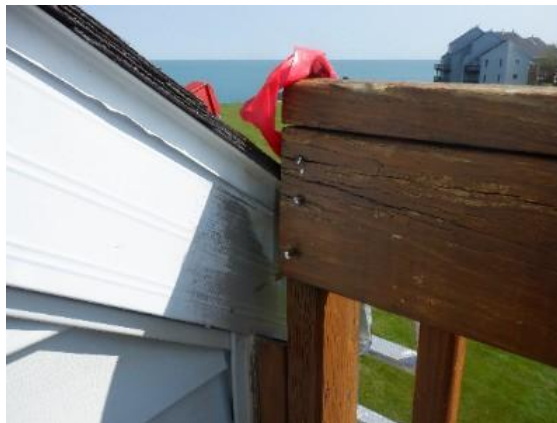
Image(s) For Finding No.161

161. At the topside of unit 433 deck, at the East guardrail North end, the 2x6 nails are popped out.

161. Remove the existing fasteners and secure the baluster connection with the proper size and type exterior screws for decks. Repair Priority: P2

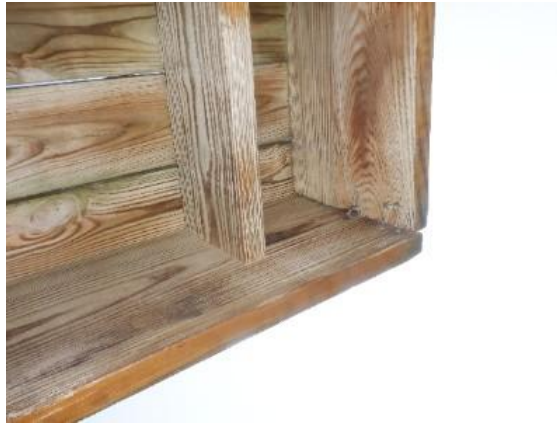
Image(s) For Finding No.162

162. At the underside of unit 433 deck, the East joist South end connection is end nailed, lagged and separating.

162. Remove the existing fasteners and secure the joist connection with the proper size and type exterior screws for decks.
Repair Priority: P2

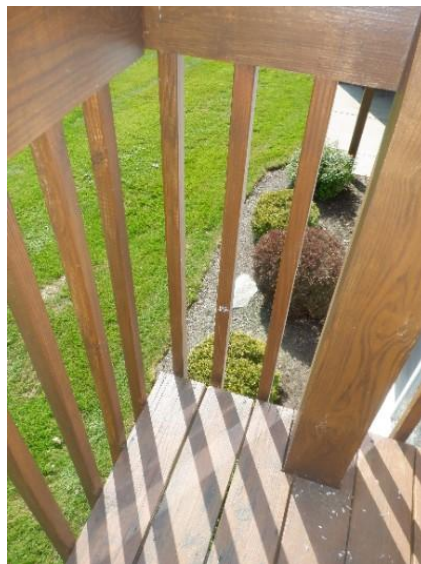
Image(s) For Finding No.163

163. At the topside of unit 423 deck, at the South guardrail, there is 1 loose baluster.

163. Remove the existing fasteners and secure the baluster connection with the proper size and type exterior screws for decks.
Repair Priority: P3

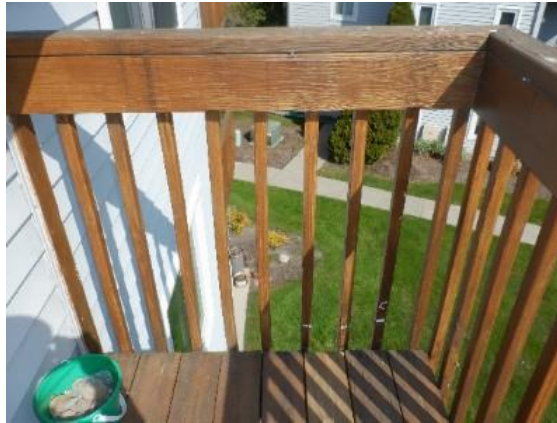
Image(s) For Finding No.165

165. At the topside of unit 432 deck, at the North guardrail, there are 2 loose balusters and 1 cracked baluster.

165. Replace the cracked baluster in kind with pressure treated lumber and secure the new and existing loose balusters with proper size and type screws for decks. Repair Priority: P2

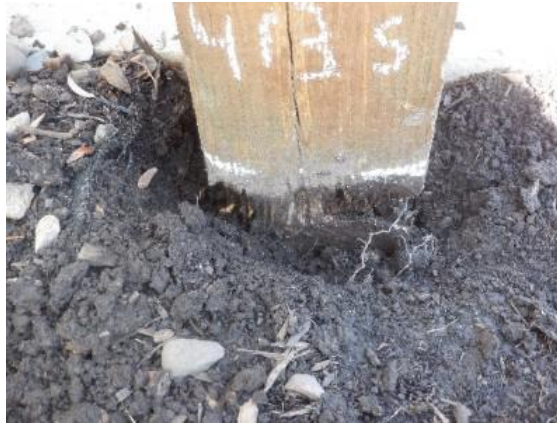
Image(s) For Finding No.167

167. At the underside of unit 423 deck, the South support column below grade is starting to decay with rounded corners.

167. Monitor the condition of the column base until the next inspection.
Repair Priority: P5

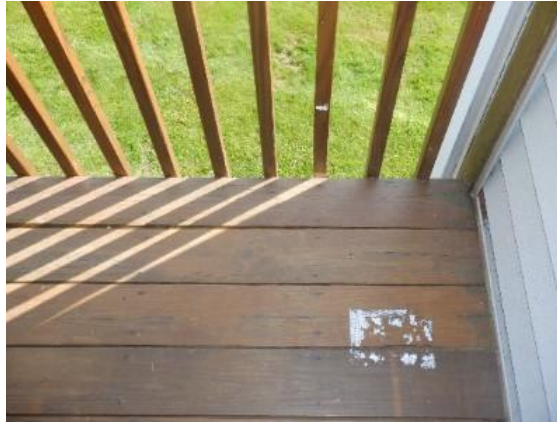
Image(s) For Finding No.168

168. At the topside of unit 422 deck, at the East guardrail South end, there is 1 loose baluster.

168. Remove the existing fasteners and secure the baluster connection with the proper size and type exterior screws for decks. Repair Priority: P2

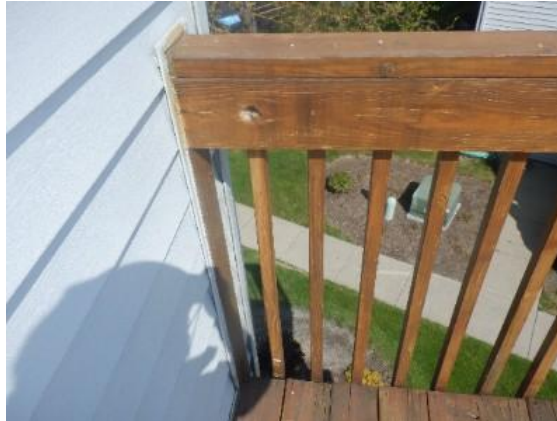
Image(s) For Finding No.170

170. At the topside of unit 431 deck, at the North guardrail, there is 1 loose baluster.

170. Remove the existing fasteners and secure the baluster connection with the proper size and type exterior screws for decks. Repair Priority: P2

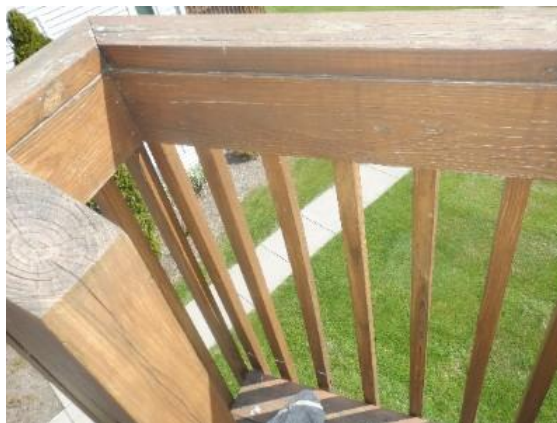
Image(s) For Finding No.171

171. At the topside of unit 431 deck, at the East guardrail North end, there are 3 loose balusters.

171. Remove the existing fasteners and secure the baluster connections with the proper size and type exterior screws for decks. Repair Priority: P2

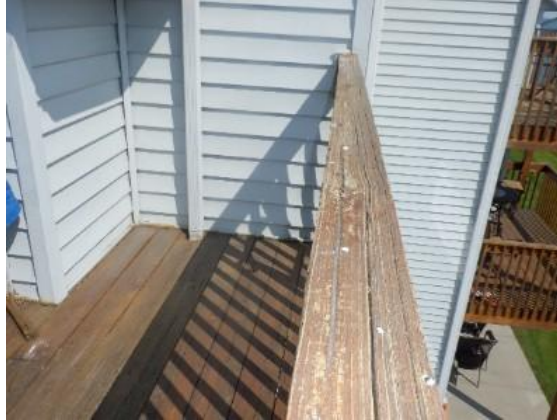
Image(s) For Finding No.176

176. At the topside of unit 537 deck, the guardrail 2x4 is weathered and splintered.

176. Replace the deteriorated 2x4 guardrail in kind with pressure treated lumber. Secure with proper size and type of exterior screws for decks.
Repair Priority: P3

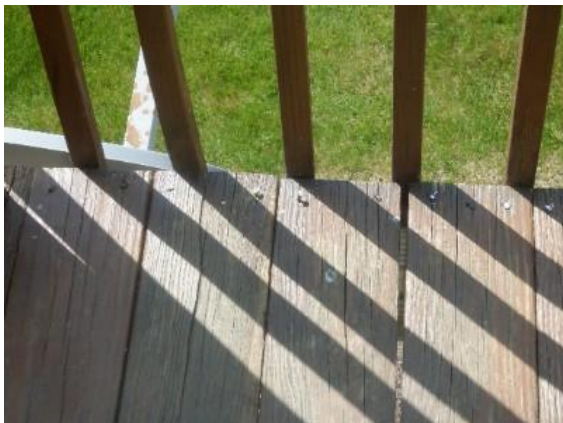
179. At the topside of unit 527 deck, at the South end, the deck boards are loose with popped nails.

179. Remove the existing fasteners and secure the deck boards with the proper size and type exterior screws for decks.
Repair Priority: P3

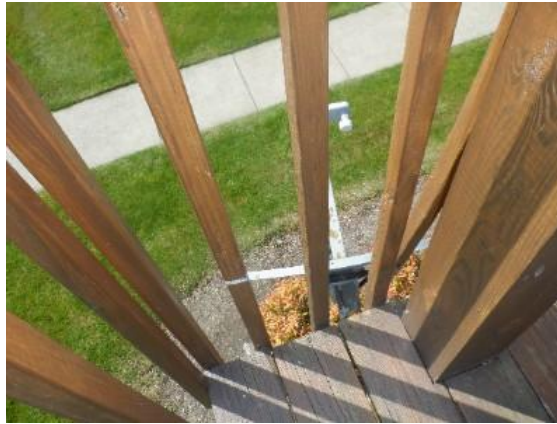
Image(s) For Finding No.180

180. At the topside of unit 527 deck, at the South guardrail, there are 2 loose balusters.

180. Remove the existing fasteners and secure the baluster connections with the proper size and type exterior screws for decks. Repair Priority: P2

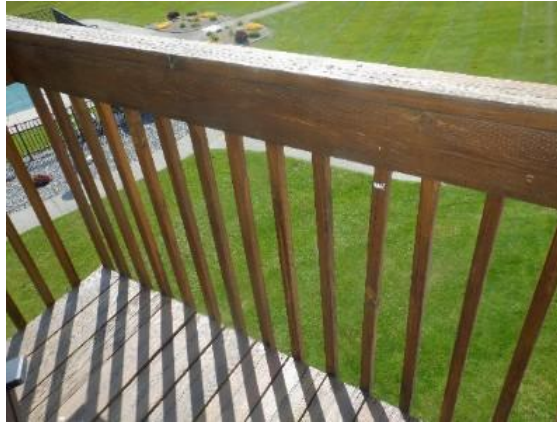
Image(s) For Finding No.182

182. At the topside of unit 536 deck, at the South guardrail, there is 1 loose baluster.

182. Remove the existing fasteners and secure the baluster connection with the proper size and type exterior screws for decks.
Repair Priority: P2

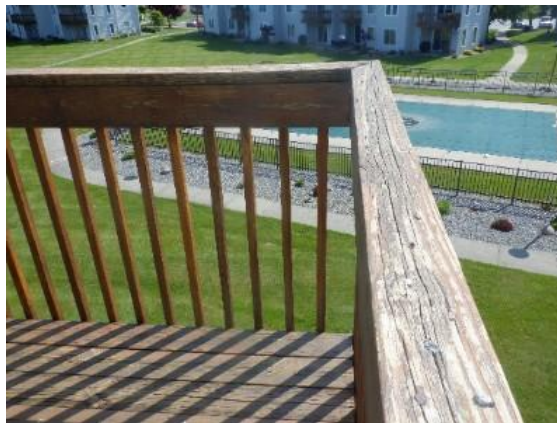
Image(s) For Finding No.183

183. At the topside of unit 536 deck, the guardrail 2x4 weathered and splintered.

183. Replace the deteriorated 2x4 guardrail in kind with pressure treated lumber. Secure with proper size and type of exterior screws for decks.
Repair Priority: P3

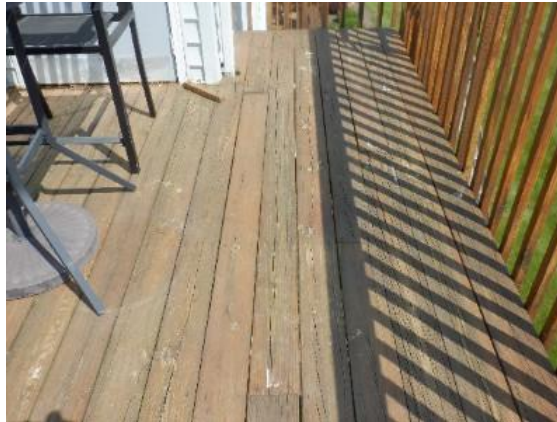
Image(s) For Finding No.184

184. At the topside of unit 536 deck, there are 6 loose deck boards.

184. Remove the existing fasteners and secure the deck boards with the proper size and type exterior screws for decks.
Repair Priority: P4

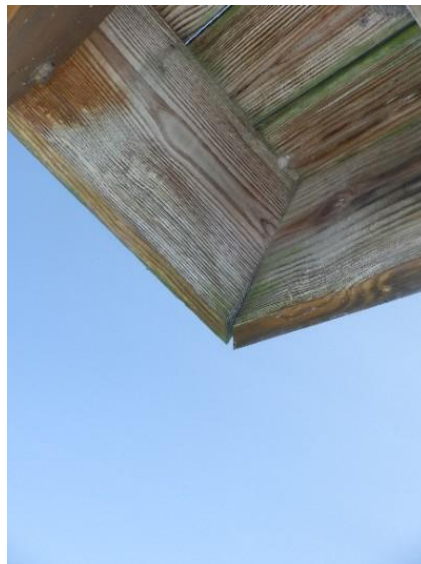
Image(s) For Finding No.185

185. At the underside of unit 536 deck, the North rim joist corner is lagged and separated.

185. Remove the existing fasteners and secure the baluster connection with the proper size and type exterior screws for decks.
Repair Priority: P3

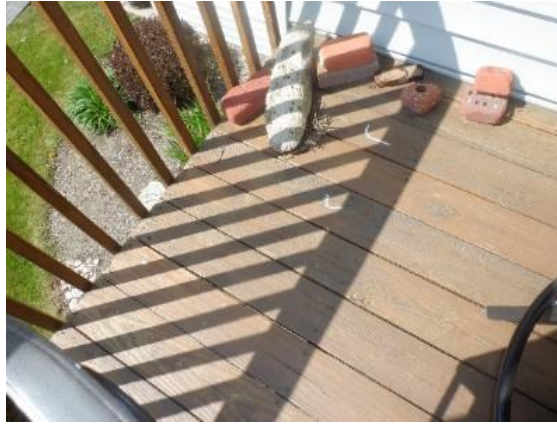
Image(s) For Finding No.186

186. At the topside of unit 526 deck, there are 2 loose deck boards.

186. Remove the existing fasteners and secure the deck boards with the proper size and type exterior screws for decks.
Repair Priority: P3

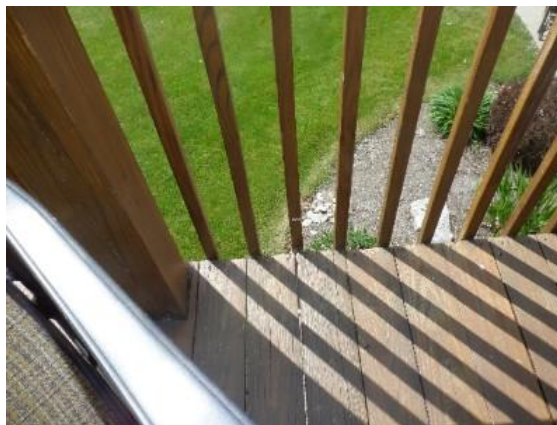
Image(s) For Finding No.187

187. At the topside of unit 526 deck, at the South rail, there are 2 loose balusters.

187. Remove the existing fasteners and secure the baluster connections with the proper size and type exterior screws for decks.
Repair Priority: P2

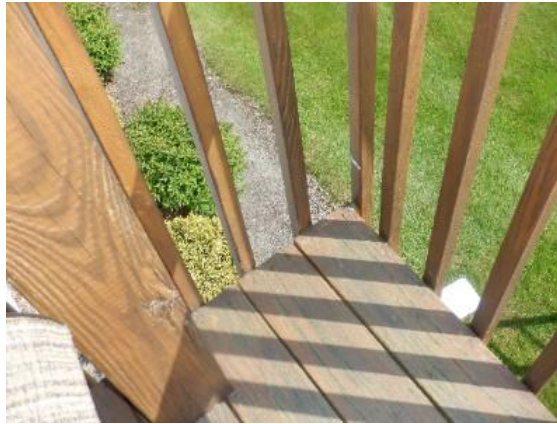
Image(s) For Finding No.188

188. At the topside of unit 526 deck, at the N.E. corner, there is 1 loose baluster.

188. Remove the existing fasteners and secure the baluster connection with the proper size and type exterior screws for decks. Repair Priority: P2

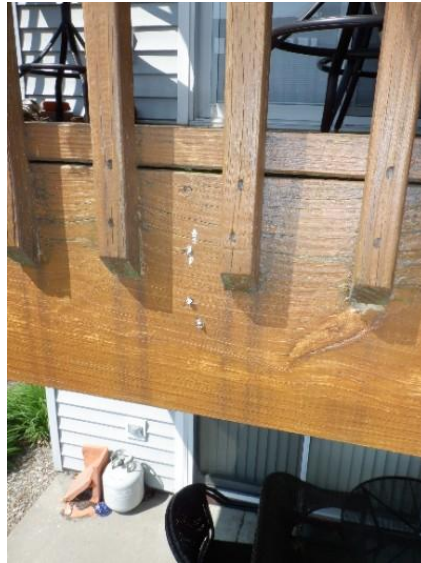
Image(s) For Finding No.190

190. At the underside of unit 526 deck, on the East rim joist, at the 4th joist from the North, the nails are popped out.

190. Remove the existing fasteners and secure the rim joist connection with the proper size and type exterior screws for decks. Repair Priority: P2

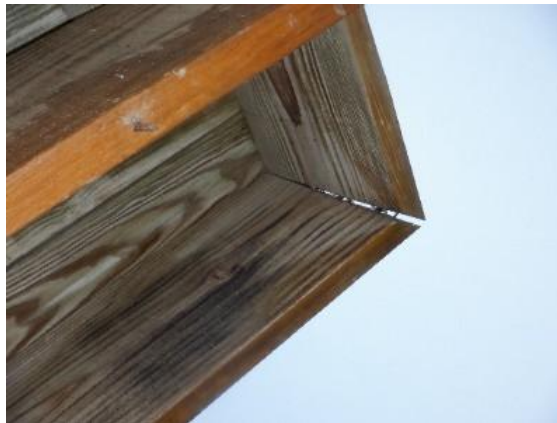
Image(s) For Finding No.191

191. At the underside of unit 526 deck, the S.E. corner connection of rim joist is end nailed, lagged and separated.

191. Remove the existing fasteners and secure the baluster connection with the proper size and type exterior screws for decks. Repair Priority: P3

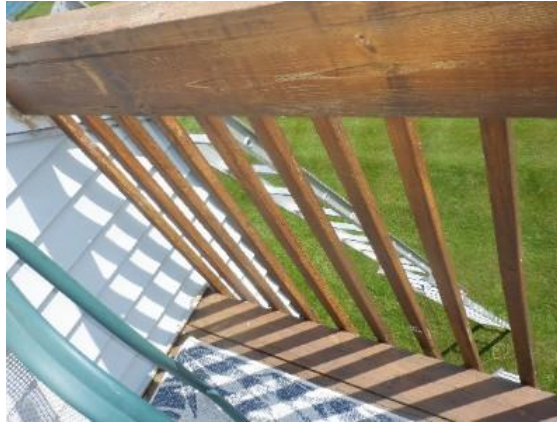
Image(s) For Finding No.192

192. At the topside of unit 535 deck, at the East guardrail, there is 1 loose baluster.

192. Remove the existing fasteners and secure the baluster connection with the proper size and type exterior screws for decks. Repair Priority: P2

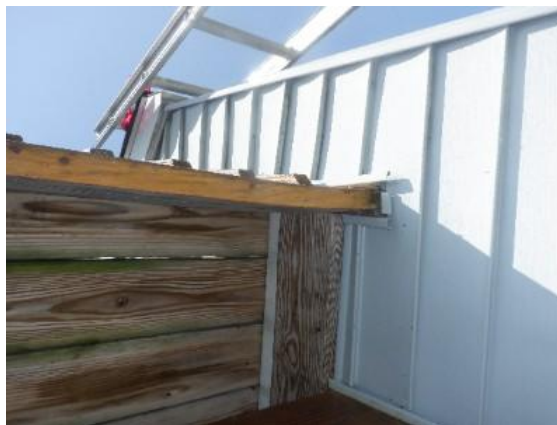
Image(s) For Finding No.193

193. At the underside of unit 535 deck, at the East rim joist North building connection is bowed and separating.

193. Remove the existing fasteners and secure the rim joist connection with the proper size and type exterior screws for decks. Repair Priority: P2

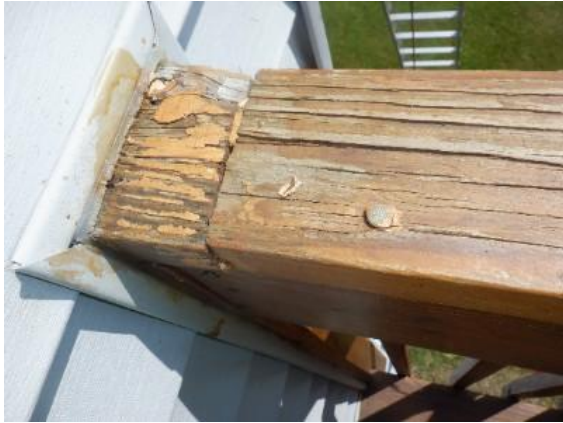
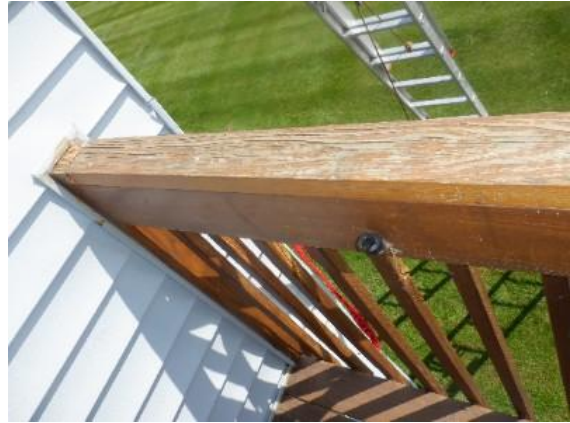
Image(s) For Finding No.194

194. At the topside of unit 525 deck, the guardrail 2x4 is weathered and splintered.

194. Replace the deteriorated 2x4 guardrail in kind with pressure treated lumber. Secure with proper size and type of exterior screws for decks.
Repair Priority: P2

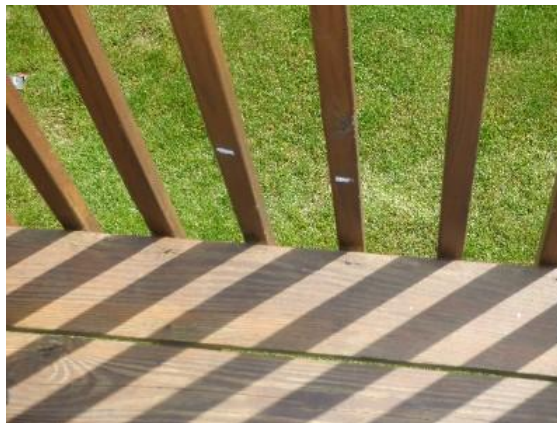
Image(s) For Finding No.195

195. At the topside of unit 525 deck, at the East guardrail, there are 2 loose balusters

195. Remove the existing fasteners and secure the baluster connections with the proper size and type exterior screws for decks.
Repair Priority: P2

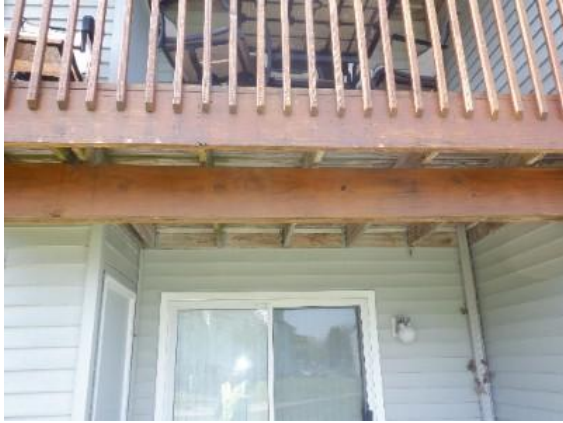
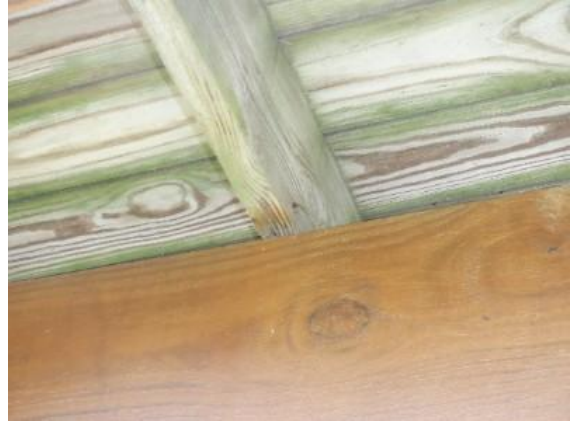
Image(s) For Finding No.196

196. At the underside of unit 525 deck, the east 2x12 beam is bowed downward in center and the joists are no longer bearing on it.

196. Replace the bowed 2x12 beam in kind with pressure treated lumber. secure both beams with Simpson DJTZ connectors in accordance with the manufactures recommendations. Repair Priority: P3

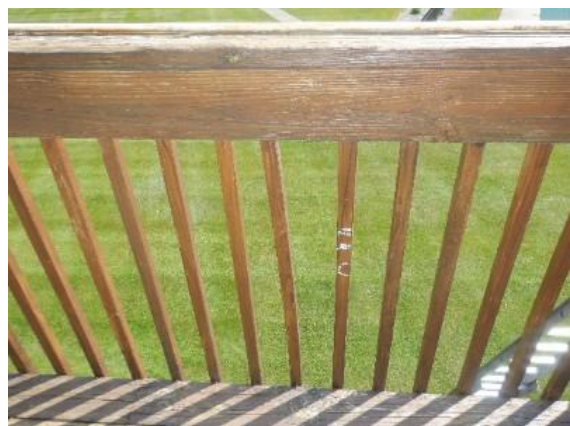
Image(s) For Finding No.197

197. At the topside of unit 534, the guardrail has 2 cracked balusters and 1 loose baluster.

197. Replace the cracked balusters in kind with pressure treated lumber and secure the new and existing loose balusters with proper size and type exterior screws for decks. Repair Priority: P2

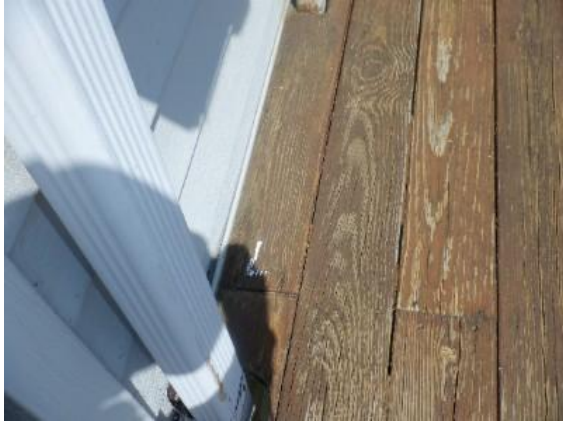
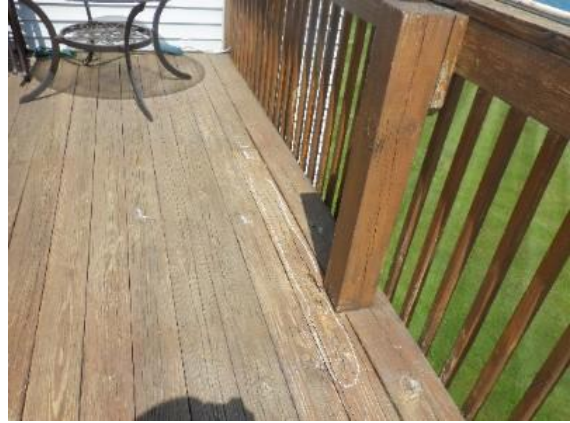
Image(s) For Finding No.198

198. At the topside of unit 534, there are 8 loose deck boards and 1 deteriorated deck board.

198. Replace the deteriorated deck board in kind with pressure treated lumber and secure the new and existing loose deck boards with proper size and type exterior screws for decks.
Repair Priority: P3

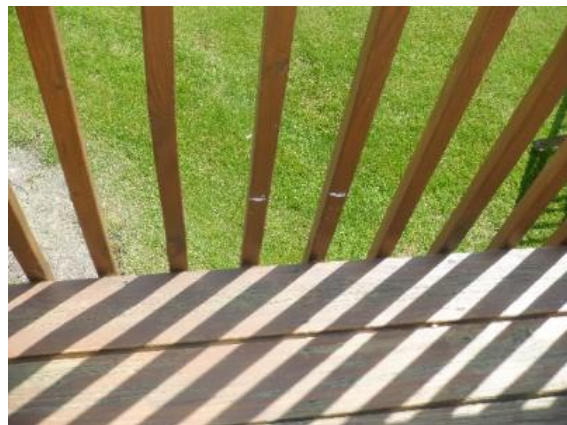
Image(s) For Finding No.203

203. At the topside of unit 524 deck, there are 3 loose balusters.

203. Remove the existing fasteners and secure the baluster connections with the proper size and type exterior screws for decks.
Repair Priority: P2

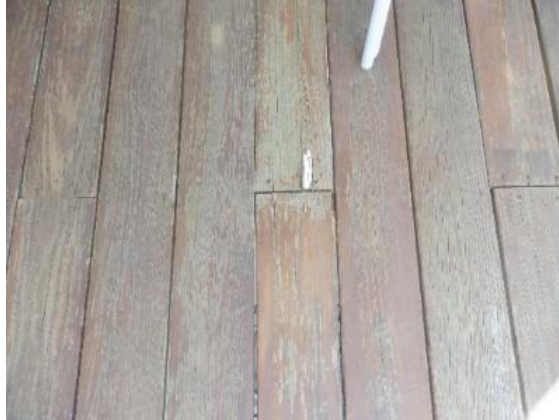
Image(s) For Finding No.204

204. At the topside of unit 524 deck, there is 1 deck board that is bowed upward and splintering at the end.

204. Replace the damaged deck board in kind with pressure treated lumber. Secure with proper size and type of exterior screws for decks.
Repair Priority: P3

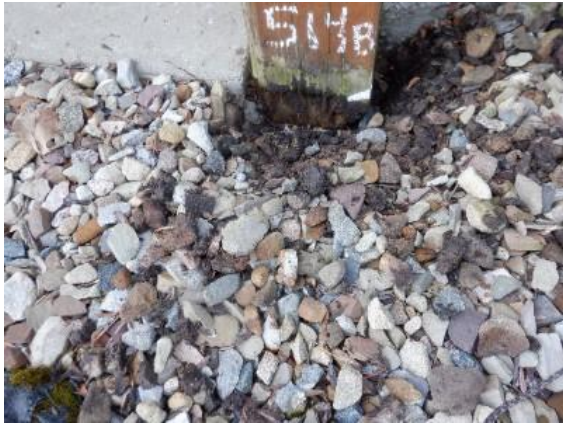
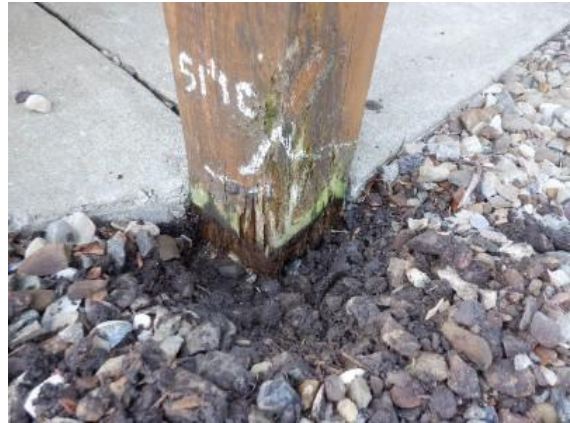
Image(s) For Finding No.206

206. At the underside of unit 524, at the center 2 support columns are starting to decay with rounded corners.

206. Monitor the condition of the column bases until the next inspection
Repair Priority: P5

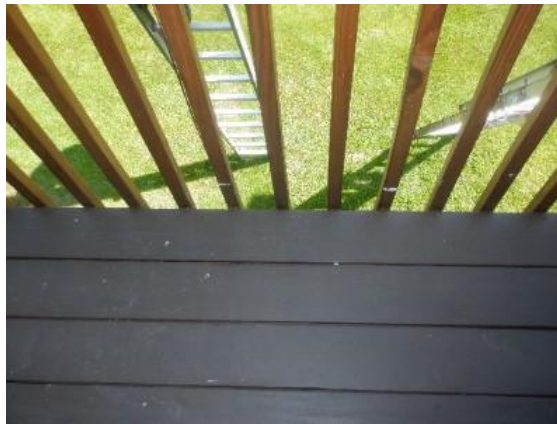
Image(s) For Finding No.209

209. At the topside of unit 523 deck, there are 2 loose balusters.

209. Remove the existing fasteners and secure the baluster connections with the proper size and type exterior screws for decks.
Repair Priority: P2

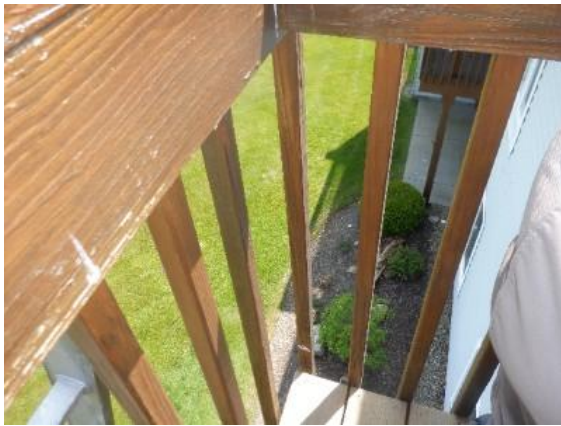
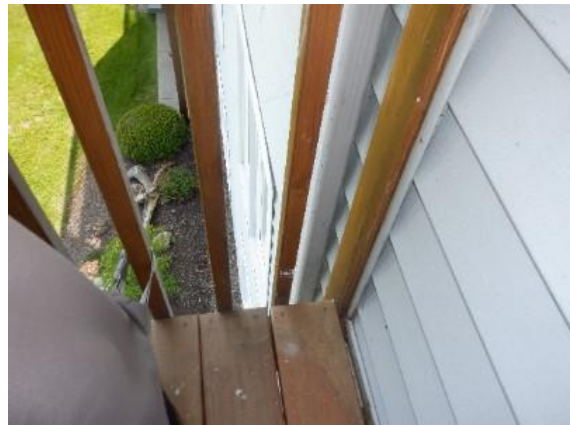
Image(s) For Finding No.211

211. At the topside of unit 532 deck, at the South guardrail, there are 2 loose balusters.

211. Remove the existing fasteners and secure the baluster connections with the proper size and type exterior screws for decks. Repair Priority: P2

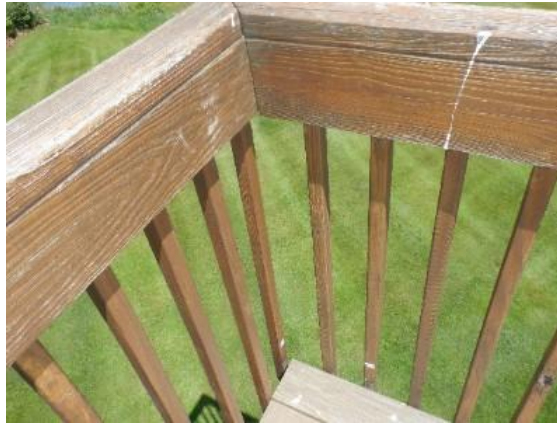
Image(s) For Finding No.212

212. At the topside of unit 532 deck, at the N.E. corner of guardrail, there are 2 loose balusters.

212. Remove the existing fasteners and secure the baluster connections with the proper size and type exterior screws for decks. Repair Priority: P2

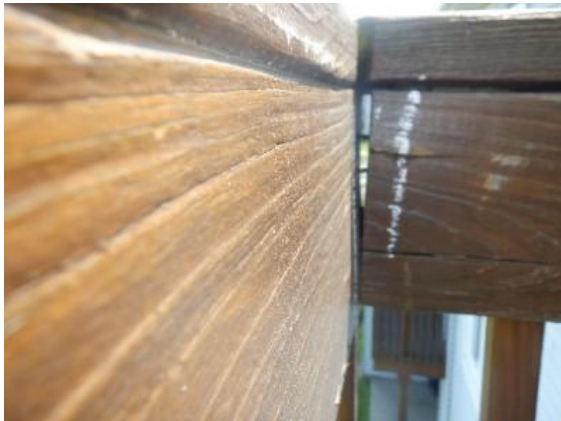
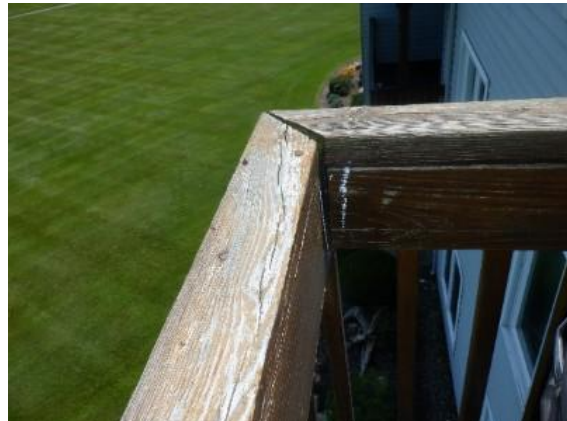
Image(s) For Finding No.213

213. At the topside of unit 532 deck, at the S.E. corner of guardrail, the 2x6 is separating.

213. Remove the existing fasteners and secure the guardrail connection with the proper size and type exterior screws for decks. Repair Priority: P2

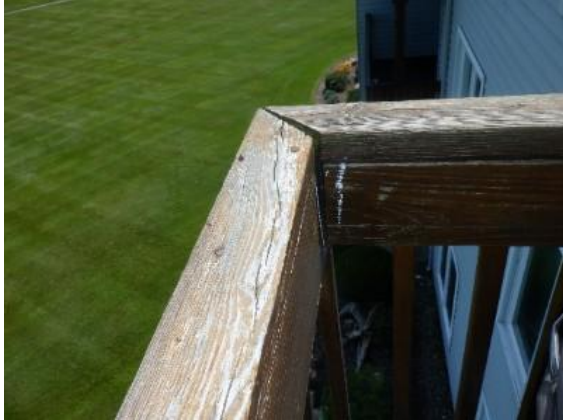
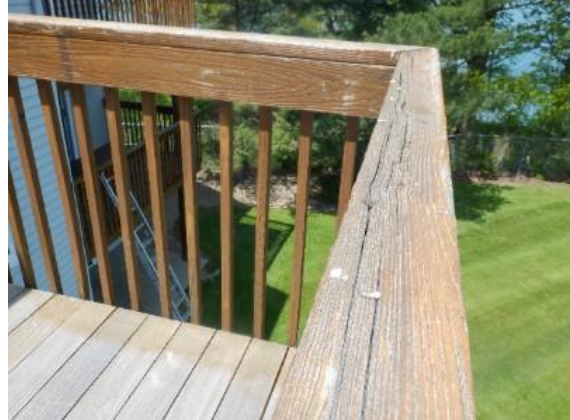
Image(s) For Finding No.214

214. At the topside of unit 532 deck, the guardrail 2x4 is weathered and splintering.

214. Replace the deteriorated 2x4 guardrail in kind with pressure treated lumber. Secure with proper size and type of exterior screws for decks.
Repair Priority: P3

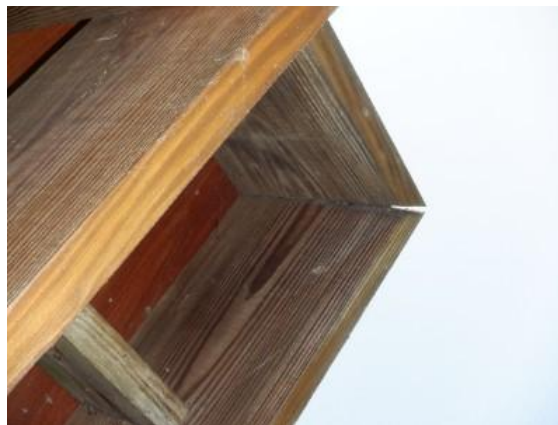
Image(s) For Finding No.215

215. At the underside of unit 532, the S.E. corner of rim joist is lagged and separating.

215. Remove the existing fasteners and secure the rim joist connection with the proper size and type exterior screws for decks.
Repair Priority: P3

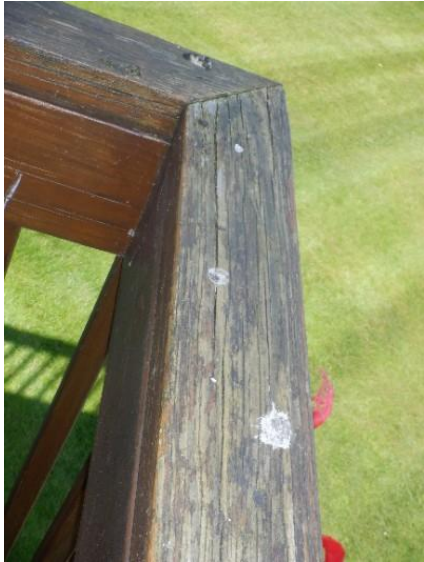
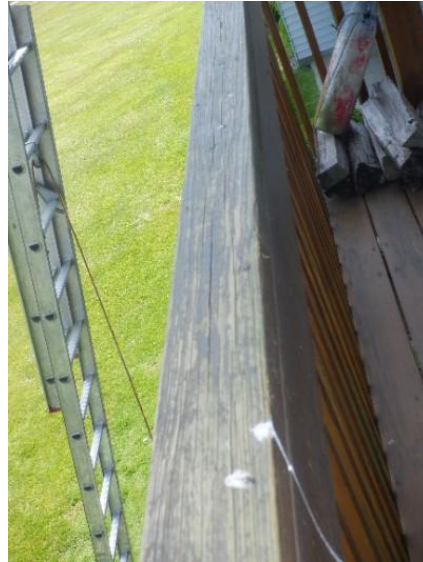
Image(s) For Finding No.216

216. At the topside of unit 522 deck, the guardrail 2x4 is weathered and splintering.

216. Replace the deteriorated 2x4 guardrail in kind with pressure treated lumber. Secure with proper size and type of exterior screws for decks.
Repair Priority: P3

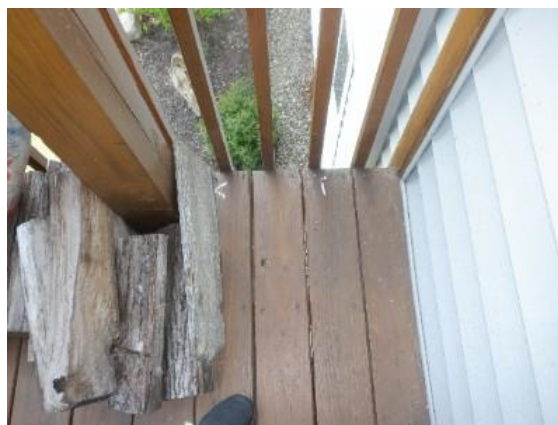
Image(s) For Finding No.217

217. At the topside of unit 522 deck, there are 2 loose deck boards at the South end.

217. Remove the existing fasteners and secure the deck boards with the proper size and type exterior screws for decks.
Repair Priority: P3

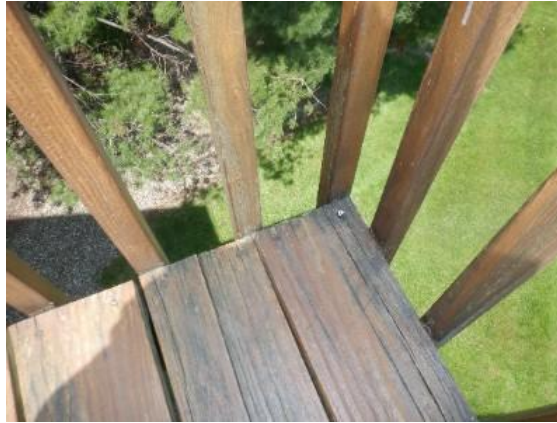
Image(s) For Finding No.219

219. At the topside of unit 531 deck, there is a deck board with a popped nail.

219. Remove the existing fasteners and secure the deck board with the proper size and type exterior screws for decks.
Repair Priority: P3

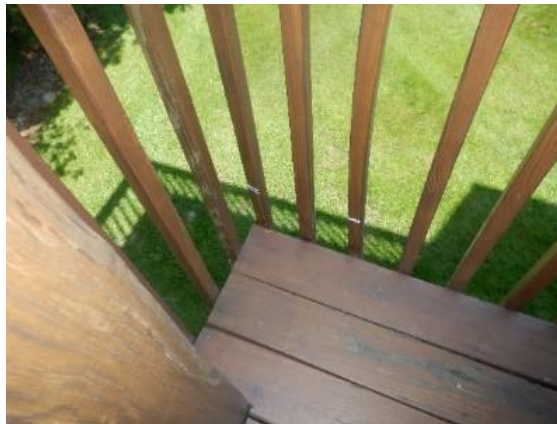
Image(s) For Finding No.221

221. At the topside of unit 521 deck, the East guardrail has 2 loose balusters.

221. Remove the existing fasteners and secure the baluster connections with the proper size and type exterior screws for decks. Repair Priority: P2
