# 2023 STRUCTURAL INSPECTION REPORT MARINERS POINT CONDOMINIUMS Parking Lot Side

**STRUCTURE TAG NO.: WALKWAYS AND STAIR TOWER**

**Date Of Inspection:** 04/25/2023

**Globex Job No.:** G-6970

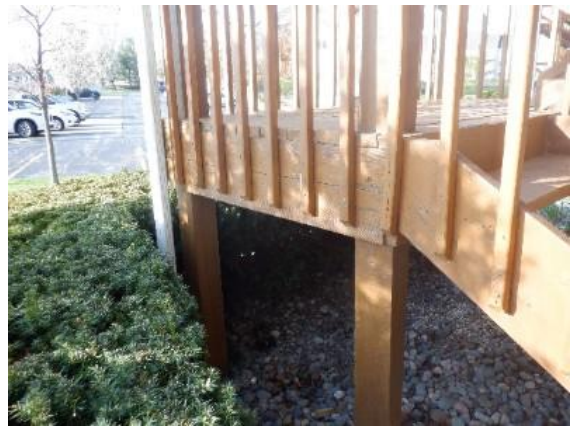
Image(s) For Finding No.1

1. At landing 1, the East (2 x 12) rim joist has a full-length horizontal crack.

1. Replace the cracked rim joist in kind with pressure treated lumber and proper fasteners.  
Repair Priority: P3

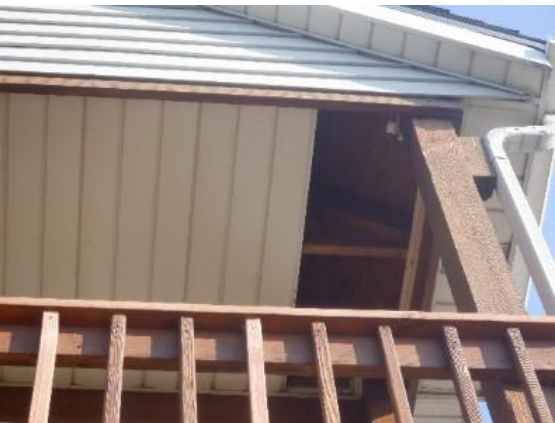
Image(s) For Finding No.4

4. At the top of the stair tower, there is a section of overhead soffit missing and laying on the ground below.

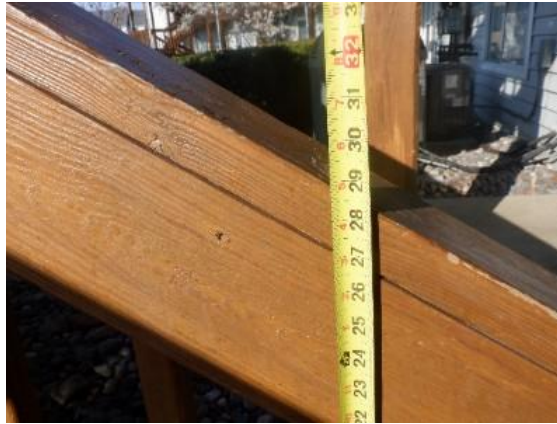
Image(s) For Finding No.5

5. The stairway handrailing height is 29" and the required minimum handrailing guard height on stairs is 34".

5. Properly modify the existing handrailing system to achieve a minimum height of 34".  
Repair Priority: P2

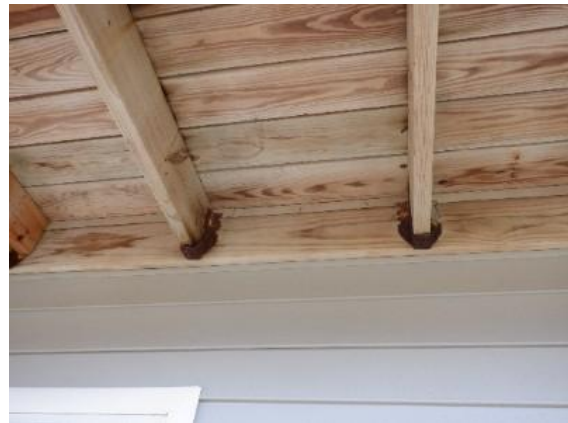
Image(s) For Finding No.6

6. At the 1st 11 joist hangers from the East on the building side, the galvanized coating is corroded.

6. Monitor the condition of the joist hangers until the next inspection.  
Repair Priority: P5

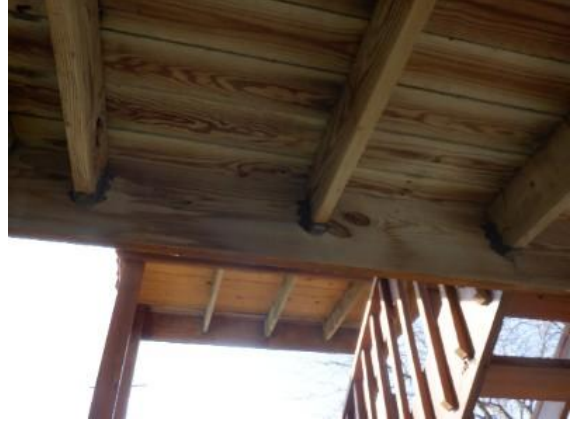
Image(s) For Finding No.7

7. At the East stair tower, 4 - 2x6 joist hanger brackets were used on the 2 x 8 joists on the stair tower side connection. There was no evidence of any failure at the connections.

7. For the record only.No action is required at this time.

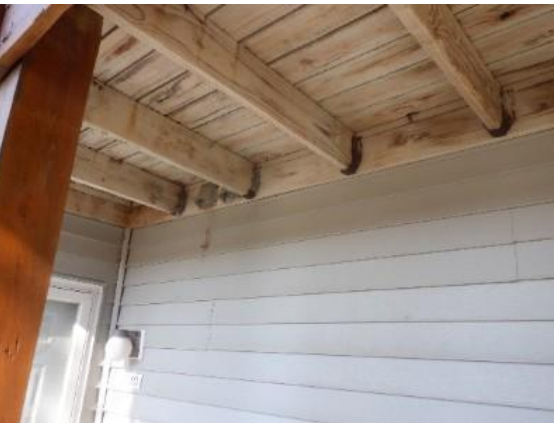
8. At the 1st 12 joist hangers from West on the building side, the galvanized coating is corroded.

8. Monitor the condition of the joist hangers until the next inspection.  
Repair Priority: P5

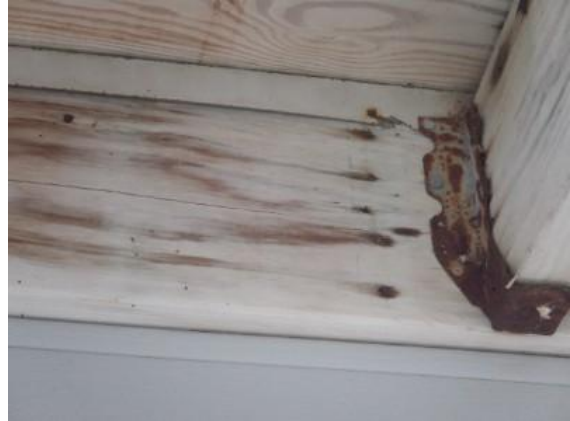
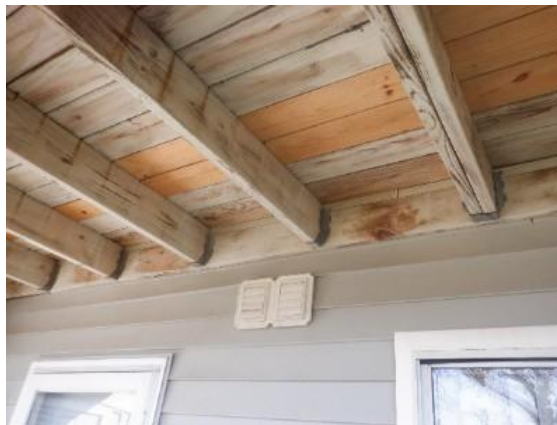
Image(s) For Finding No.9

9. There are no visible lag screws and only a few sporadic visible nails. It appears that the ledger board connection nails may be located behind each joist which are not visible for inspection. No evidence of any ledger pullout was observed.

9. Since the ledger board connection to the building cannot be verified, further engineering and investigation is recommended to review original design drawings and the ledger connections for code compliance.  
Repair Priority: P4

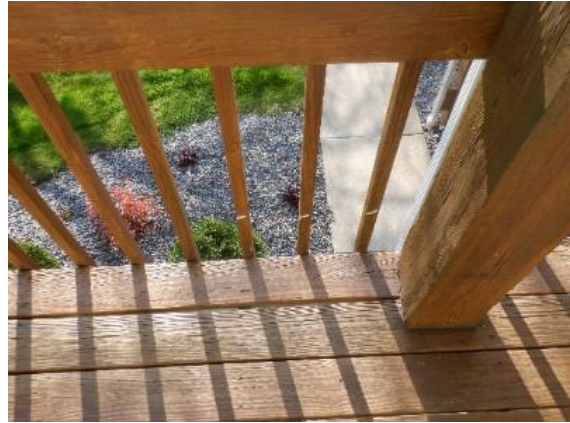
Image(s) For Finding No.10

10. Between columns 3 and 4 from the West, there are 4 balusters loose at the bottom connection.

10. Secure the loose balusters with a proper length exterior deck screw.  
Repair Priority: P2

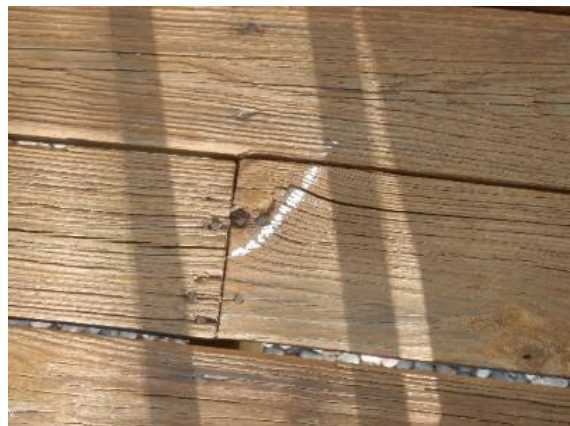
Image(s) For Finding No.11

11. Between columns 4 and 5 from the West, there is 1 deck board loose.

11. Secure the loose deck board with proper length exterior deck screws.  
Repair Priority: P3

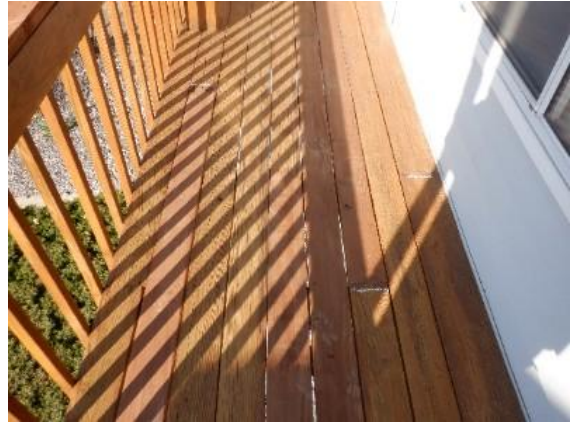
Image(s) For Finding No.14

14. Between columns 8 and 9 from the West, there are 3 deck boards loose with nails pulling up.

14. Secure the loose deck boards with proper length exterior deck screws and remove the loose nails.

Repair Priority: P3

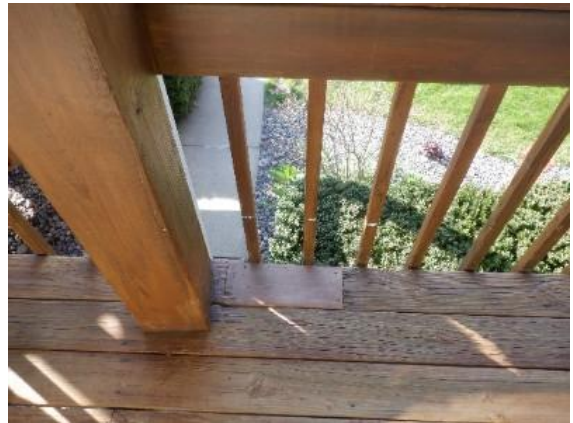
Image(s) For Finding No.15

15. Between columns 9 and 10, from the West, there are 2 deck boards and 3 balusters loose.

15. Secure the loose deck boards and balusters with proper length exterior deck screws.

Repair Priority: P2

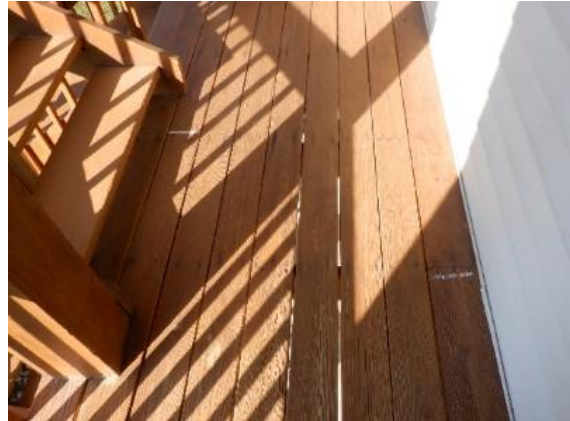
Image(s) For Finding No.16

16. Between columns 11 and 12 from the West, there are 2 deck boards loose.

16. Secure the loose deck boards with proper length exterior deck screws.  
Repair Priority: P3

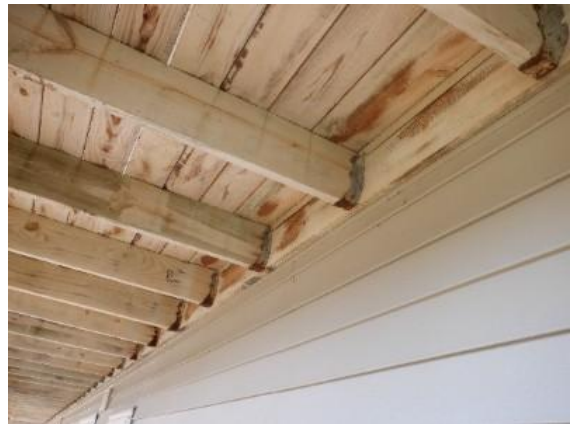
Image(s) For Finding No.17

17. At the 1st 8 joist hangers from the East on the building side, the galvanized coating is corroded.

17. Monitor the condition of the corroded hangers until the next inspection.  
Repair Priority: P5

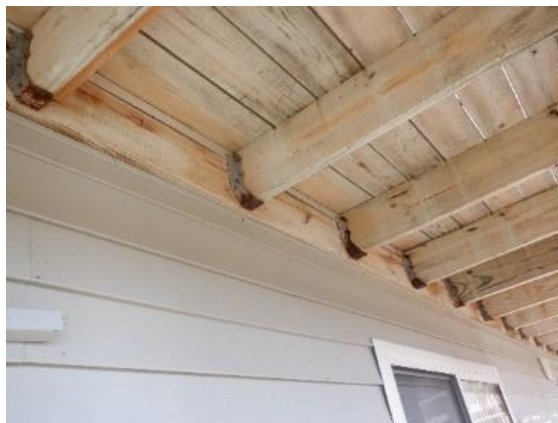
Image(s) For Finding No.19

19. At the 2nd through 9th joist hangers from the West on the building side, the galvanized coating is corroded

19. Monitor the condition of the corroded hangers until the next inspection. Repair Priority: P5

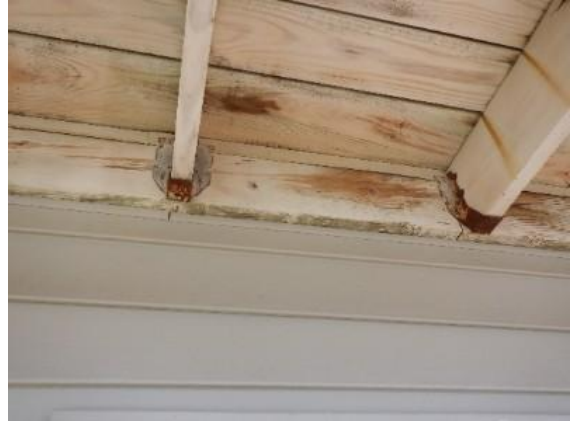
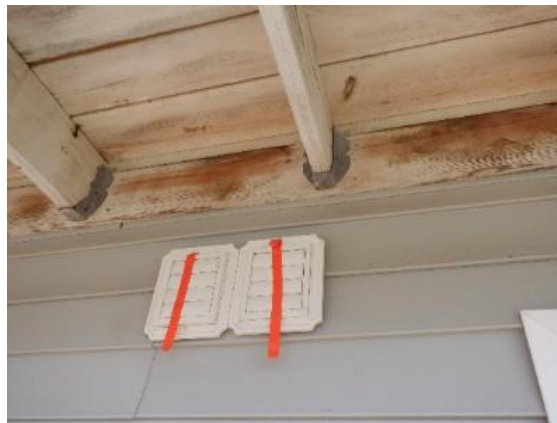
Image(s) For Finding No.20

20. There are no visible lag screws and only a few sporadic visible nails. It appears that the ledger board connection nails may be located behind each joist making them not visible for inspection. No evidence of any ledger pullout was observed.

20. Since the ledger board connection to the building cannot be verified, further engineering and investigation is recommended to review original design drawings and the ledger connections for code compliance.

Repair Priority: P4

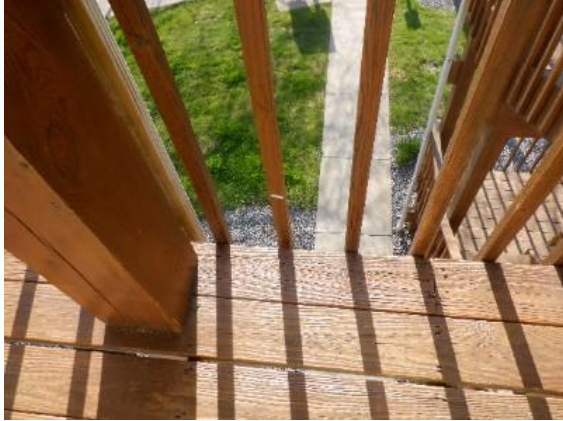
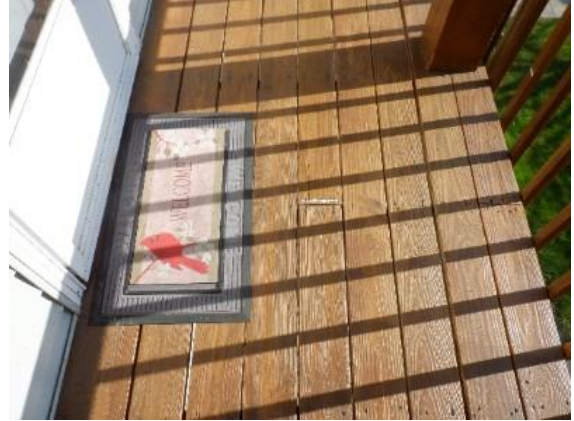
Image(s) For Finding No.21

21. Between columns 2 and 3 from the West, there is 1 baluster and 1 deck board loose.

21. Secure the loose baluster and deck board with proper length exterior deck screws. Repair Priority: P2

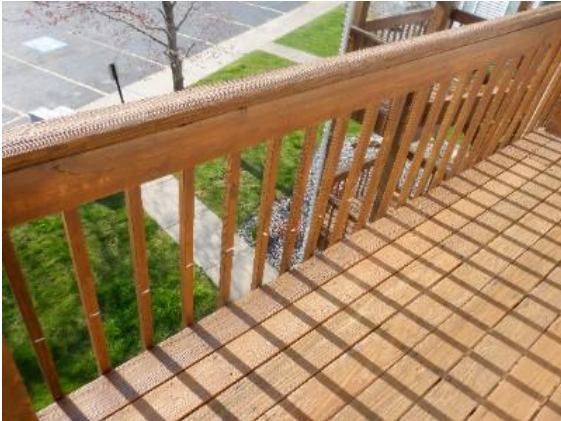
22. Between columns 3 and 4 from the West, there are 11 balusters loose.

22. Secure the loose balusters with proper length exterior deck screws.  
Repair Priority: P2

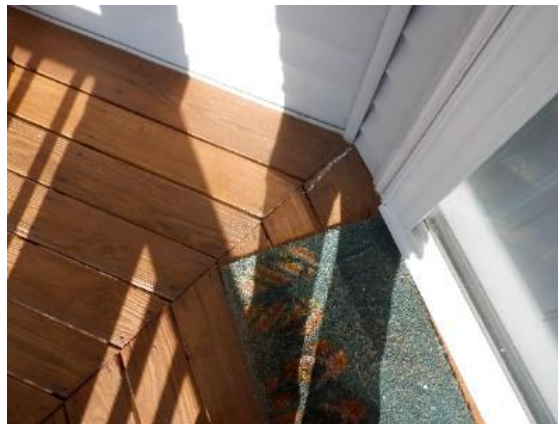
Image(s) For Finding No.25

25. At column 6 from the West, there is 1 deck board loose.

25. Secure the loose deck board with proper length exterior deck screws.  
Repair Priority: P3

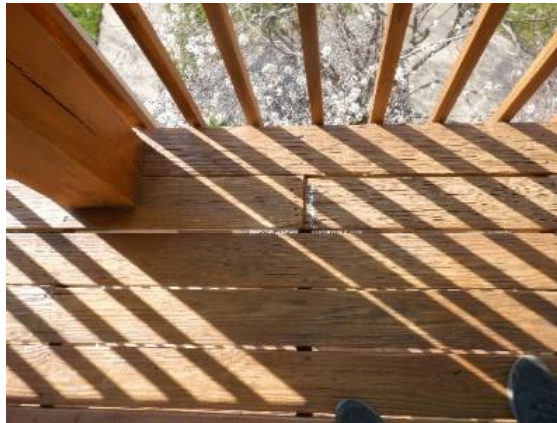
Image(s) For Finding No.26

26. Between columns 6 and 7 from the West, there is 1 deck board loose.

26. Secure the loose deck board with proper length exterior deck screws.  
Repair Priority: P3

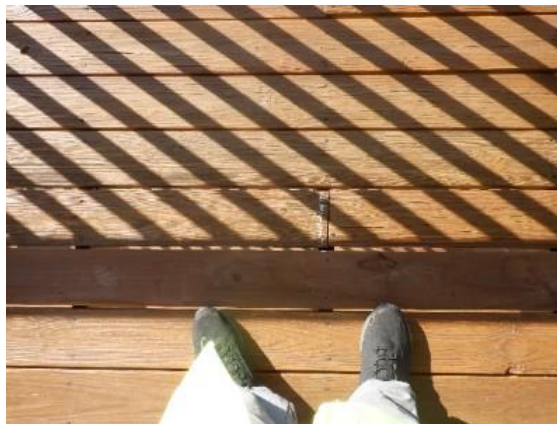
Image(s) For Finding No.27

27. Between columns 7 and 8 from the West, there is 1 deck board loose.

27. Secure the loose deck board with proper length exterior deck screws.  
Repair Priority: P3

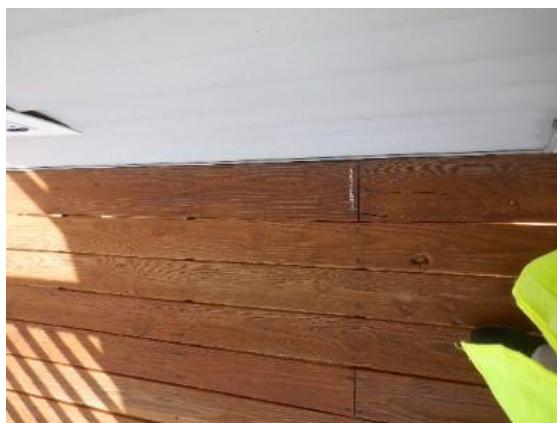
29. Between columns 9 and 10 from the West, there are 4 deck boards loose.

29. Secure the loose deck boards with proper length exterior deck screws.  
Repair Priority: P3

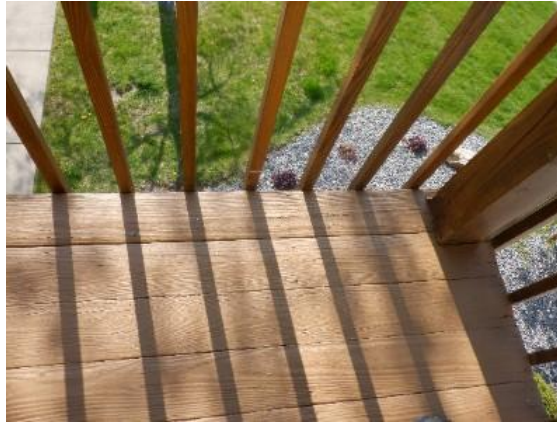
Image(s) For Finding No.30

30. At the 2nd landing, on the South side there is 1 baluster loose.

30. Secure the loose baluster with a proper length exterior deck screw.  
Repair Priority: P2

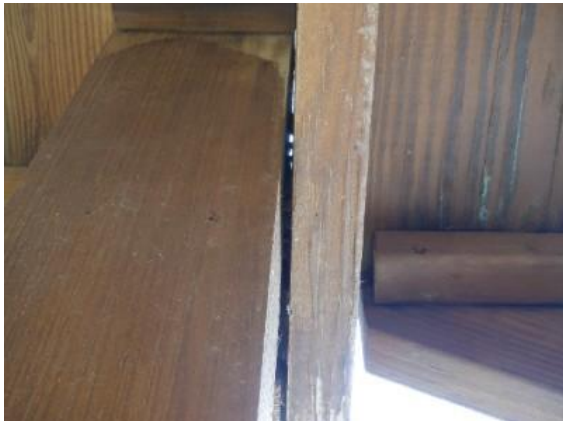
33. At the 2nd landing, the North rim joist has no lag screws, only nails that are pulling out.

33. Secure the rim joist to the support columns with the proper length lag screws.  
Repair Priority: P2

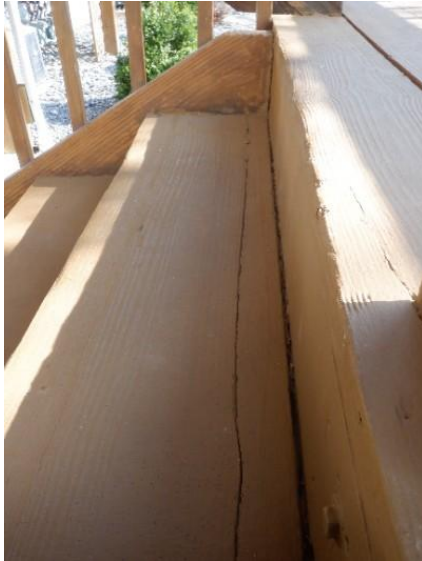
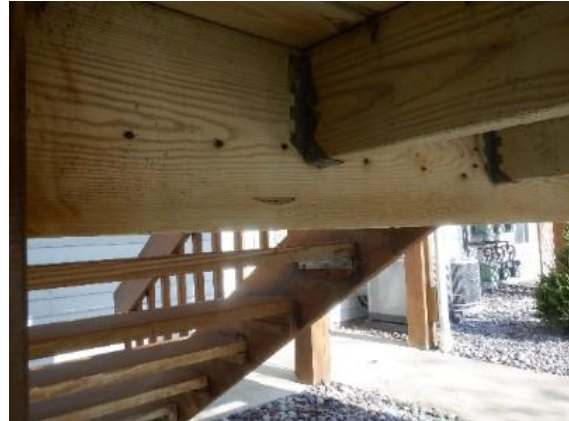
Image(s) For Finding No.34

34. At the stair stringer between 1st landing and ground elevation, the top stair stringer connections are not attached to the rim joist. Instead, the top stair tread was nailed to the rim joist. As a result, the stair tread is cracked.

34. Replace the cracked stair tread in kind with pressure treated lumber. Secure the stair stringers to the rim joist by pre-drilling and installing two ½" diameter x 4" lg. lag screws with washers on each stringer or installing adjustable u-joist hangers in accordance with the manufacturer's recommendations.

Repair Priority: P2

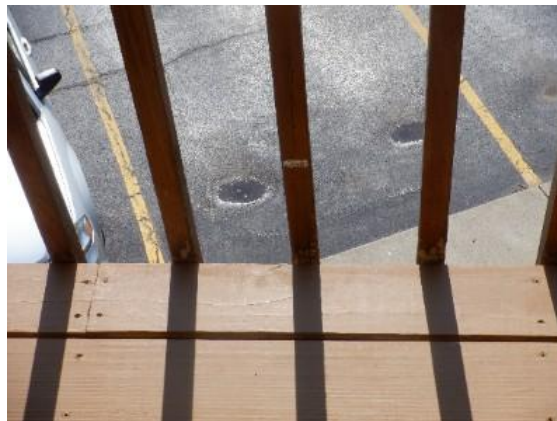
Image(s) For Finding No.35

35. At 2nd landing, there is 1 baluster loose.

35. Secure the loose baluster with a proper length exterior deck screw.  
Repair Priority: P2

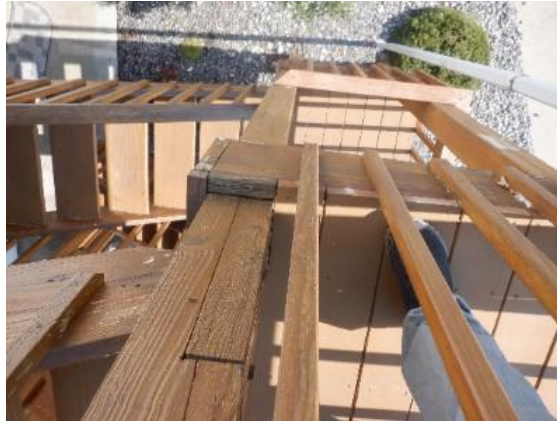
Image(s) For Finding No.36

36. At 2nd landing, the East rim board has no lag screws only nails.

36. Secure the rim joist to the support columns with proper length lag screws.  
Repair Priority: P3

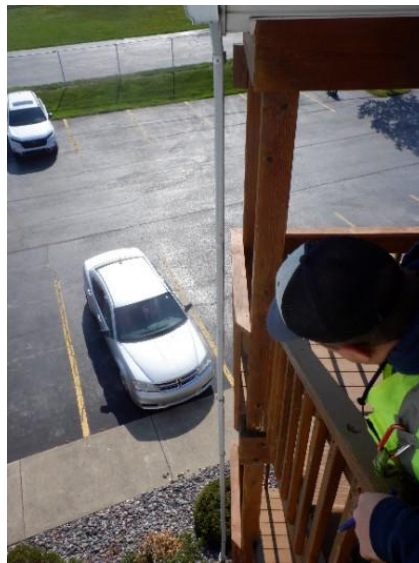
Image(s) For Finding No.37

37. At East side of stair tower, the down spout is loose and detached.

37. Secure the loose down spout to the stair tower.  
Repair Priority: P3

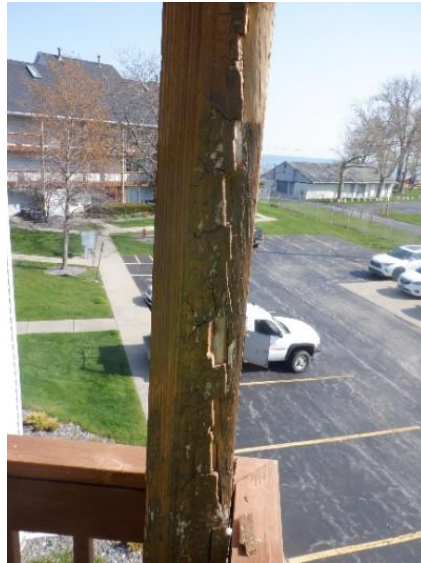
Image(s) For Finding No.38

38. At 2nd landing, the Northeast column has wane (lumber defect with wood missing along the corner).

38. For the record only. No action is required at this time.

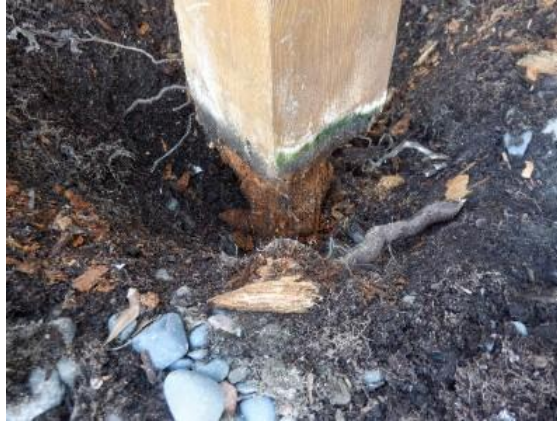
Image(s) For Finding No.40

40. At the North stair tower, at the North column on the building side, the column base below grade is wet and decayed 100% through.

40. Repair the deteriorated column base. See cover sheet notes for suggested repair options.  
Repair Priority: P2

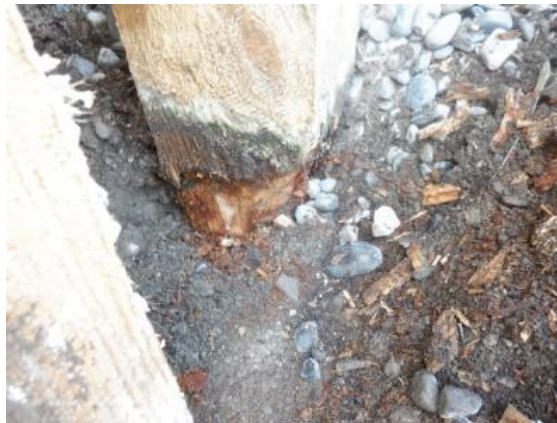
Image(s) For Finding No.41

41. At the North stair tower, at the South column on the building side, the column base below grade is wet and decayed with approximately 25% section loss.

41. Repair the deteriorated column base. See cover sheet notes for suggested repair options.  
Repair Priority: P3

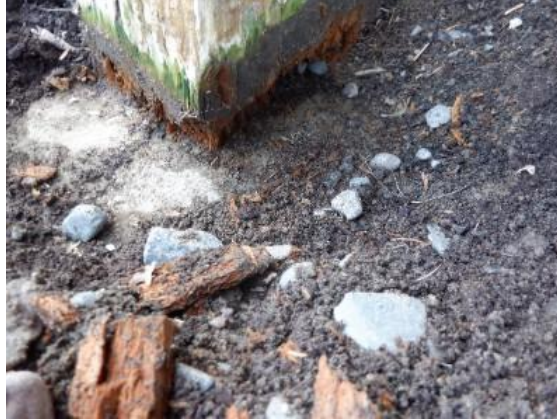
Image(s) For Finding No.42

42. At the North stair tower, at the South column on the parking lot side, the column base below grade is wet and decayed with approximately 25% section loss.

42. Repair the deteriorated column base. See cover sheet notes for suggested repair options.  
Repair Priority: P3

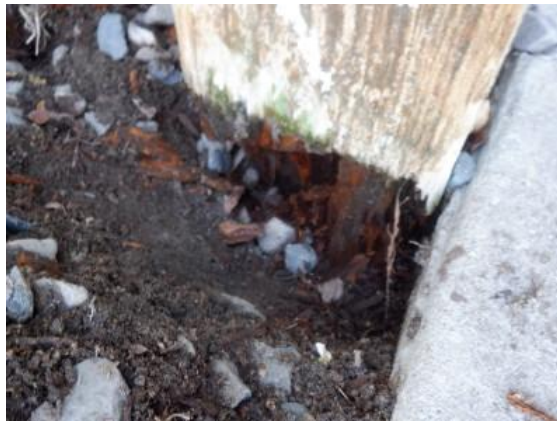
Image(s) For Finding No.43

43. At column 1 from South, at the parking lot side column below grade, the column base wet and decayed 100% through.

43. Repair the deteriorated column base. See cover sheet notes for suggested repair options.  
Repair Priority: P2

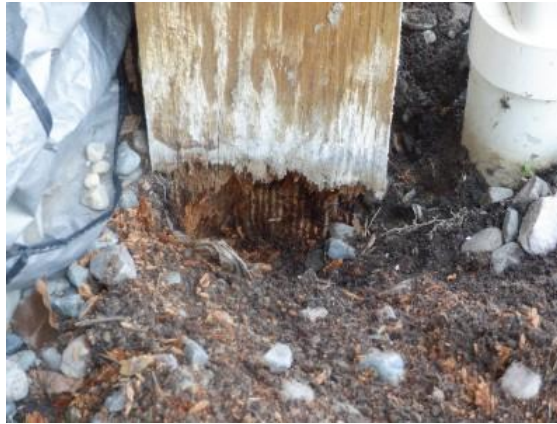
Image(s) For Finding No.44

44. At column 2 from South, the column base below grade is wet and decayed with approximately 75% section loss.

44. Repair the deteriorated column base. See cover sheet notes for suggested repair options.  
Repair Priority: P2

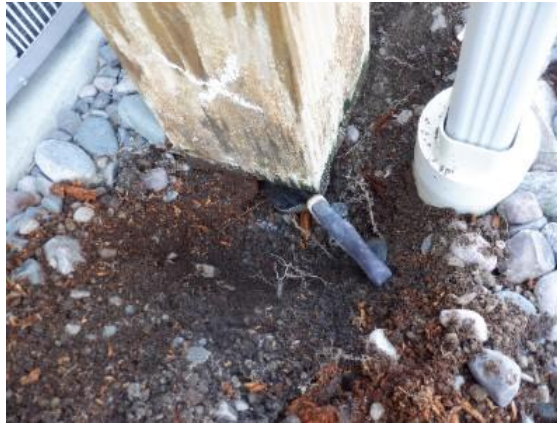
Image(s) For Finding No.46

46. At column 4 from South, the column base below grade is wet and decayed with approximately 75% section loss.

46. Repair the deteriorated column base. See cover sheet notes for suggested repair options.  
Repair Priority: P2

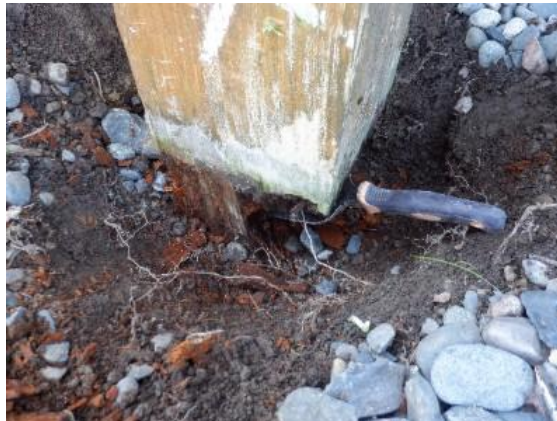
Image(s) For Finding No.47

47. At column 5 from South, at the building side column below grade, the column is wet and decayed 100% through.

47. Repair the deteriorated column base. See cover sheet notes for suggested repair options.  
Repair Priority: P2

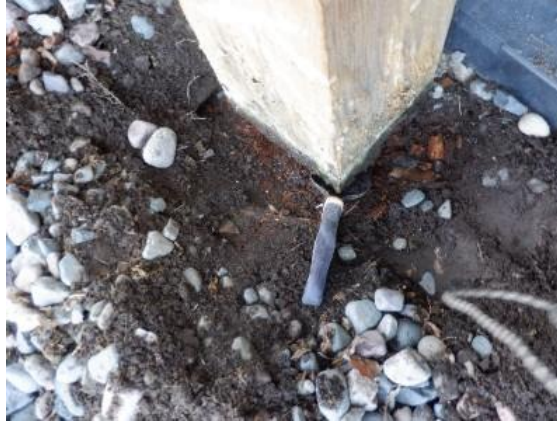
Image(s) For Finding No.48

48. At column 5 from South, at the parking lot side column below grade, the column is wet and decayed with approximately 75% section loss.

48. Repair the deteriorated column base. See cover sheet notes for suggested repair options.  
Repair Priority: P2

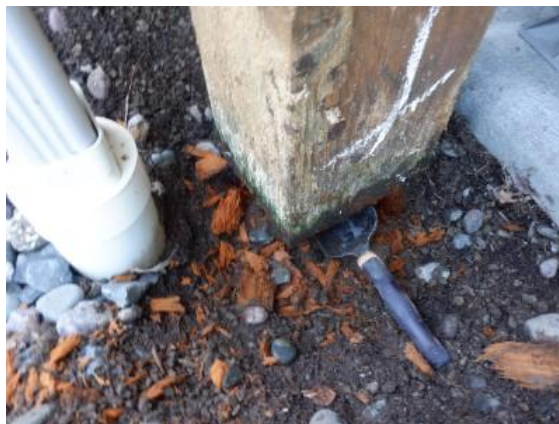
Image(s) For Finding No.50

50. At column 7 from South, the column base below grade is wet and decayed with approximately 50% section loss.

50. Repair the deteriorated column base. See cover sheet notes for suggested repair options.  
Repair Priority: P3

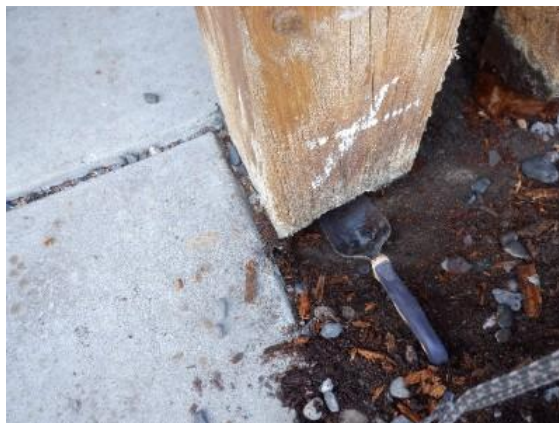
Image(s) For Finding No.51

51. At column 8 from South, at the parking lot side column below grade, the column is wet and decayed with approximately 50% section loss.

51. Repair the deteriorated column base. See cover sheet notes for suggested repair options.  
Repair Priority: P3

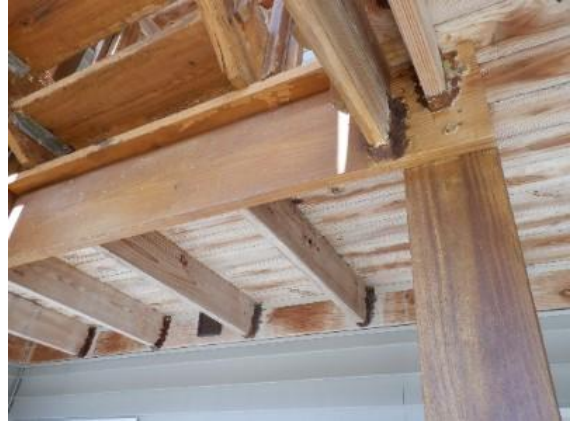
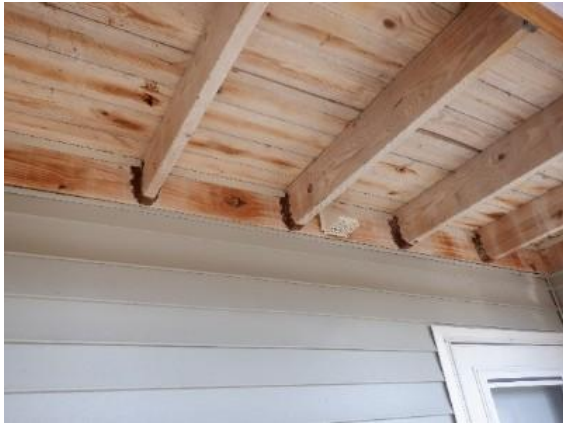
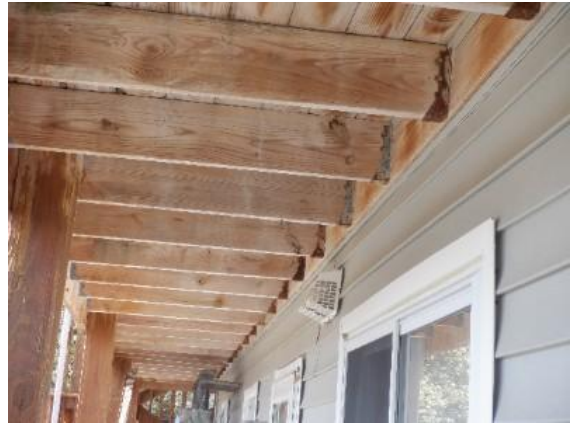
Image(s) For Finding No.52

52. At the joist hanger brackets along the entire building length, the galvanized coating is corroded. This condition is worse near the stair towers.

52. Monitor the condition of the hanger brackets until the next inspection.  
Repair Priority: P5

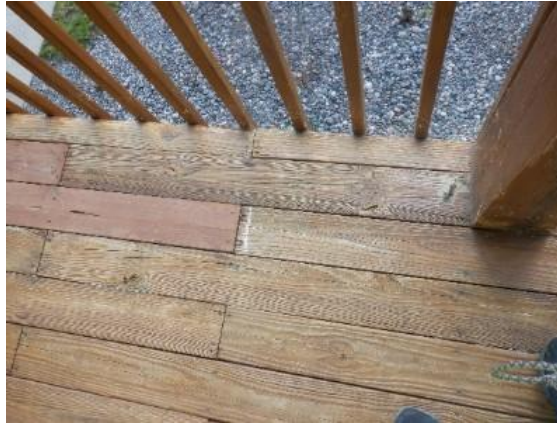
Image(s) For Finding No.54

54. Between columns 2 and 3 from the South, there is 1 deck board loose.

54. Secure the loose deck board with proper length exterior deck screws.  
Repair Priority: P3

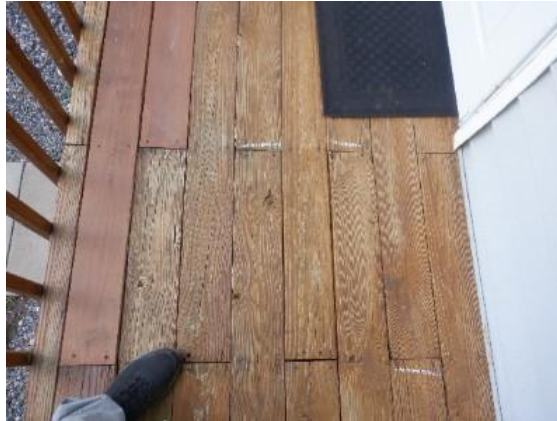
Image(s) For Finding No.55

55. Between columns 3 and 4 from the South, there are 3 deck boards loose.

55. Secure the loose deck boards with proper length exterior deck screws.  
Repair Priority: P3

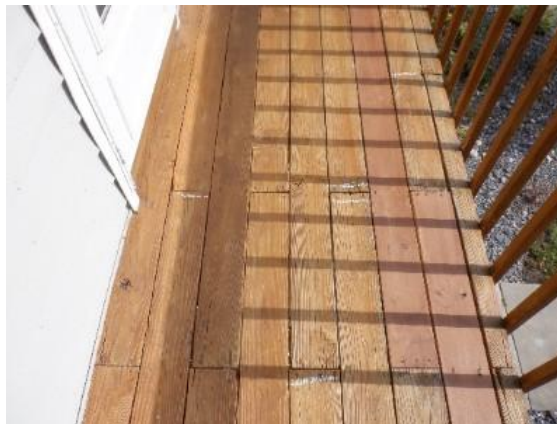
Image(s) For Finding No.56

56. Between columns 5 and 6 from the South, there are 5 deck boards loose.

56. Secure the loose deck boards with proper length exterior deck screws.  
Repair Priority: P3

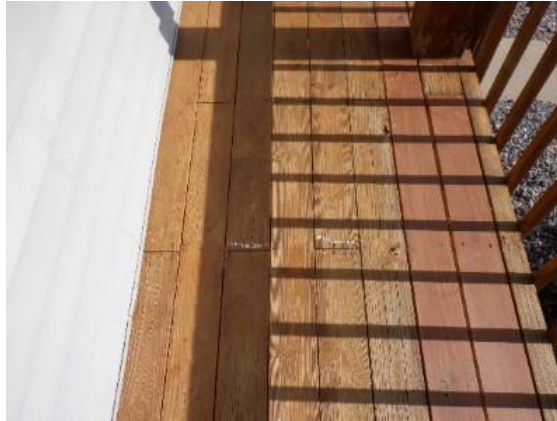
Image(s) For Finding No.57

57. Between columns 6 and 7 from the South, there are 2 deck boards loose.

57. Secure the loose deck boards with proper length exterior deck screws.  
Repair Priority: P3

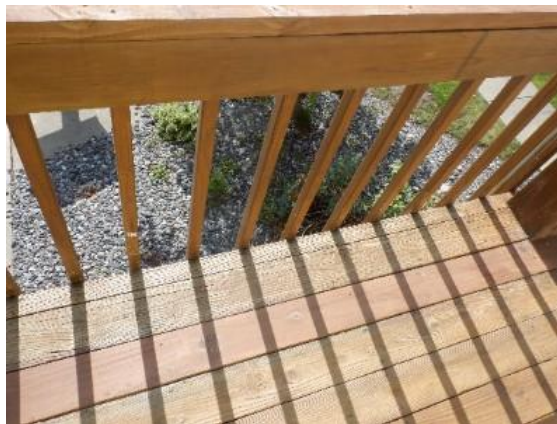
Image(s) For Finding No.58

58. Between columns 7 and 8 from the South, there is 1 baluster loose.

58. Secure the loose baluster with a proper length exterior deck screw.  
Repair Priority: P2

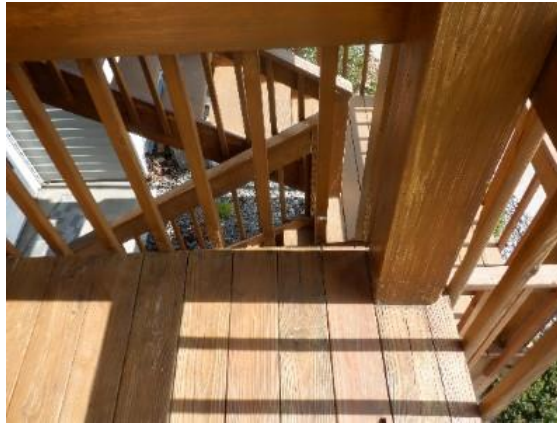
Image(s) For Finding No.59

59. At column 8 on the North side, there is 1 cracked baluster.

59. Replace the cracked baluster in kind with pressure treated lumber and secure the with proper length exterior deck screws.  
Repair Priority: P2

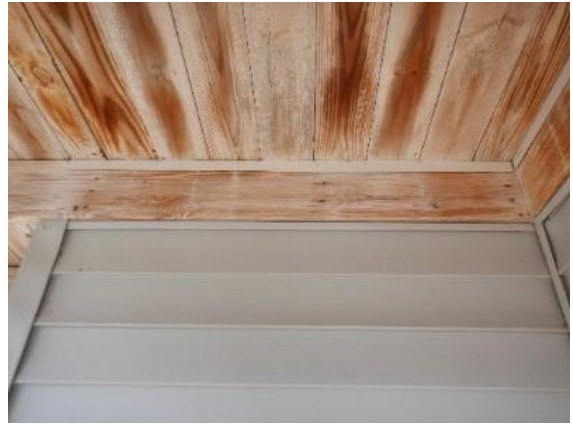
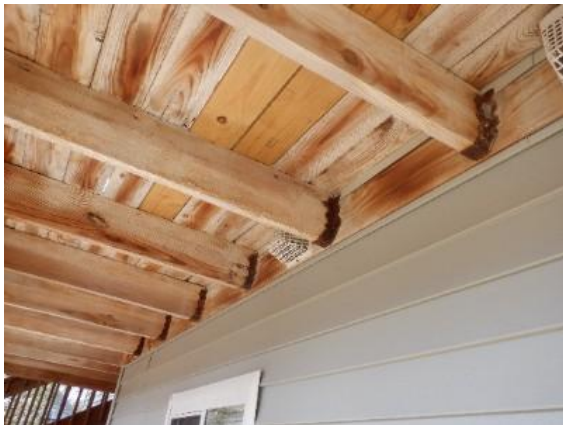
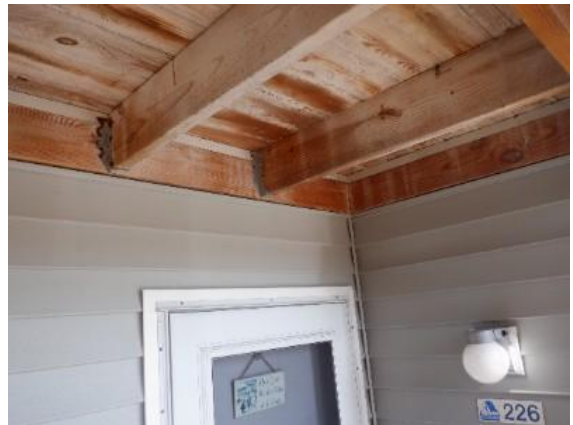
Image(s) For Finding No.60

60. At the joist hanger brackets along the entire building length, the galvanized coating is corroded. This condition is worse near the stair towers.

60. Monitor the condition of the hanger brackets until the next inspection.  
Repair Priority: P5

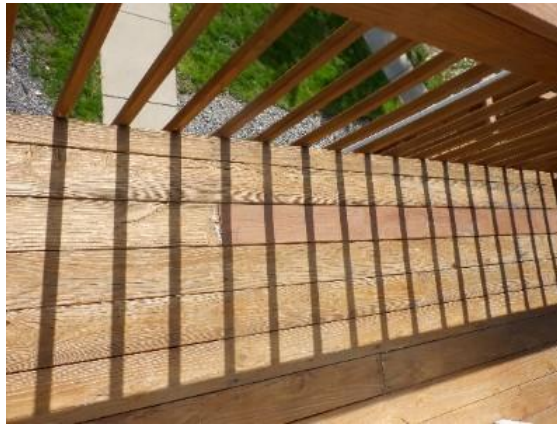
Image(s) For Finding No.63

63. Between columns 1 and 2 from the South, there is 1 deck board loose.

63. Secure the loose deck board with proper length exterior deck screws.  
Repair Priority: P3

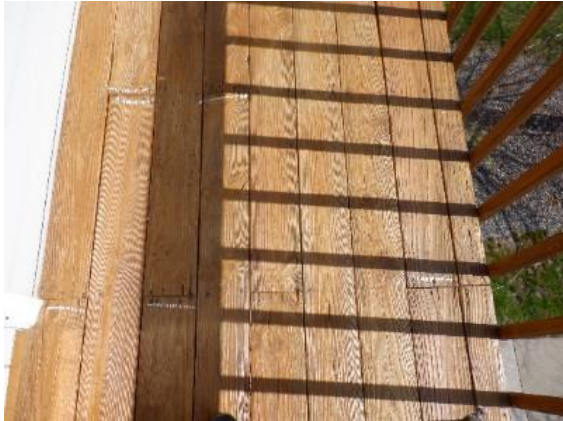
65. Between columns 3 and 4 from the South, there are 7 deck boards loose.

65. Secure the loose deck boards with proper length exterior deck screws  
Repair Priority: P3

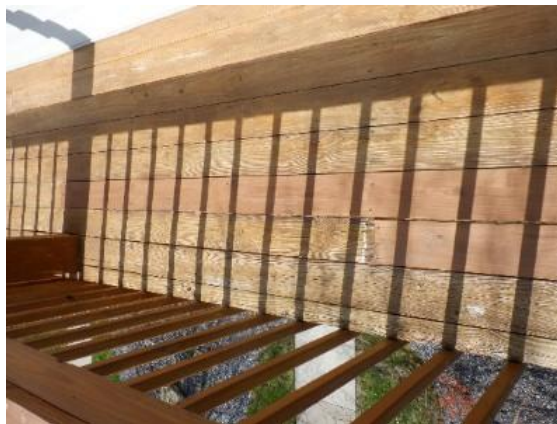
Image(s) For Finding No.66

66. Between columns 4 and 5 from the South, there is 1 deck board loose.

66. Secure the loose deck board with proper length exterior deck screws.  
Repair Priority: P3

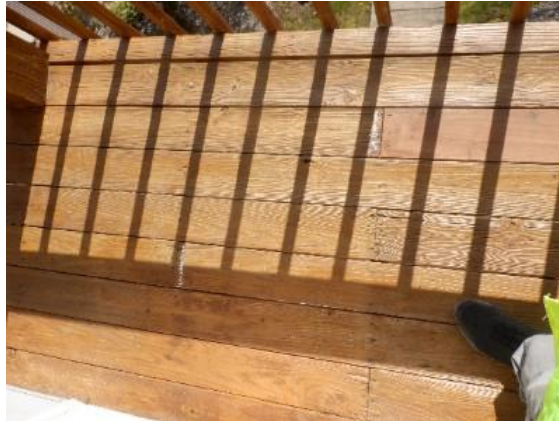
Image(s) For Finding No.67

67. Between columns 5 and 6 from the South, there are 2 deck boards loose.

67. Secure the loose deck boards with proper length exterior deck screws.  
Repair Priority: P3

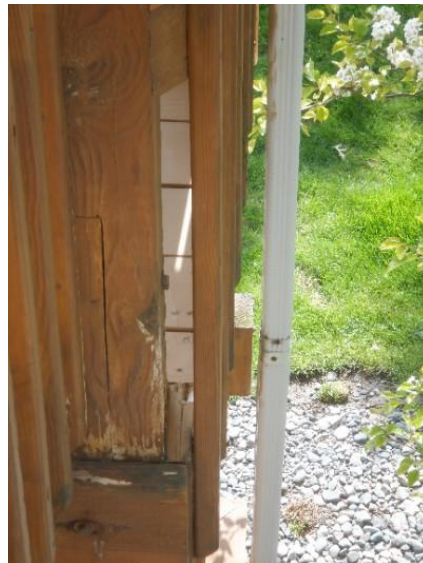
Image(s) For Finding No.68

68. On the South side, the down spout is loose and detached.

68. Secure the loose down spout to the stair tower.  
Repair Priority: P3

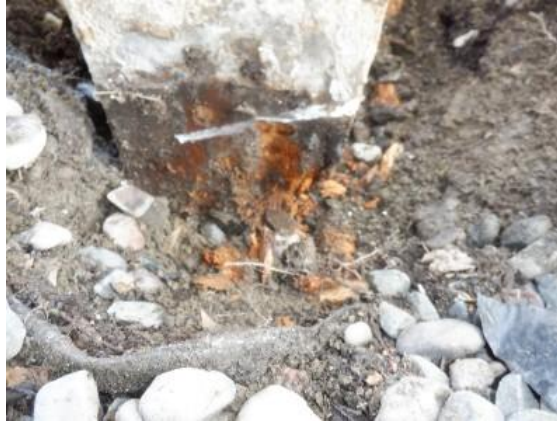
Image(s) For Finding No.69

69. At the South stair tower, at the South column on the building side, the column base below grade is wet and decaying with approximately 60% section loss.

69. Repair the deteriorated column base. See cover sheet notes for suggested repair options.  
Repair Priority: P2

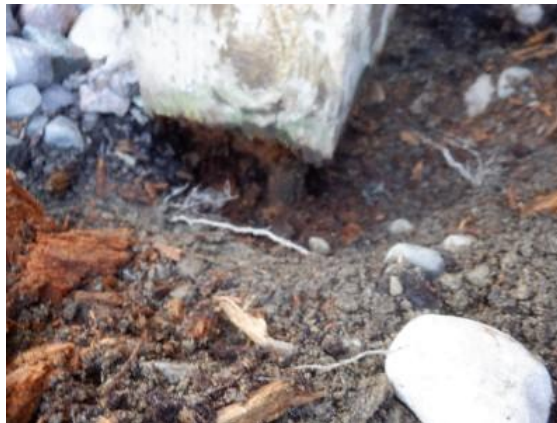
Image(s) For Finding No.70

70. At the South stair tower, at the South column on the parking lot side, the column base below grade is wet and decayed 100% through.

70. Repair the deteriorated column base. See cover sheet notes for suggested repair options.  
Repair Priority: P2

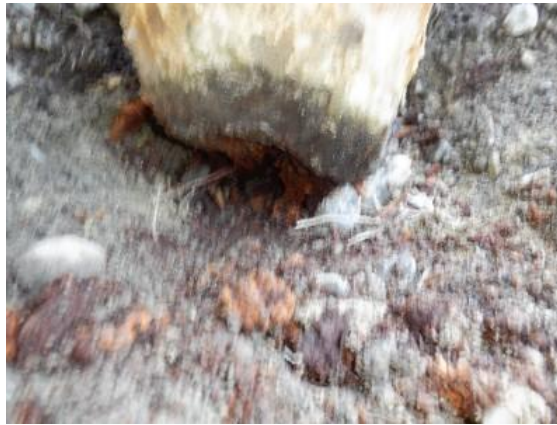
Image(s) For Finding No.71

71. At the South stair tower, at the North column on the parking lot side, the column base below grade is wet and decayed 100% through.

71. Repair the deteriorated column base. See cover sheet notes for suggested repair options.  
Repair Priority: P2

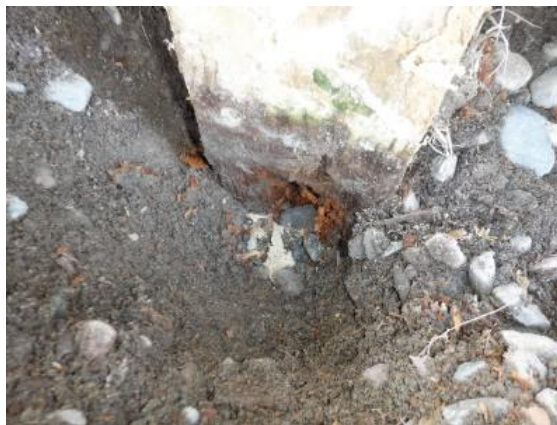
Image(s) For Finding No.72

72. At the South stair tower, at the North column on the building side, the column base below grade is wet and decayed 100% through.

72. Repair the deteriorated column base. See cover sheet notes for suggested repair options.  
Repair Priority: P2

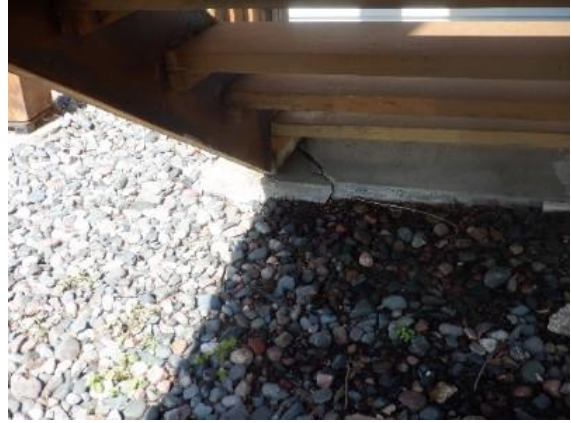
Image(s) For Finding No.73

73. The concrete pad at the base of the 1st stair is cracked under the South stair stringer.

73. Replace the cracked concrete pad.  
Repair Priority: P4

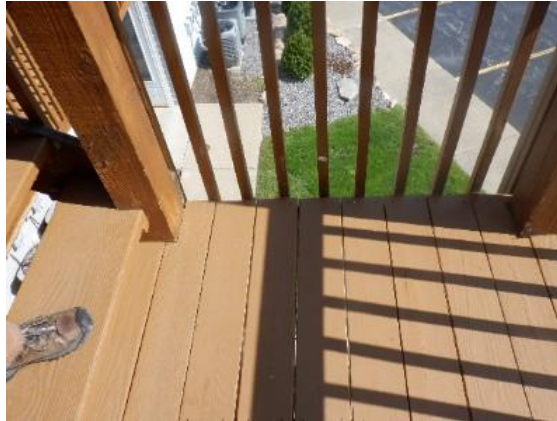
Image(s) For Finding No.75

75. At the 2nd landing on the North side, there is 1 baluster loose.

75. Secure the loose baluster with a proper length exterior deck screw.  
Repair Priority: P2

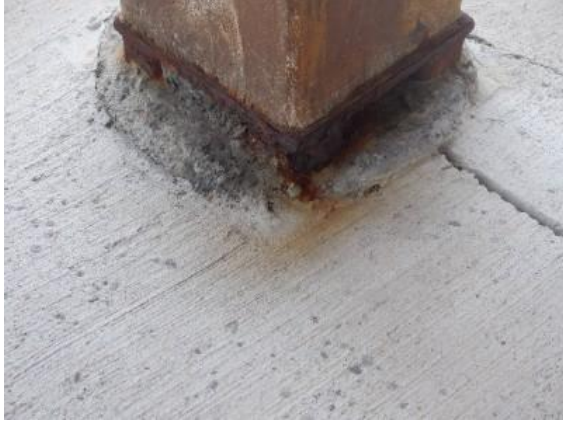
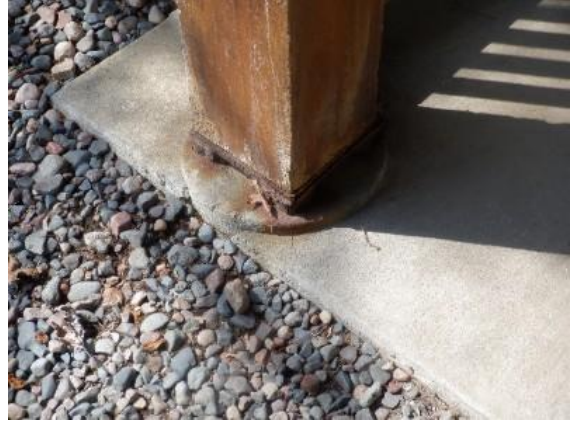
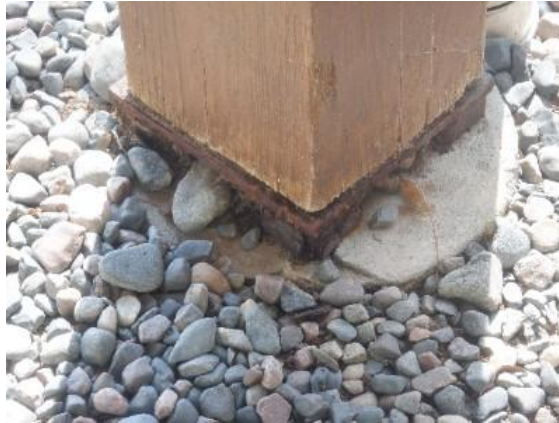
Image(s) For Finding No.76

76. At columns 2, 3 and 4 from the South, the column base plates are rust packed and expanding.

76. Monitor the condition of the column base plates until the next inspection.  
Repair Priority: P5

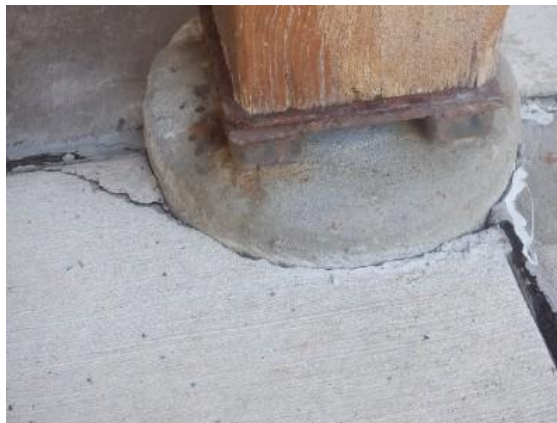
Image(s) For Finding No.77

77. At columns 13, 14 and 15 from the South, the column base plates are rust packed and expanding.

77. Monitor the condition of the column base plate until the next inspection.  
Repair Priority: P5

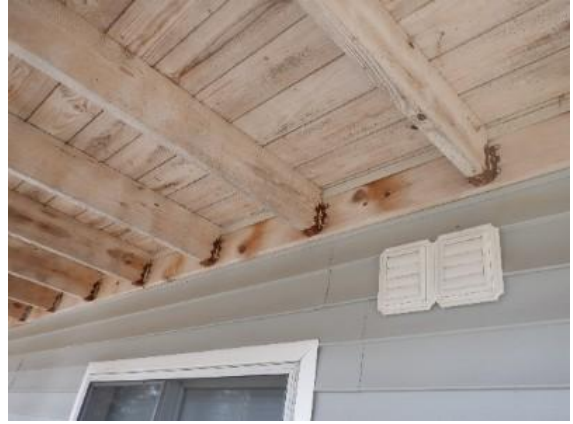
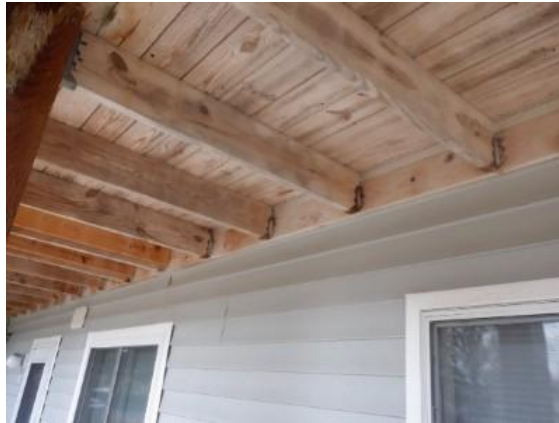
Image(s) For Finding No.78

78. At the stair tower areas, at the building side joist hangers, the galvanized coating is corroded on the joist hangers.

78. Monitor the condition of the hanger brackets until the next inspection.  
Repair Priority: P5

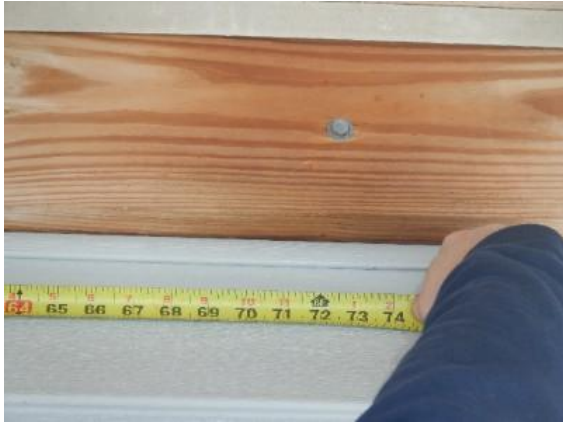
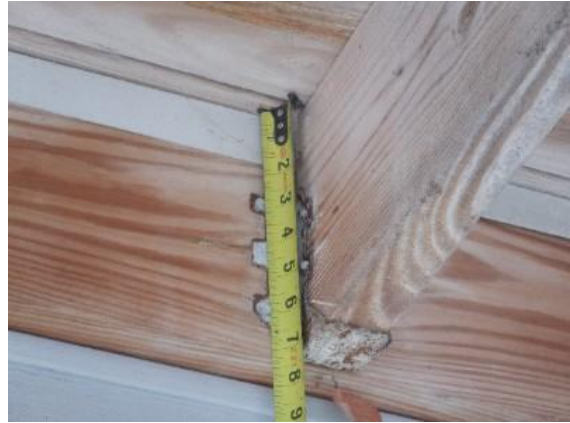
80. The ledger boards have a lag screw installed every 6' on center. The building side joist hangers are 2x6 hangers and the parking lot side joist hangers are for 2x8 hangers. No evidence of any ledger or joist hanger pullout was observed.

80. For the record only. No action is required at this time.

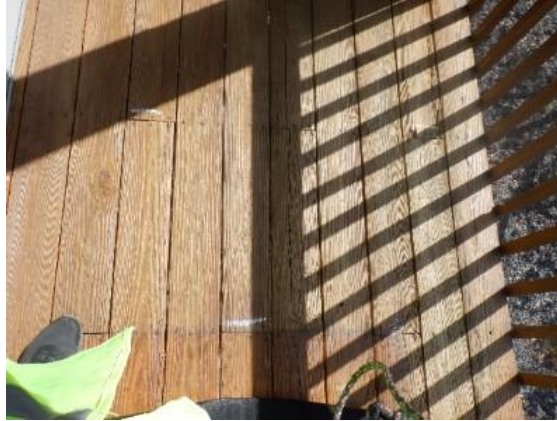
0285

81. At column 1 from the South, on the South side, there are 3 deck boards loose and nails popped up.

81. Secure the loose deck boards with proper length exterior deck screws.  
Repair Priority: P3

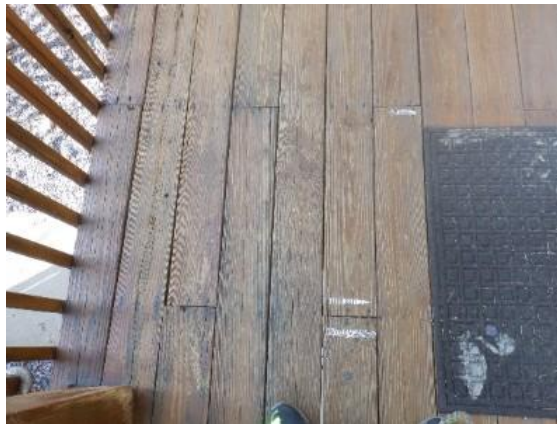
0286

82. Between columns 1 and 2 from the South, there are 2 deck boards loose.

82. Secure the loose deck boards with proper length exterior deck screws.  
Repair Priority: P3

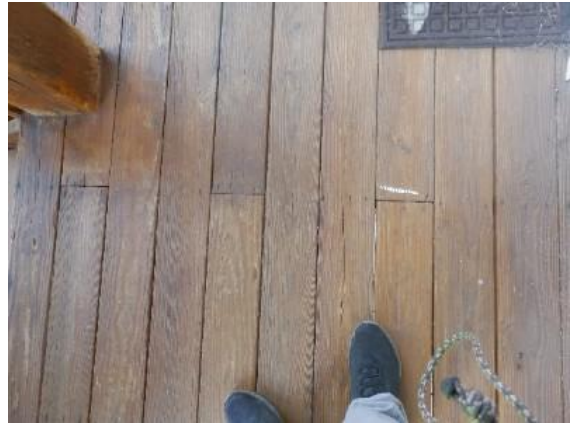
0287

83. Between columns 2 and 3 from the South, there is 1 deck board and 1 baluster loose.

83. Secure the loose deck board and baluster with proper length exterior deck screws.  
Repair Priority: P2

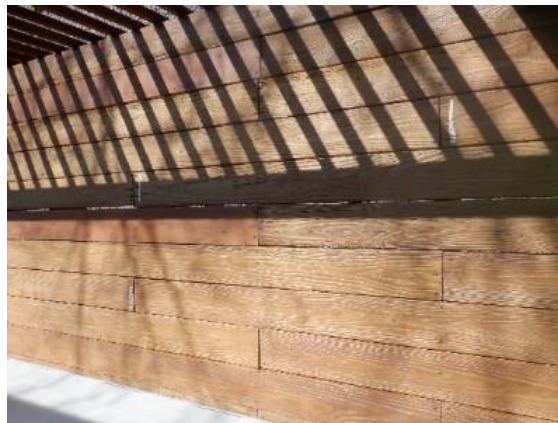
0289

84. Between columns 4 and 5 from the South, there are 3 deck boards loose.

84. Secure the loose deck boards with proper length exterior deck screws.  
Repair Priority: P3

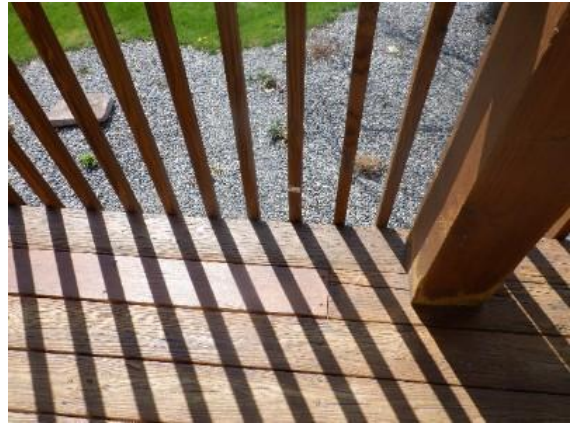
0290

85. Between columns 5 and 6 from the South, there are 2 deck boards and 1 baluster loose.

85. Secure the loose deck boards and baluster with proper length exterior deck screws.  
Repair Priority: P2
