# 2023 STRUCTURAL INSPECTION REPORT MARINERS POINT CONDOMINIUMS Parking Lot Side

**STRUCTURE TAG NO.: WALKWAYS AND STAIR TOWER**

**Date Of Inspection:** 04/25/2023

**Globex Job No.:** G-6970

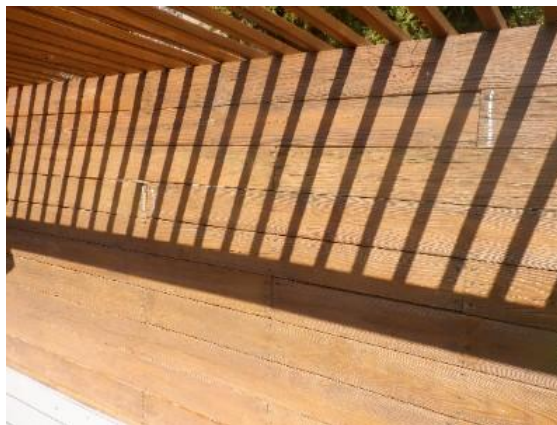
0292

86. Between columns 7 and 8 from the South, there are 3 deck boards loose.

86. Secure the loose deck boards with proper length exterior deck screws.  
Repair Priority: P3

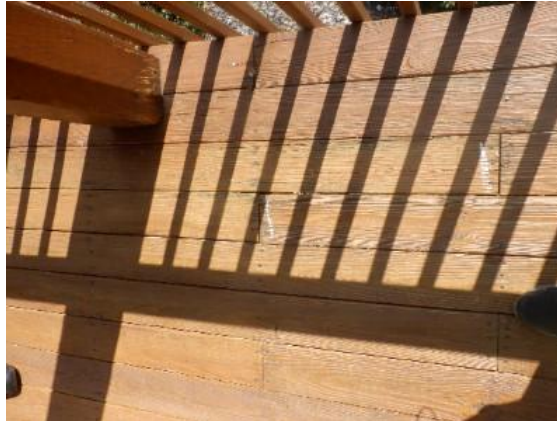
0293

87. Between columns 8 and 9 from the South, there are 2 deck boards loose.

87. Secure the loose deck boards with proper length exterior deck screws.  
Repair Priority: P3

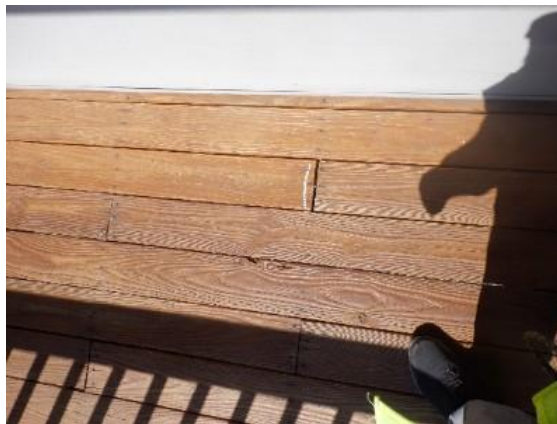
0294

88. Between columns 12 and 13 from the South, there is 1 deck board loose.

88. Secure the loose deck board with proper length exterior deck screws.  
Repair Priority: P3

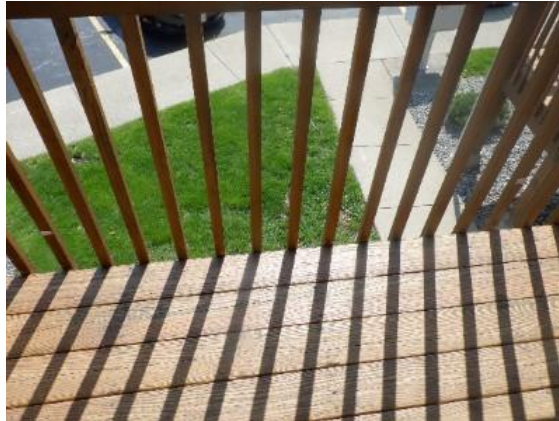
0295

89. Between columns 15 and 16 from the South, there are 2 balusters loose.

89. Secure the loose balusters with proper length exterior deck screws.  
Repair Priority: P2

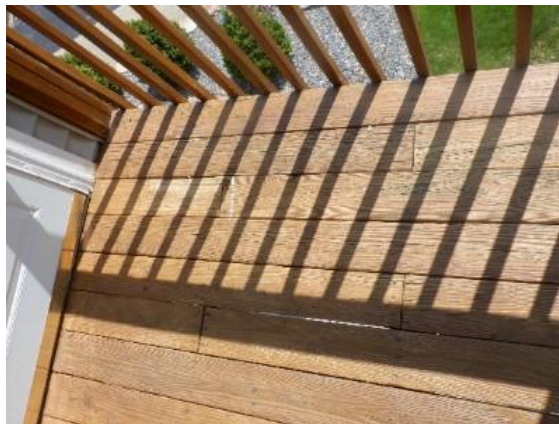
0296

90. North of column 16 from the South, there is 1 deck board loose.

90. Secure the loose deck board with proper length exterior deck screws.  
Repair Priority: P3

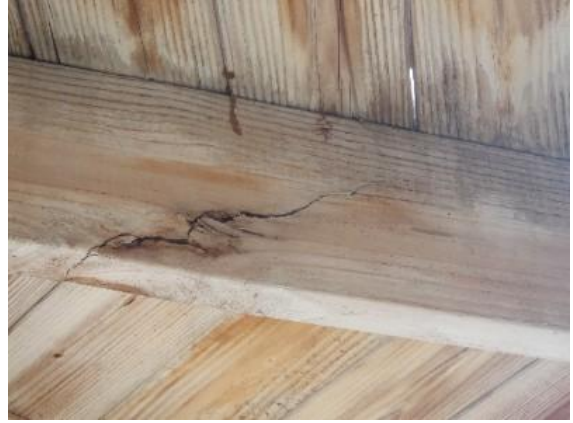
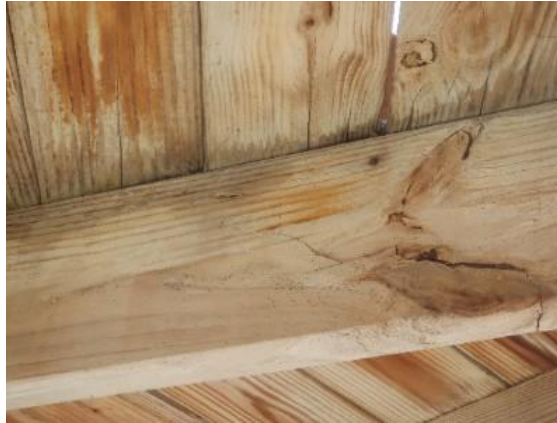
There is a joist cracked at mid-span and a stair tread which is spongy on one side when stepped on. See findings no. 91 and 108, as these are high priority P2 findings.

91. At column 7 from the South, there is a 2x8x4'-4" Lg. joist that is cracked at mid span.

91. Replace the joist in kind with pressure treated lumber  
Repair Priority: P2

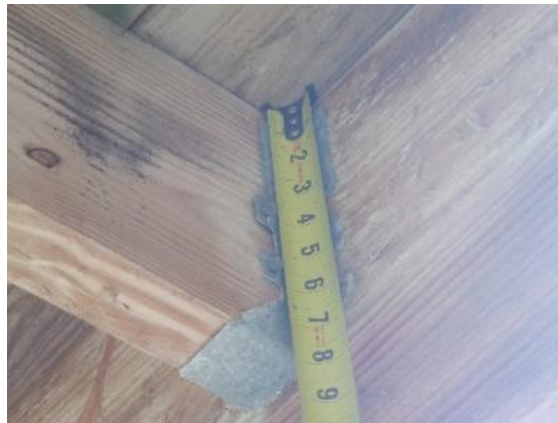
0275

92. The ledger boards have a lag screw installed every 6' on center. The building side joist hangers are 2x6 hangers and the parking lot side joist hangers are for 2x8 hangers. No evidence of any ledger or joist hanger pullout was observed.

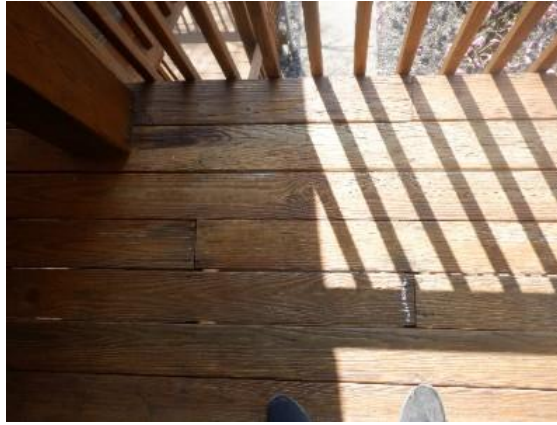
0302

93. Between columns 1 and 2, there is 1 deck board loose.

93. Secure the loose deck board with proper length exterior deck screws.  
Repair Priority: P3

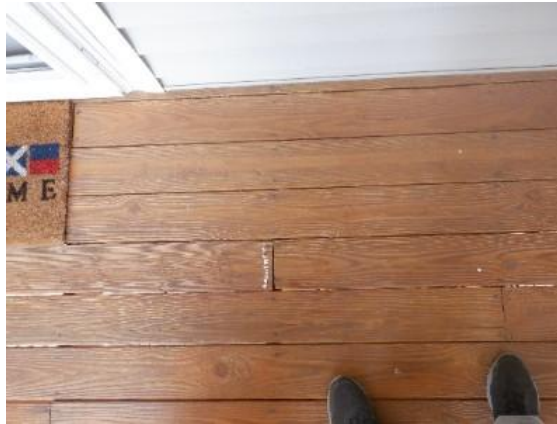
0303

94. Between columns 2 and 3, there is 1 deck board loose.

94. Secure the loose deck board with proper length exterior deck screws.  
Repair Priority: P3

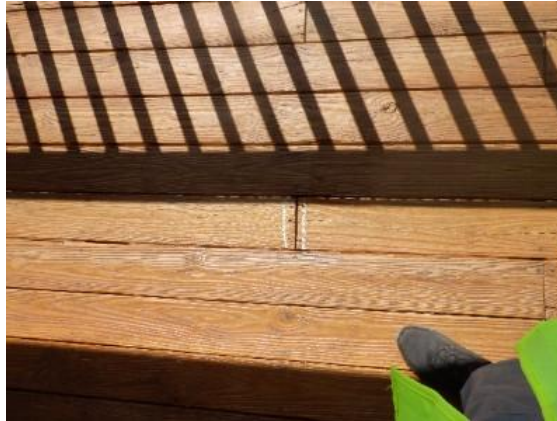
0304

95. Between columns 4 and 5, there are 2 deck boards loose.

95. Secure the loose deck boards with proper length exterior deck screws.  
Repair Priority: P3

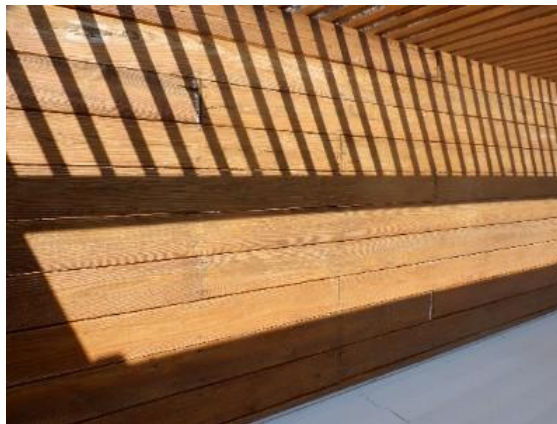
0305

96. Between columns 5 and 6, there are 2 deck boards loose.

96. Secure the loose deck boards with proper length exterior deck screws.  
Repair Priority: P3

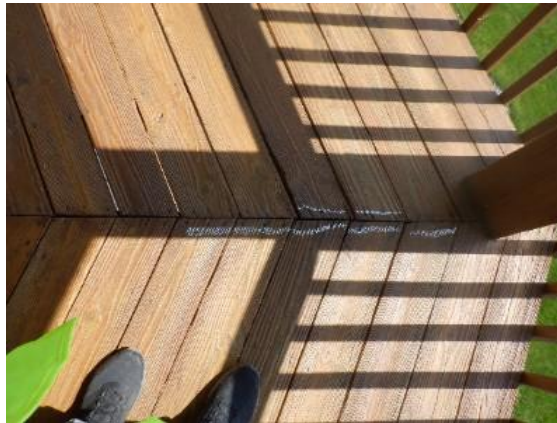
0306

97. At column 7 from the South, there are 7 deck boards loose.

97. Secure the loose deck boards with proper length exterior deck screws.  
Repair Priority: P3

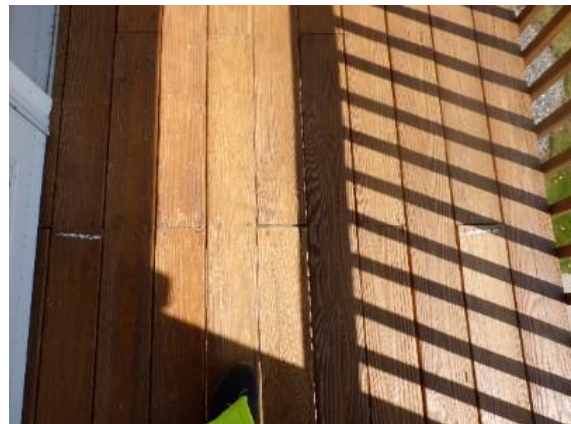
0307

98. Between columns 8 and 9, there are 4 deck boards loose.

98. Secure the loose deck boards with proper length exterior deck screws.  
Repair Priority: P3

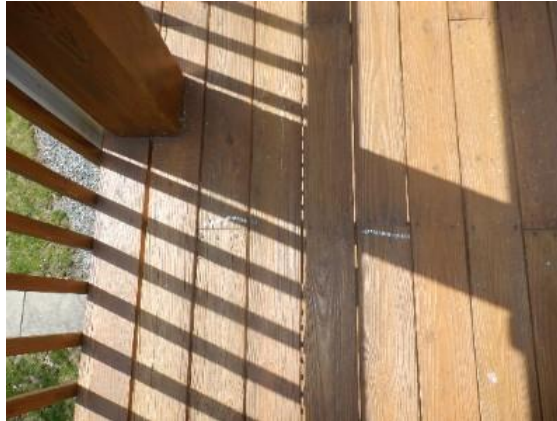
0309

99. Between columns 10 and 11, there are 2 deck boards loose.

99. Secure the loose deck boards with proper length exterior deck screws.  
Repair Priority: P3

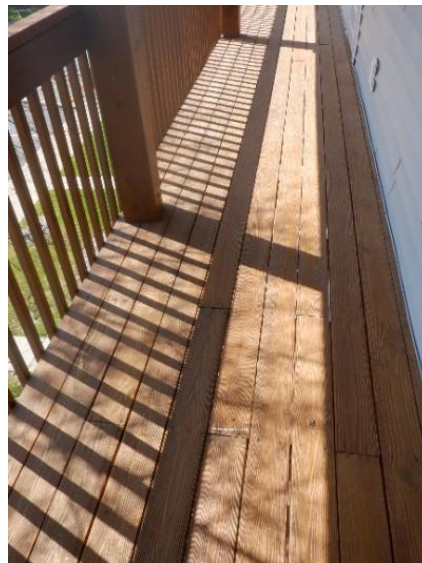
0310

100. Between columns 11 and 12, there is 1 deck board and 1 baluster loose.

100. Secure the loose deck board and baluster with proper length exterior deck screws.  
Repair Priority: P2

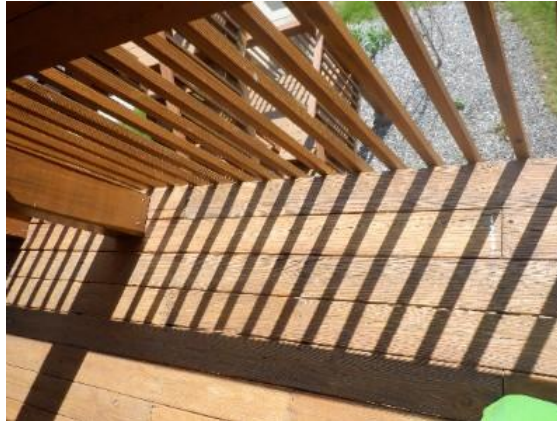
0312

101. Between columns 12 and 13, there is 1 deck board loose.

101. Secure the loose deck board with proper length exterior deck screws.  
Repair Priority: P3

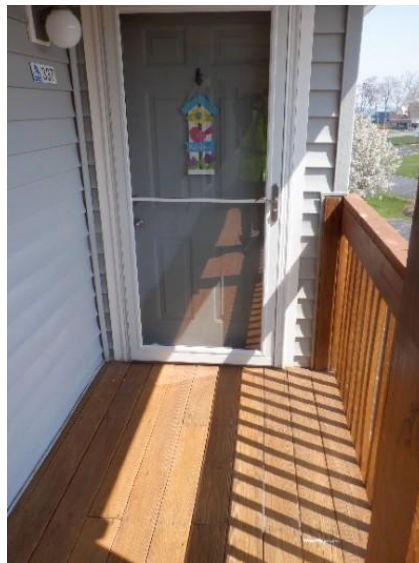
0313

102. North of column 16 from the South, there is 1 deck board loose.

102. Secure the loose deck board with proper length exterior deck screws.  
Repair Priority: P3

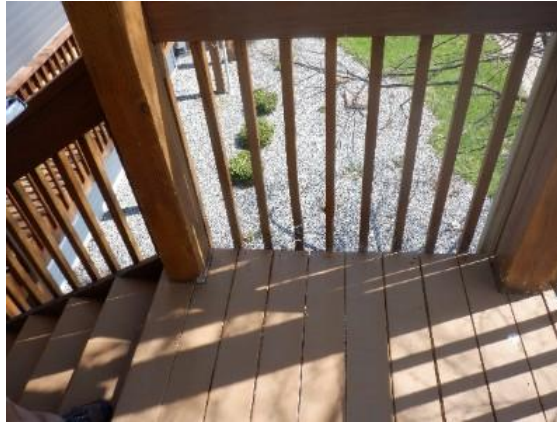
0314

103. At the 2nd landing, on the North side, there is 1 cracked baluster.

103. Replace the cracked baluster in kind with pressure treated lumber and secure with proper length exterior deck screws.  
Repair Priority: P2

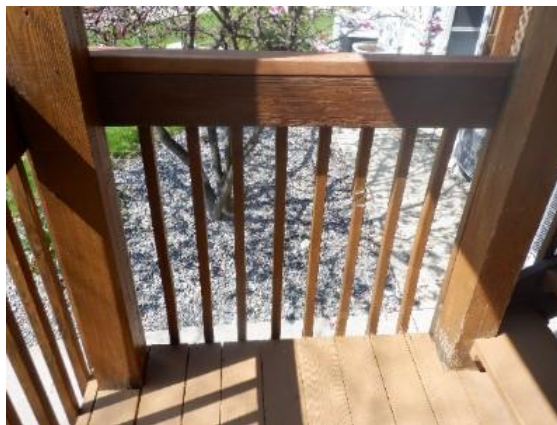
0317

104. At the 1st landing, on the South side, there is 1 cracked baluster.

104. Replace the cracked baluster in kind with pressure treated lumber and secure with proper length exterior deck screws.  
Repair Priority: P2

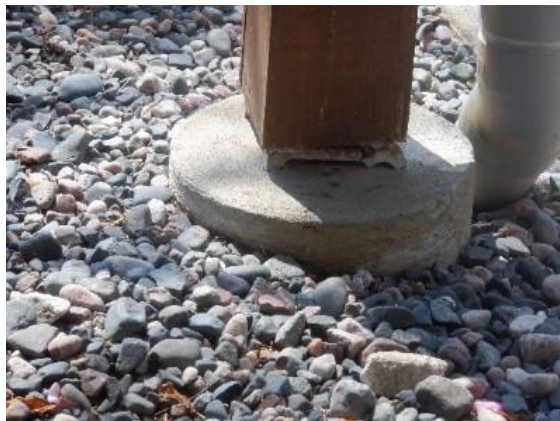
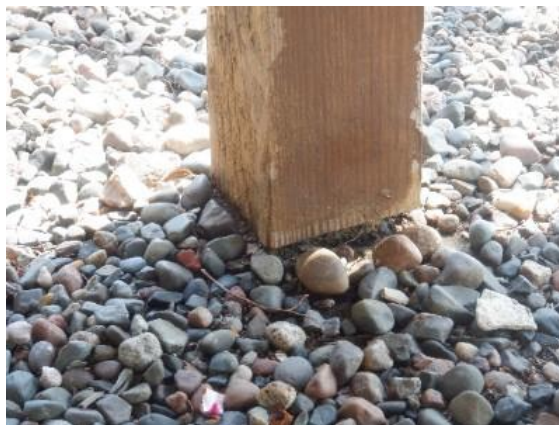
105. At the column base, the base plates are cracked at 4 columns.

105. Monitor the condition of the base plates until the next inspection.  
Repair Priority: P5

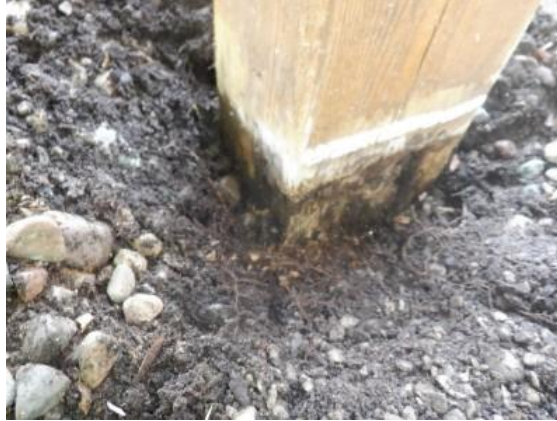
0447

107. At the South stair tower, the North West column base is wet and starting to decay below grade.

107. Monitor the condition of the support column until the next inspection.  
Repair Priority: P5

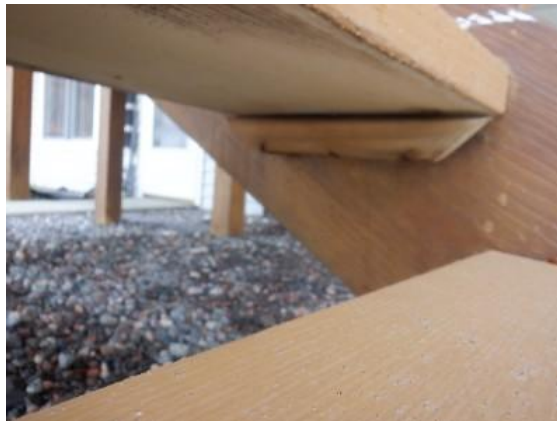
0324

108. At the stairs between ground and 1st landing, the 3rd tread up is spongy on East side when stepped on.

108. Replace the existing ledger strips under the stair tread with corrosion resistant tread connectors  
Repair Priority: P2

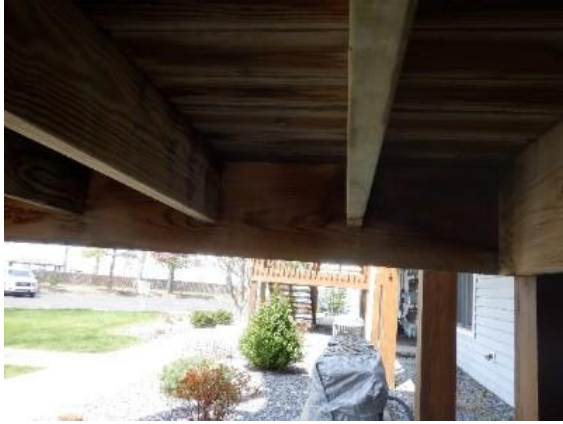
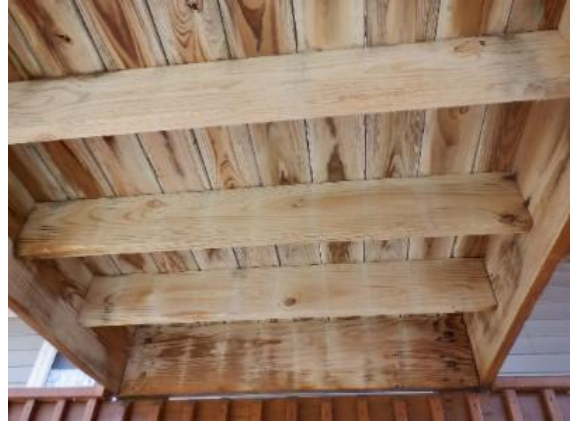
109. At South stair tower landings, the joists are end nailed with no joist hangers. No evidence of any joist pull out was observed.

109. For the record only. No action is required at this time.

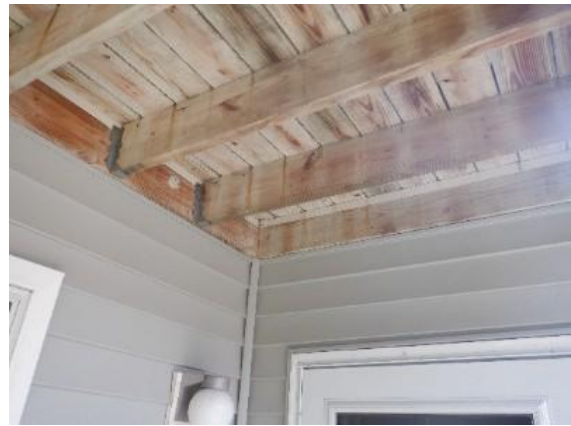
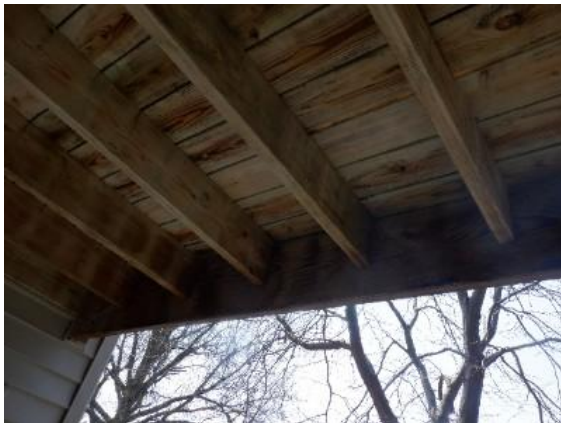
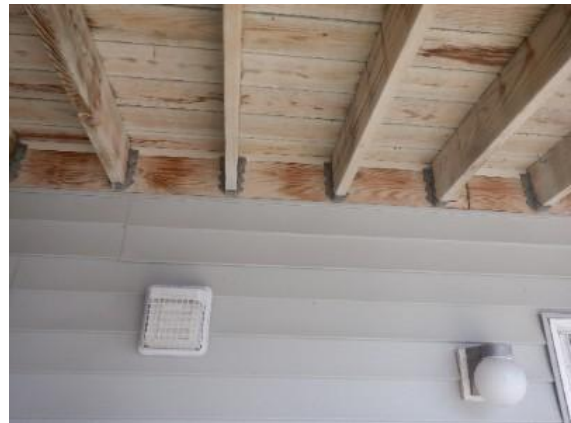
110. The ledger boards have no visible lag screws only a few sporadic visible nails. It appears that the ledger board connection nails may be located behind each joist making them not visible for inspection. The building side joist hangers are 2x8 hangers and there are no hangers on parking lot side. The parking lot side joists were end nailed. No evidence of any ledger or joist hanger pullout was observed.

110. Since the ledger board connection to the building cannot be verified, further engineering and investigation is recommended to review original design drawings and the ledger connections for code compliance.  
Repair Priority: P4

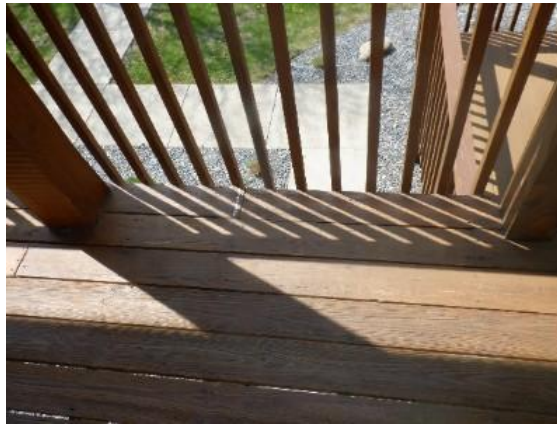
0335

111. Between columns 5 and 6 from the North, there is 1 deck board loose.

111. Secure the loose deck board with proper length exterior deck screws.  
Repair Priority: P3

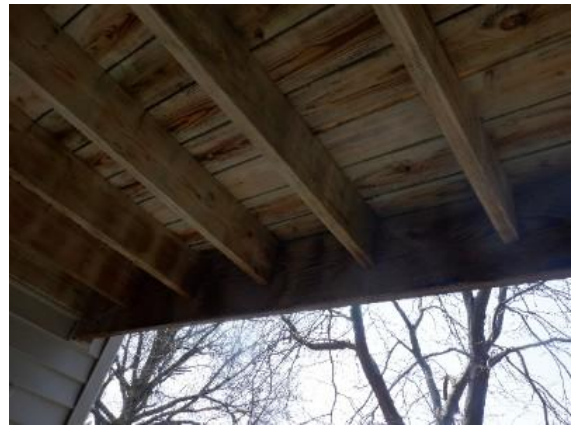
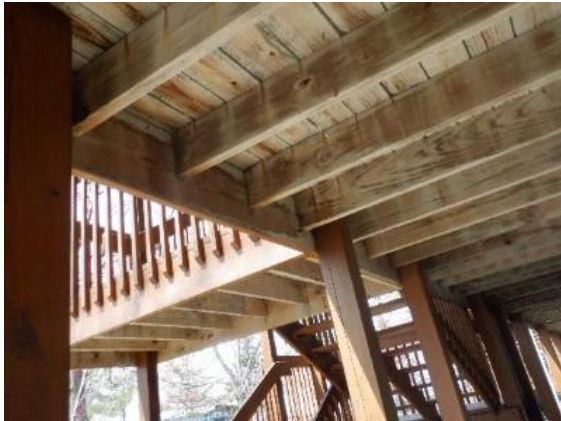
112. The ledger boards have no visible lag screws only a few sporadic visible nails. It appears that the ledger board connection nails may be located behind each joist making them not visible for inspection. The building side joist hangers are 2x8 hangers and there are no hangers on parking lot side. The parking lot side joists were end nailed. No evidence of any ledger or joist hanger pullout was observed.

112. Since the ledger board connection to the building cannot be verified, further engineering and investigation is recommended to review original design drawings and the ledger connections for code compliance.  
Repair Priority: P4

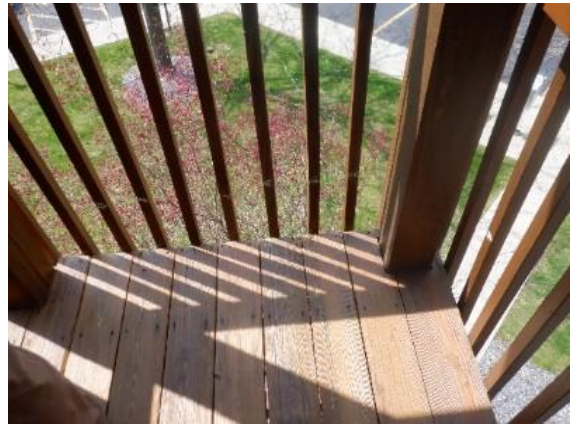
0341

113. At the 4th landing, there are 7 balusters loose.

113. Secure the loose balusters with proper length exterior deck screws.  
Repair Priority: P2

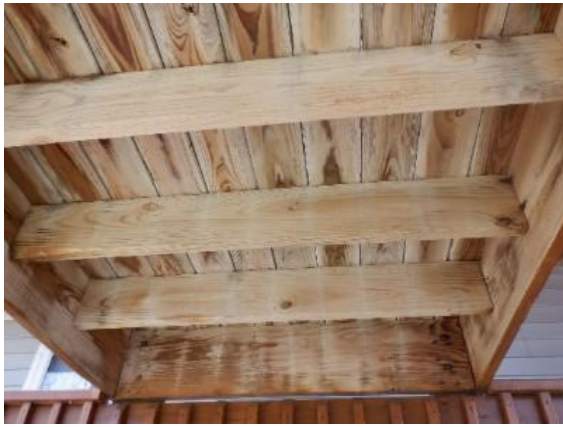
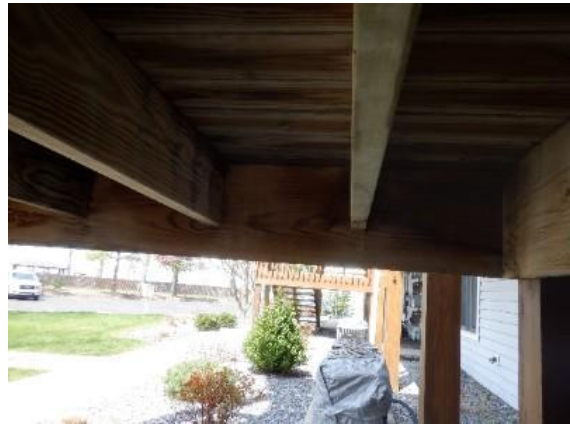
115. At North stair tower landings, the joists are end nailed with no joist hangers. No evidence of any joist pullout twas observed.

115. For the record only. No action is required at this time.

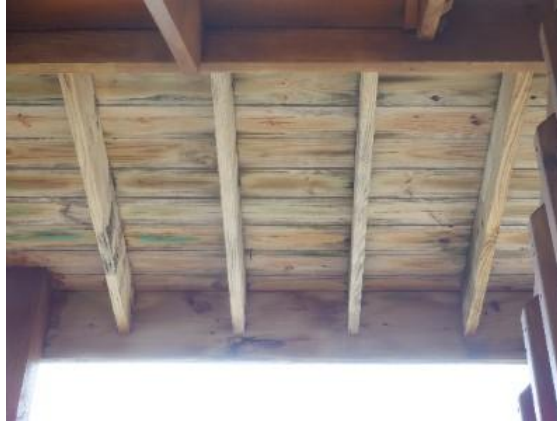
0345

117. At South stair tower landings, the joists are end nailed with no joist hangers. No evidence of any joist pullout was observed.

117. For the record only. No action is required at this time.

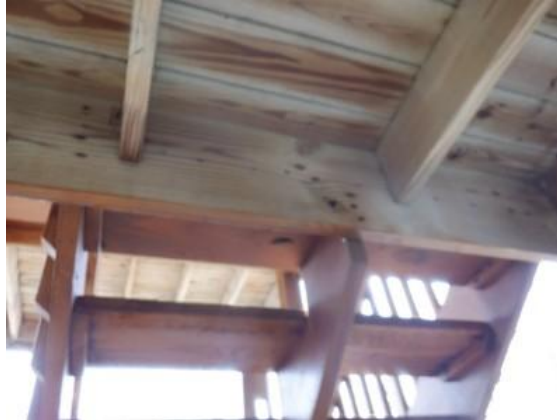
0346

118. All stair stringers are end nailed at top connection to the rim joist but there is no gap.

118. For the record only. No action required at this time.

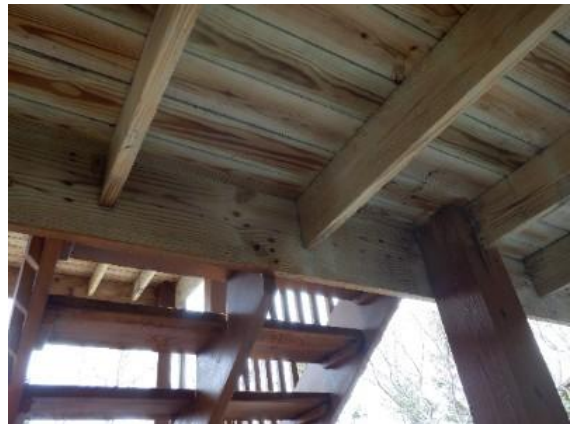
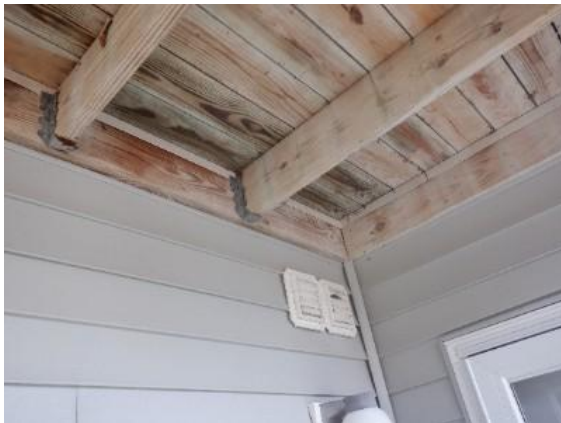
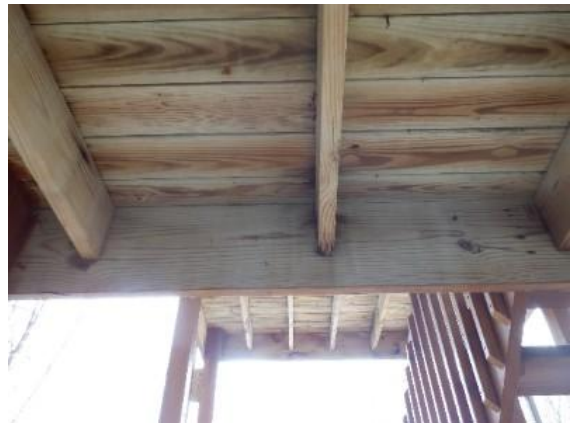
119. The ledger boards have no visible lag screws only a few sporadic visible nails. It appears that the ledger board connection nails may be located behind each joist making them not visible for inspection. The building side joist hangers are 2x8 hangers and there are no joist hangers on parking lot side. The joist are end nailed on the parking lot side. No evidence of any ledger or joist hanger pullout was observed.

119. Since the ledger board connection to the building cannot be verified, further engineering and investigation is recommended to review original design drawings and the ledger connections for code compliance.  
Repair Priority: P4

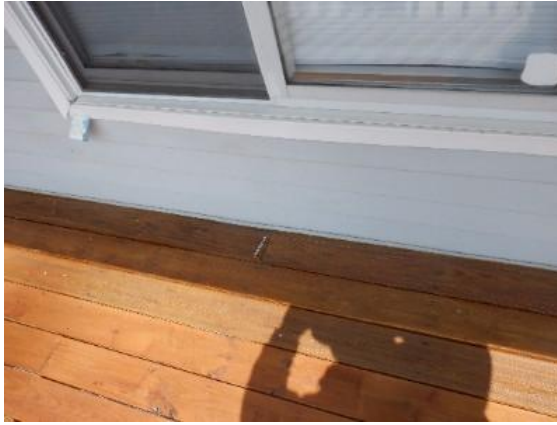
0351

120. Between columns 3 and 4 from North, there is 1 deck board loose.

120. Secure the loose deck board with proper length exterior deck screws.  
Repair Priority: P3

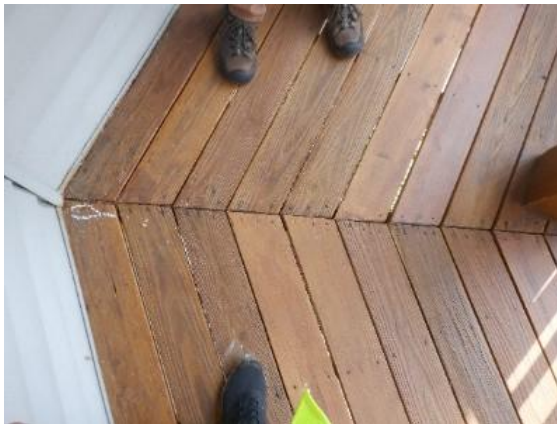
0352

121. At column 6 from North, there is 1 deck board loose.

121. Secure the loose deck board with proper length exterior deck screws.  
Repair Priority: P3

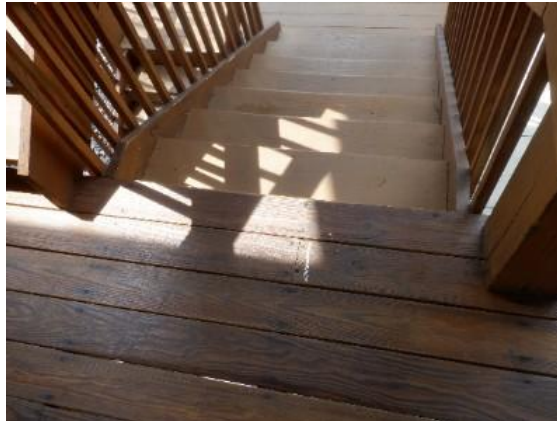
0353

122. Between columns 11 and 12 from North, there is 1 deck board loose at top of stairs.

122. Secure the loose deck board with proper length exterior deck screws.  
Repair Priority: P3

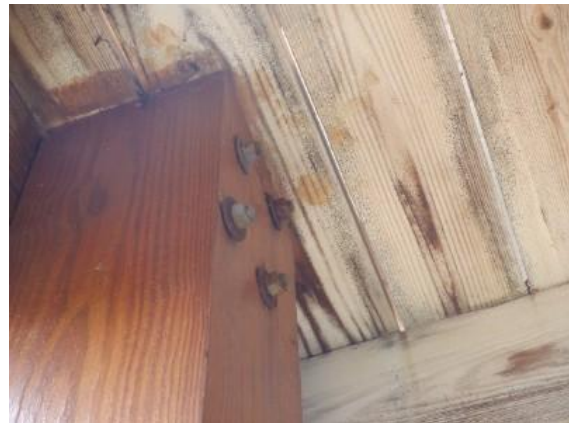
0355

123. At column 3 from North, there are 4 of 4 carriage bolts loose.

123. Tighten the loose carriage bolts until the bolt head and washer are tight and flush with the wood surfaces.

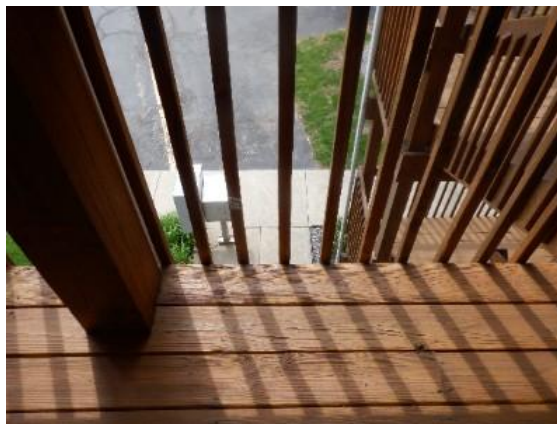
0357

125. Between column 2 and 3 from North, there is 1 baluster loose

125. Secure the loose baluster with proper length exterior deck screws.  
Repair Priority: P2

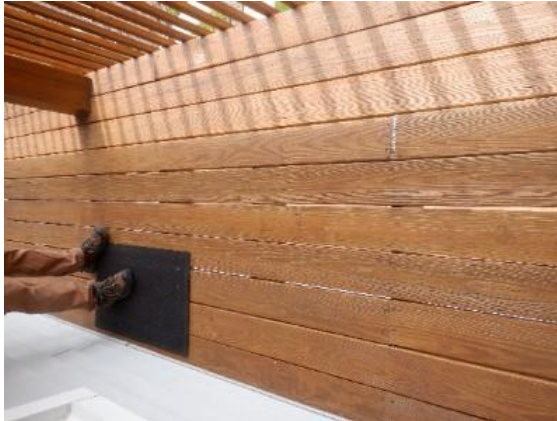
0358

126. Between column 3 and 4 from North,  
there is 1 deck board loose.

126. Secure the loose deck board with proper  
length exterior deck screws.  
Repair Priority: P3

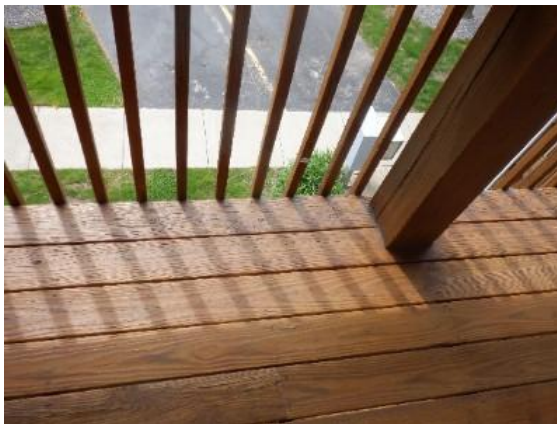
0359

127. Between column 4 and 5 from North,  
there is 1 baluster loose.

127. Secure the loose baluster with a proper  
length exterior deck screw.  
Repair Priority: P2

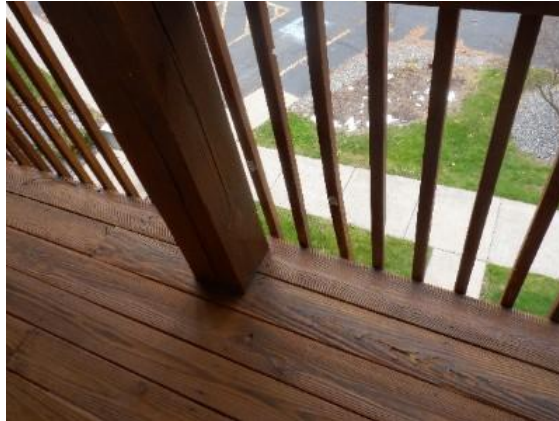
0360

128. Between column 7 and 8 from North, there are 2 balusters loose.

128. Secure the loose balusters with proper length exterior deck screws.  
Repair Priority: P2

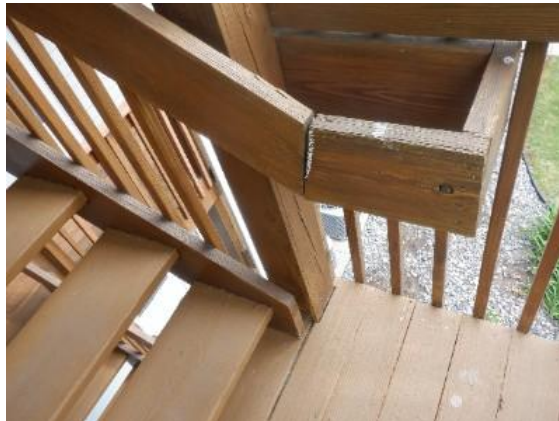
0361

129. At the 2nd landing, the South handrailing is separating.

129. Draw the separated handrailing sections together and secure with a splice plate on the backside or other appropriate means.  
Repair Priority: P2

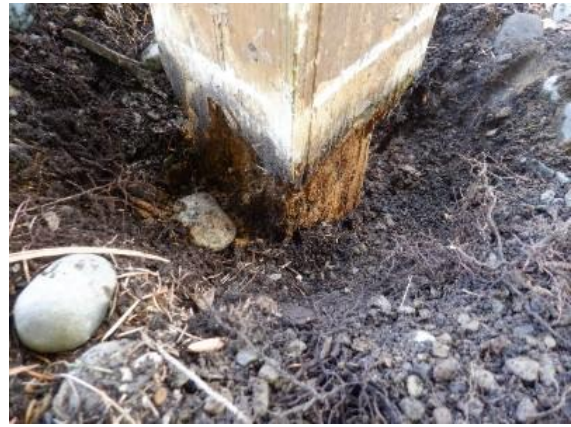
0440

130. At the North stair tower, the North column on the building side, the column base below grade is wet and decaying with approximately 25% section loss.

130. Monitor the condition of the column bases until the next inspection.  
Repair Priority: P5

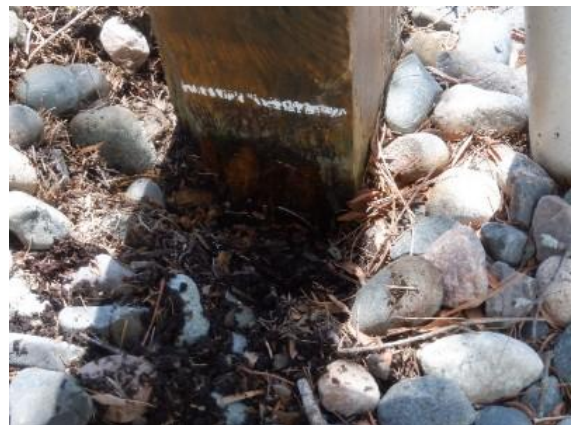
0441

131. At the North stair tower, at the North column on the parking lot side, the column base below grade is wet and starting to decay.

131. Monitor the condition of the column bases until the next inspection.  
Repair Priority: P5

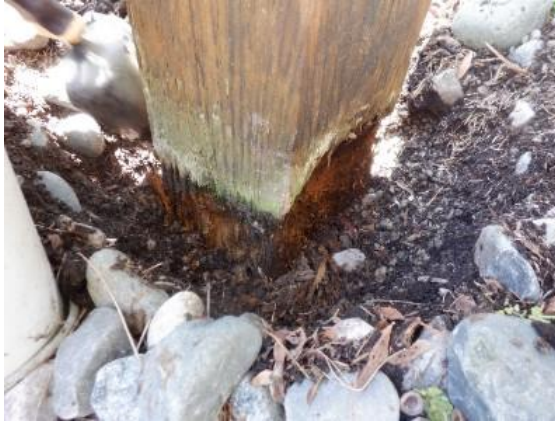
0444

132. At the North stair tower, South column on the parking lot side, at the column base below grade, is wet and decaying with approximately 25% section loss.

132. Monitor the condition of the column bases until the next inspection.  
Repair Priority: P5

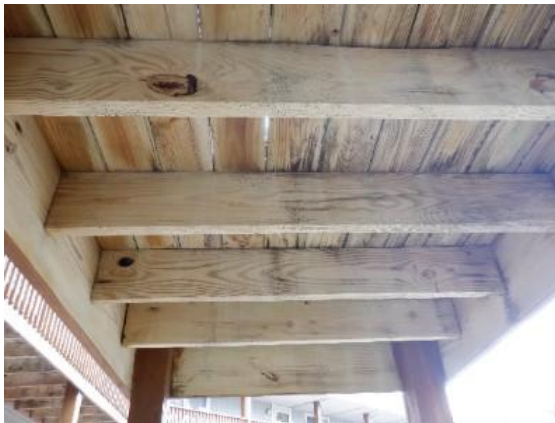
0362

133. At North stair tower landings, the joists are end nailed with no joist hangers. No evidence of any joist pullout was observed.

133. For the record only. No action is required at this time.

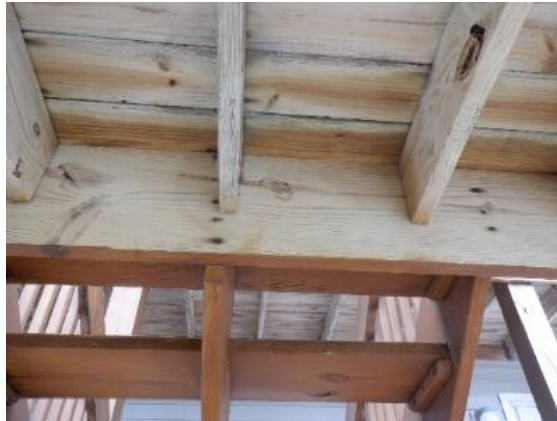
0363

134. All stair stringers are end nailed at top connection to the rim joist but there is no gap.

134. For the record only. No action is required at this time.
