1428/report 6898

## Electrical

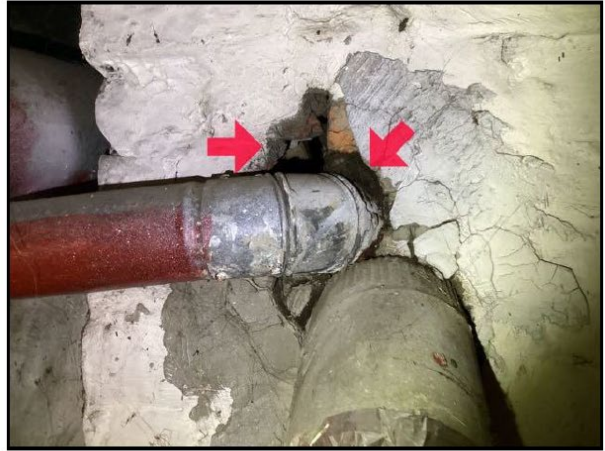
Condition: \* Not properly sealed at chimney

Implication(s): Hazardous combustion products entering home Location: Basement

11. Not properly sealed at chimney

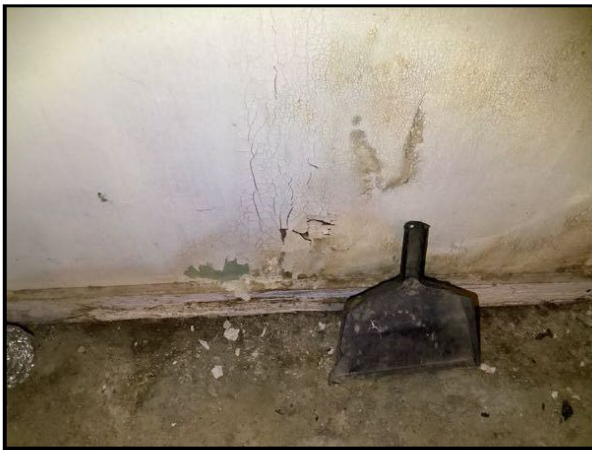
Stains and crumbling plaster/ masonry noted to walls in the basement. Areas appeared dry at time of inspection. Recommend ensuring all gutters / downspouts / drain tile are free and clear. Ensure proper grading on exterior. Use of de-humidifier may be needed to control moisture levels. Recommend monitoring area and seeking further evaluation by water proofing contractor if conditions worsen or desired.

23. Crumbling plaster, dry wall or concrete walls

**Task:** Further evaluation - **Remove drywall and molding, coat wall where seepage, replace with new drywall & molding \$600.** (once wall is open additional work requirements may become evident. Possible sump pump may be needed.)

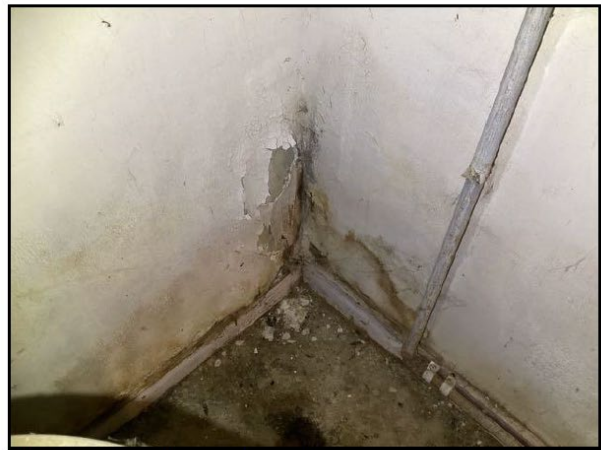
24. Crumbling plaster, dry wall or concrete walls

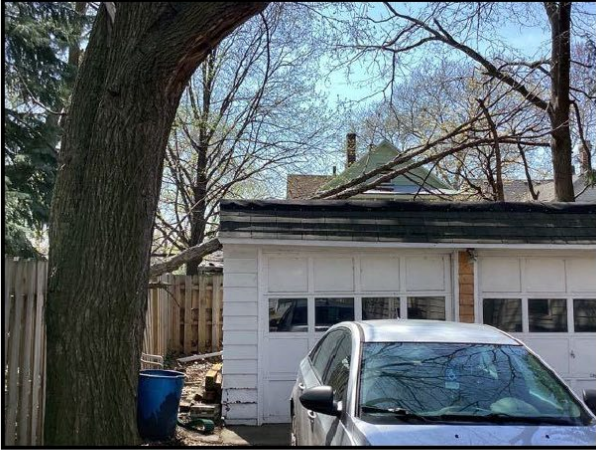
**7. Condition:** • Trees or shrubs too close to building

Tree has fallen on top of the garage. Recommend having a qualified contractor remove tree and make any needed repairs. - **remove tree from garge and fence \$350**

47. Trees or shrubs too close to building

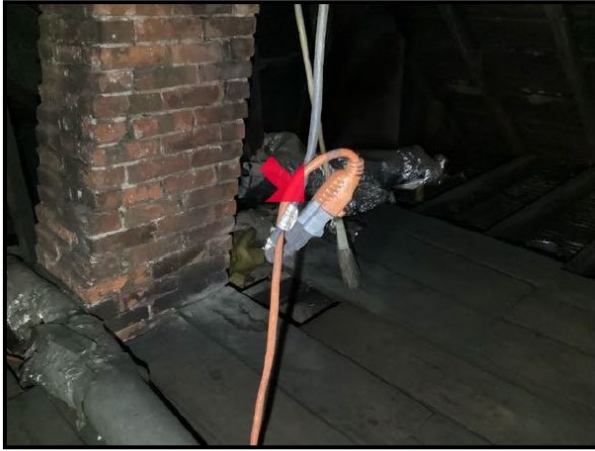
72. Extension cord used as permanent wiring

Task: Correct

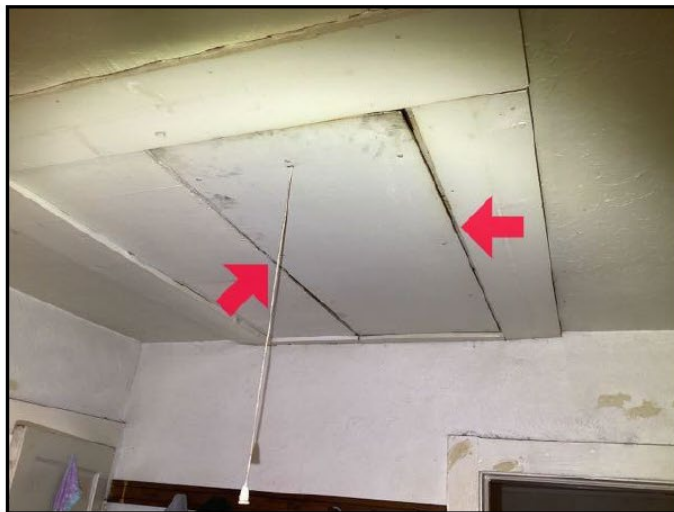
106. Not insulated / Weatherstripped

**Task:** Improve - **Install attic door weather stripping** -\$200

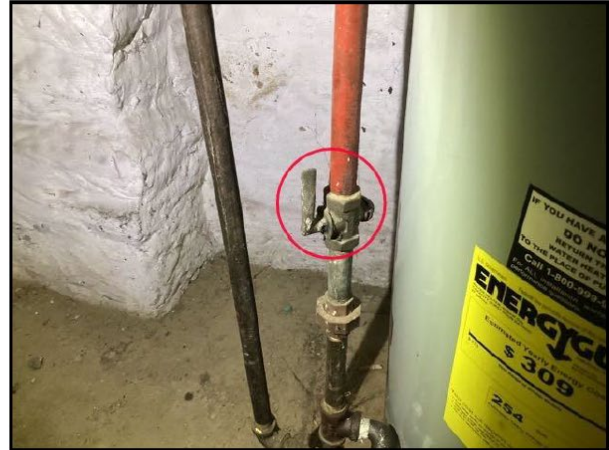
119. Older style gas shut off valves
