Report Introduction

Report Summary

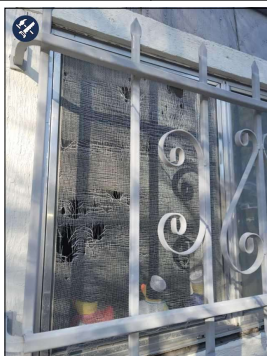
Page 47 Item: 2 Window Condition • Some window screens missing and some damaged.

South Side--Screen Damaged

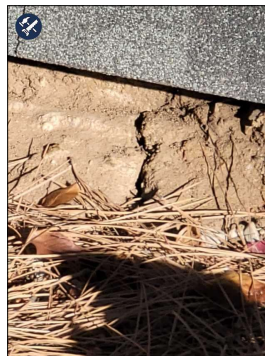
Page 50 Item: 2	Foundation Perimeter	<ul style="list-style-type: none"> • Cracks and deterioration observed.
-----------------	----------------------	--

West Side--Crack in the Perimeter Wall

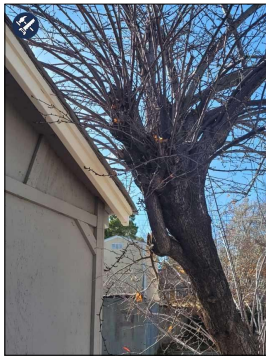
Tree is interfering with the Building.

- Tree limbs within 10 feet of roof should be trimmed away to provide air and sunlight to roof, while minimizing debris & dampness.
- Trim trees that are in contact or proximity to home, as branches can abrade roofing or siding.

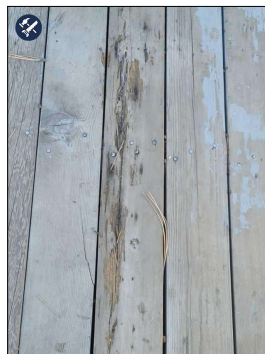
North Side Deck--Floor Boards are Showing Peeling Paint & Bare Wood Observed.

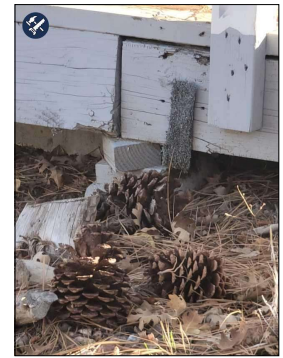
North Side--Fascia Board is twisting Supports are blocks of Wood

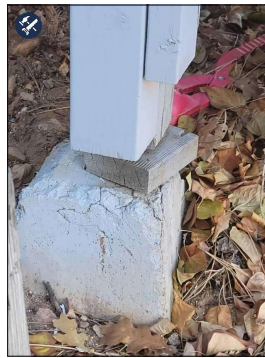
Northeast Corner--Barely sitting on the wood that was put on top of the Falling Apart Footing

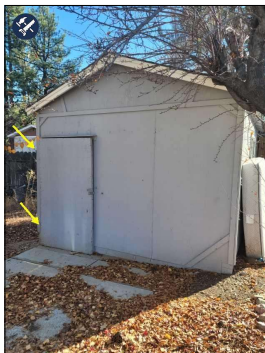
Page 58 Item: 1	Storage Shed Exterior Condition	<ul style="list-style-type: none"> • Front Door is barely holding on with the way the Hinges are • Some of the Siding is Material to Soil.
-----------------	---------------------------------	--

Hinges on the Door are placed in a strange place.

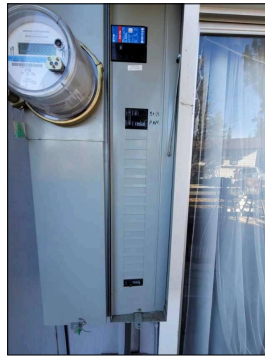
One 15 Amp in the Bottom of the Breakers

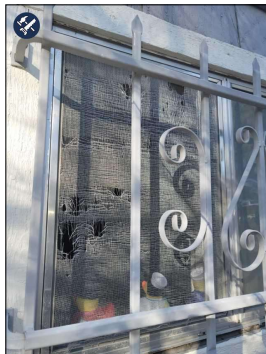
South Side--Screen Damaged

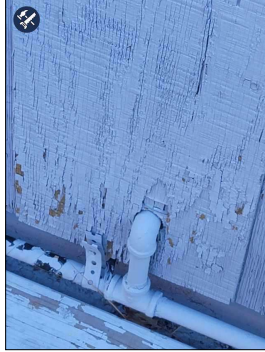
East Side--Peeling Paint Observed.

- Peeling paint observed, suggest scraping and painting as necessary.
- Exposed wood surfaces observed. Wood rot & deterioration can occur. Prep, prime and paint wood trim surface where paint is peeling or missing.

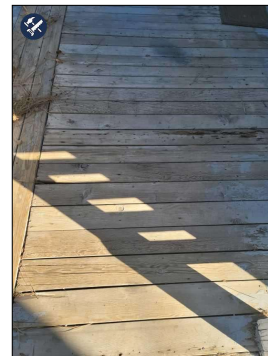
North Side Deck floor Boards are almost bare of wood.

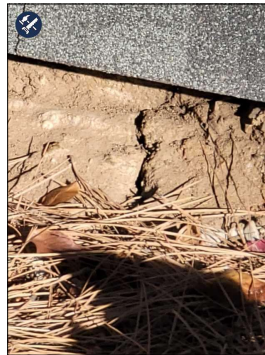
- Cracks and deterioration observed.

West Side--Crack in the Perimeter Wall

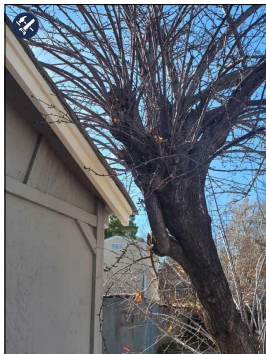
Tree is interfering with the Building.

- Tree limbs within 10 feet of roof should be trimmed away to provide air and sunlight to roof, while minimizing debris & dampness.
- Trim trees that are in contact or proximity to home, as branches can abrade roofing or siding.

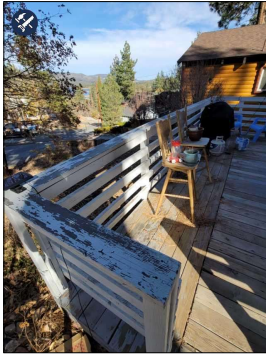
Railing is Loose

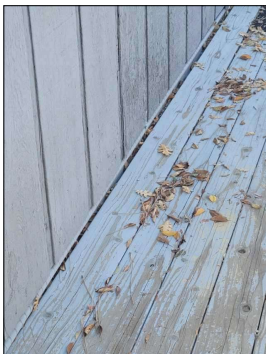
East Side--Gap is forming between the Deck & the Home. Recommend further evaluation by a Handyman for Answers & Options to this issue.

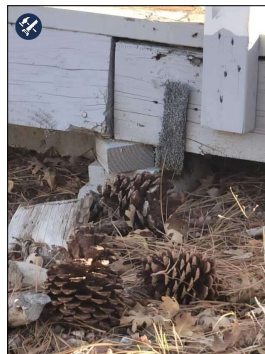
North Side--Fascia Board is twisting Supports are blocks of Wood

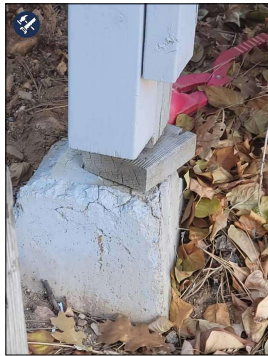
Northeast Corner--Barely siting on the wood that was put on top of the Falling Apart Footing

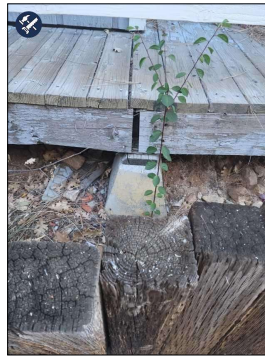
East Side--The Deck is Sagging at this point. May have to do with the Footing that are Cracked, crumbling, tilted and so on.
