# PROPERTY INSPECTION REPORT

**Donald D'Angelo  
Big Bear Home Inspectors**

**828 Angeles Blvd.  
Inspection Prepared For: Jaiden Ng  
Agent: Lila Mova -**

**Date of Inspection: 10/25/2021  
Age of House: Built in 1930--91 Yrs..old Size: 695 SqFt.  
Weather: Raining & Cold**

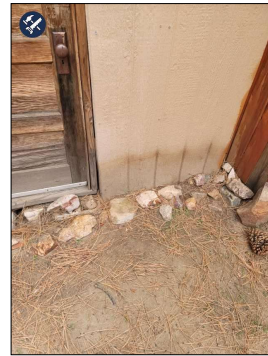
Shed Siding in the Rear of the Property

- Caulk and seal all gaps, cracks and openings.
- Some siding deterioration noted. Have repaired as necessary.

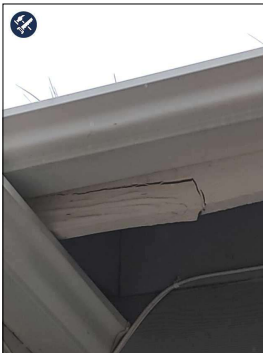
- Fill & Seal All Gaps & Cracks in the Eaves & Fascia Boards
- Broken Board Observed

South Side--Crack in the Board

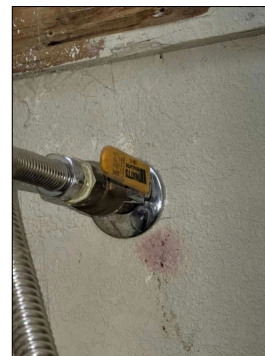
Water Supply Shut Off Valve for the Water Heater

- No Apparent Issues with the Plumbing

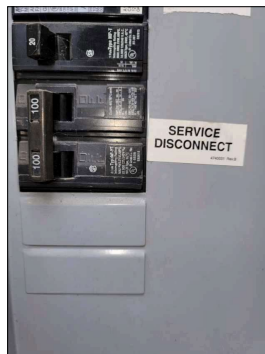
- 100 amp

100 Amp Main Breaker

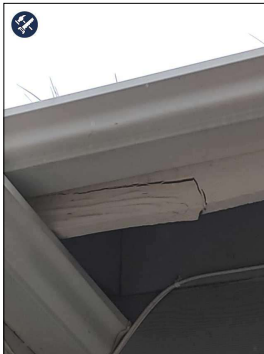
- No Apparent Issues with the Eaves
- Fill & Seal All Gaps & Cracks in the Eaves & Fascia Boards
- Broken Board Observed

South Side--Crack in the Board
