Inspected Property

Inspector: De Chen
Westpoint GDNS SW
Calgary, AB, T3H4M4
(587)437-8014
6/19/2020

DCU Home Inspection Ltd

Address
xxxxx Crescent SW
Calgary AB T3H 4Z5

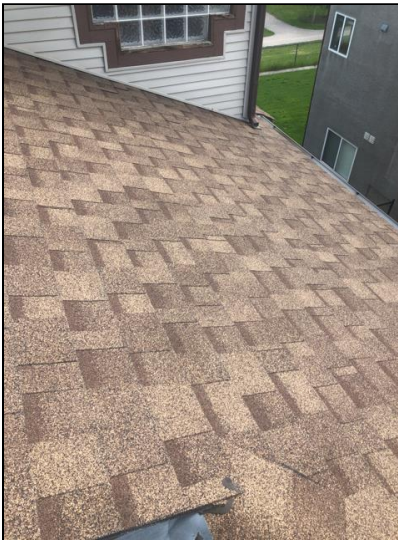
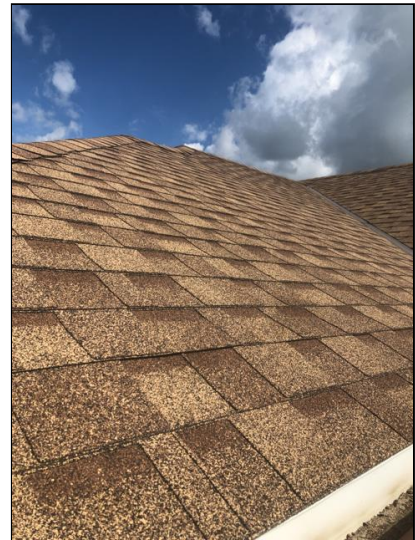
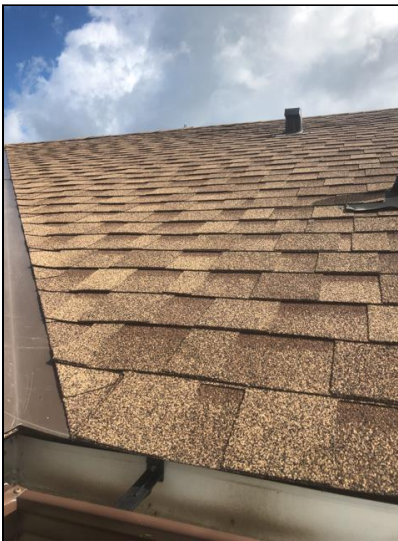
Upper roof

1.0 (1) An evidence of shingles that has missed and damage. Upper roofs have few damaged shingles were missed. over the years and properly repair by licensed contractor is inquired to avoid the future leaks.

In the inspector's opinion, the roof covering was near the end of their useful life due to wearing. Life expectation of shingle type roof is generally the last 20 years with proper maintenance and care.

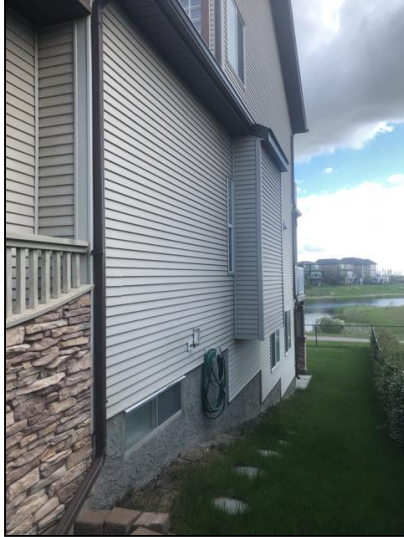
Right siding

2.1 (2) The Vinyl siding at the right side of home installed improperly or not according to standard workmanship practices. deterioration can eventually occur if not corrected. A qualified person should repair or replace as needed.
