# **Lower Putah Creek**

## **Gravel Bed Scarification**

### **Final Report (Amended)**

April 30, 2021

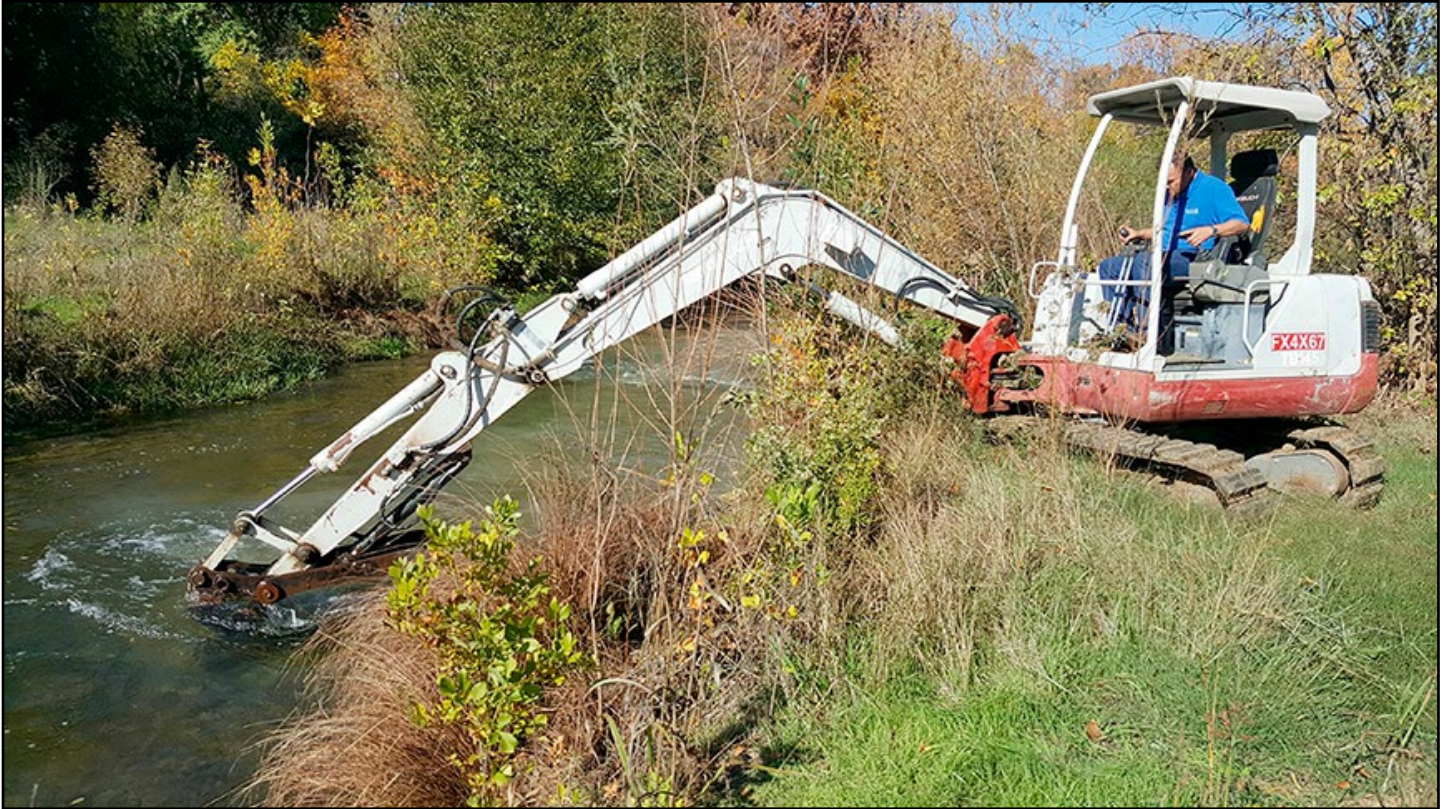
Scarification process prior to the 2016 salmon spawning season. Using expert operators, riparian damage is minimal. A biologist is always on-site before and during the process to watch for wildlife. Image Ken W. Davis.

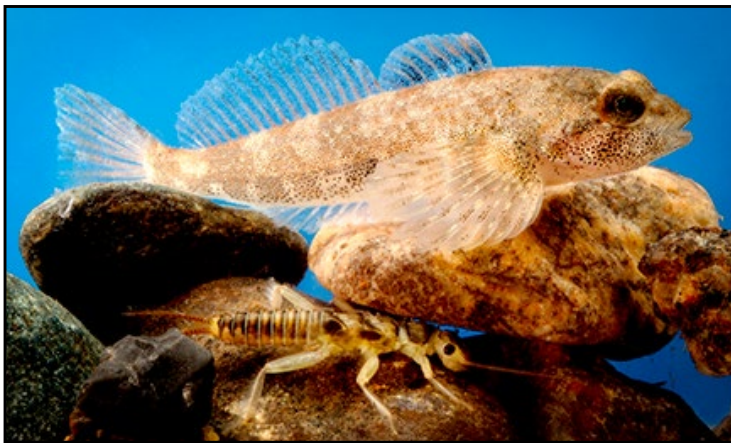
Some important groups of benthic macroinvertebrates can only survive when the spaces between cobble particles are open and allow them to forage and seek harbor from predators such as trout and other predatory fish. Ken W. Davis

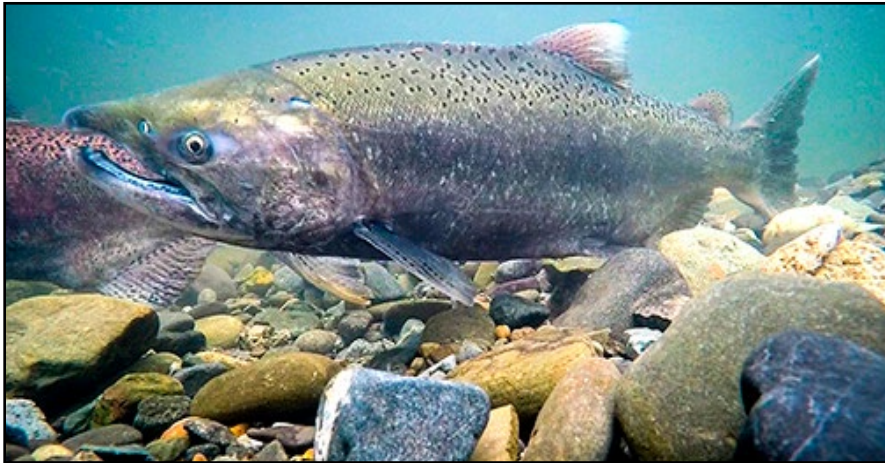
Salmon over a redd developed in a Scarification Site. Note the smaller cobble in the middle of the "pot" and the larger cobble used to armor the redd. Image Ken W. Davis.

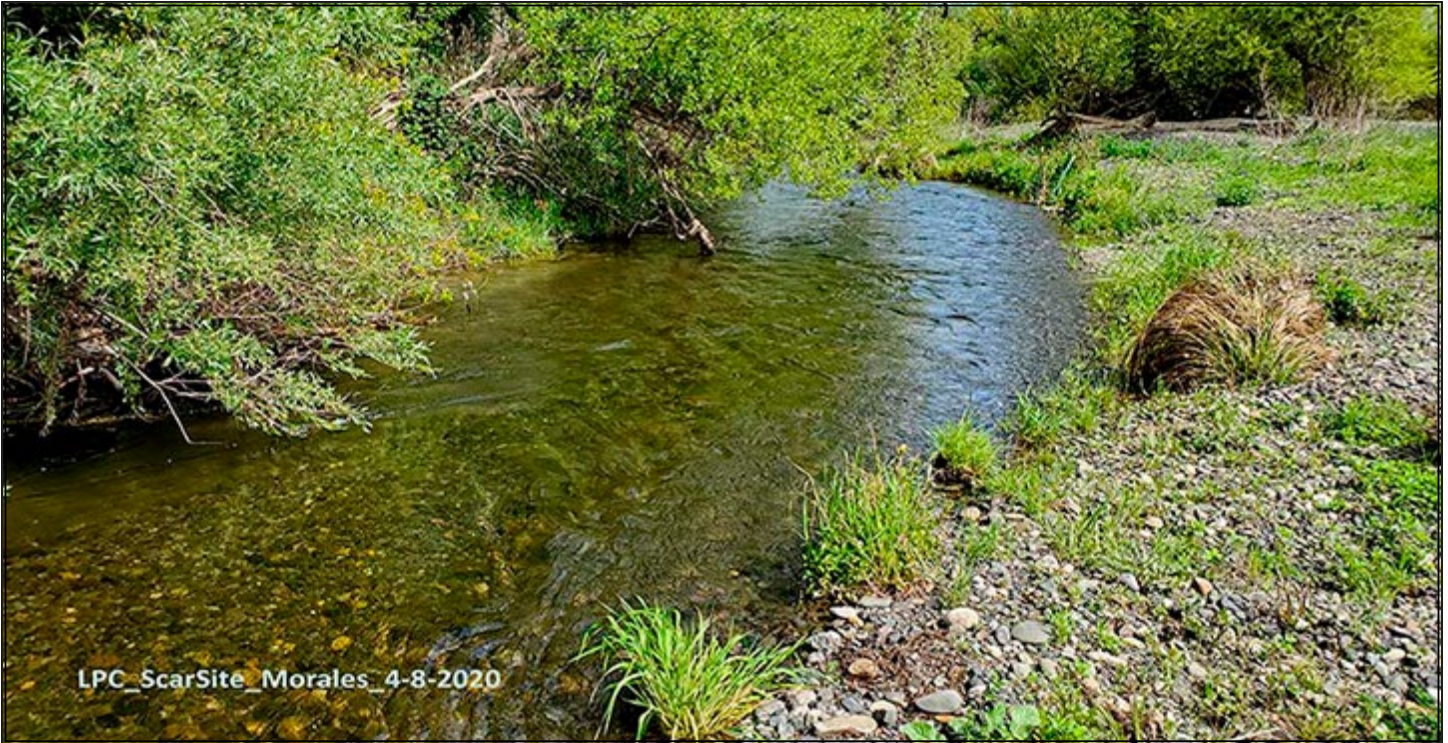
Morales Scarification Site taken on 4-8-2020. Salmon have spawned in this site every year since 2014. Image Ken W. Davis.

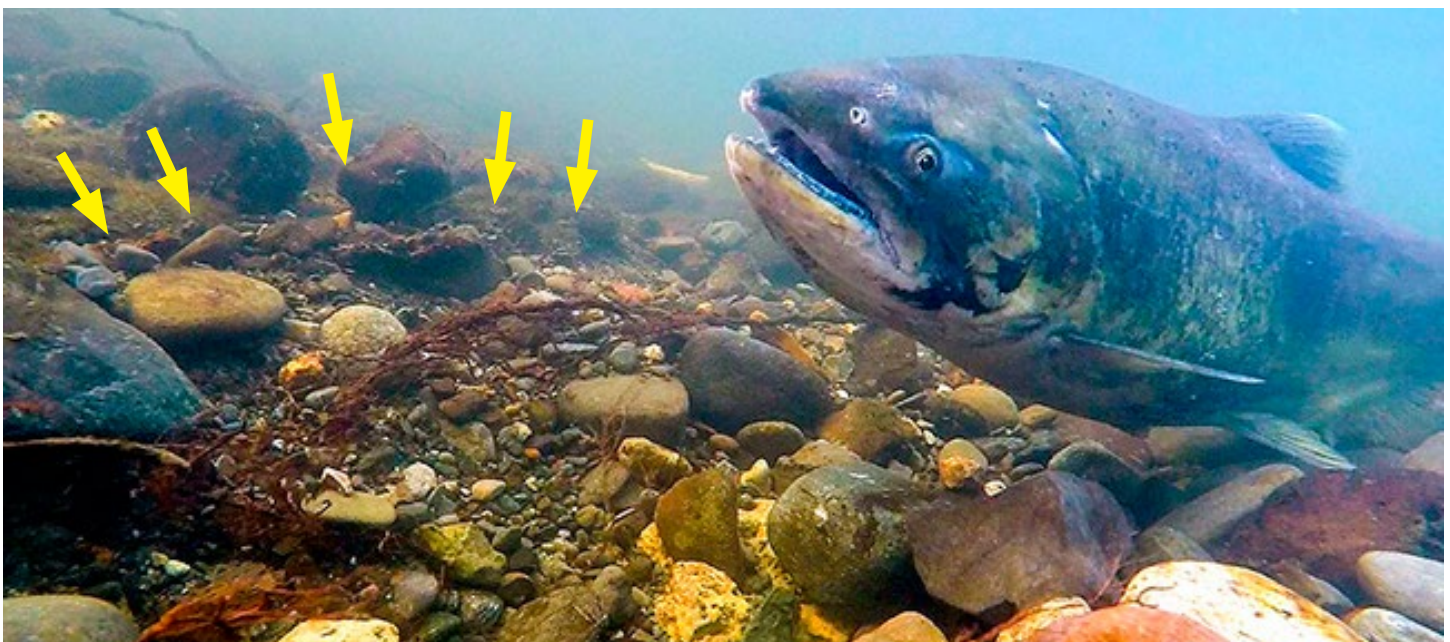
Female Chinook salmon working the “edge” of a scarification site. The arrows show the upstream edge. The female continued digging at the open edge. Ken Davis image

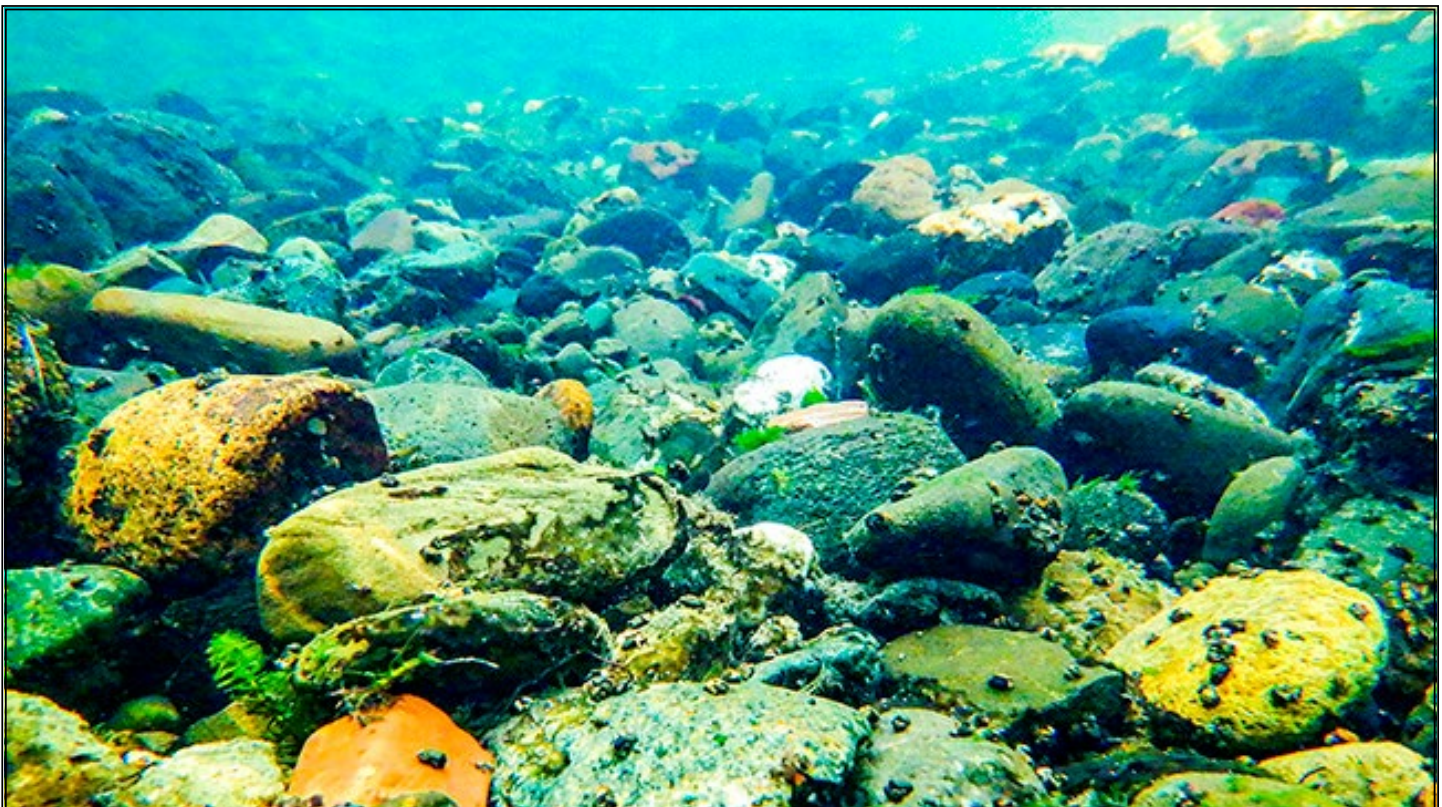
Subsurface image of a salmon redd approximately six months after it was constructed. You can see the “pot” of the redd which is highly visible. The interstitial spaces remain mostly open. The area is being colonized by a caddisfly, *Glossosoma* sp. Ken Davis image

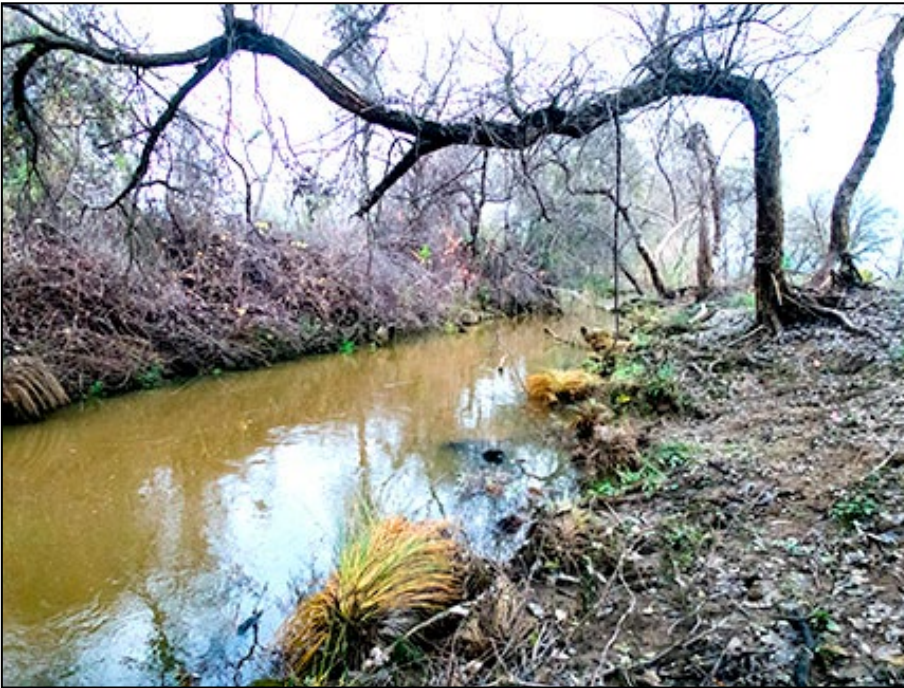
### 2014

**12/13/2014 Image:** Sediment tainted flood water from a significant storm on 12/12/2014. Most species of BMIs cannot generally tolerate such water conditions for extended periods of time. Being that their gills are external, sensitive species such as mayflies and stoneflies will succumb. The tainted water probably originated in Pleasant Creek an upstream tributary.

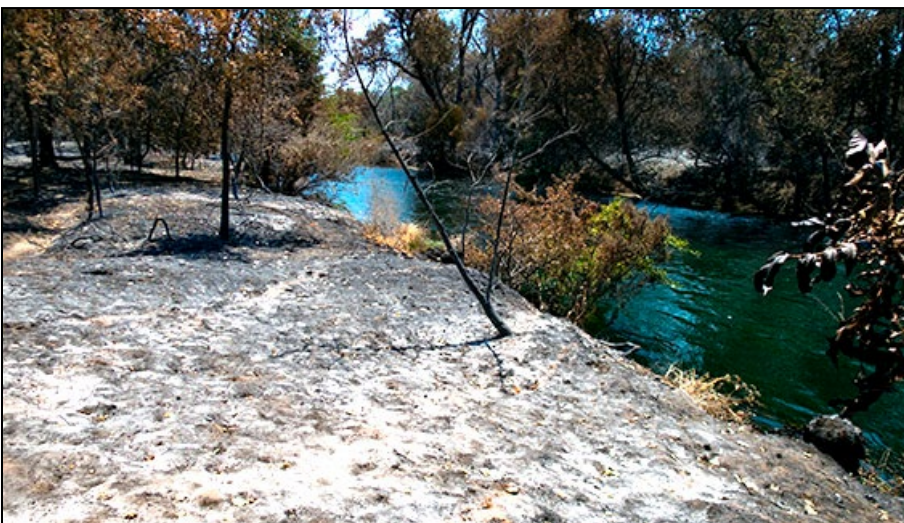
### 2015

**7/29/2015 Image:** The Wragg Fire on 7/22/2015 contributed significant amounts of burned material and other fire dregs into Putah Creek. Most of those materials are toxic to benthic macroinvertebrates.

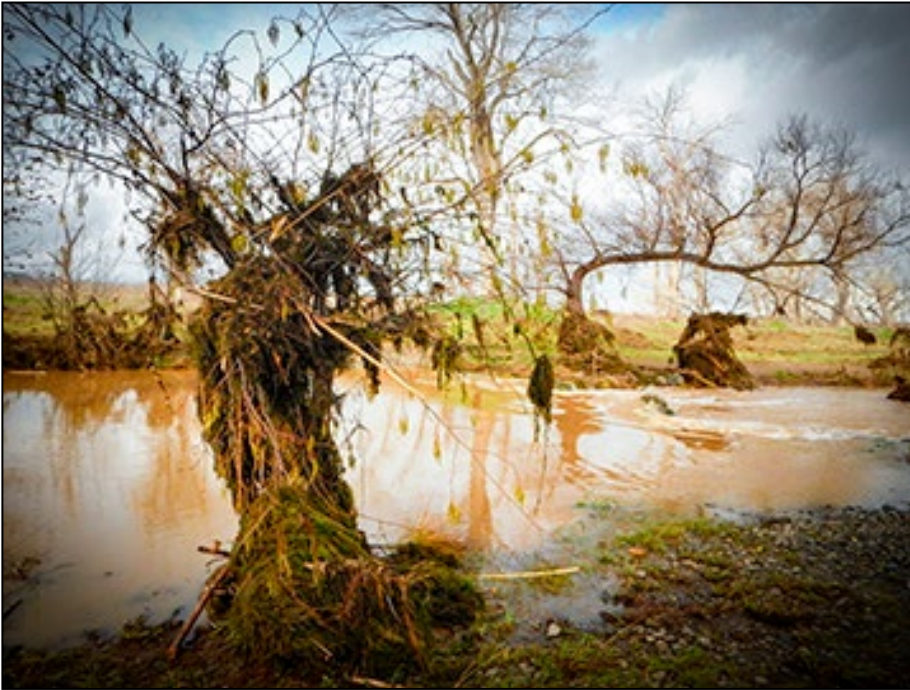
## 2017

**1/9/2017 Image:** Image at the Pick-erel Weir / Crossing after a series of high water events. The Lake Berryessa Glory Hole over-flowed on 2/17/2017 which increased the deluge on Lower Putah Creek. Many species of BMIs were either buried or suffocated by the suspended sediment.

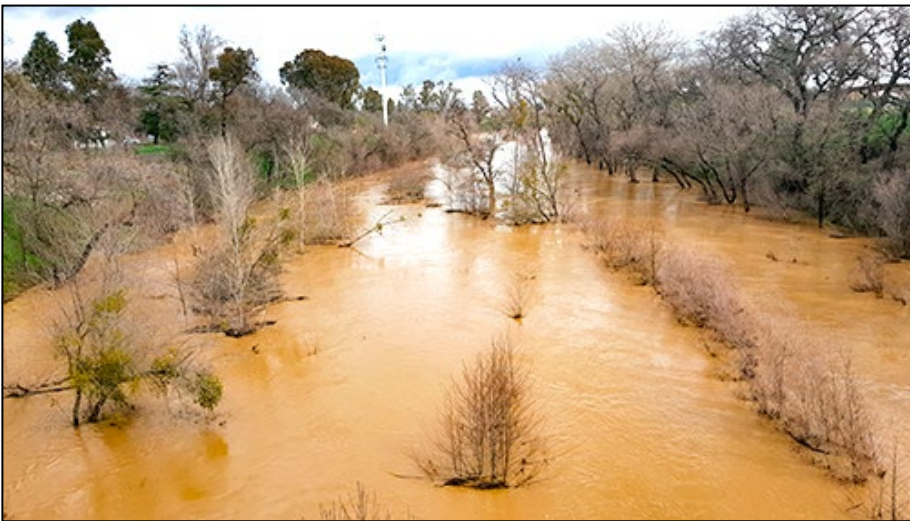
## 2017

**2/7/2017 Image:** Winters Putah Creek Parkway inundated with the flood water even before the Glory Hole at Lake Berryessa breached. The sediment load is from upstream erosion, NOT mechanical scarification.

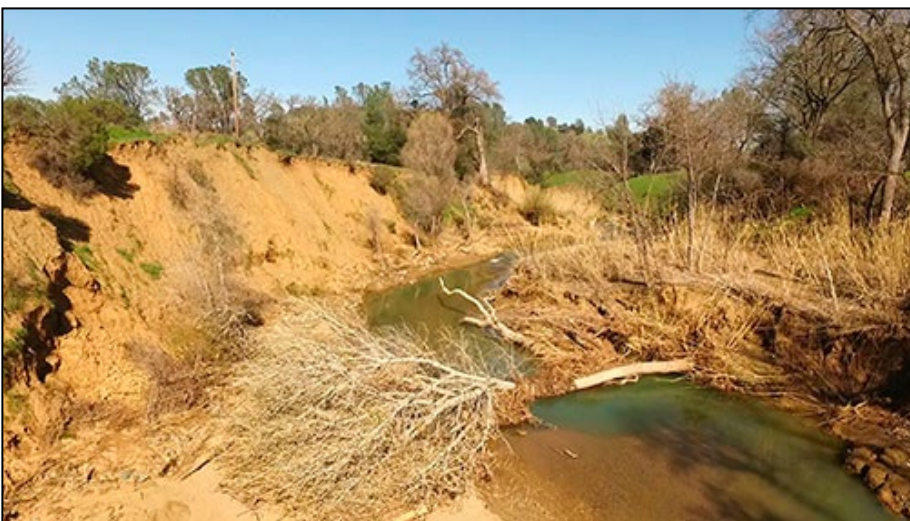
## 2017

**3/2/2017 Image:** Pleasant Creek drain-ing sediment and some fire debris. Pleasant Creek (and upstream tributar-ies) is the main corridor for the recruit-ment of BMIs into Lower Putah Creek.

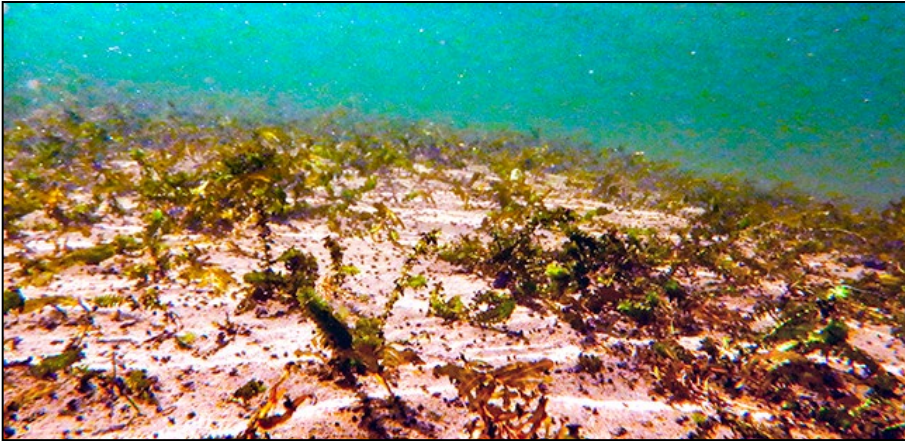
## 2018

**9/20/2018 Image:** Subsurface image taken at the Pickerel Scarification Complex. Shows several feet of (deep) sand that has been colonized by aquatic weeds. BMI populations in this condition are typically mudsnails, other snails and midges (Chironomidae).

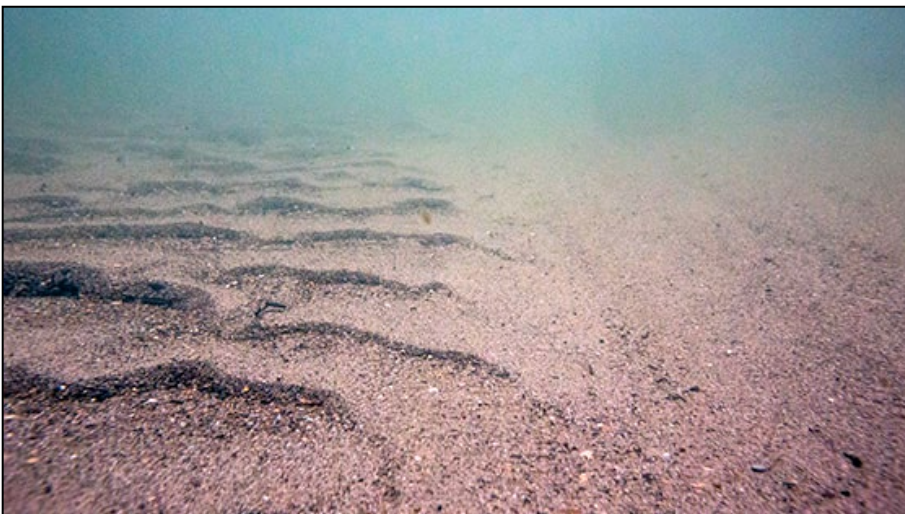
## 2018

**8/3/2018 Image:** Subsurface image of the Cody Control Site that was inundated with 5-6 feet of sand from the 2017 high water events and the overflow of the Lake Berryessa Glory Hole. BMIs here are primarily New Zealand Mudsnails.

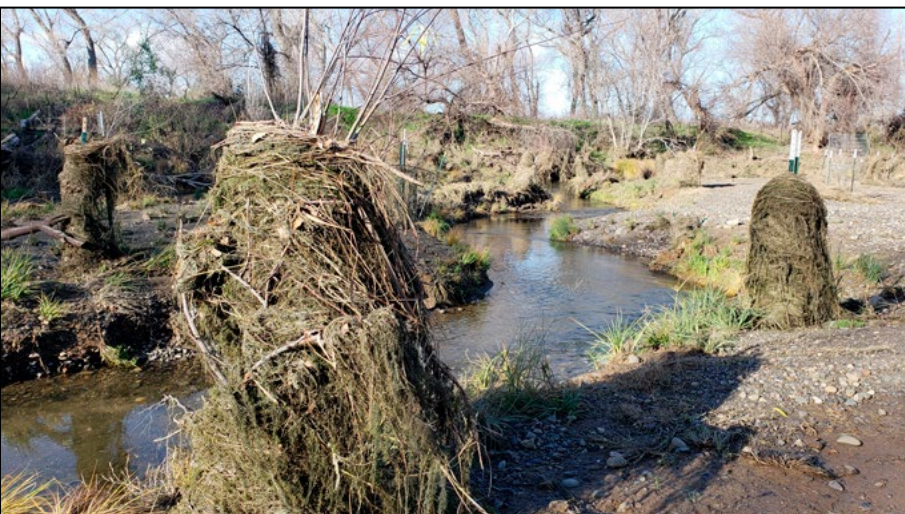
## 2019

**1/10/2019 Image:** Image show a side channel (Scarification Site) with plant cages covered with aquatic plants swept downstream by floodwaters.

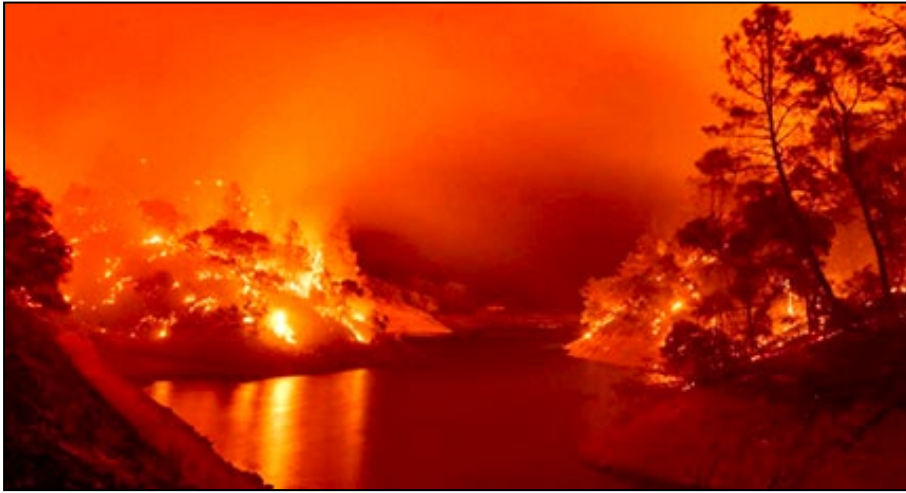
## 2020

**8/17/2020 Image:** LNU Lightning Complex fire at Lake Berryessa. Fire dregs will eventually reach Lower Putah Creek.

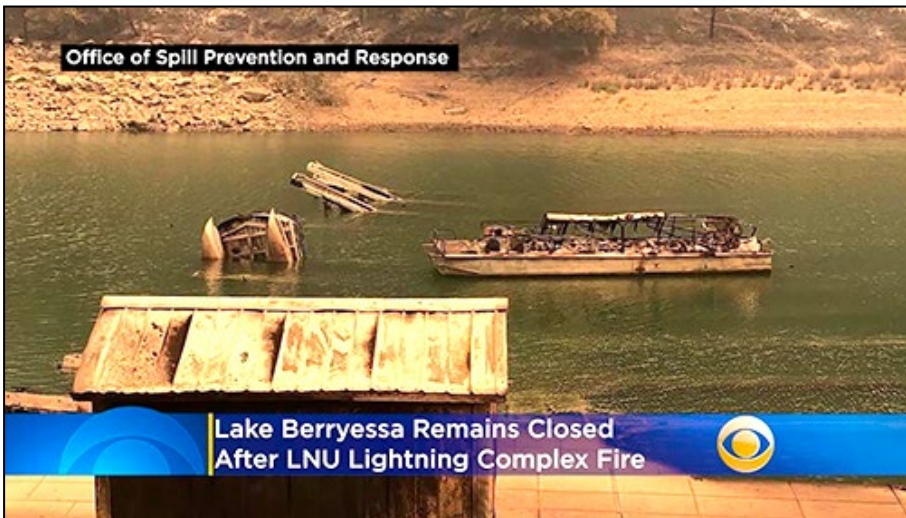
## 2020

Shows some watercraft that were burned at Markley Cove Marina during the LNU Lightning Complex fire.
