Home Inspection Report

123 Some Street
Somewhere, US 12345

Inspected by:
Umar Wyatt
Accurate Home Inspections LLC

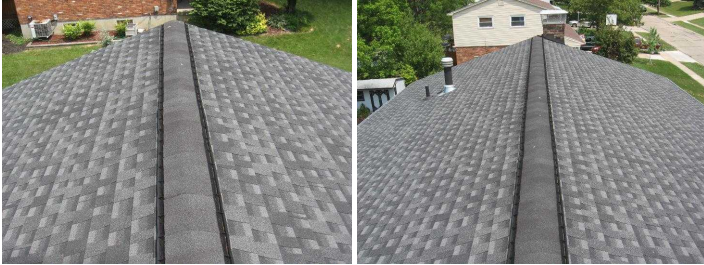
Acceptable Unable to Inspect: 0%
Acceptable Material: Fiberglass shingle
Type: Gable
Approximate Age: 5
Acceptable Flashing: Metal
Acceptable Plumbing Vents: Copper
Acceptable Electrical Mast: Underground utilities
Marginal Gutters: Aluminum - **Loose nails, Sagging gutters at front and rear**

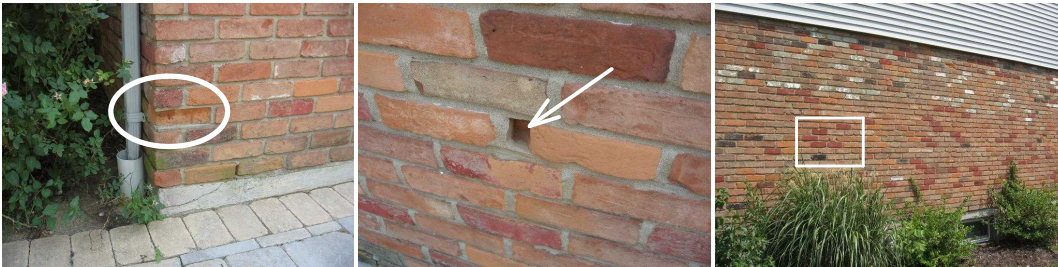
- Marginal Type: Brick veneer - Some damaged bricks, Recommend sealing brick with penetration sealer products

2. 1st Floor Exterior Surface Type: Brick veneer - **Some damaged bricks, Recommend sealing brick with penetration sealer products**

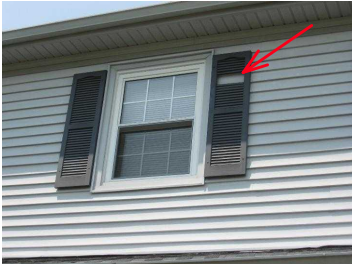
- Marginal Type: Vinyl siding - Damaged front shutter, Chalking noted due to age, One panel needs to be repositioned at rear elevation

3. 2nd Floor Exterior Surface Type: Vinyl siding - **Damaged front shutter, Chalking noted due to age, One panel needs to be repositioned at rear elevation**

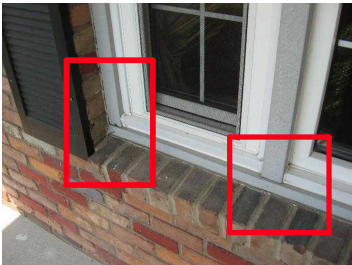
4. Trim: Aluminum - **Chalking noted due to age, Loose nails in areas**
5. Soffits: Vinyl - **Loose/sagging at front porch**
6. Patio Door: Vinyl sliding - **Resecure loose handle hardware, Screen damage noted**
7. Windows: Vinyl insulated - **Reseal caulking at window perimeters at brick window openings**

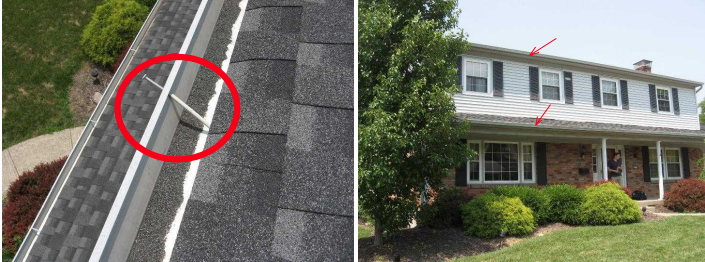
9. Gutters: Aluminum - **Loose nails, Sagging gutters at front and rear**

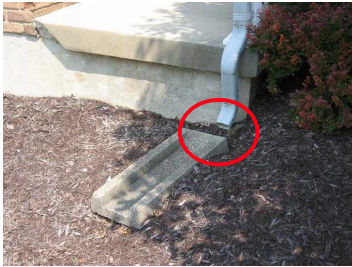
10. Leader/Extension: Splash blocks - **Splash block(s) not properly installed**

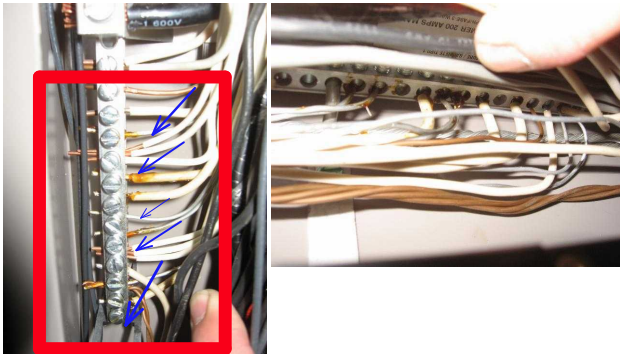
Marginal Aluminum Wiring: Present at several circuits - *Aluminum branch wiring has had a history of problems relating to poor connections due to galvanic corrosion, dissimilar metals, brittle conductors and type of aluminum alloy used during the time period of 1965 through 1972. These problems create unsatisfactory conditions at connections and splice locations and therefore create potential fire hazards. Recommend wiring update for aluminum wiring by a licensed electrician, Circuits are recommended to be upgraded with special compression type connectors at splices and branch circuits to reduce the potential risks of aluminum branch wiring.(Cop-Alum Crimp System)*

- 14. 120 VAC Branch Circuits: Copper and aluminum - **Evaluation by a licensed electrician is recommended, See aluminum wiring notes below**
- 15. Aluminum Wiring: Present at several circuits - **Aluminum branch wiring has had a history of problems relating to poor connections due to galvanic corrosion, dissimilar metals, brittle conductors and type of aluminum alloy used during the time period of 1965 through 1972. These problems create unsatisfactory conditions at connections and splice locations and therefore create potential fire hazards. Recommend wiring update for aluminum wiring by a licensed electrician, Circuits are recommended to be upgraded with special compression type connectors at splices and branch circuits to reduce the potential risks of aluminum branch wiring.(Cop-Alum Crimp System)**

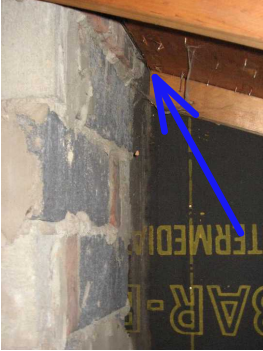
Marginal Roof Framing: 2x3/4 Truss - Wood blocking components missing at chimney perimeter

16. Attached Garage Attic Roof Framing: 2x3/4 Truss - Wood blocking components missing at chimney perimeter

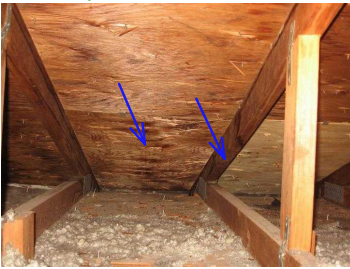
Marginal Sheathing: Plywood - Water stains and slight damage present, Areas of sheathing have been repaired

17. Attached Garage Attic Sheathing: Plywood - Water stains and slight damage present, Areas of sheathing have been repaired

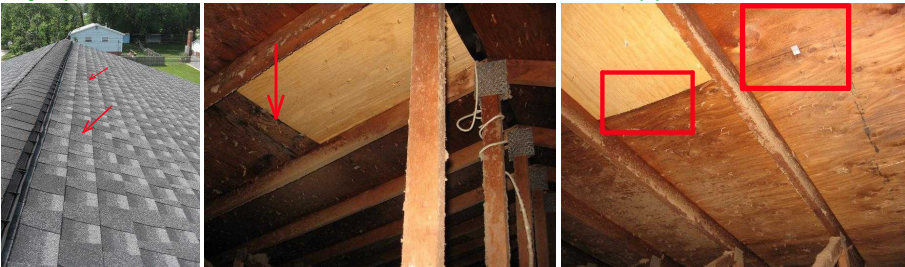
Marginal Sheathing: Plywood - Poor repair at 2 areas near ridge at rear slope - No H clips installed and repair only spanned one truss - Recommend additional support be installed

18. Main Attic Sheathing: Plywood - Poor repair at 2 areas near ridge at rear slope - No H clips installed and repair only spanned one truss - Recommend additional support be installed

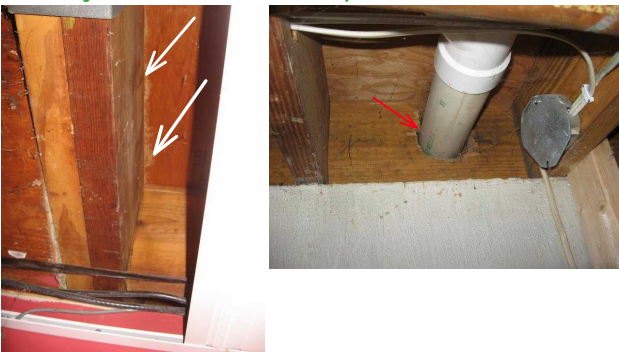
- Acceptable Structure Type: Wood frame
- Acceptable Foundation: Poured concrete
- Acceptable Differential Movement: Slight settlement present - Minor settlement at front porch, Cracks will require monitoring
- Acceptable Beams: Steel I-Beam
- Acceptable Bearing Walls: Wood frame
- Marginal Joists/Trusses: 2x10 - Areas not visible due to ceiling finishes or other obstructions, Framing joist near fireplace chimney shows evidence of previous termite infestation - No repairs required, Seal penetration as required

19. Joists/Trusses: 2x10 - Areas not visible due to ceiling finishes or other obstructions, Framing joist near fireplace chimney shows evidence of previous termite infestation - No repairs required, Seal penetration as required

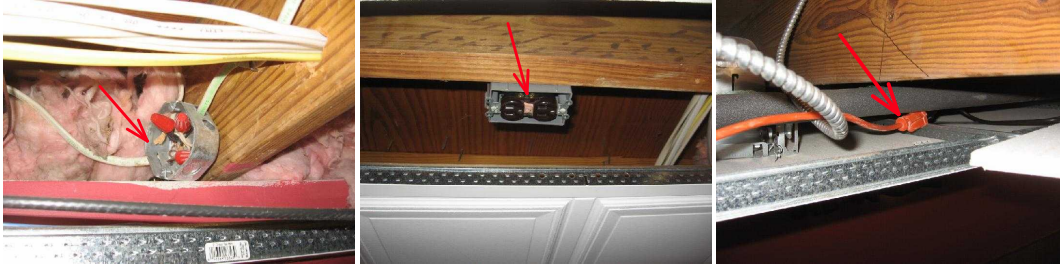
Marginal Electrical: 110 VAC - Loose junction boxes, missing and mis-sized covers, extension cord wiring to projector

- 20. Main Basement Floor: Carpet - Carpet stains noted
- 21. Main Basement Electrical: 110 VAC - Loose junction boxes, missing and mis-sized covers, extension cord wiring to projector

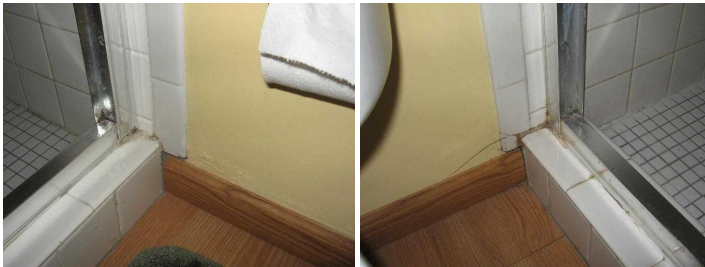
Marginal Shower/Surround: Ceramic tile - **Leaking at corner of door frame**

- 22. Master Bathroom Floor: Laminated flooring - Gapping noted in planks
- 23. Master Bathroom Shower/Surround: Ceramic tile - Leaking at corner of door frame

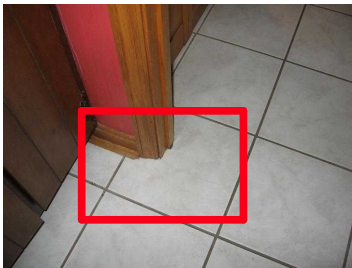
Acceptable Ceiling: Drywall
Acceptable Walls: Drywall
Marginal Floor: Ceramic tile - **Cracked tile noted**

- 24. 2nd Floor Hall Bathroom Closet: Large - Alignment needed at closet doors
- 25. 2nd Floor Hall Bathroom Floor: Laminated flooring - Gapping noted in planks
- 26. 1st Floor Hall Half Bathroom Floor: Ceramic tile - Cracked tile noted

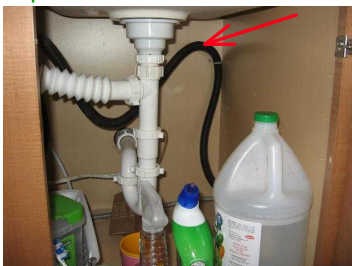
- 27. 1st Floor Kitchen Dishwasher: Maytag - Properly secure the dishwasher discharge hose so that it creates a "high loop" above the basin drain to minimize food or water backup under dishwasher

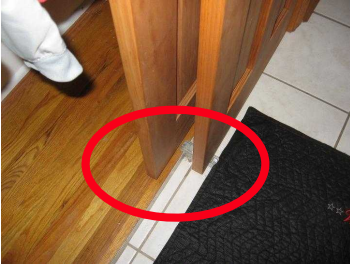
Marginal Closet: Various - **Missing door glides at bypass closet door in Foyer**

28. 1st Floor Kitchen Sink: Stainless Steel - Chipping at drain
Living Space

29. 1st Floor Living Space Closet: Various - Missing door glides at bypass closet door in Foyer

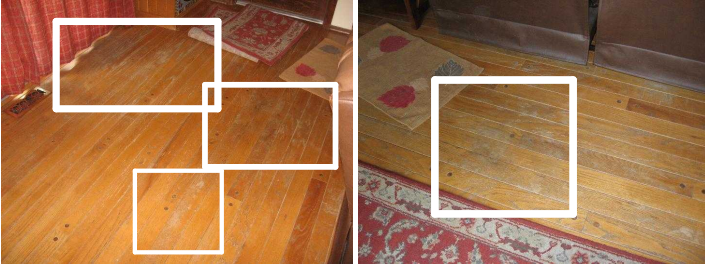
Acceptable Ceiling: Drywall
Acceptable Walls: Drywall
Marginal Floor: Ceramic tile, Carpet, Hardwood - **Worn wood finish in Family room**

30. 1st Floor Living Space Floor: Ceramic tile, Carpet, Hardwood - Worn wood finish in Family room

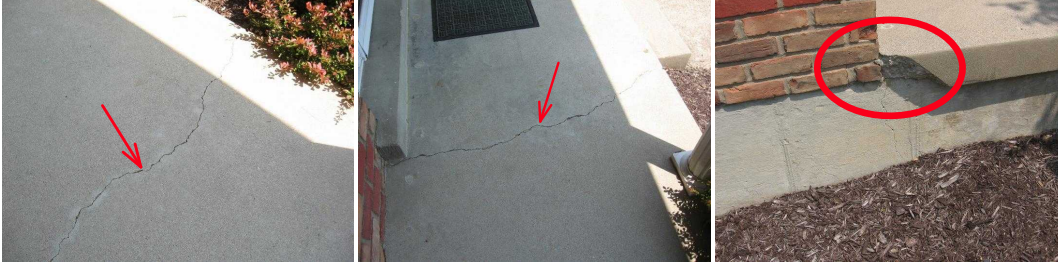
- Acceptable Driveway: Concrete
- Acceptable Walks: Concrete
- Defective Porch: Concrete - Settling away from foundation with surface cracks noted

1. Porch: Concrete - **Settling away from foundation with surface cracks noted**

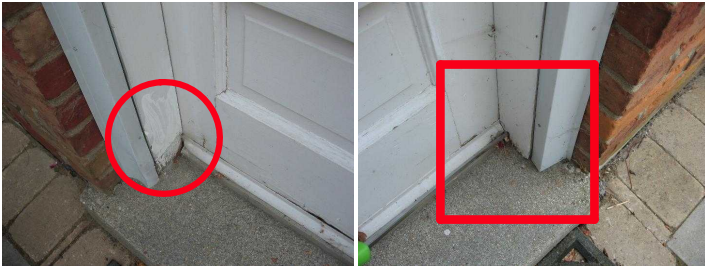
Defective Service Doors: Wood - **Wood rot at bottom of door and frame**

2. Attached Garage Service Doors: Wood - **Wood rot at bottom of door and frame**

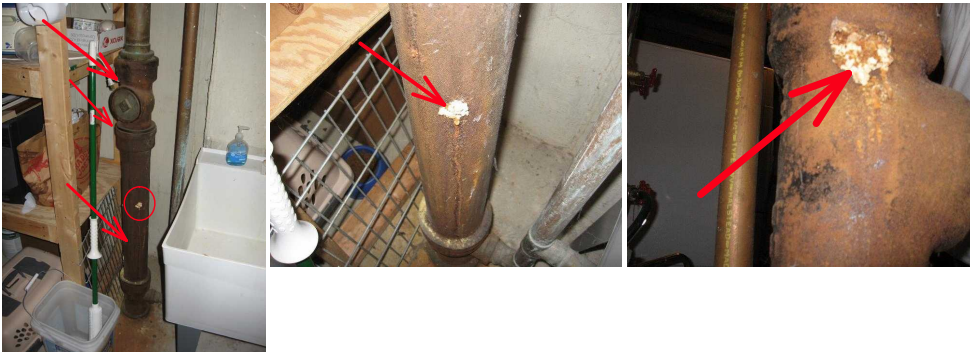
Acceptable Service Line: Copper
Acceptable Main Water Shutoff: Basement
Acceptable Water Lines: Copper
Defective Drain Pipes: Cast iron, Copper - **Pitting cast iron drain piping stack - replace affected sections where required**

3. Basement Heating System Humidifier: General - **Inoperative - Requires service/replacement**

4. Drain Pipes: Cast iron, Copper - **Pitting cast iron drain piping stack - replace affected sections where required**

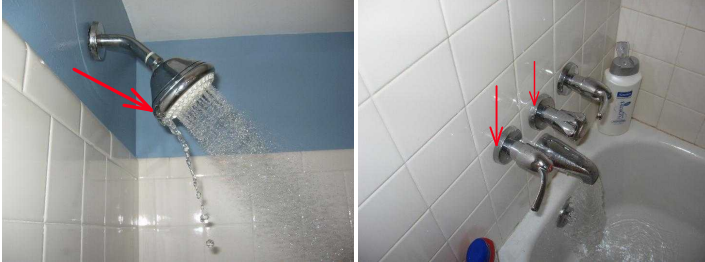
Marginal Closet: Large - **Alignment needed at closet doors**
Acceptable Ceiling: Drywall
Acceptable Walls: Drywall
Marginal Floor: Laminated flooring - **Gapping noted in planks**
Acceptable Doors: Hollow wood
Acceptable Windows: Vinyl Insulated
Acceptable Electrical: GFCI
Acceptable Counter/Cabinet: Wood
Acceptable Sink/Basin: One piece sink/counter top
Defective Faucets/Traps: Delta fixtures with a metal trap - **Leaking shower head, Loose trim rings**

5. 2nd Floor Hall Bathroom Faucets/Traps: Delta fixtures with a metal trap - **Leaking shower head, Loose trim rings**

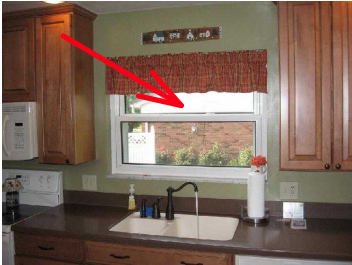
Acceptable Floor: Ceramic tile
Acceptable Doors: Hollow wood
Defective Windows: Vinyl Insulated - **Insulated glass unit seal failure**

6. 1st Floor Kitchen Windows: Vinyl Insulated - Insulated glass unit seal failure
