# RIO GRANDE DIVERSION INFRASTRUCTURE INVENTORY

**Structure Name:** SAN LUIS VALLEY CANAL

**Date:** April 10, 2019

PHOTO LOG

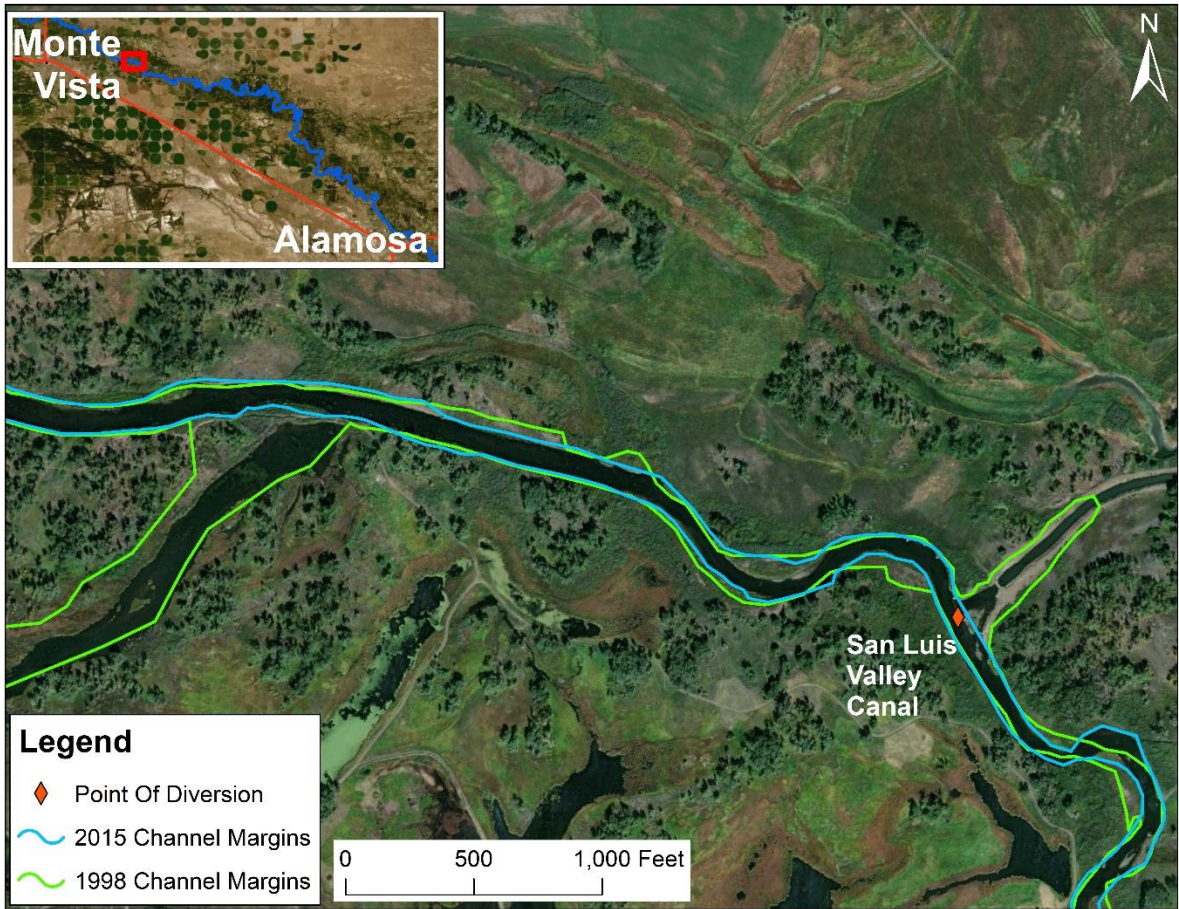
**Structure Description:** This structure is located in the transition zone between two broad meanders in the river. Since 1975, the channel has migrated both upstream and downstream of this structure. The meander immediately upstream of the diversion has been tightening and migrating to the northwest. Just downstream of the diversion, the river is migrating to the southwest, away from the diversion, and the next downstream meander is also tightening. Channel capacity is limited in this part of the river, which has caused the bank upstream of the structure to breach during past high flow events. During the spring 2019 runoff, the bank downstream of the newly installed headgate breached, allowing water to enter the ditch around the headgate (see maps below).

Headgate location with 1998 and 2015 channel margins overlaid

**Repair(s) or Improvement(s) Currently Needed:** Although the headgate has been repaired, the SMP Technical Advisory Team (TAT) recommends regular monitoring given the potential risk of breaching.
