Rio Grande Stream Management Plan

Rio Grande Basin Roundtable and the
Stream Management Plan Technical Advisory Team

Rio Grande Headwaters Restoration Project
623 E Fourth St
Alamosa, CO 81101

2020

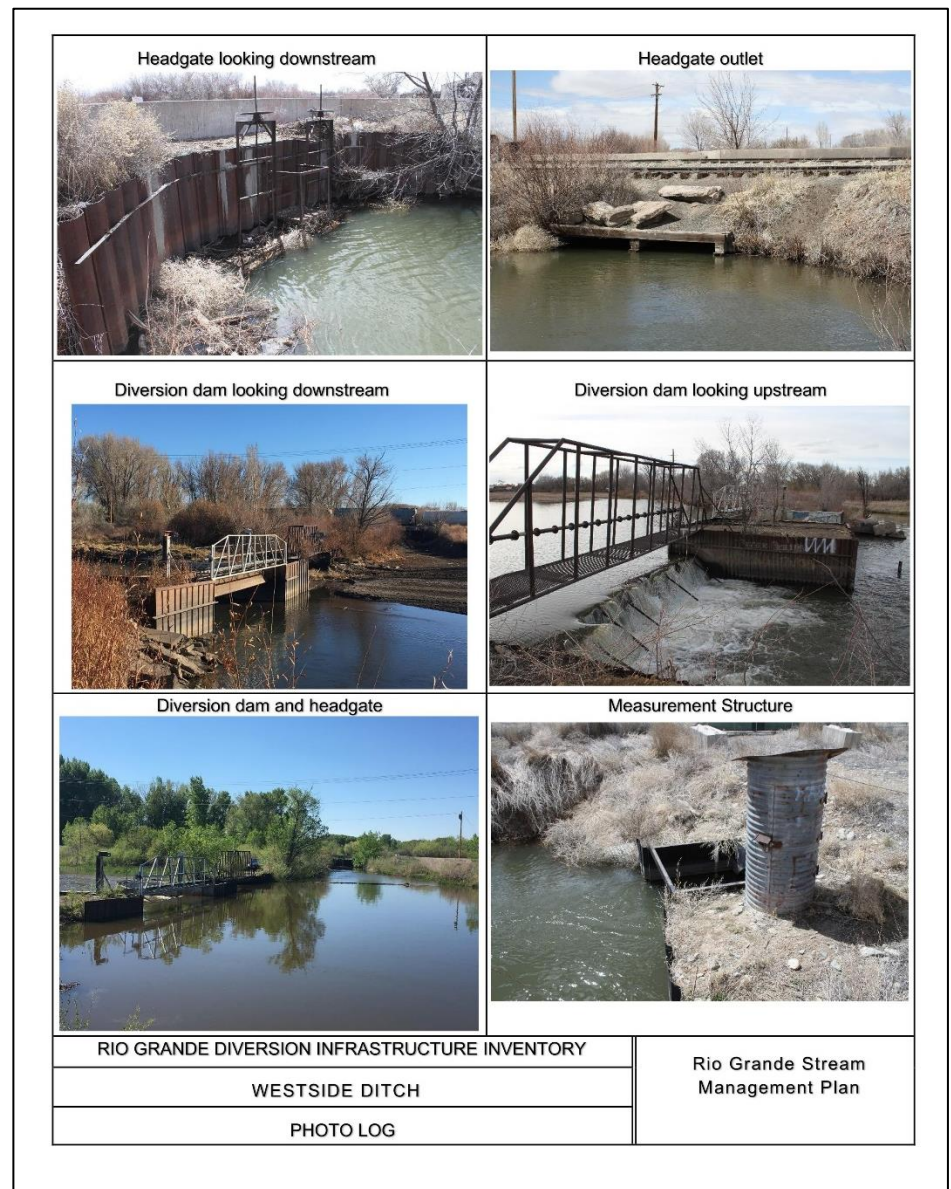
Figure 2.3: Example report card developed for diversion infrastructure inventory (pages 1-2).

RIO GRANDE			
<u>DIVERSION INFRASTRUCTURE INVENTORY</u>			
Structure Name: WESTSIDE D			
Reported By: Daniel Boyes			
Date: April 11, 2019			
Headgate	Latitude		
Location:	37.46663333		
	Longitude		
	-106.85586667		
Headgate Type: Manually operated 3' wide steel slide gates (3)			
Headgate Condition:	Diversion and other Condition:	River Miles From New Mexico State Line (Point of Diversion):	Structure Submerged:
A <input type="checkbox"/>	A <input type="checkbox"/>	49.95 mi	Yes <input type="checkbox"/>
B <input type="checkbox"/>	B <input type="checkbox"/>		No <input checked="" type="checkbox"/>
C <input type="checkbox"/>	C <input type="checkbox"/>		
D <input checked="" type="checkbox"/>	D <input checked="" type="checkbox"/>		
F <input type="checkbox"/>	F <input type="checkbox"/>		
<p>Repair(s) or Improvement(s) Completed Since 2006: Ditch maintenance, including debris removal.</p> <p>Repair(s) or Improvement(s) Currently Needed: The headgates do not function well and could be repaired or replaced. The flume is often submerged and does not measure accurately. It should also be repaired or replaced. The diversion dam functions for water rights holders, but it could function significantly better if it was replaced. During spring runoff in 2019, the levee forming the bank north of the diversion dam washed out (see photo below). This has occurred in the past, and an updated diversion dam with higher flow and sediment transport capacity is recommended. If the diversion dam is improved, boat and fish passage should be included, especially considering the increasing popularity of recreational boating in the Alamosa area. Diversion structure improvements were also identified in the 2017 Rio Grande River Corridor Feasibility Study. If improvements are made that allow for boat passage, a safe takeout location adjacent to or downstream of the diversion is also recommended. Any required Army Corps of Engineers permitting also needs to be considered. Improvements should carefully consider riparian area restoration near the structure. Additionally, ~1 mile below the headgate, the ditch crosses the Alamosa Ditch, where a portion of water is diverted from the Westside to the Alamosa. See map below. The water rights holders in both ditches would like to improve the diversion at this junction, diverting more water to the Alamosa Ditch.</p> <p>Structure Description: There is a corrugated sheet metal diversion dam with a 20' steel weir and 20' radial gate that spans the river and directs river flow to a short feeder channel that services the headgate. There is a log trash boom across the entrance of the feeder channel. At the headgate, the ditch enters a culvert before passing through the flume. Upstream of the diversion dam, the channel has migrated south (see 1975 and 1960 channel margin maps), although significant migration is limited by the levees and thus the migration has not affected the diversion's ability to function. The diversion dam gates do not have sufficient capacity to pass flood flows. For this reason, during high flow events (e.g. spring 2019), the river bank north of the structure can fail, leading to significant flows bypassing the structure via the failed bank. High flow scenarios could also potentially lead to flooding upstream of the diversion dam or in East Alamosa due to a backwater effect. Significant debris and sediment are deposited upstream of this diversion due to the structure's limited sediment transport capacity along with regularly low river velocities. This structure impacts the sediment transport regime and channel capacity of the river upstream of the diversion dam.</p> <p>Comments: This ditch includes priorities 165, 234, 259, 274, 280, 304, 322, 346, and 363.</p> <p>Estimated Range of Cost: High</p>

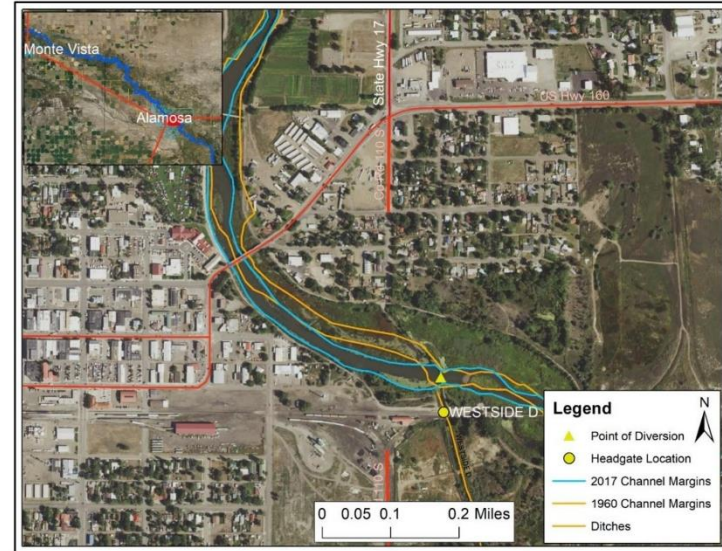
Headgate location with 1960 and 2017 channel margins overlaid.

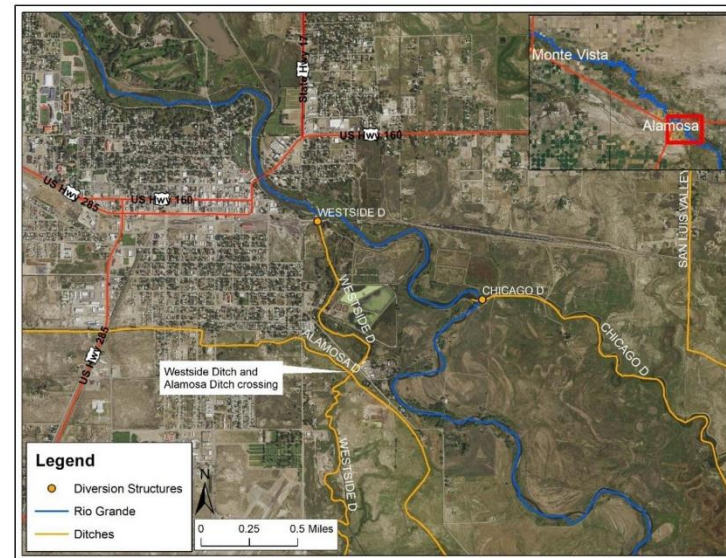
Westside Ditch and Alamosa Ditch junction, ~1 mile beyond of the headgate.

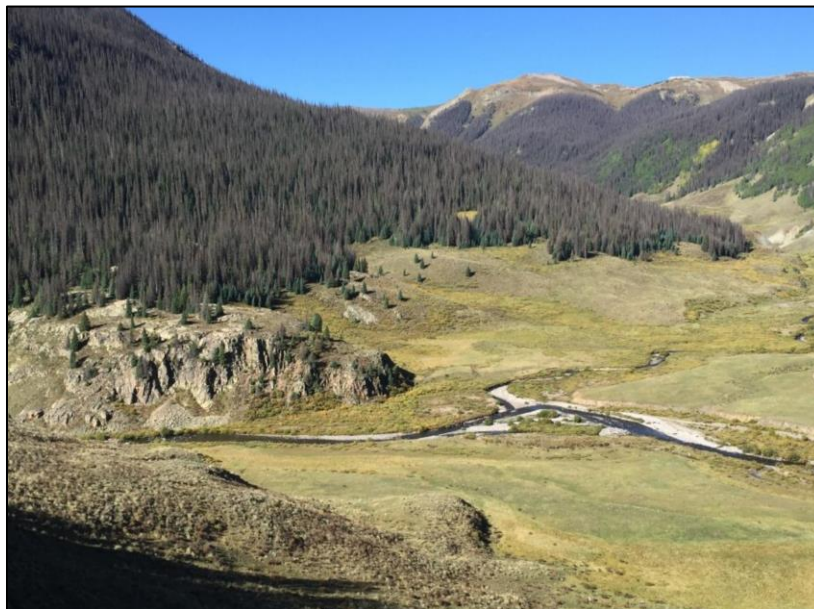
Representative Reach Photo

High alpine headwaters valley that had been glaciated. The reach gathers headwater and material including inputs from Pole Creek, Quartzite Creek and Bear Creek. Near the top the reach appears to be dominated by step-pools and cascades in a confined corridor. In the middle of the reach, it finds some sediment contributions from fans and slope failures creating alluvial pockets in a semi-confinement valley in a more moderate sloped riffle-pool and plane bedded system. The reach is moderately sensitive and is likely to make adjustments with small scale changes but maintain meta-stability.								
Stressors						Degree of Geomorphic Impairment		
Stressors to reach are natural. Frequent wood and sediment inputs from avalanche and debris paths.						A

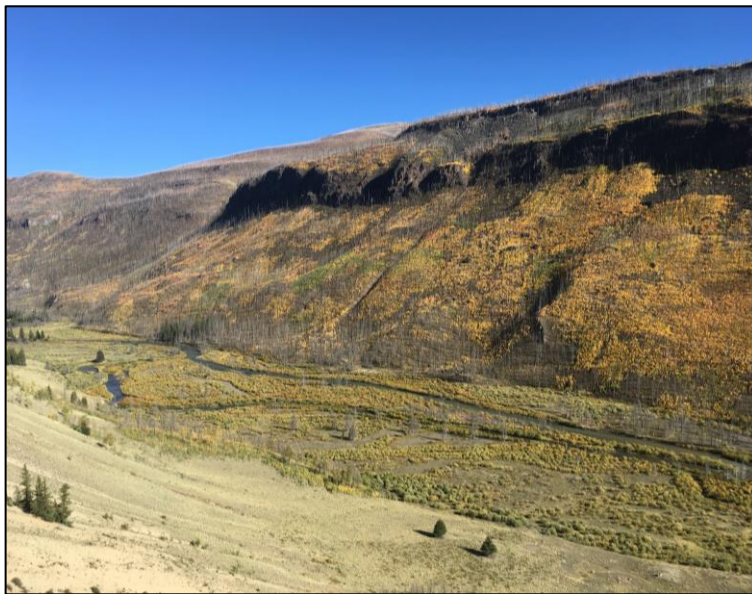
Representative Reach Photo

Stressors						Degree of Geomorphic Impairment		
Valley walls on both sides burned during the West Fork Complex Fire in 2013. Valley side slopes appear to be bedrock dominated. No evidence of slope failures or significant sediment inputs. Camping spots and forest access roads start to encroach with at least one undersized crossing. The reach is sediment supply limited. The natural hydrologic regime is altered by Rio Grande Reservoir.						A-

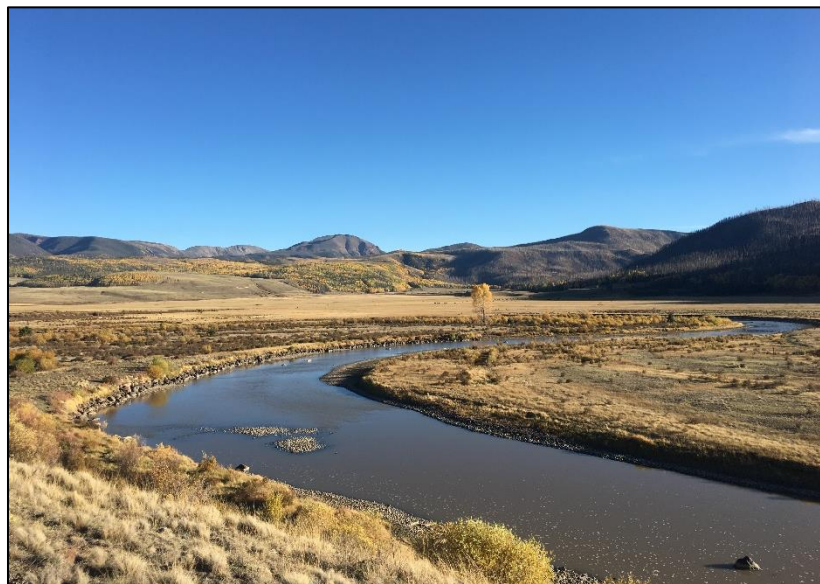
Representative Reach Photo

Stressors						Degree of Geomorphic Impairment		
Valley walls on southern side burned during the West Fork Complex Fire in 2013 otherwise stressors to the reach are all natural and limited. Largely the reach is reacting to sediment inputs and flows from the upper watershed, which are still limited by the reservoir. The major drivers of hydrology and biotic inputs that would otherwise have significant influence on the geomorphology of this reach are altered and therefore degree of impairment listed as B+.						B+

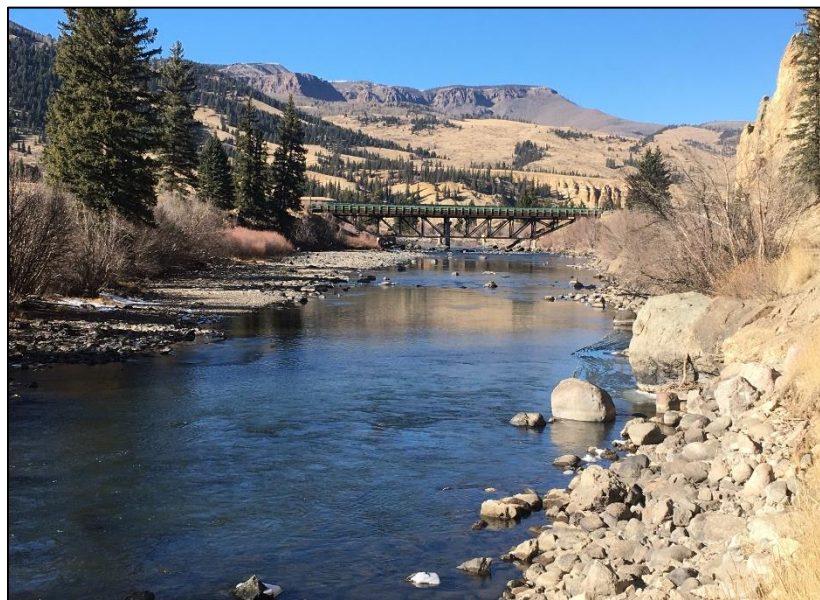
Representative Reach Photo

Stressors						Degree of Geomorphic Impairment		
Stressors to reach included a lack of large wood; some development that is or may encroach upon natural channel adjustment. Reach may have seen limited temporary impacts from West Fork Complex Fire burning in the reaches upstream in 2013.						B+

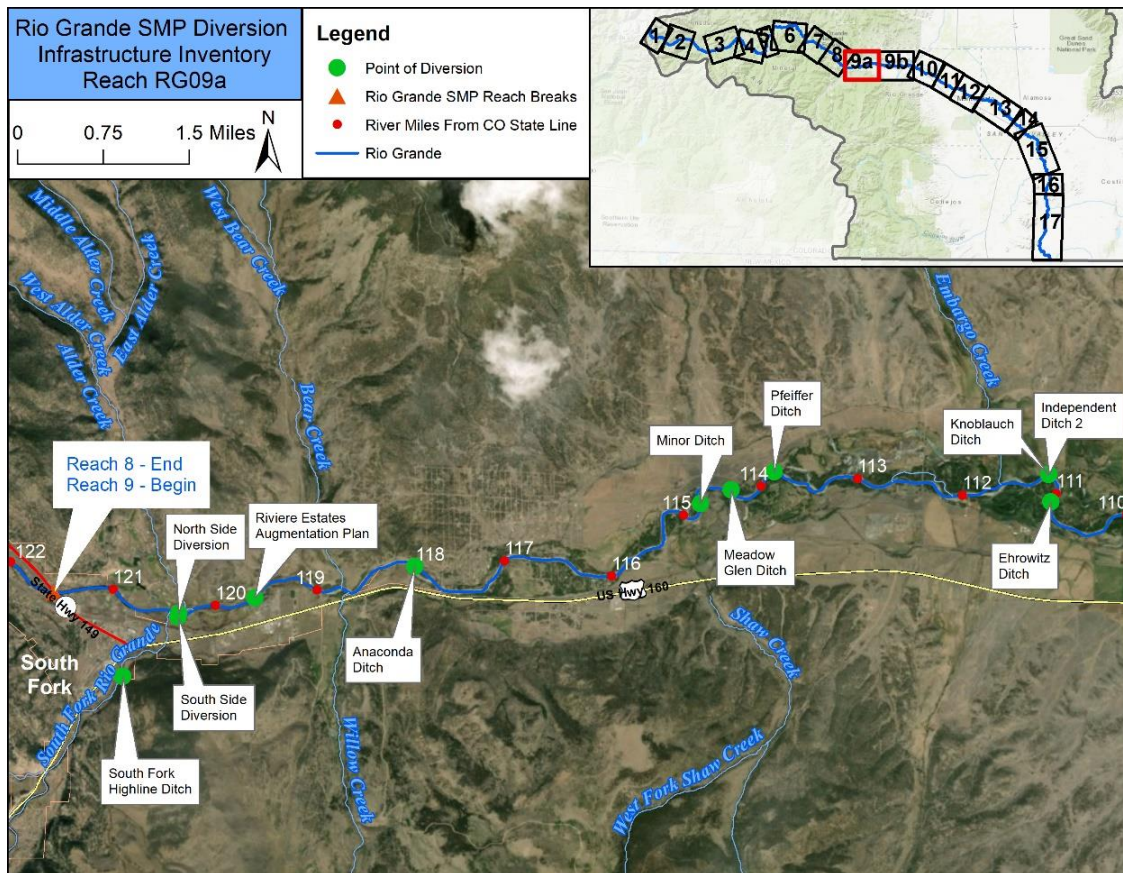
RG09a Diversion Infrastructure

South Fork Highline Ditch: This structure is located on the South Fork Rio Grande and functions effectively overall. A concrete diversion dam spans the river and has semi-permanent metal posts which support stop boards and increase head pressure during low flows. The headgate is located on the east side of the river. The headgate is set in concrete. The flume currently measures accurately, but may need to be replaced in the near future due to rust damage.

South Side Diversion: A small rock diversion dam on the south side of the river submerses the structure's point of diversion. Water is pumped directly from the river. The pump is housed in a small building and is metered. It is located just downstream of a pedestrian bridge serving the Rio Grande Club & Resort golf course. The channel is relatively stable in this reach and is not expected to migrate significantly in the future. There were no major issues identified at this structure.

water to the headgate and an overflow channel directs return flows back to the river. Sedimentation in the feeder channel requires regular maintenance. Additionally, the return flow structure has sunken and makes headgate control challenging. Based on the assessment of this structure, the TAT recommends either the installation of a new diversion dam at this location or relocating the diversion upstream, with the possibility of using the existing Independent Ditch 2 diversion. A new diversion dam, either in its current location or moved upstream, would effectively divert water and reduce maintenance. Repair or replacement of the return flow structure is also recommended to improve control of flows to the headgate.

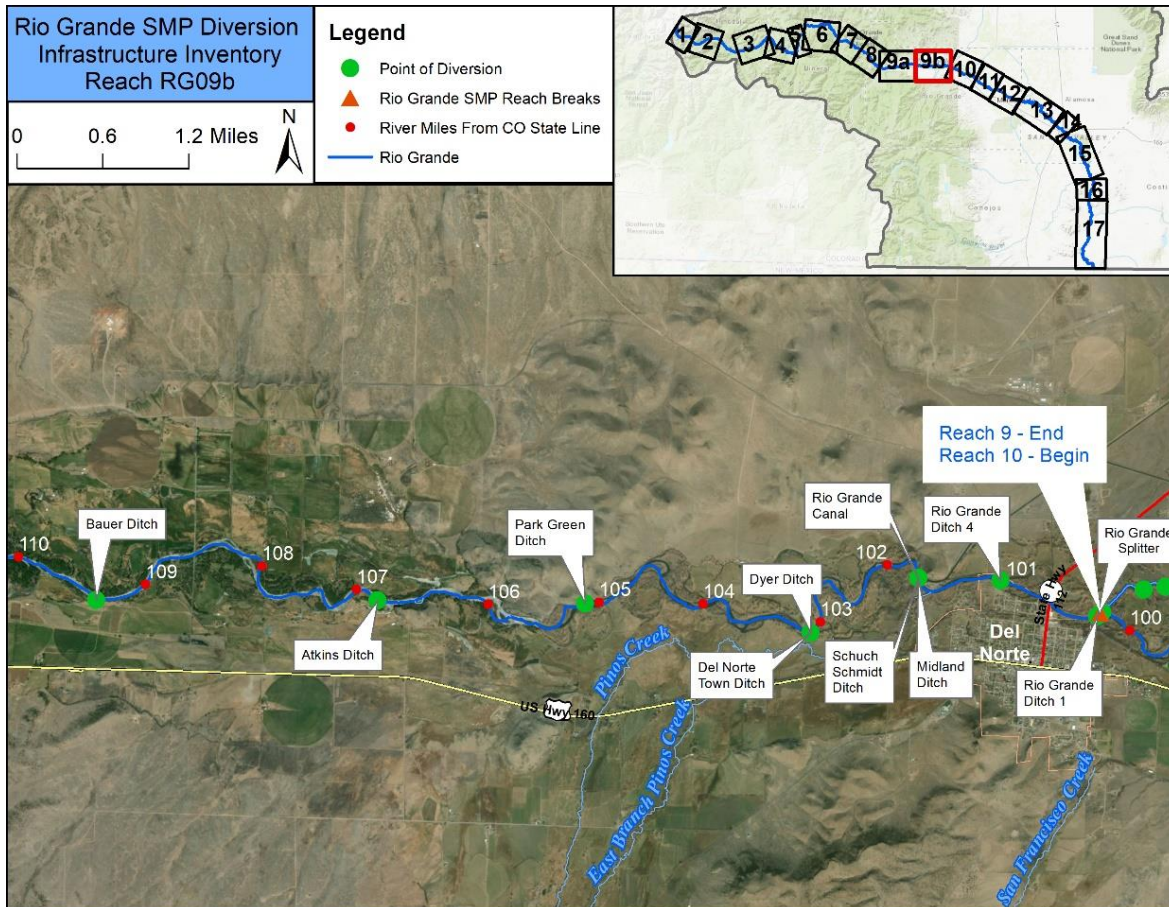
RG09b Diversion Infrastructure

Bauer Ditch: There is no diversion dam, but this ditch functions on grade with the river. Occasionally, this ditch has difficulty diverting its full decree due to the lack of a diversion dam. The point of diversion is located on the outside bend of the river, just downstream of the apex. The river channel has migrated very little in the last 45 years, although localized bank erosion has occurred. Bank stabilization structures were installed upstream and downstream of this structure in 2009 to mitigate bank erosion. Flows are directed into a feeder channel located on the south bank. The feeder channel is approximately 1,200 ft long and delivers water to the headgate. A 2 ft culvert (see report card) returns overflow water to the Rio Grande. The feeder channel and a significant portion below the headgate are within the floodplain. This is problematic due to constant erosion by the river as well as sediment deposition in the feeder channel. The TAT recommends raising the elevation of the feeder

channel and/or installing a sluice gate to mitigate sediment accumulation. Additionally, a small diversion dam would enable the ditch to operate at all flow levels.

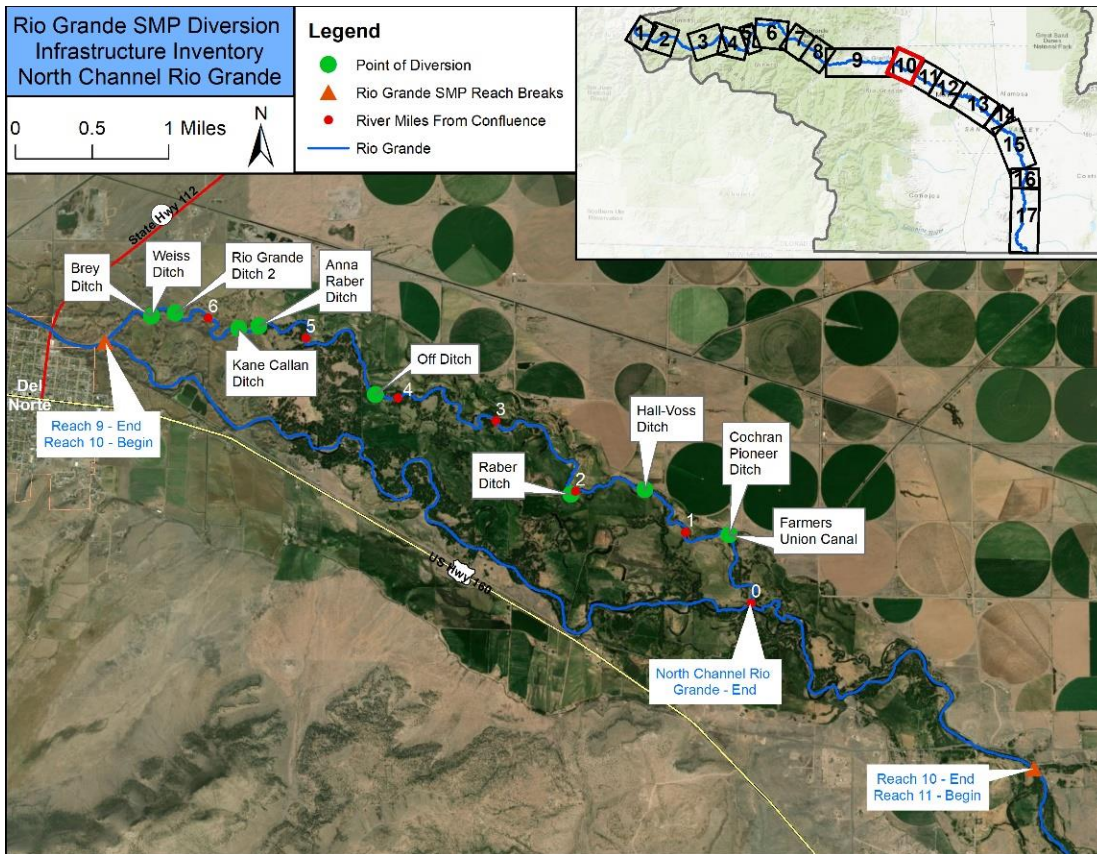
North Channel Rio Grande Diversion Infrastructure

Weiss Ditch: This structure is located on the south bank of the North Channel Rio Grande just upstream of Brey Ditch. The channel has remained very stable in this reach and is not expected to migrate significantly in the near future. The headgate is located on the outside of a meander and has no trash rack. It is difficult to operate and functions poorly. A very minimal rock diversion dam, shared with the Brey Ditch, is located just downstream of this structure and does not appear to significantly benefit this ditch. When this ditch is in priority, flows are high enough that a diversion dam is not necessary. The diversion dam is unstable and in poor condition. The flume for this structure could not be located. Given the issues identified, the TAT recommends headgate improvement and the installation of a functional measurement device. To reduce maintenance and improve efficiency of both this ditch and the Brey Ditch, consolidation of the two structures is also an option. If consolidation was pursued, the TAT recommends replacing or improving the diversion dam.

Brey Ditch: This structure is located on the North Channel of the Rio Grande just downstream of Weiss Ditch. The channel has remained very stable in this reach and is not expected to migrate significantly in the near future. This structure's diversion dam is shared with the Weiss Ditch, directing water into a short feeder channel and to this ditch's headgate. The diversion has difficulty diverting water at low flows and the ditch has insufficient capacity to convey its full decree during high flows due to debris and sediment accumulation. Given these challenges facing water users, the TAT recommends replacing or improving the diversion and possible consolidation with the Weiss Ditch to reduce overall maintenance for both ditches. Whether or not consolidation occurs, ditch enlargement is also recommended to allow for conveyance of higher flow.

Rio Grande Ditch 2: This structure is located on the north bank of the river in the transition zone between two meanders. The river has migrated very little in the last 40 years and is not expected to migrate significantly in the future. A rock cross vane diversion dam diverts water to the headgate, which is located on the north bank of the river. The old headgate still exists downstream of the main headgate (see report card). As part of the *Five Ditches Project*, a full structure replacement was completed in 2018. The project included a new diversion dam, new headgate, and bank stabilization near the structure. The diversion dam is now a rock cross vane that is passable by both fish and boats. The surrounding banks were reinforced with boulders and riparian vegetation. No immediate repair needs were noted.

Kane Callan Ditch: Channel migration analysis shows the river is stable in the area near this structure. A short feeder channel, located on the north bank of the river, leads to the headgate. A boulder diversion across the river directs water into the feeder channel. A return flow structure adjacent to the headgate is controlled by a 5 ft steel slide gate. Regular diversion dam maintenance is required due to debris accumulation. The TAT recommends installation of a sluice gate to mitigate debris or, alternatively, continued maintenance to ensure proper function.

Anna Raber Ditch: Channel migration analysis shows the river is stable in the area near this structure. A rock boulder diversion dam directs water to a short feeder channel, located on the south bank of the Rio Grande. The headgate is located on the inside of a bend. The diversion is just upstream of a river bridge. The feeder channel travels underneath the bridge to the headgate. The headgate leaks and is difficult to operate. The diversion dam collects some woody debris, but otherwise functions well. The

Off Ditch: Channel migration analysis shows the river is stable in the area immediately surrounding this structure. A concrete and rock diversion dam spans the river channel just downstream of the structure, directing water to a short feeder channel and the headgate, which sits along the south bank of the Rio Grande. The diversion functions moderately well but has washed out during previous high flow events and is a maintenance need for water users. A wire fence serves as a trash rack at the entrance of the feeder channel. Given the diversion dam maintenance need, the TAT recommends improving or replacing the diversion with a new stacked rock structure that is more resilient during high flow events.

Raber Ditch: Channel migration analysis shows the river is stable in the area immediately surrounding this structure. A stacked rock diversion dam directs water to the headgate, which is located on the south bank of the river. The diversion dam functions well and no immediate need for improvement was identified. The flume is aging and the TAT recommends replacing it in the near future.

Hall-Voss Ditch: The river both upstream and downstream of this structure has remained stable in the recent past. A small stacked rock diversion dam directs water to the headgate, which is located on the south bank of the river. The diversion dam functions moderately well, but the ditch has difficulty conveying high flows. The headgate is wired to a fence post for support. The headgate lacks a supporting headwall and it leaks and is difficult to operate. The TAT recommends headgate replacement, installation of a headgate support structure, and ditch enlargement and/or cleaning to increase conveyance capacity.

TAT recommends headgate repair or replacement to increase efficiency and reduce maintenance. Debris mitigation, either through installation of a sluice gate or continued maintenance, is also recommended.

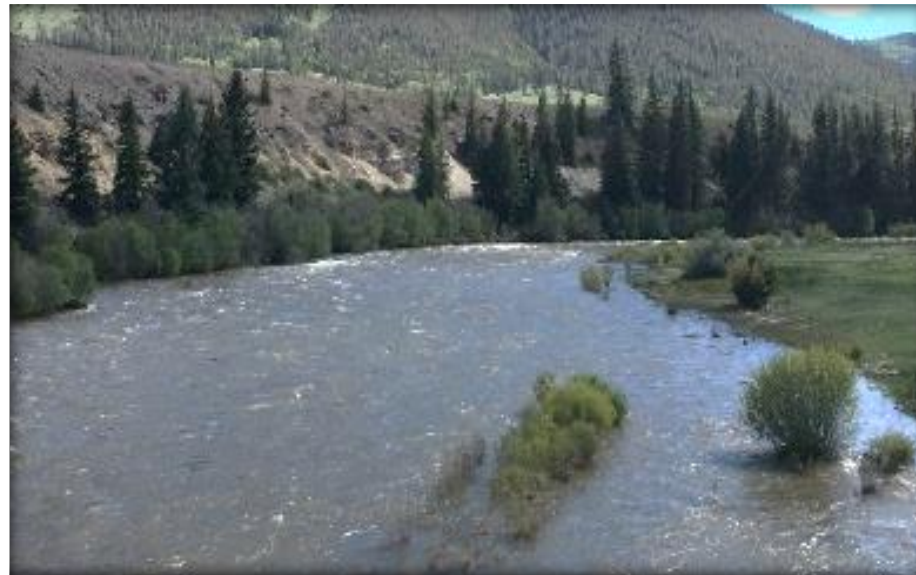
Figure 4.2: The Rio Grande overtopping its banks near Creede (reach RG06) and accessing its floodplain, spring 2019.
