Report of Shalda Creek Water Level Study 2017-2020

Little Traverse Lake Property Owners Association
Cleveland Township, Leelanau County, Michigan

Published: December 15, 2020

Gosling Czubak Engineering Sciences, Inc.

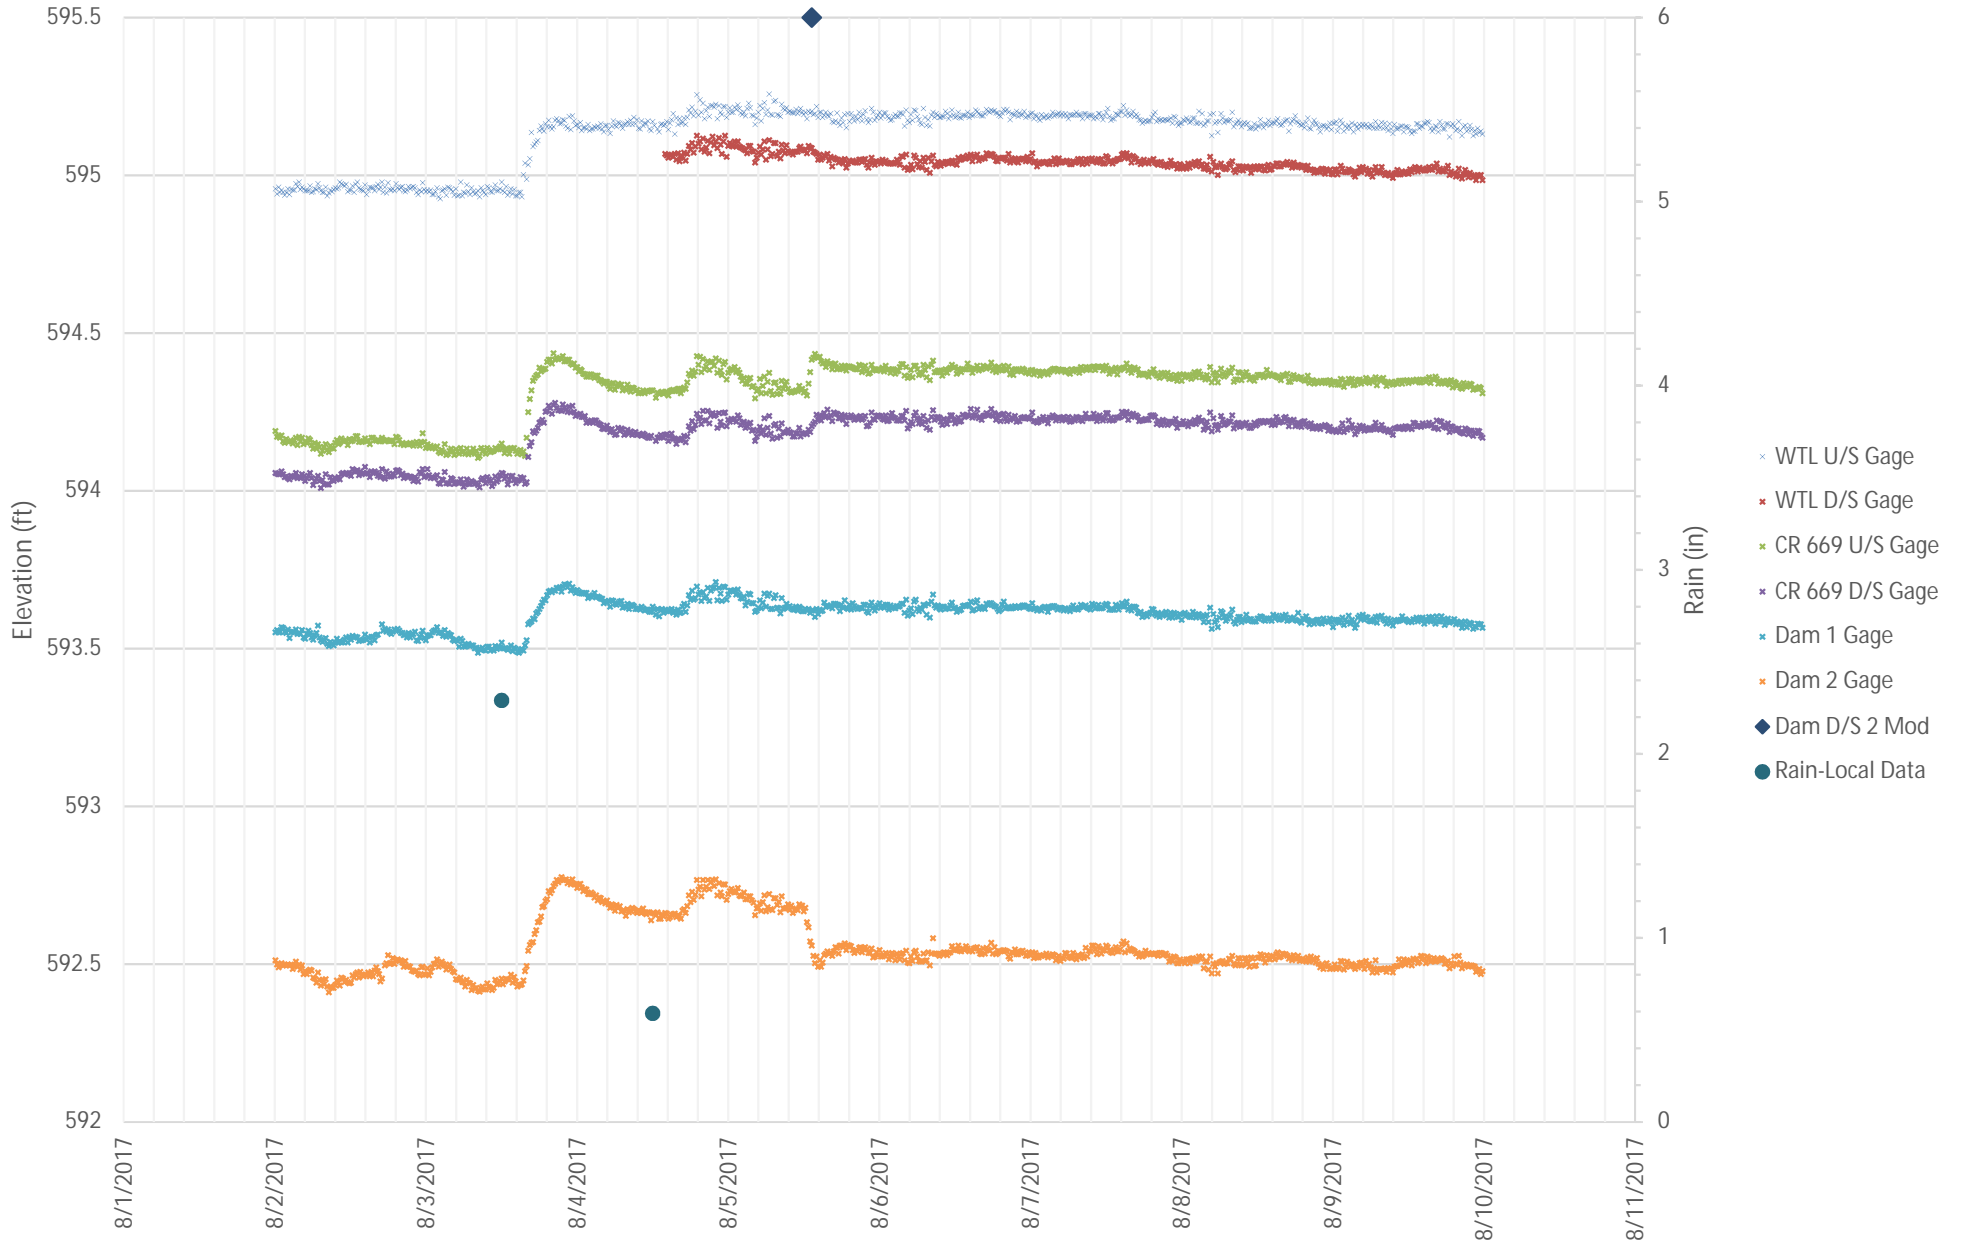
Fall 2017 Shalda Creek Water Level Study - 8/5 Event

A description of the work conducted at the 8/5 dam modification event was prepared by the NPS and included for reference as Attachment 6. The location of this dam is just downstream approximately 200 feet of dam 2 and is noted as “Dam Mod D/S/ 2” on the Shalda Creek map. Prior to the 8/5/17 dam modification, significant rain events of 2.29 inches on 8/3/2017 and .59 inches on 8/4/2017 were recorded. Observations of the water surface elevations around these events are:

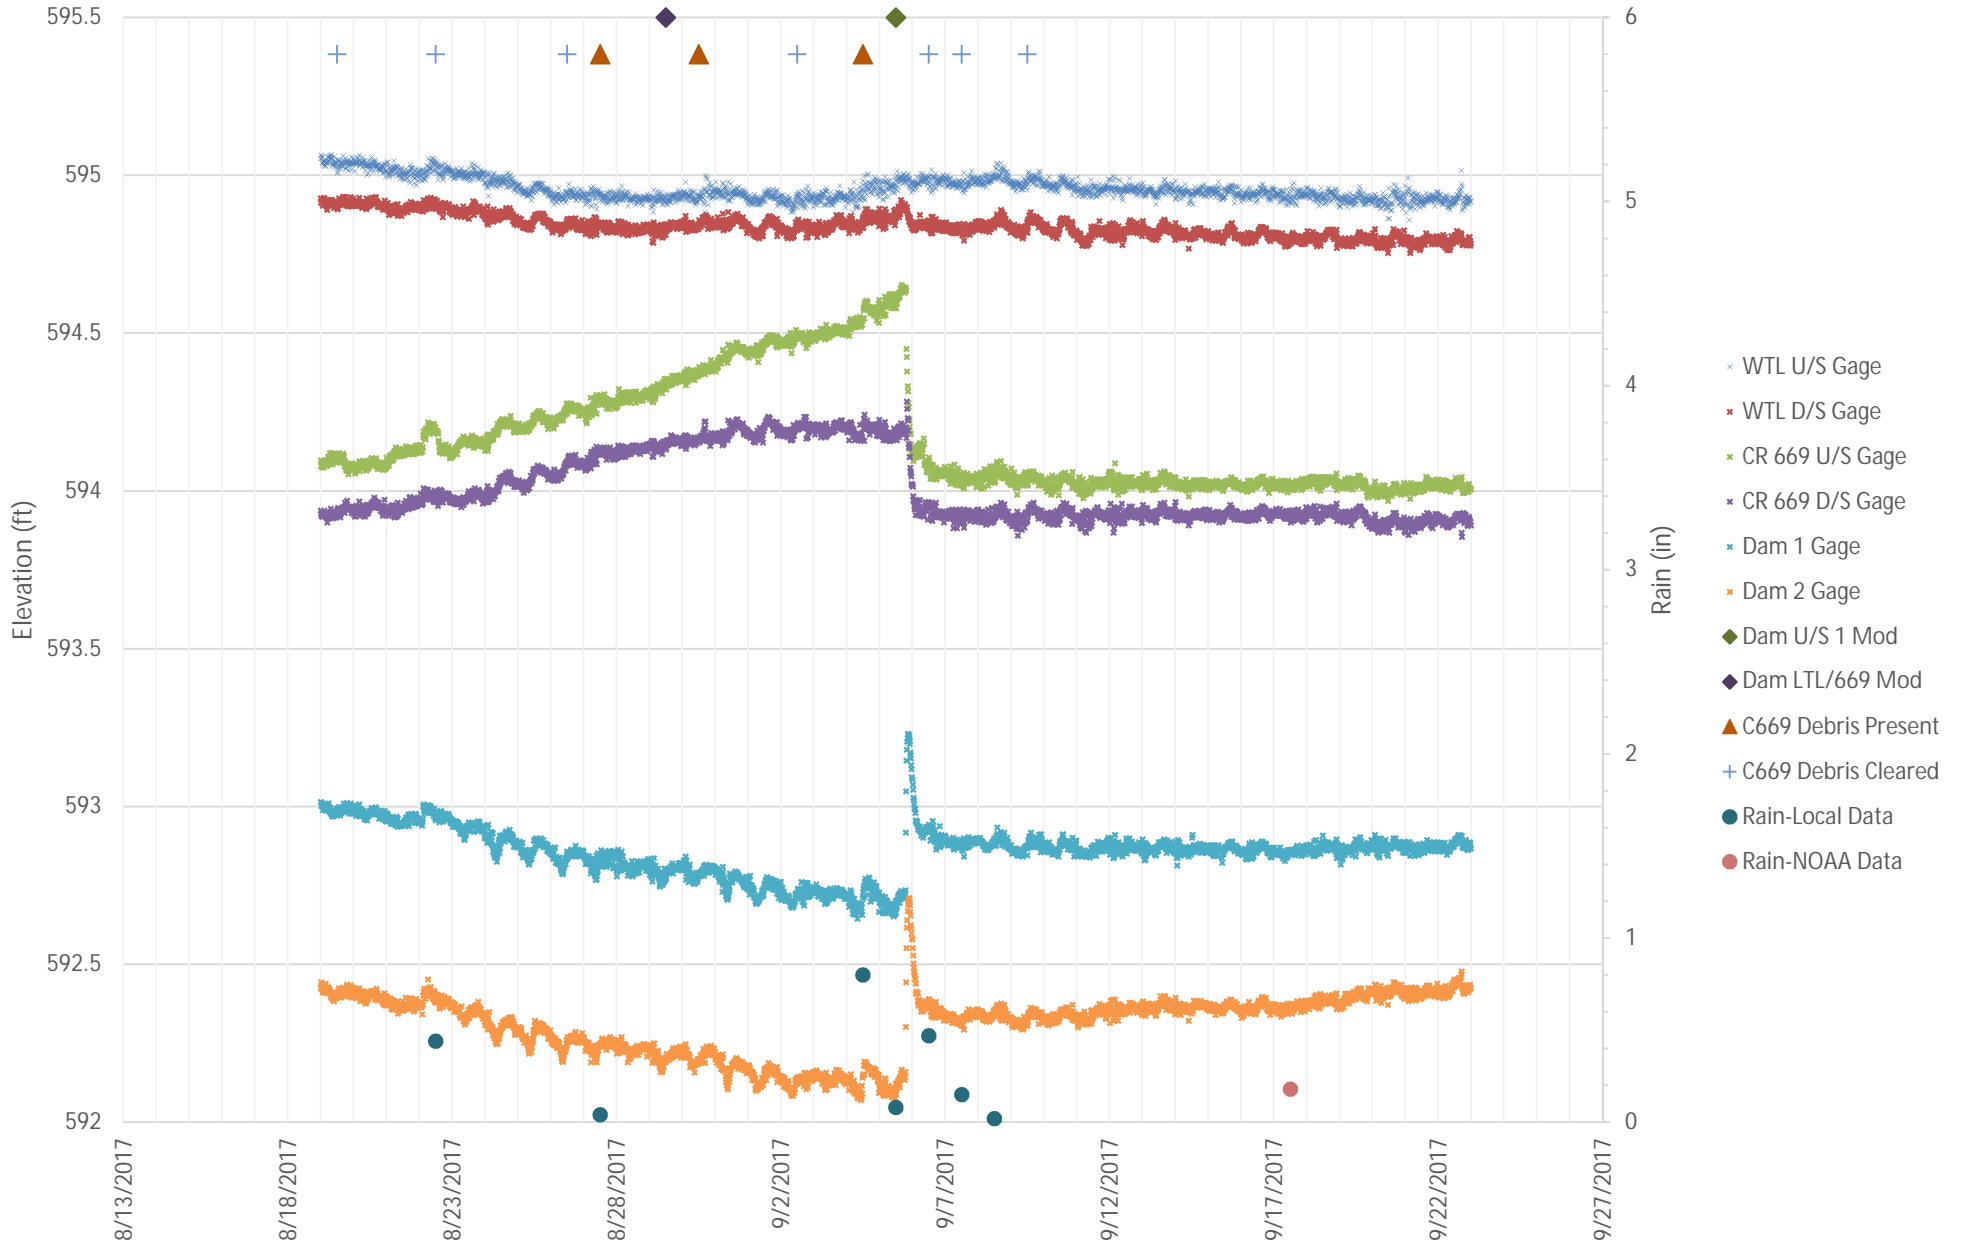
Fall 2017 Shalda Creek Water Level Study - 8/29 & 9/5 Events

- 2) A presence of debris at the CR 669 upstream culvert is noted before and after the 8/29 event. A noticeable rise in water level at the upstream CR 669 gauge occurs while the downstream gauge is unchanged.

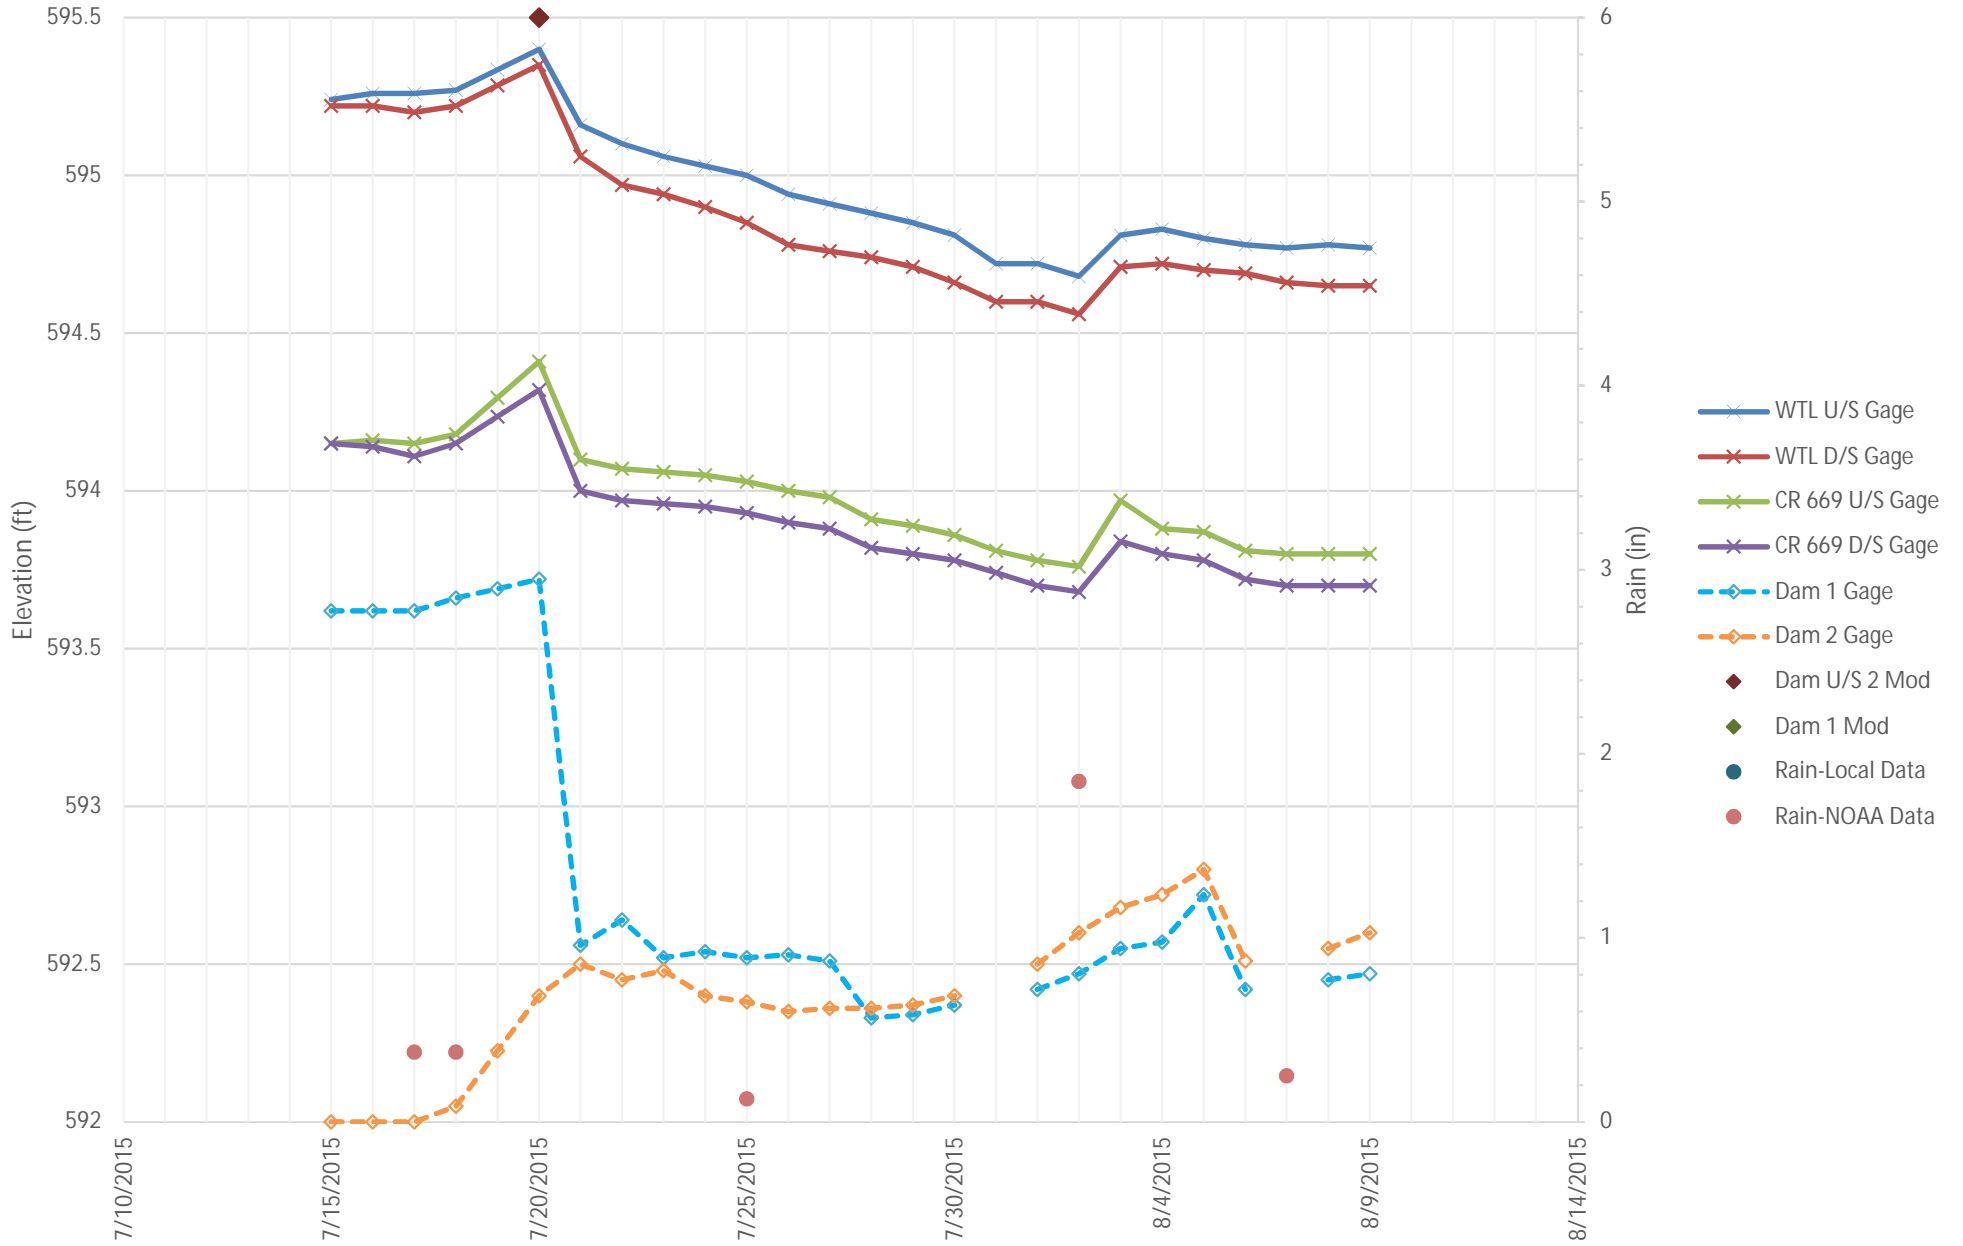
2015 Shalda Creek Water Level Study - 7/20 Event

7/20/2015 shown below in Figure 8. The modification indicated the dam was of significant size impounding at least 1.16 feet of water when it was removed. At that point, the water level of LTL was at a high of 595.4. Following removal of the dam, it dropped .72 feet (8.64 inches) to a relative low of 594.68 over thirteen days when a significant rain event of 1.85 inches pushed levels up about .1 foot where the leveled off. The observed drop in water levels on at 669 were nearly the same magnitude. The downstream water level at CR 669 was 594.32 on 7/20 before the dam was modified and fell .64 feet (7.68 inches).

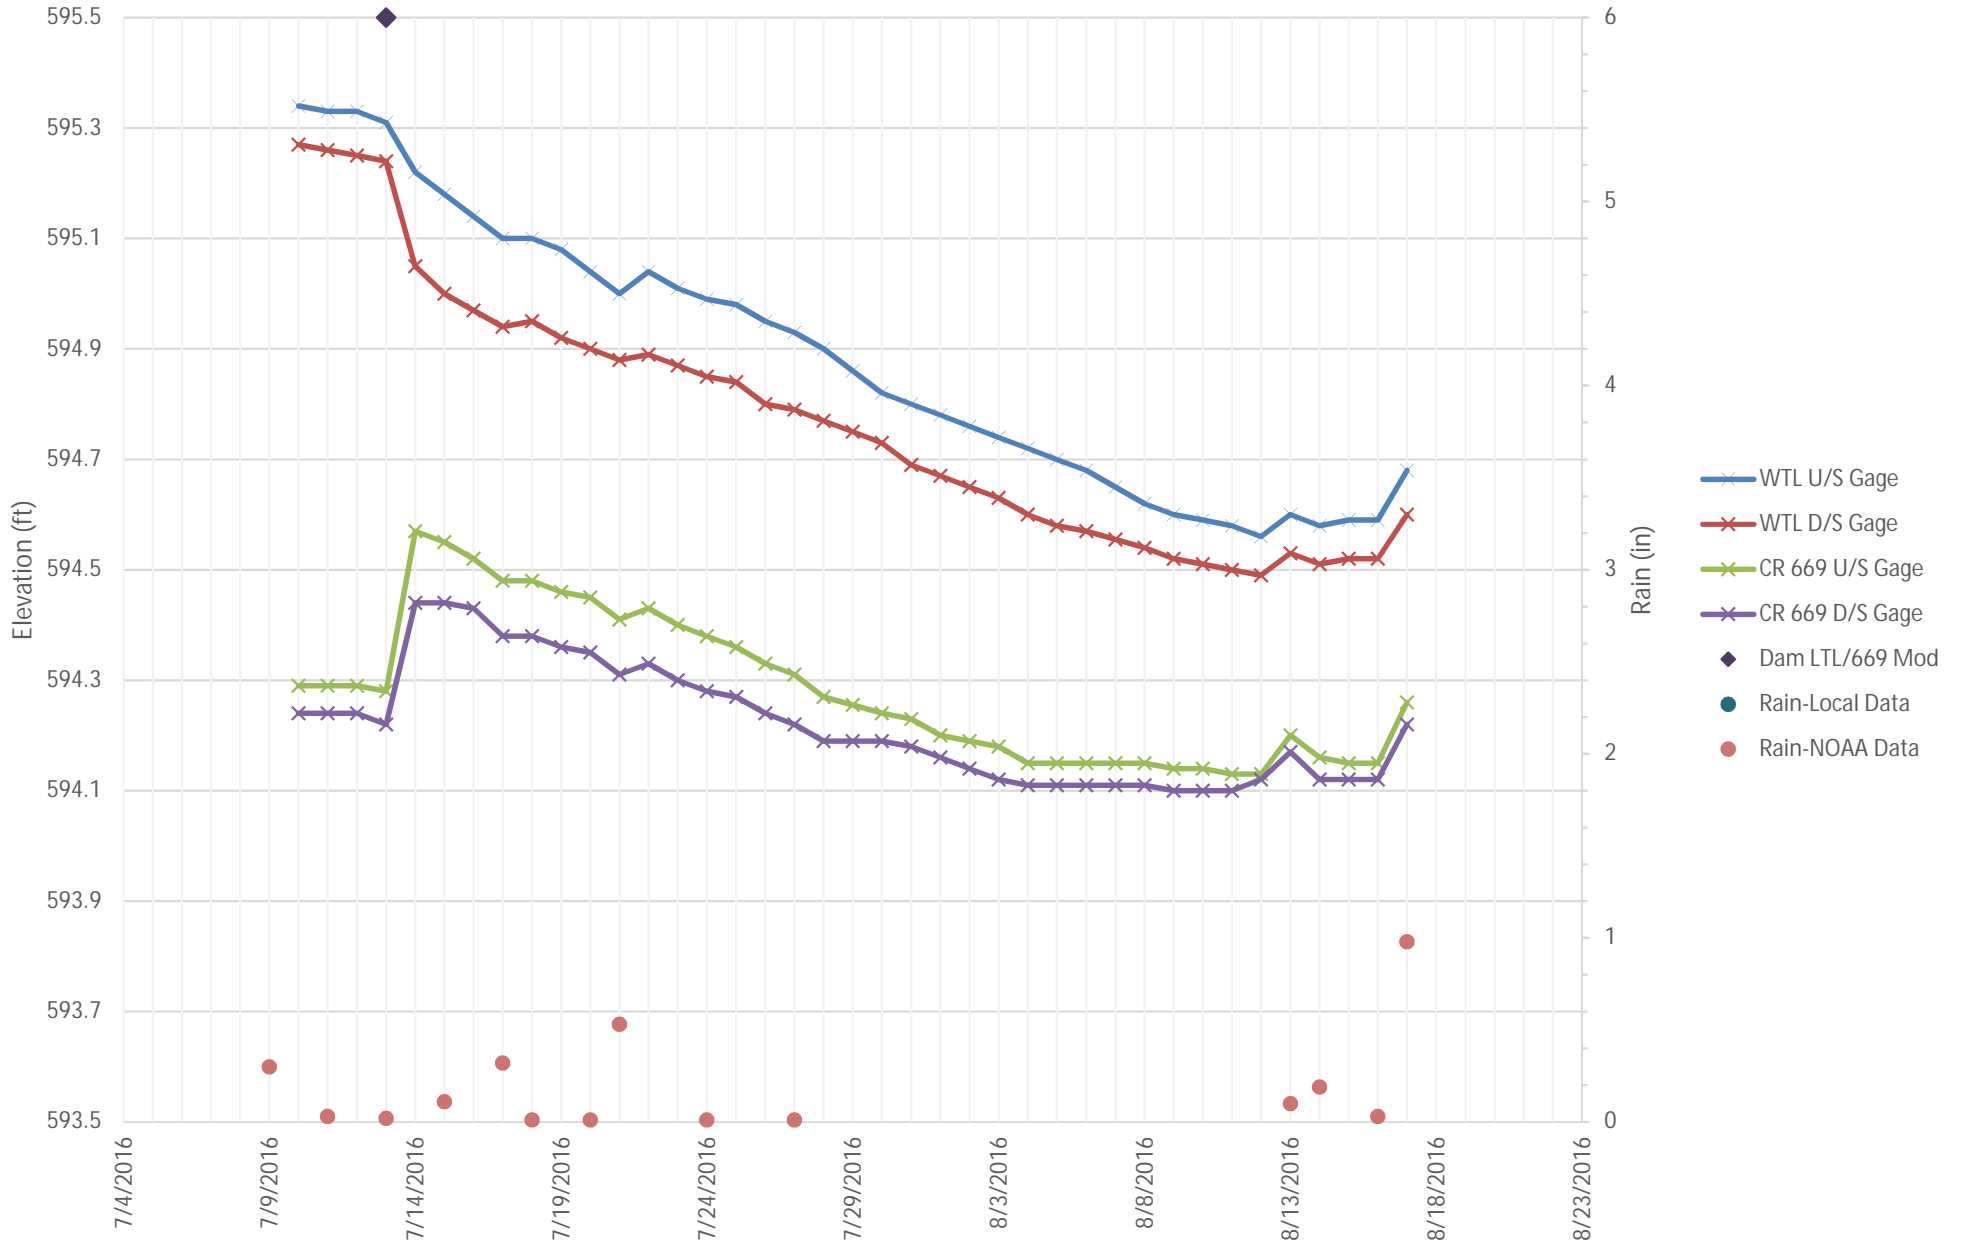
2016 Shalda Creek Water Level Study - 7/13 Event

A modification of the dam found between LTL and CR 669 was completed on 7/13/2016. This modification event is shown in Figure 9. At the time of this modification, the water level of LTL was again at a relative high of 595.3. Following the removal of the dam, it steadily dropped .75 feet (9 inches) over 30 days to 594.56.

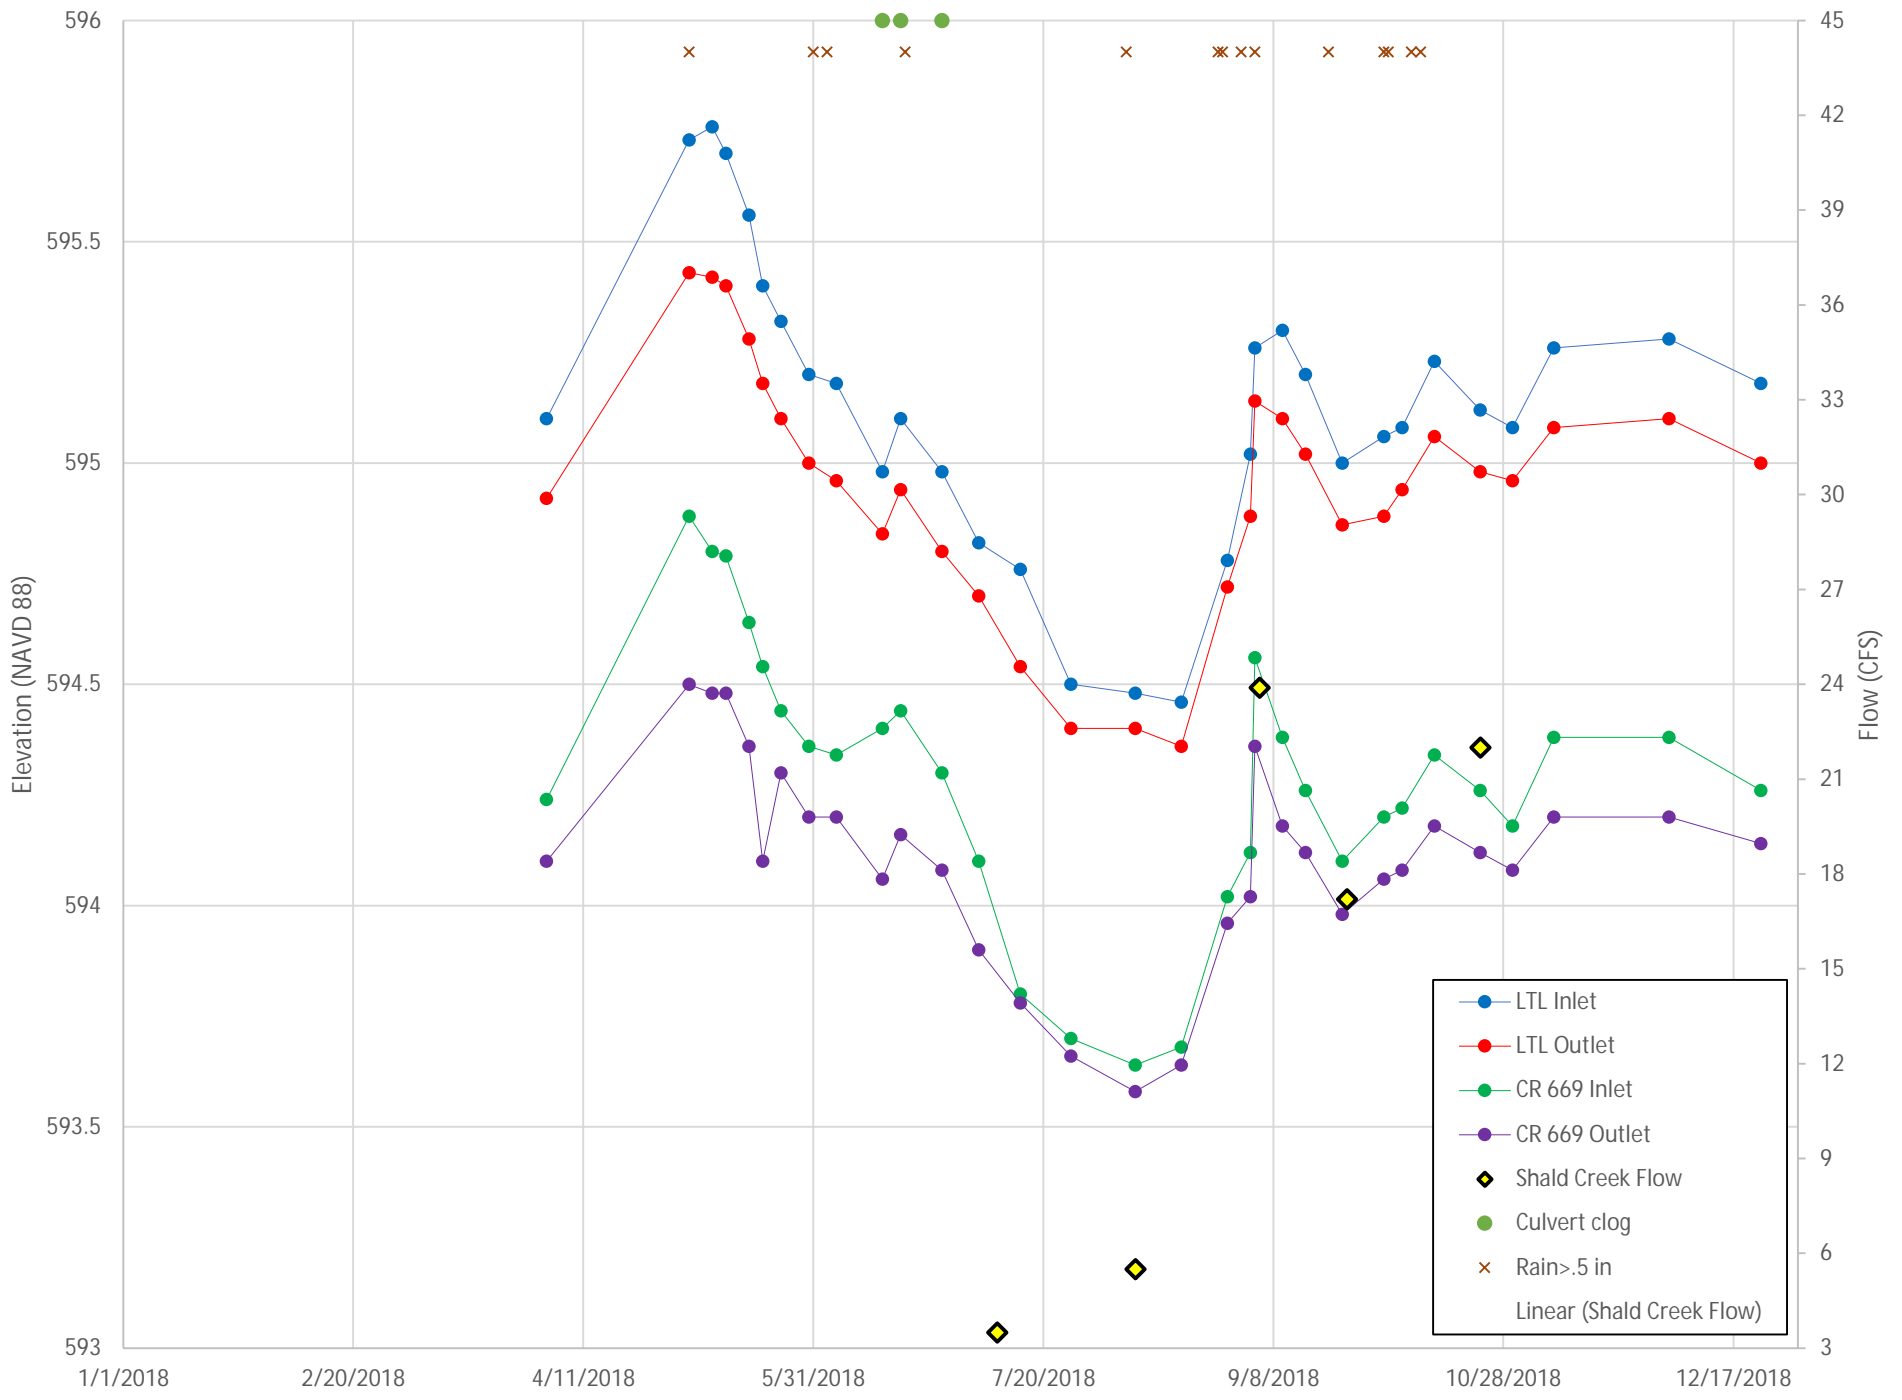
Figure 11 - 2018 Little Traverse Lake & Shalda Creek System Observed Water Levels

It was noted by LTLPOA that 2018 was an unusually quiet year for beaver activity with no new dams reported within the original study area. Figure 11 below is a graph of the 2018 data recorded by the LTLPOA. The data starts in early April when spring runoff is working its way through the system. The peak water level at Little Traverse Lake for the year was 595.76 and recorded on May 9. This followed 1.58 inches of rain recorded on May 4. That water level is .11 feet above the elevation of 595.65 identified in previous reports that lake residents experience adverse impacts to their property, such as flooded crawl spaces. Without beaver activity and significant rain, the water levels in the system generally drop over the summer season and that is what was observed in 2018. Table 2 below summarizes the monthly precipitation for 2018, 2019, and 2020 along with the normal monthly precipitation. The above normal precipitation through the winter and spring and below normal precipitation through June and July align with the high and low water level observations for the period.

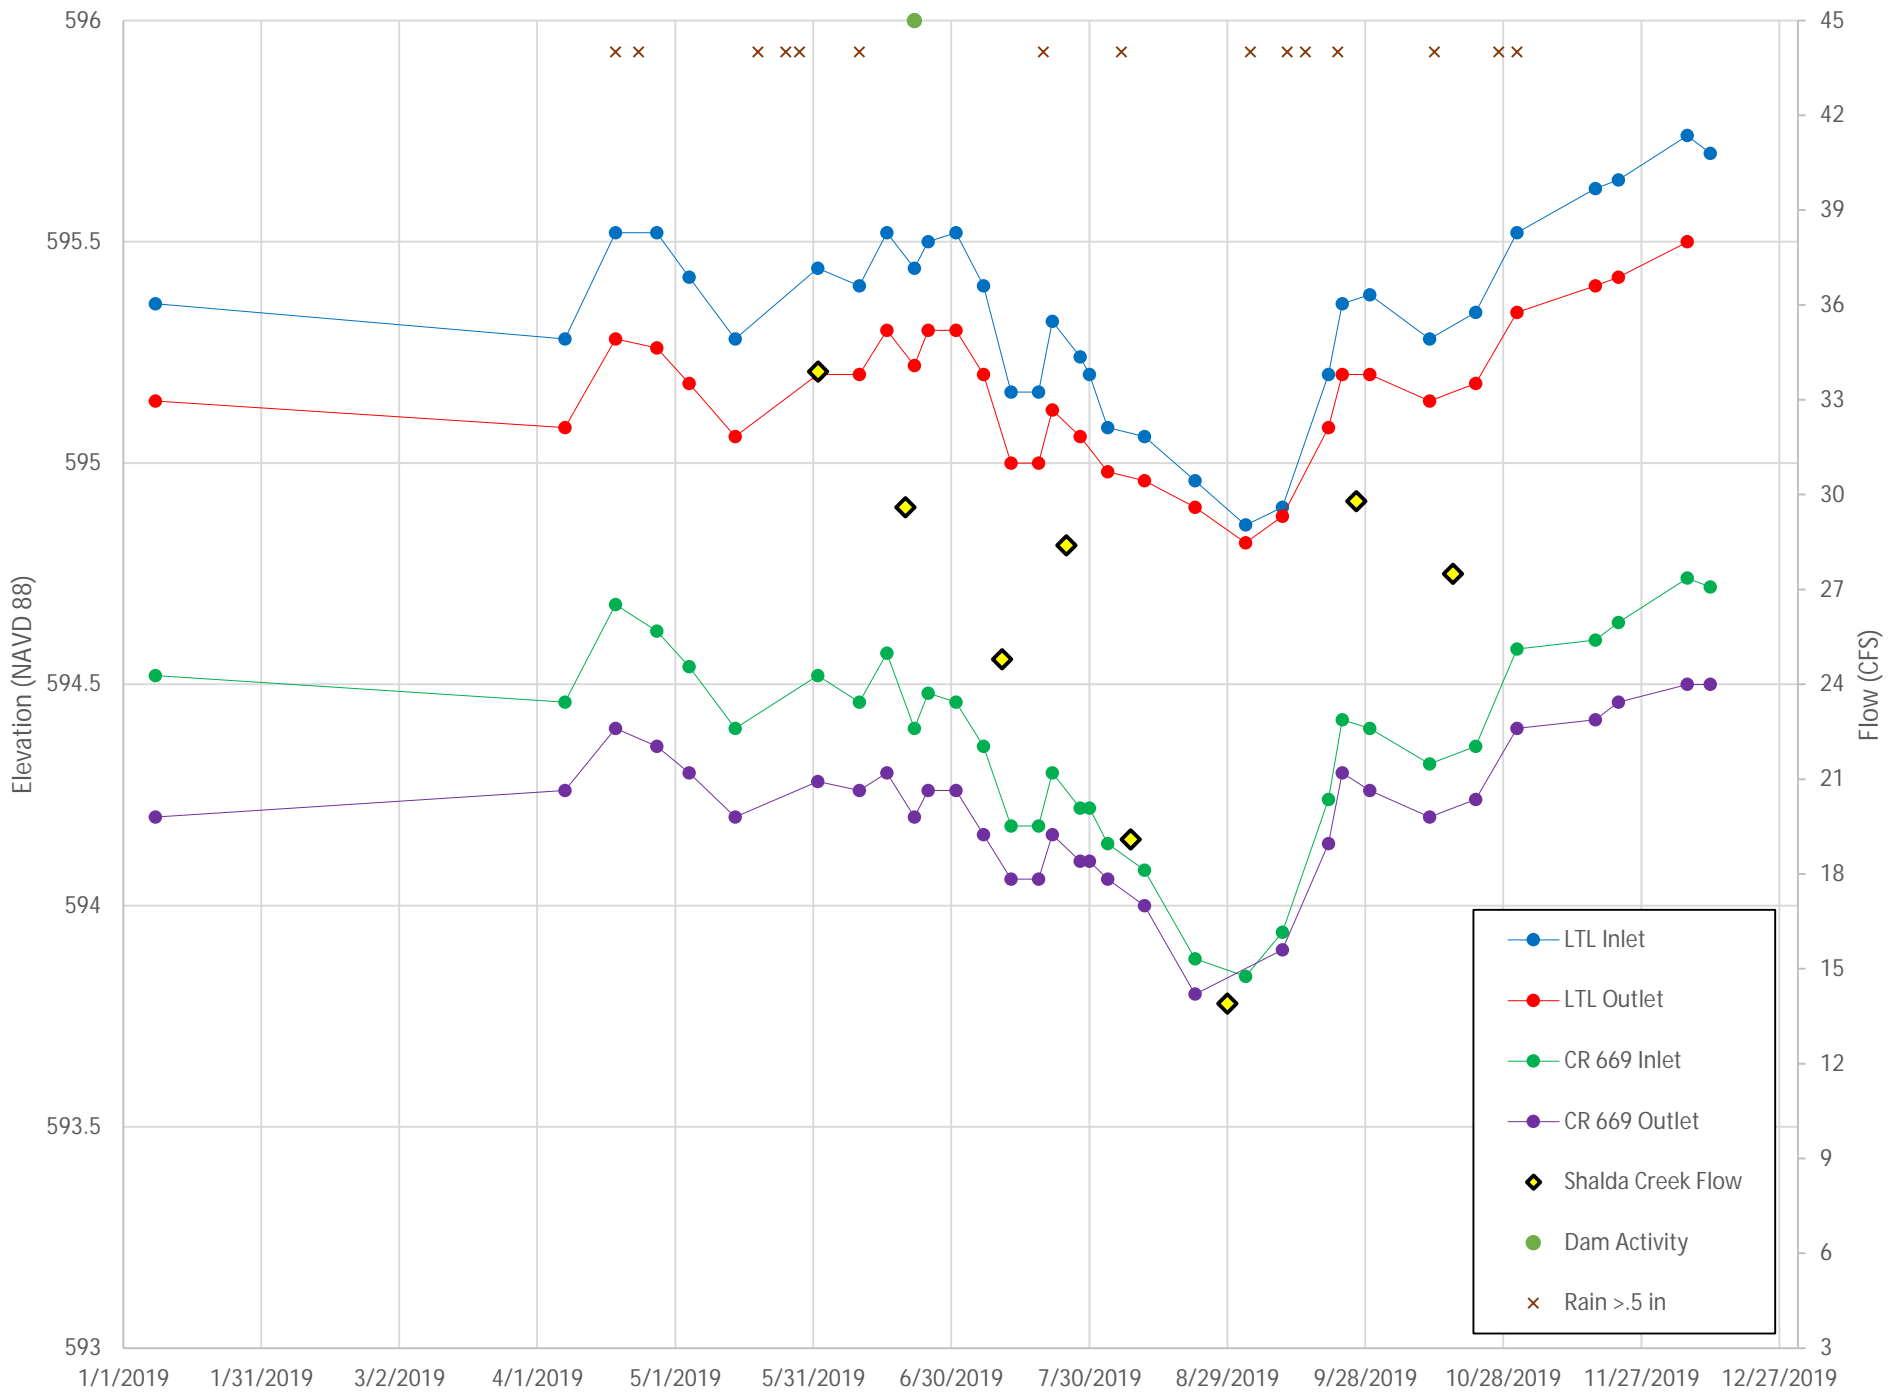
Figure 12 - 2019 Little Traverse Lake & Shalda Creek System Observed Water Levels

2019 data is shown in Figure 12 below and follows a similar trend as 2018 of water levels decreasing in the summer. However, dam activity at the Fish Camp location is noted in June. The total precipitation for May, June, July, and August is 9.4 inches and 2.91 inches below the normal total of 12.31 inches for this period of 2019. The decrease in water elevation measured at Little Traverse Lake from 595.42 on May 4, 2019 to 594.86 on September 2, 2019 is .56 feet (6.7 inches). If we compare the observations for the same period of 2018, it is noted the total precipitation is 13.09 inches which is .78 inches above normal for the period. The decrease in water elevation at Little Traverse Lake from 595.76 measured May 9, 2018 to 594.46 measured August 19, 2018 is 1.3 feet (15.6 inches). This is significant because the lake level dropped over 2.3 times as much in 2018 when there was no beaver dam activity noted but the total precipitation is above normal for the summer months. It would have been reasonable to expect a water level drop of the same magnitude over the similar time frame in 2019 especially with below normal precipitation. If you only look at June, July, and August, the precipitation is 47% below normal for this period. The meager drop of .58 feet during this time period of low precipitation is indicative of obstructive elements such as beaver dams within the system.

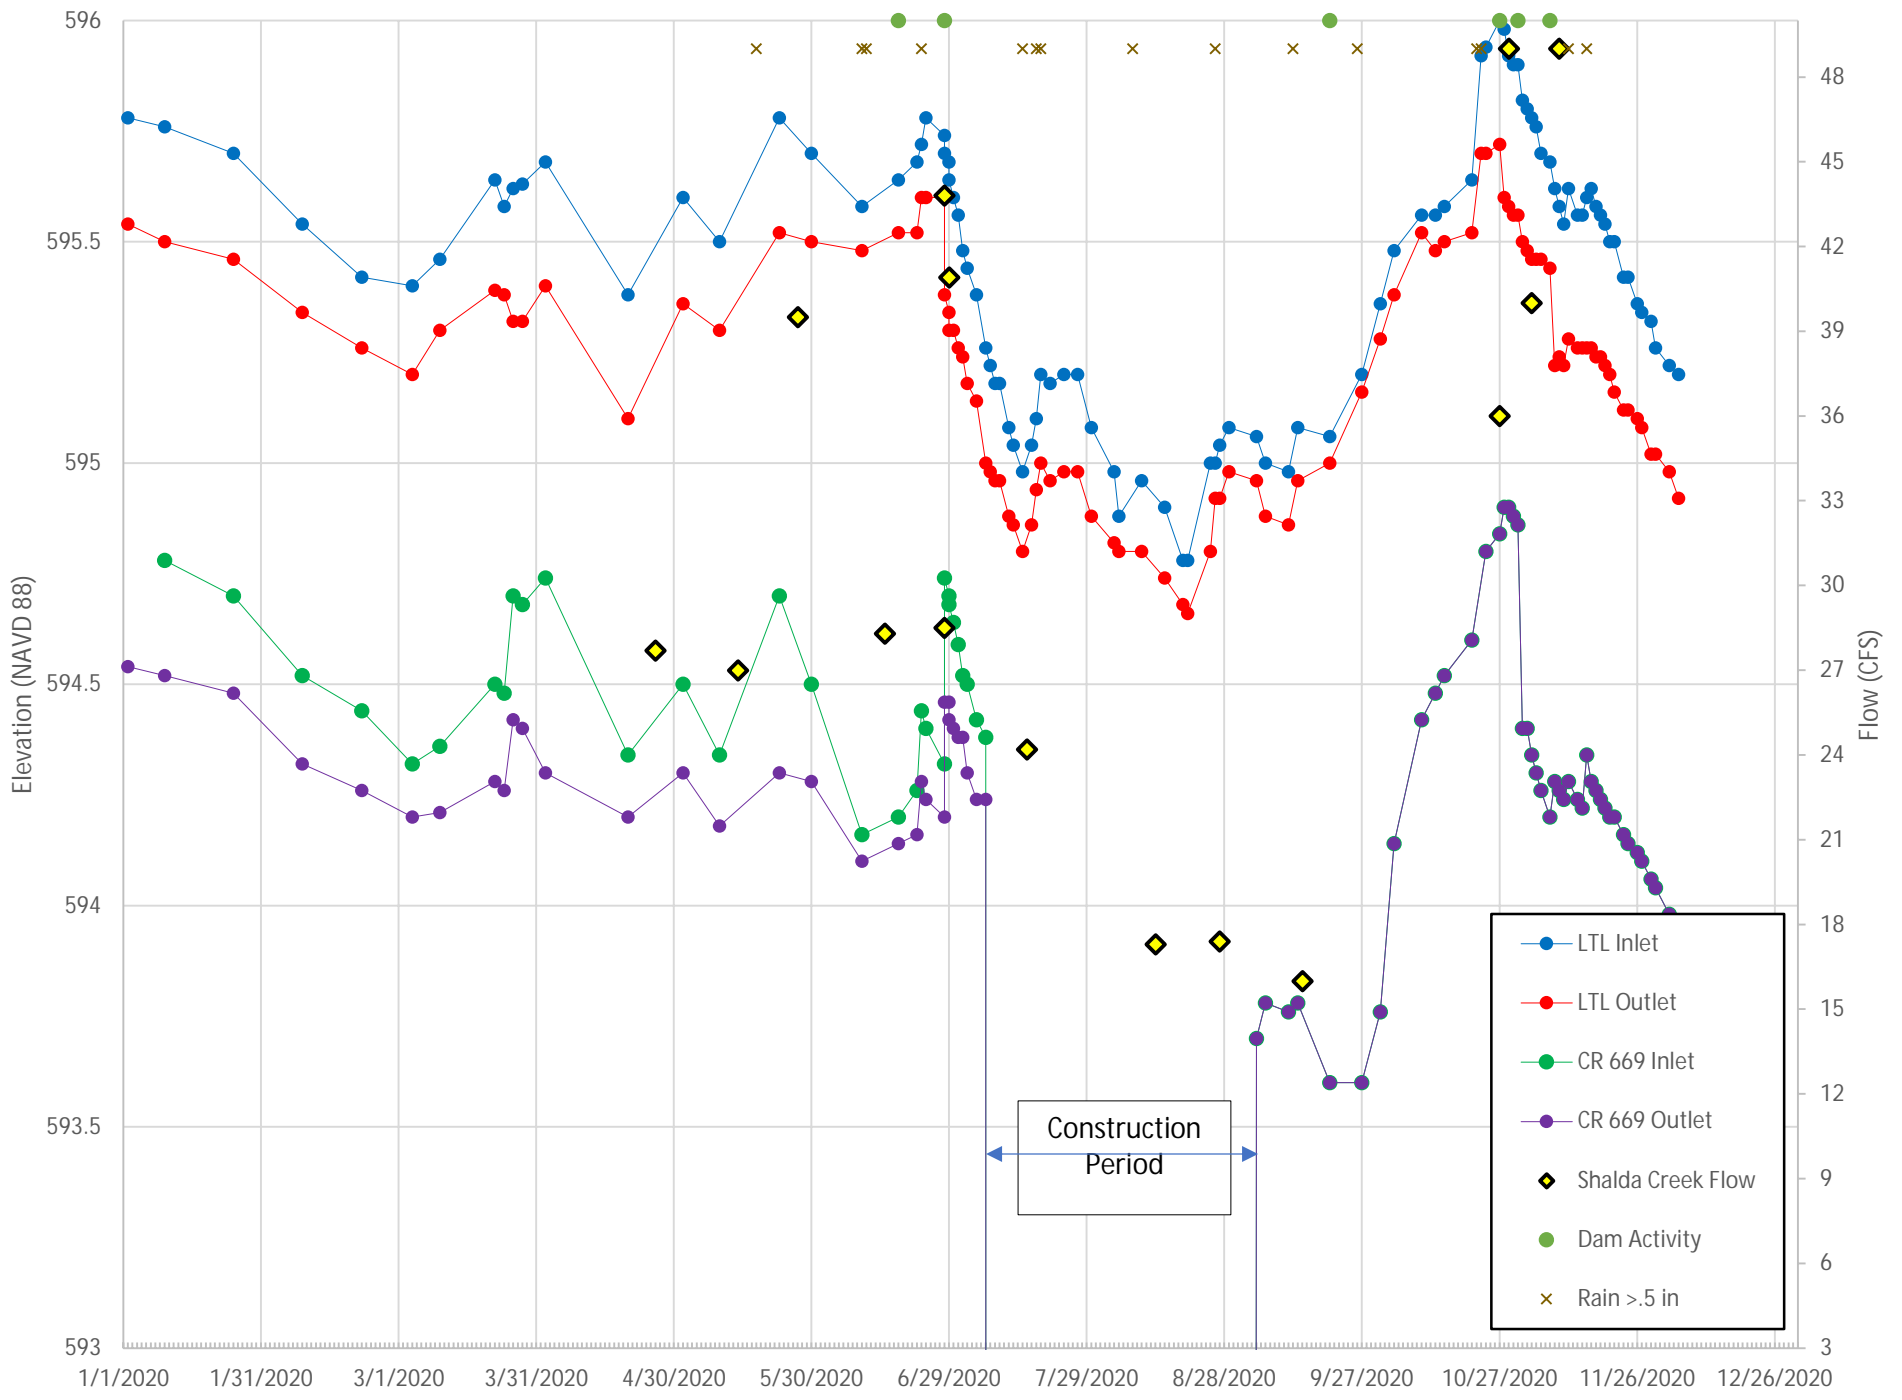
Figure 13 - 2020 Little Traverse Lake & Shalda Creek System Observed Water Levels

The overall data for 2020 is shown in Figure 13 below and an enlarged graph of the data through mid-July is shown in Figure 14. 2020 data started with LTL water levels at 595.78 just above the 595.65 level where residents are affected. The level fluctuates through the winter and spring and only gets to a low of 595.38 on April 20. Activity at the beaver dam upstream of CR669 was noted on June 18 during a period of increasing Little Traverse Lake water levels and steady flows of 28 cfs at CR669 measured by the Benzie Conservation District. Following the permitted modification of this dam on June 28, 2020 the flow rapidly increases to 44 cfs and declines to 40.9 cfs the following day. This sudden increase in flow can be attributed to the removal of the beaver dam and release of the water. Over the course of two weeks, the water level declines .76 feet. During this period on July 7, 2020 the stream diversion was installed for the removal of the culvert being replaced at CR 669. The staff gages at CR669 were removed at this time. Several days of heavy rains occurred from July 15-19 and caused a brief water

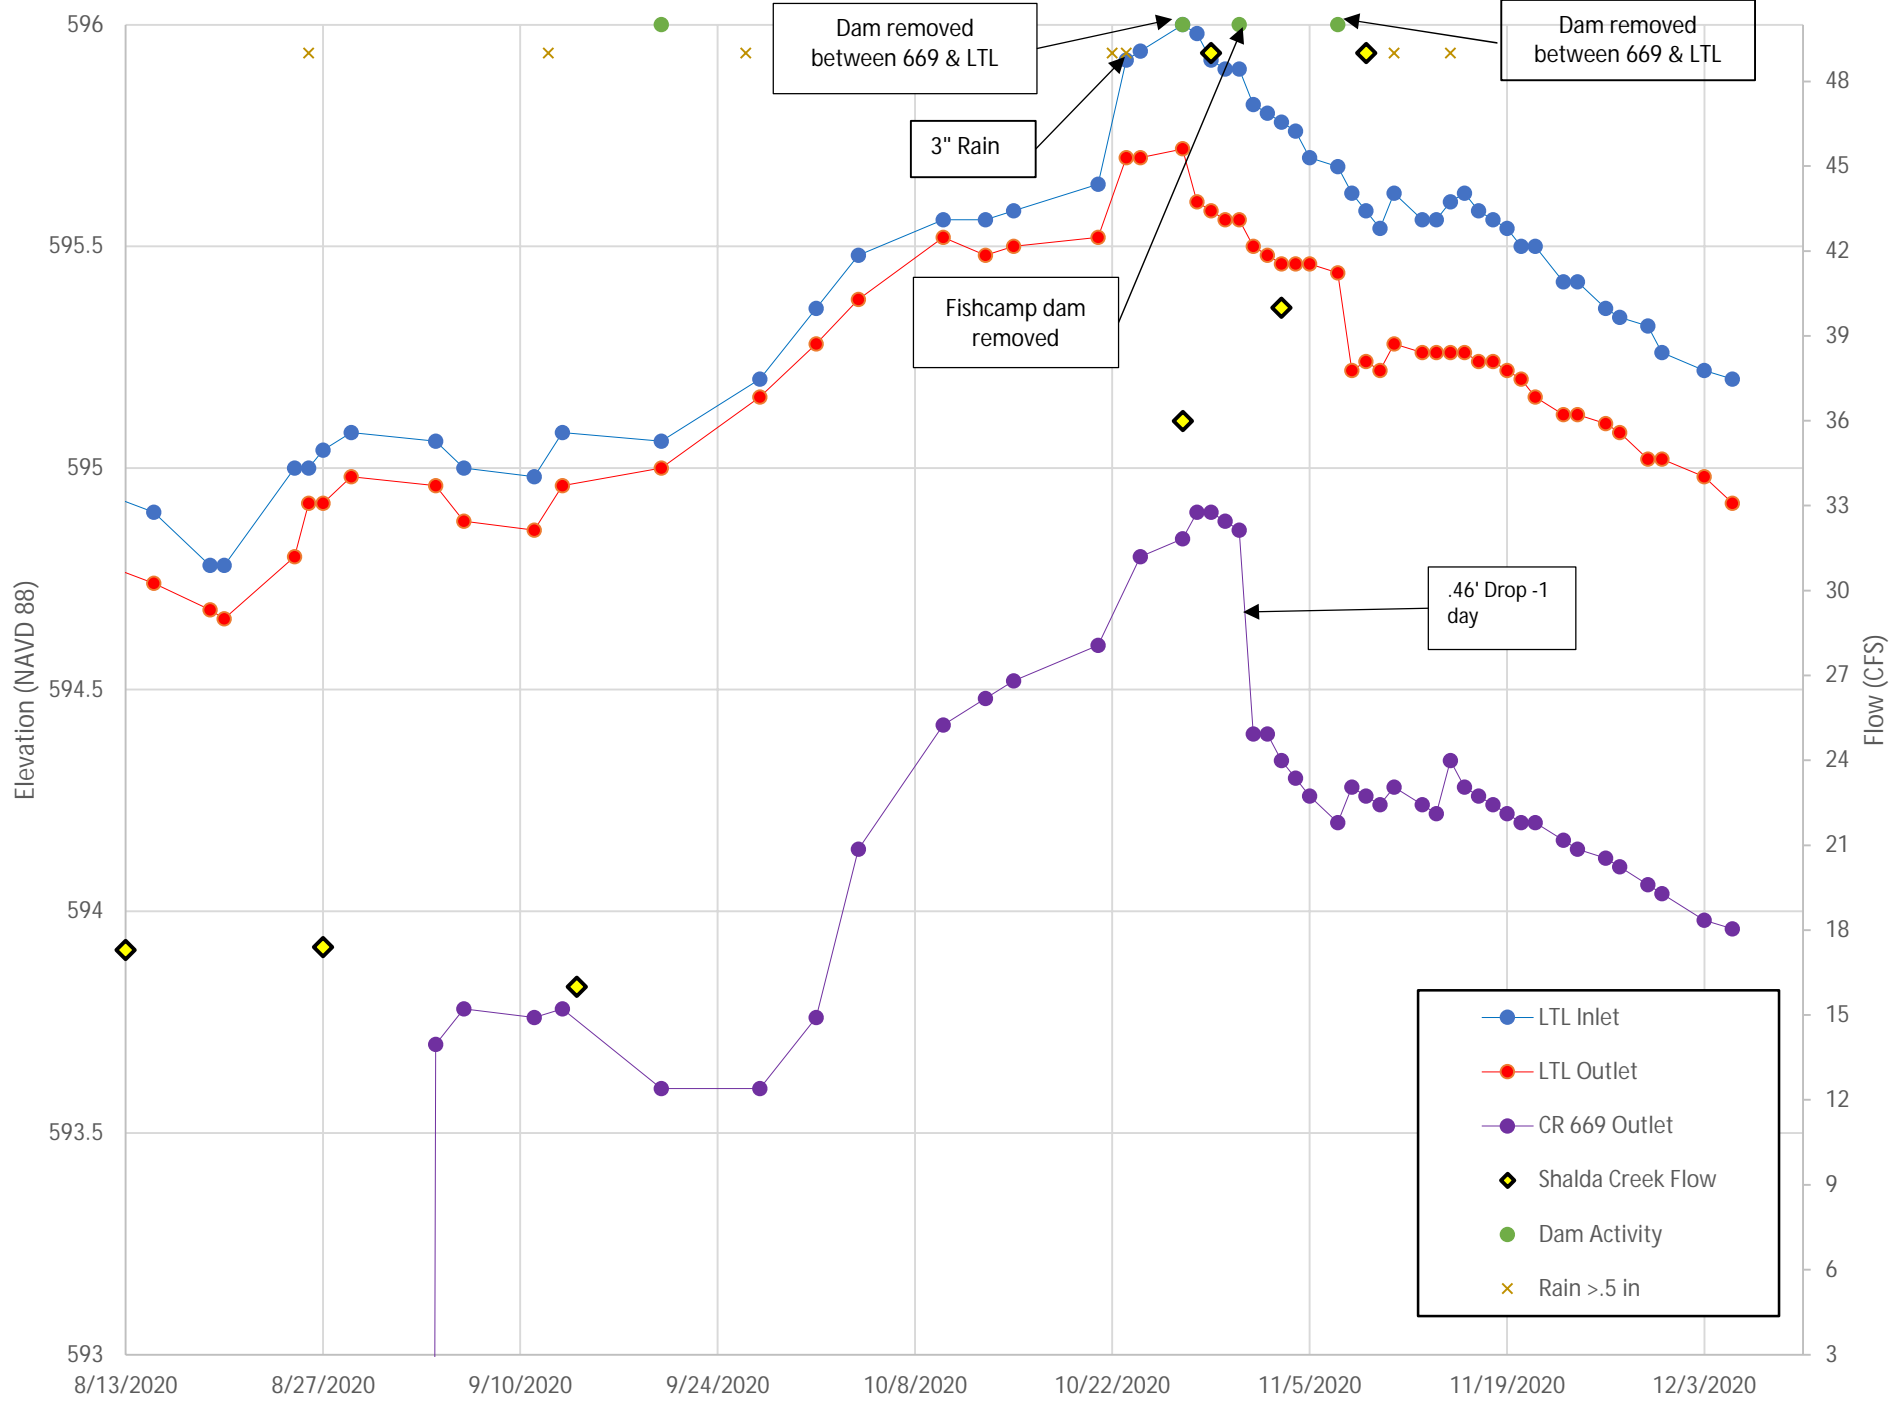
Figure 15 - 2020 Little Traverse Lake & Shalda Creek System Observed Water Levels

Figure 15 below shows an enlarged graph of the 2020 data from mid-August. Following removal of the dam between CR669 and LTL water levels dropped .1 ft at the LTL inlet, .16 ft at the outlet, and rose .06 feet at CR699. Once the downstream Fishcamp dam was removed, the system could “drain” and the water level at CR669 dropped .46 feet (5.5 inches) in one day. The dam between LTL and CR669 had been significantly rebuilt and was removed again on November 7, 2020. The LTL outlet quickly dropped .22 feet (2.64 inches) followed by a steady drop in the LTL water levels. The LTL outlet drop following this event was twice as much than the first removal event on October 27 due to the fish camp dam removal and lowering levels at CR669. Following these removal events, water levels at Little Traverse Lake have dropped from 595.9 to 595.2 as of December 5, 2020.
