Report of Shalda Creek Water Level Study 2017-2020

Little Traverse Lake Property Owners Association
Cleveland Township, Leelanau County, Michigan

Published: December 15, 2020

Gosling Czubak Engineering Sciences, Inc.

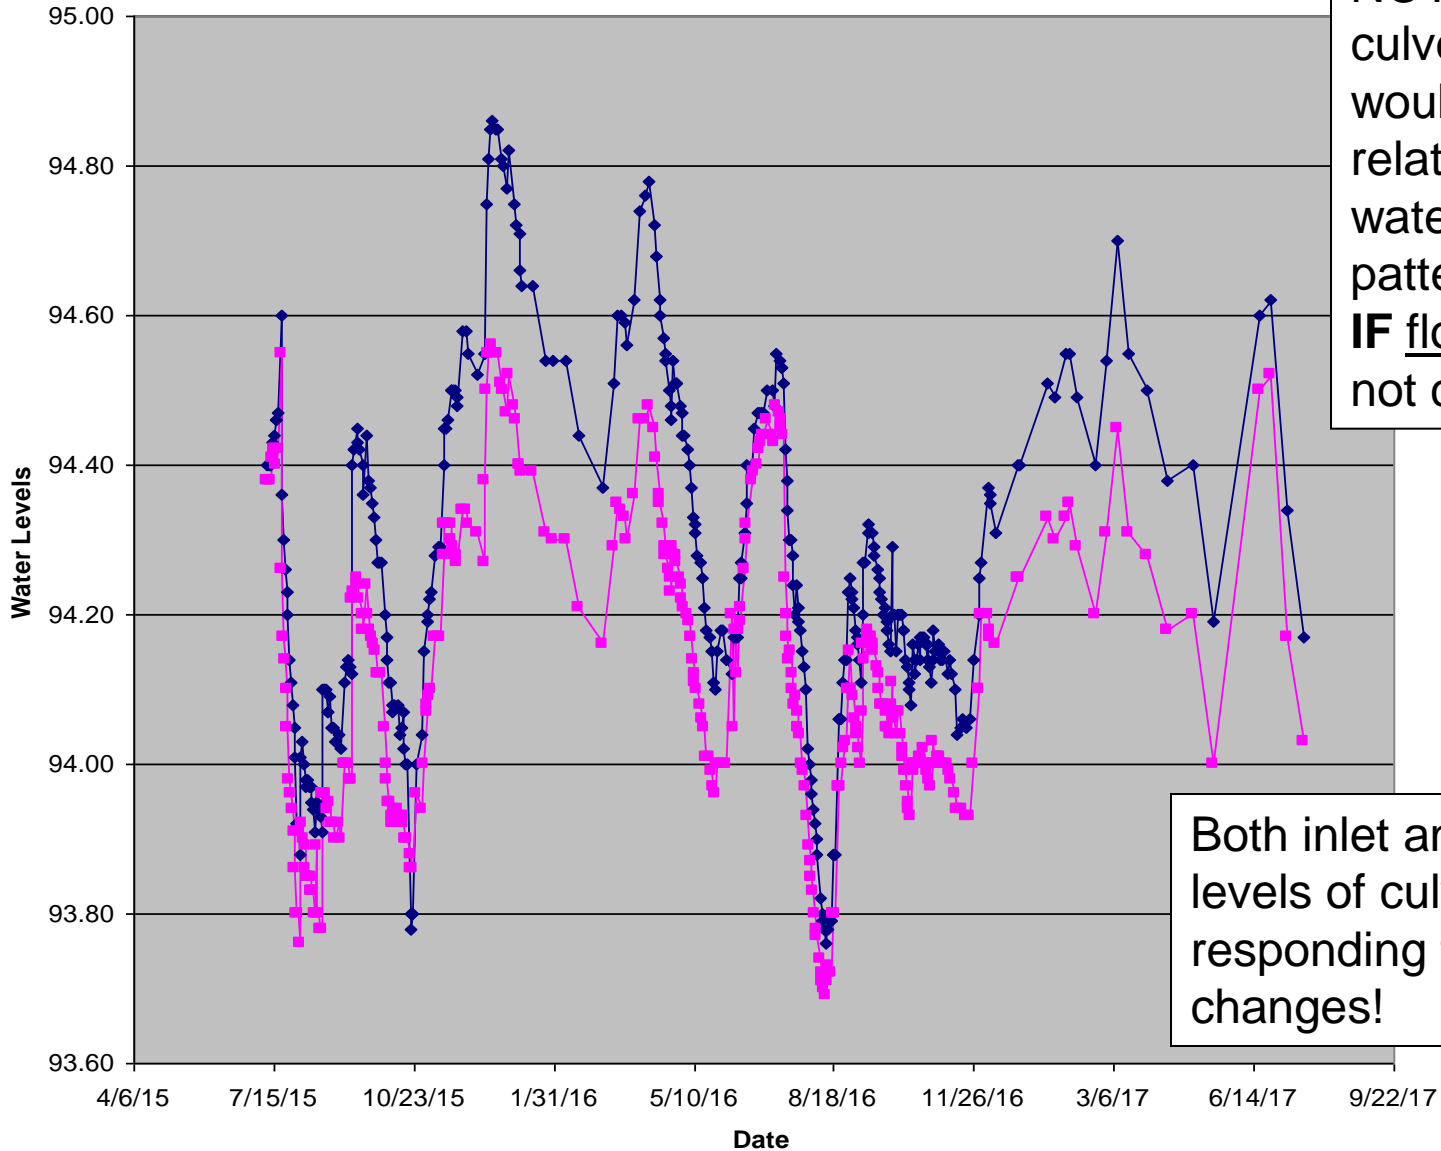
LTL Inlet vs Outlet water levels over time

Both inlet and outlet levels of culvert responding to water changes!
