# Inspection Report

**Property Address:**  
123 Happy Home Lane  
Glastonbury CT 06033

**Allied Home Inspection**

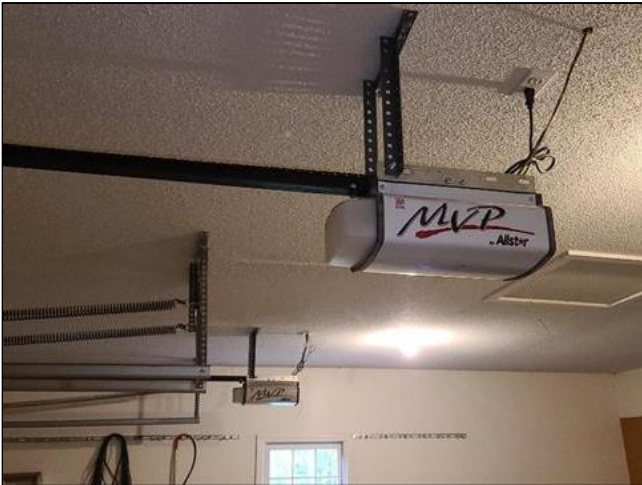
1.12 Item 1(Picture)

1.12 The garage overhead door openers and safety reverse mechanisms were tested and did operate at the time of the inspection.

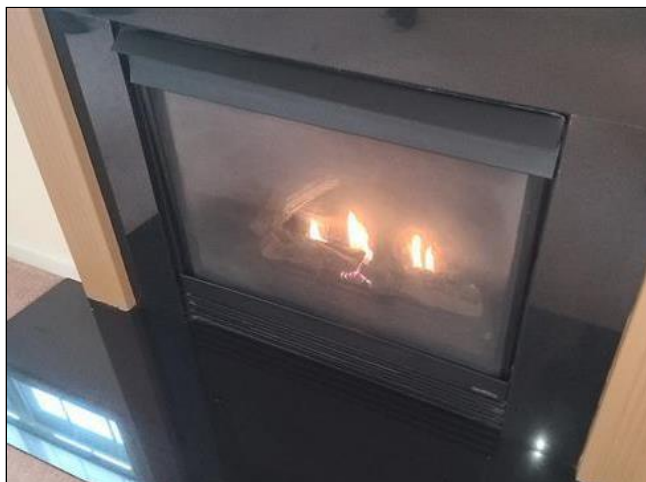
2.12 Item 1(Picture)

**2.12** The gas fireplace was tested and did operate at the time of the inspection.

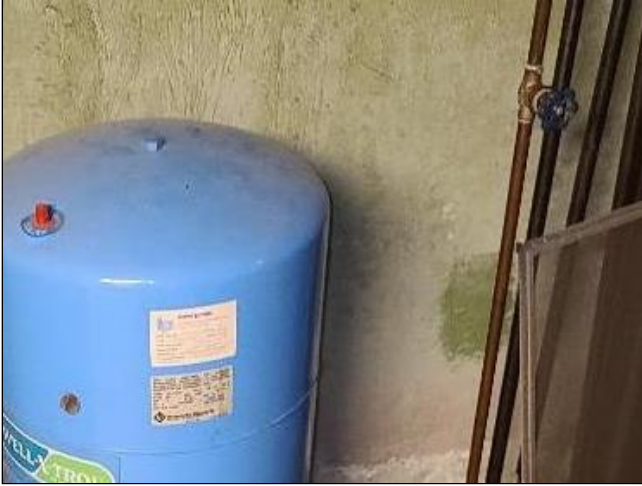
3.0 Item 1(Picture)

**3.0** The main water shut off valve is located on the vertical copper pipe to the right of the well water pressure tank. This is for your information in the event a situation arises that you need to turn the household water supply off.

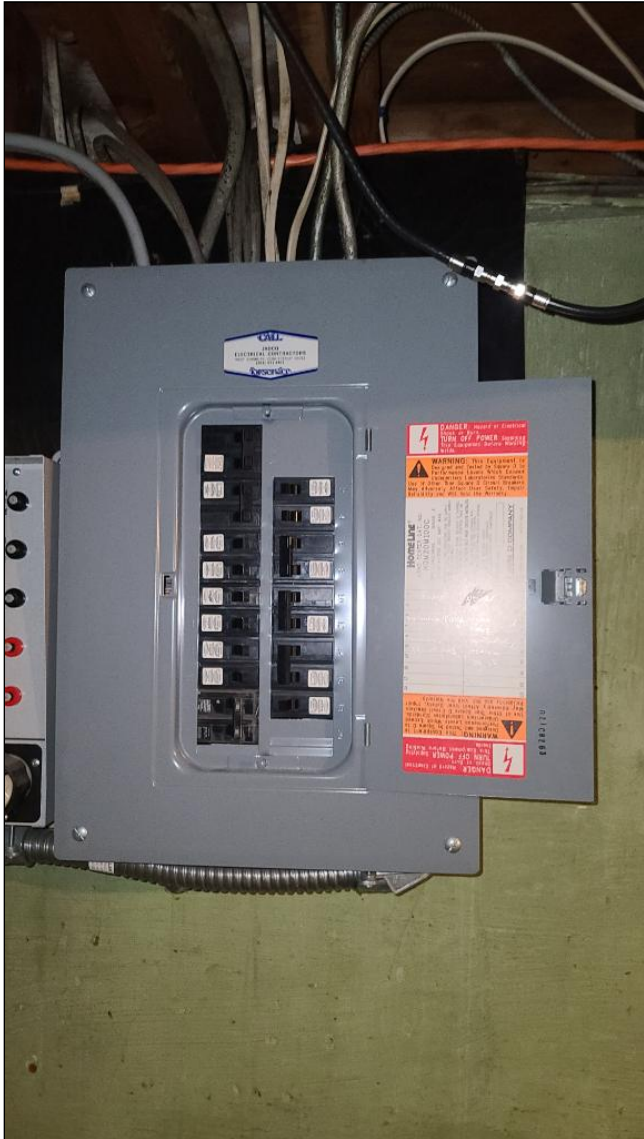
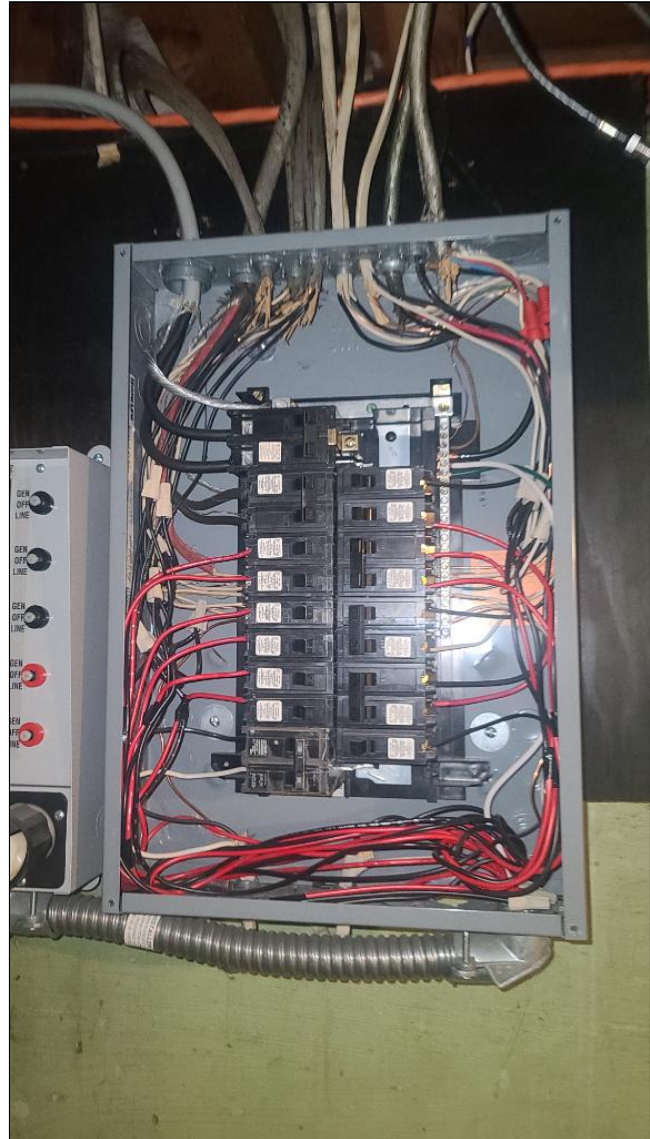
4.0 The main service panel is located in the front right corner of the basement. This is for your information in the event a situation arises that you need to turn off the power to the whole house, individual circuits, or need to reset a tripped circuit breaker.

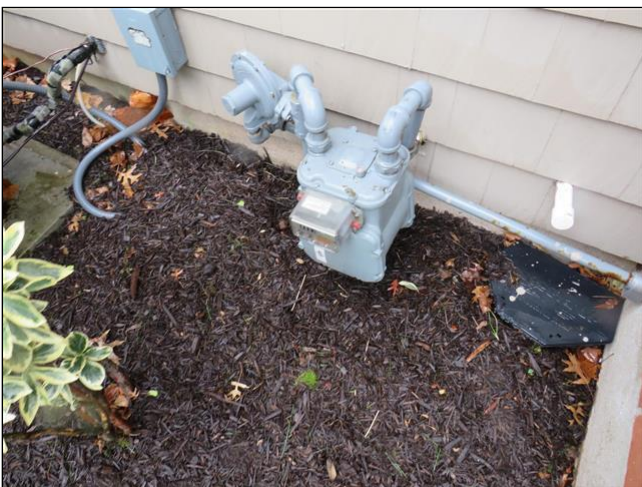
5.0 Item 1(Picture)

5.0 The main gas shut off valve is located on the supply pipe before the gas meter at the left side of the house.

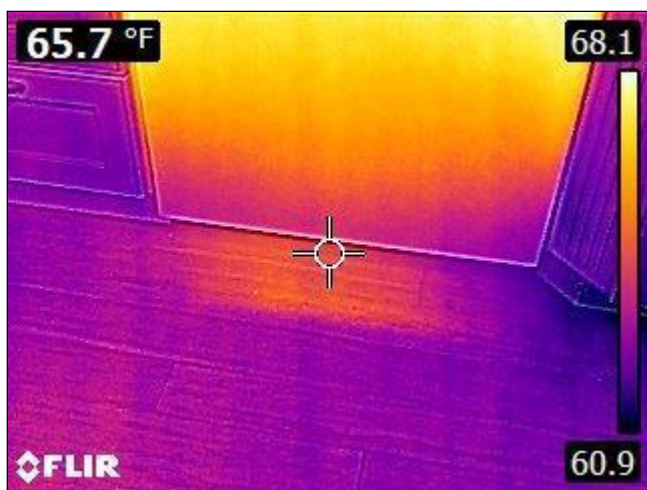
6.0 Item 1(Picture)

6.0 The dishwasher was run through a full cycle and did operate properly at the time of the inspection.

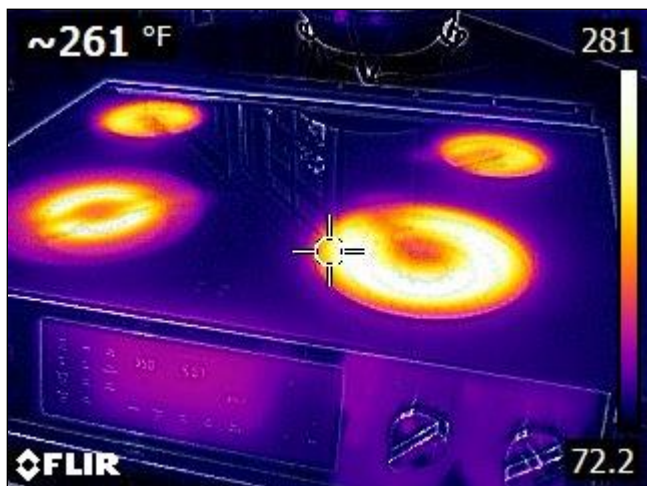
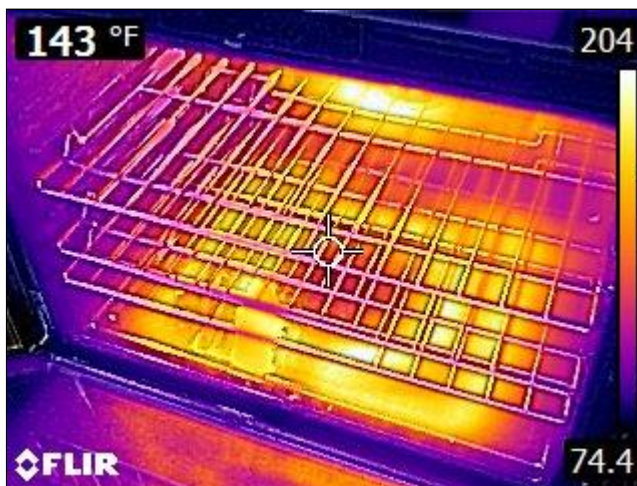
6.1 The range and oven were both tested and did operate properly at the time of the inspection.

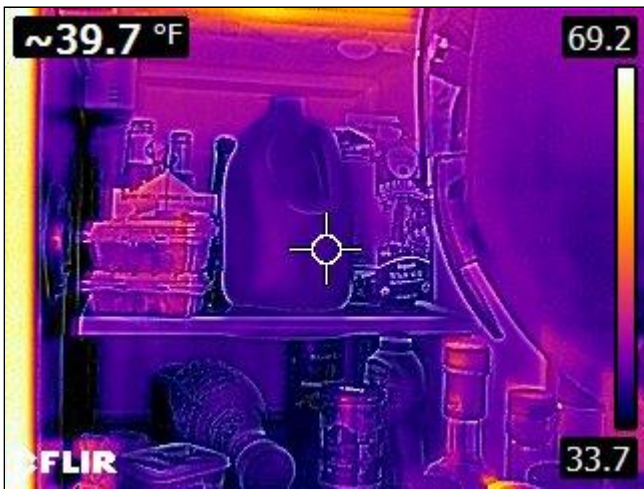
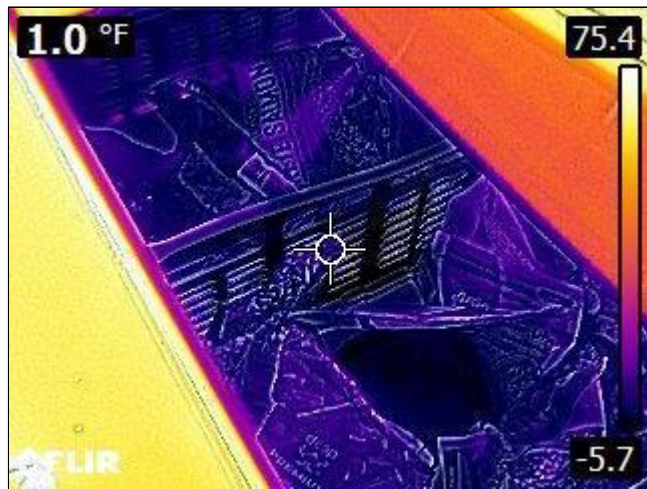
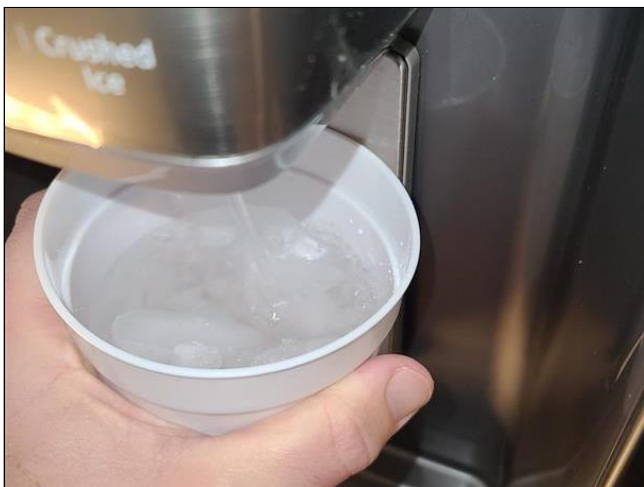
6.3 The refrigerator and freezer compartment temperatures were adequate at the time of the inspection. The ice/water dispenser was also tested and did operate.

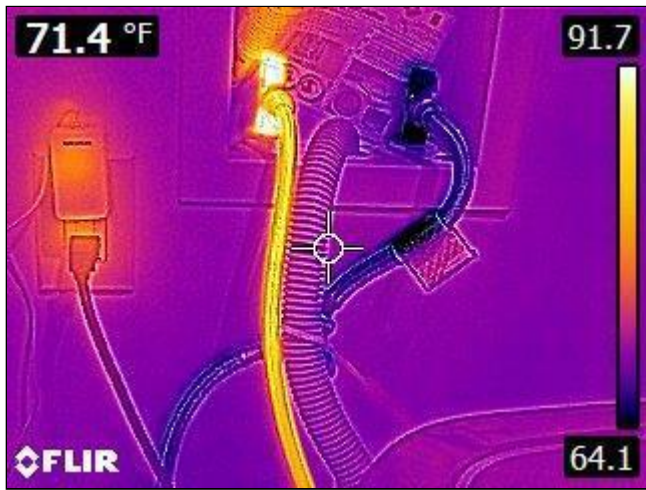
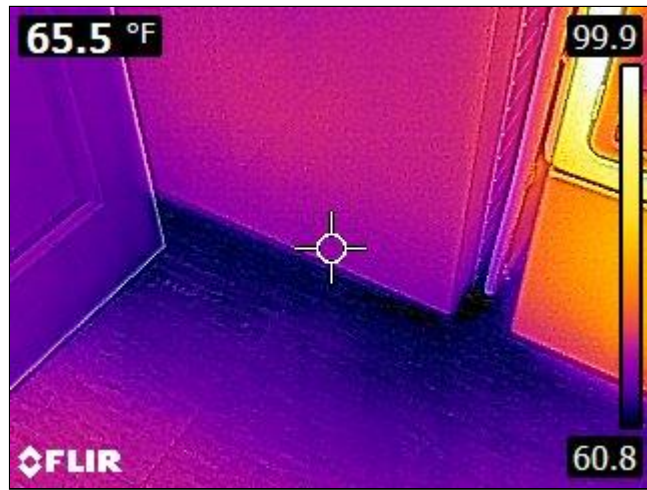
6.4 The clothes washer was run through a cycle and did appear to operate properly at the time of the inspection.

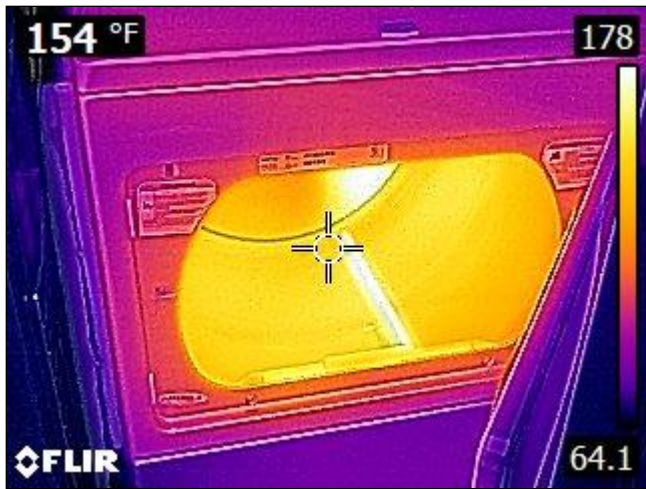
6.5 Item 1(Picture)

6.5 The dryer was tested and did operate at the time of the inspection.
