Inspection Report

Interior Exterior Home Inspection, Inc.

> Property Address Sample Report

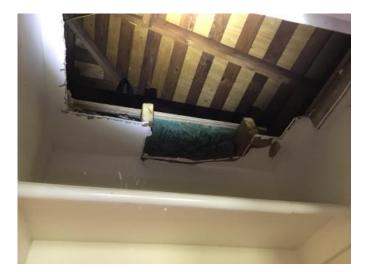
Southeast Bedroom Closet

Attic Access

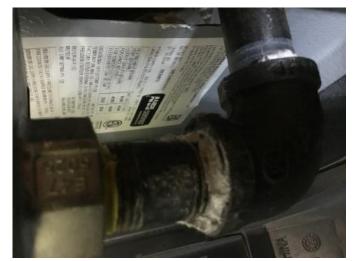
At the time of inspection, the fuel was off. Inspection of appliances that are shut down is not performed, therefore our review is very limited in scope. We suggest that the client obtain a full and complete inspection prior to close.

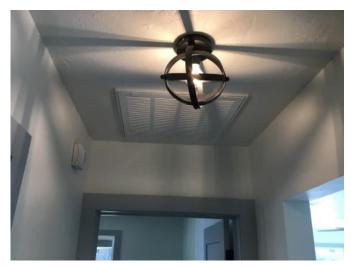
Hallway Filter

Disposable. Recommend changing filters every 30 days.

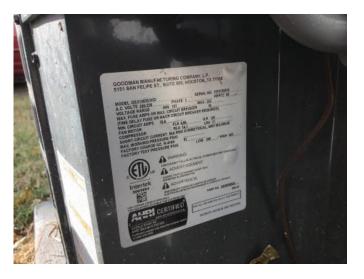
The outside air temperature was below 65 degrees within 48 hours of the inspection. Operating the system at this temperature could damage the system, therefore the inspector was unable to operate and test the system at the time of inspection. We suggest that the client obtain a full and complete inspection prior to close.

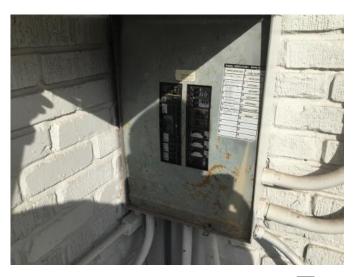
The electrical capacity of main breaker was unlisted.

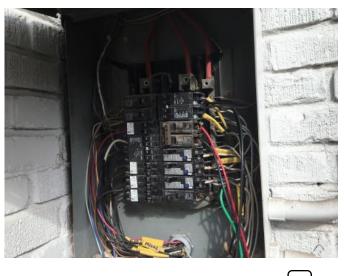
6.3) Electrical Panel Conditions

The inspector was unable to determine the amperage due to no main breaker present. Today's standards require main breakers.

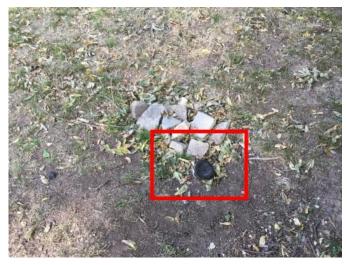
Drain Cleanout

The visible portions of the waste lines appeared to be in serviceable condition at the time of inspection. All of the waste lines were not fully visible or accessible at the time of the inspection.
