Home Inspection Report

4 Main Street, Anytown, NC 28173

Thursday, April 11, 2019

0411191

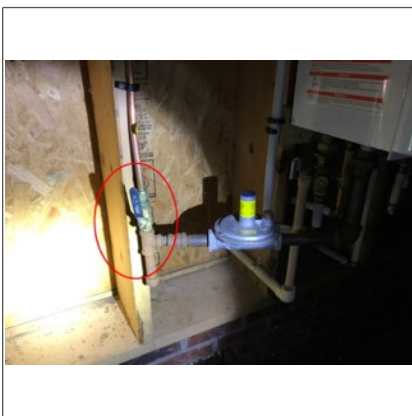
Water heater unit	<ul style="list-style-type: none"> •Water heaters have a typical life expectancy of 7 to 12 years. The existing unit is approaching the middle of this age range. One cannot predict with certainty when replacement will become necessary. •The Temperature and Pressure Relief (TPR) Valve serving the water heater is leaking slightly. Minor repairs or cleaning can usually rectify this condition.
--------------------------	--
