Inspection report for the property at
6543 Sample Townhome Report, Bainbridge Island, WA
98110

This report is prepared exclusively for **Nick Savage**
On: **2021-09-22**

Orca Inspection Services, LLC
(206) 713-5715

Inspected by: Dylan Chalk
WA State Pest License #: 65540
WA State Inspector #: 365

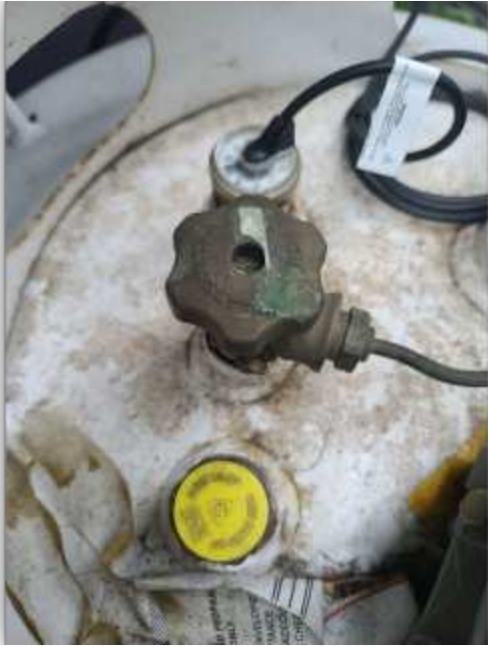
This shows the propane shutoff at the propane tank.

📷 (FSD-1) Recommended Disclosure Items: There seems to be a fill sensor on the propane tank that can alert the propane provider to the need for refilling. Disclose any additional information about this.

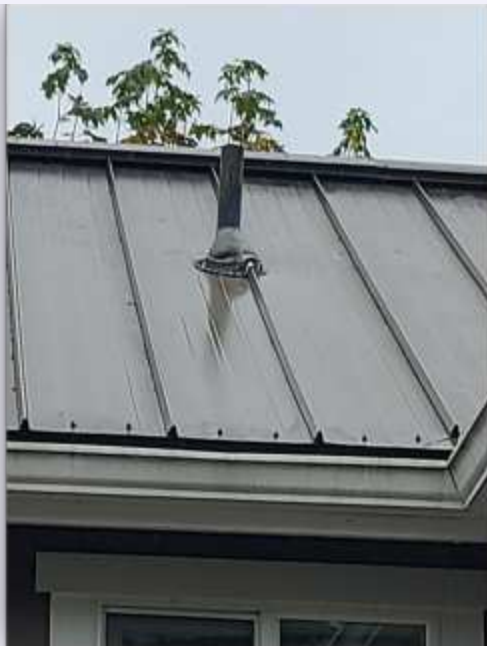
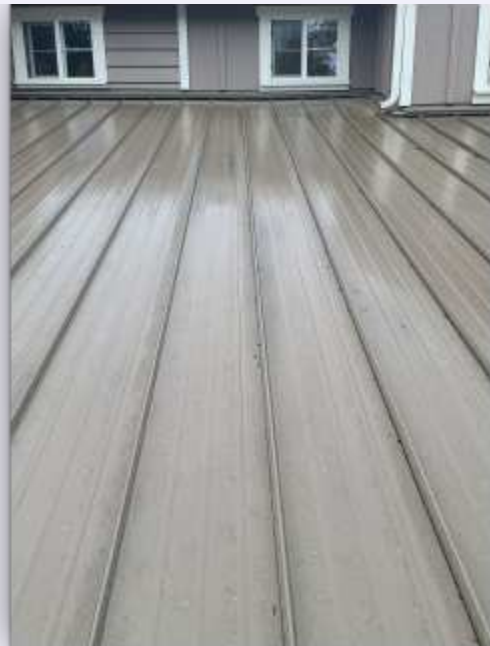
RCG-1 Home Owners Association: The roofing material on this home appears to be a recently installed standing seam [metal roof](#). These are often rated as 35-year roofing systems. In practice, service life depends a great deal on the quality of the roofing material, the quality of the installation, the steepness of the roof, roof design and the amount of exposure. The installation appears neat and professional. Inquire with the HOA regarding any installer or warranty information for this roof. Many professional roofing companies will offer limited workmanship warranties. In general, the weak points on metal roofs are flashings around penetrations where often sealant is used. Over time this can break down and fail and require tune up. Visual inspection could not find a need for repairs at this time.

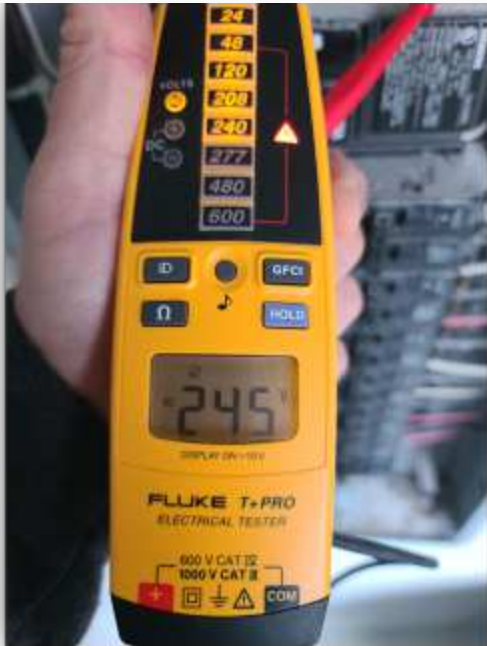
I tested the voltage at the electric panel today. It tested in a normal range of 235-245 volts. Most residential construction is listed as 120/240 volts. Slight fluctuation is normal.

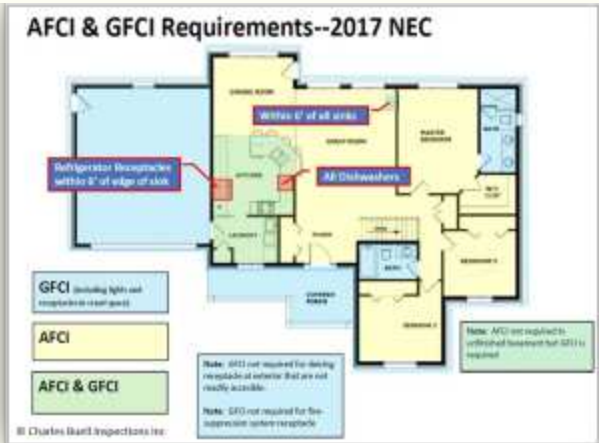
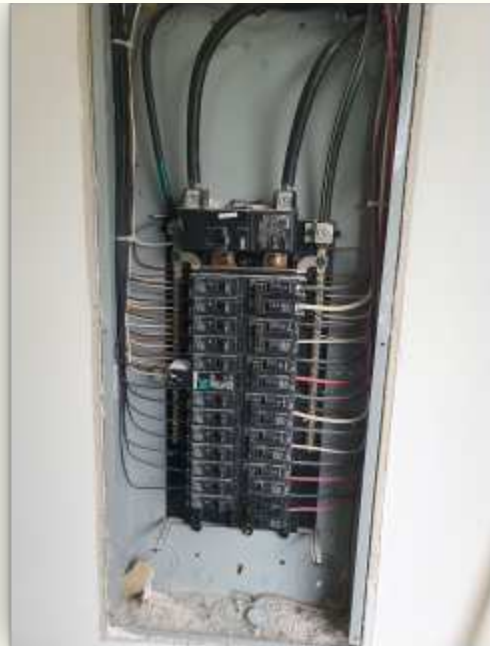
✦ **(ES1-3) Inspection Notes:** AFCI (arc fault protection) is now required on all branch circuits supplying outlets or devices installed in residential dwelling unit kitchens, family rooms, dining rooms, living rooms, parlors, libraries, dens, bedrooms, sunrooms, recreation rooms, closets, hallways, laundry areas, and similar rooms and areas. The goal of this protection is to reduce risks of electrical fires. Consult with a licensed electrician about improving circuit protection as desired. ***Please note that if you add or replace receptacle outlets to the existing system, they should comply with modern AFCI standards.***

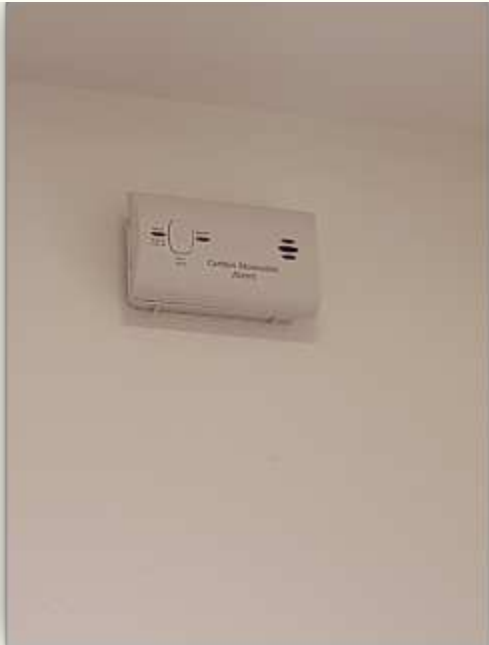
✦ **(EDFW-3) Inspection Notes:** Carbon monoxide alarms were found and noted during inspection. Be sure to check these regularly. The standard is 1/ floor and 1 outside all sleeping areas.

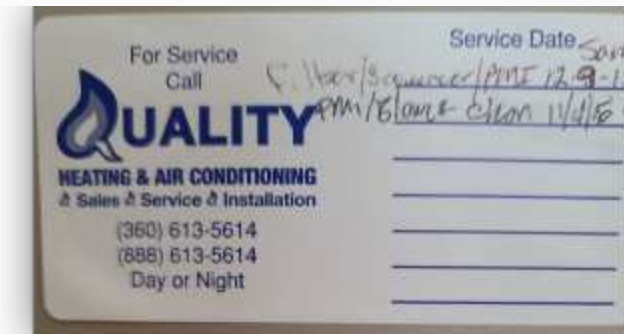
This photo shows the most recent service records found on the heating equipment during inspection.

⚠ (HCFV-1) Recommended Maintenance: Annual servicing of the electric forced air furnace is recommended for safe and reliable heat. I could not find recent service records on the furnace, so a servicing is recommended. The furnace was tested during inspection and was operational. Examples of observations noted during inspection include:

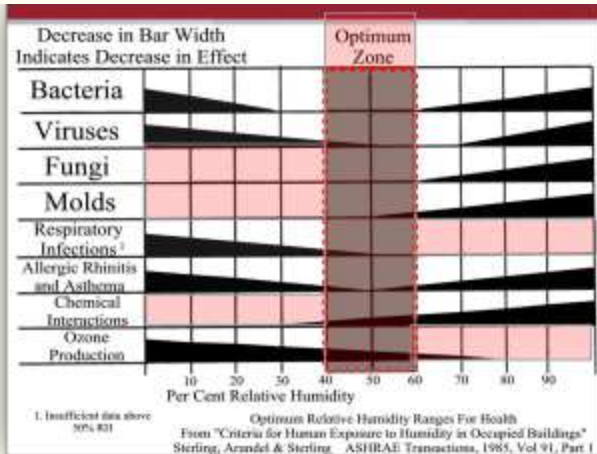
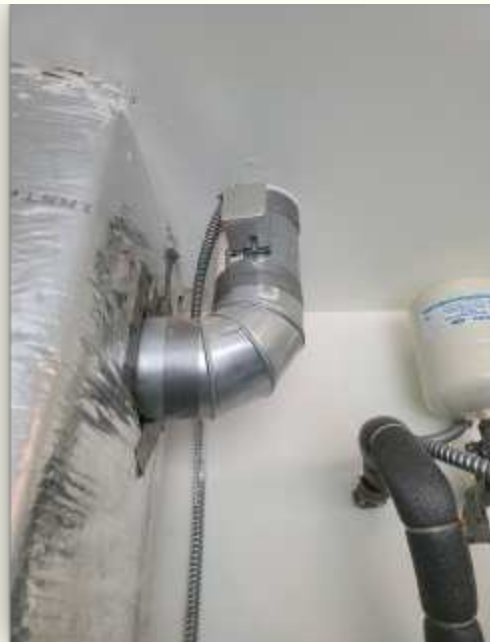
✦ **(HCFV-5) Inspection Notes:** The HVAC system has a fresh air fan installed. The goal of this fan is to provide fresh air for the house and to control relative humidity. During winter months try and keep relative humidity around 50%.

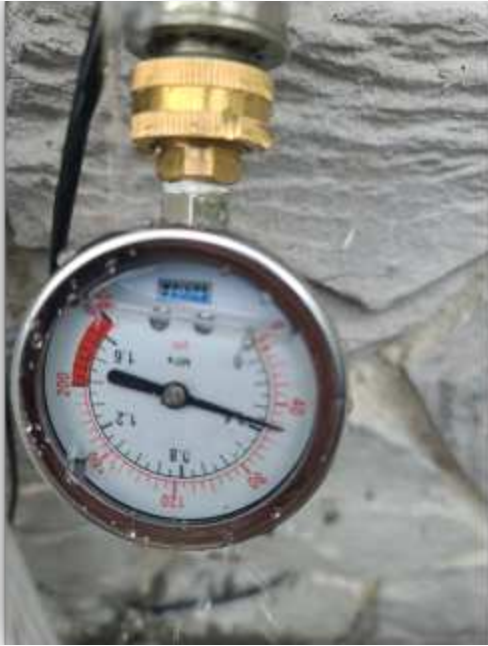
This shows the water pressure tested during inspection. Generally, "normal water pressure," should be between 30-80 PSI, though pressures near or below 30 can result in poor functional flow to fixtures. Water pressures in excess of 80 PSI risk damaging supply piping components and should be controlled with a pressure reducing valve.

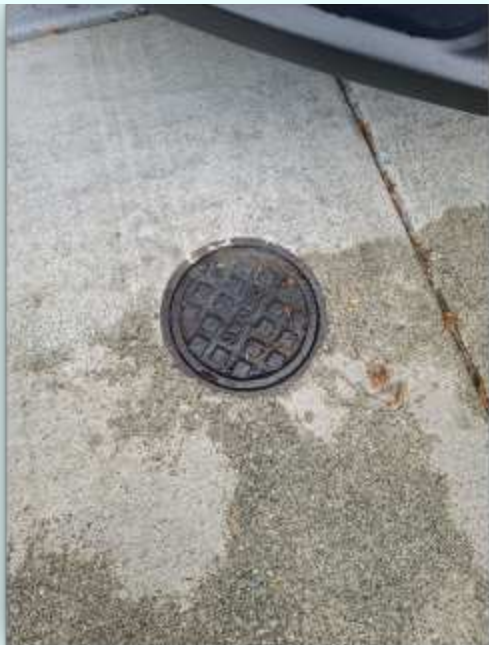
📹 (P2-2) Recommended Disclosure Items: An evaluation of the sewer line below the ground is beyond the scope of this inspection. Due to the age and location of the building, a sewer scope is recommended to further evaluate the sewer line and the below ground connections between the house and the municipal sewer line. Sewer scopes are done using video cameras and can reveal the materials, condition and reliability of the sewer line. If that has been done recently, I recommend disclosing available information. If this has not been done recently, this would be valuable information to disclose to a buyer.

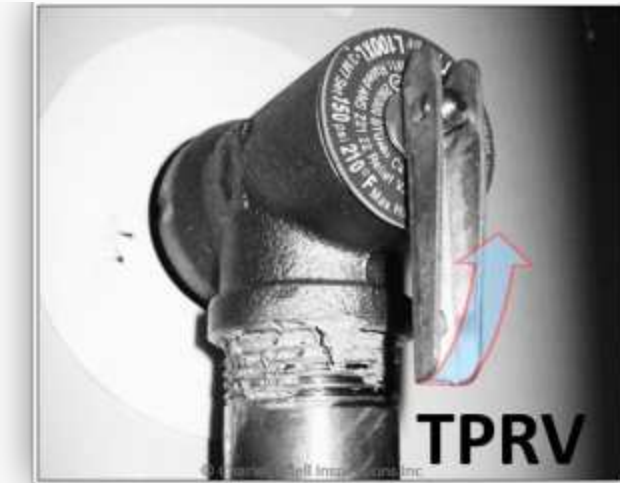
Most codes defer to manufacturer instructions and I favor those recommendations. The yellow tag on the valve states clearly the termination should be 6" above the floor which is more consistent with the UPC code requirements.

The arrow shows how a TPRV can be tested

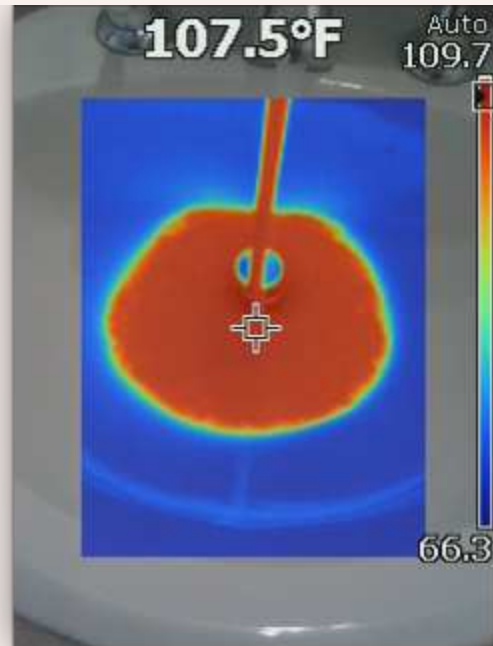
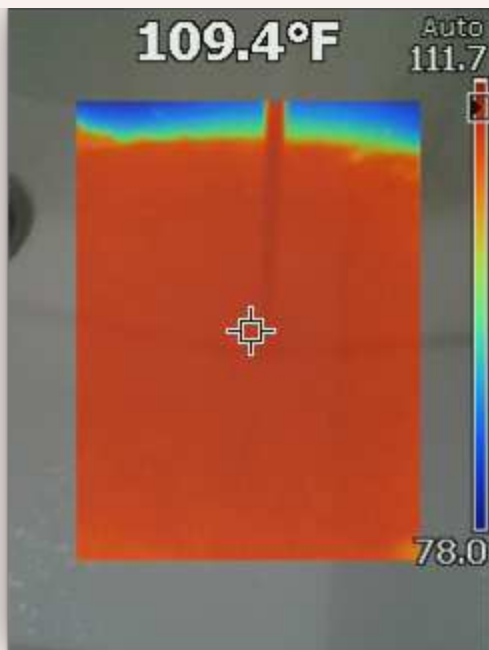
🔧 (P2-3) Recommended Maintenance: The water heater temperature seemed to be set too low at the time of inspection - just 107 degrees F. The range of 120-125 degrees F is the generally recommended temperature. This is nearly impossible to measure precisely during a home inspection as water temperature can vary between fixtures. I try and test the water temperature in several places and take the median reading. Adjust water heater temperature as needed. For best practice, set water temperature at the water heater to 130 degrees F and use a tempering valve to set water temp back to a safe 120 for domestic use. This high tank temperature will reduce risks of Legionella developing in the tank and the tempering valve will ensure a safe water temperature.

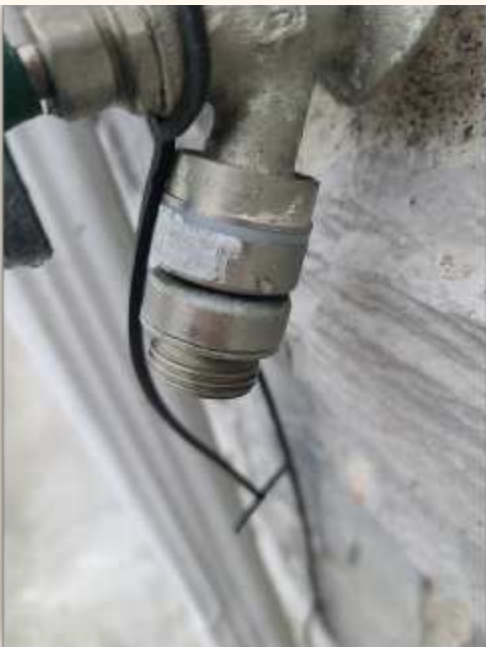
This shows the anti-siphon present at the garage side hose bib

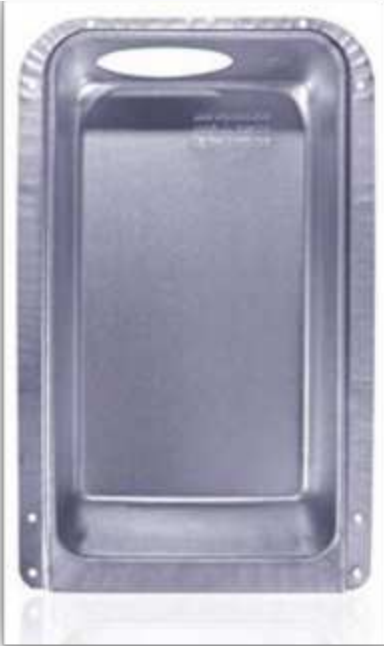
This shows an example of a dryer vent box

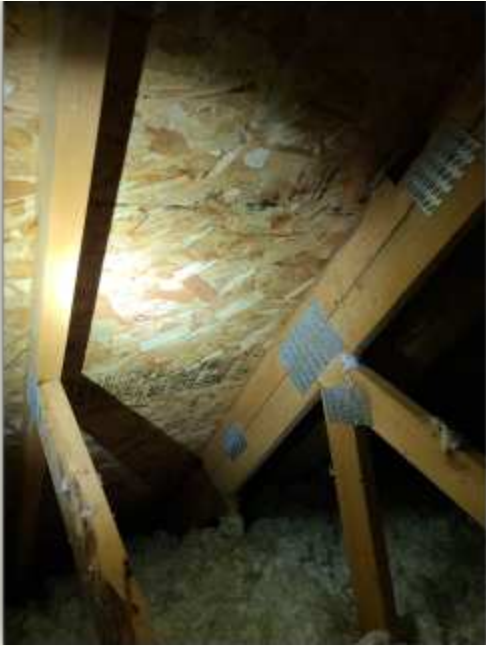
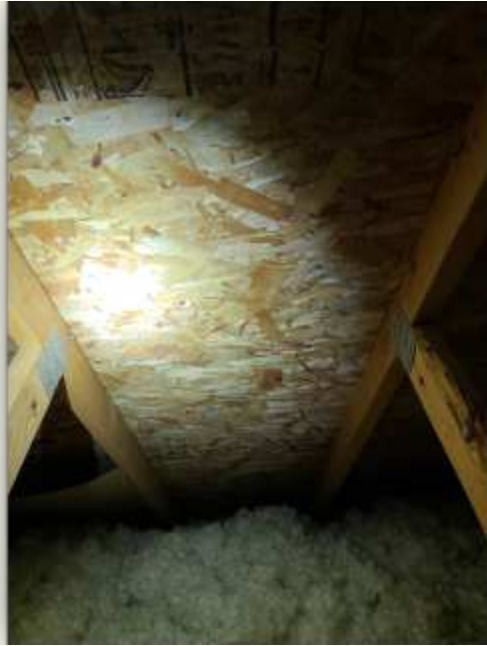
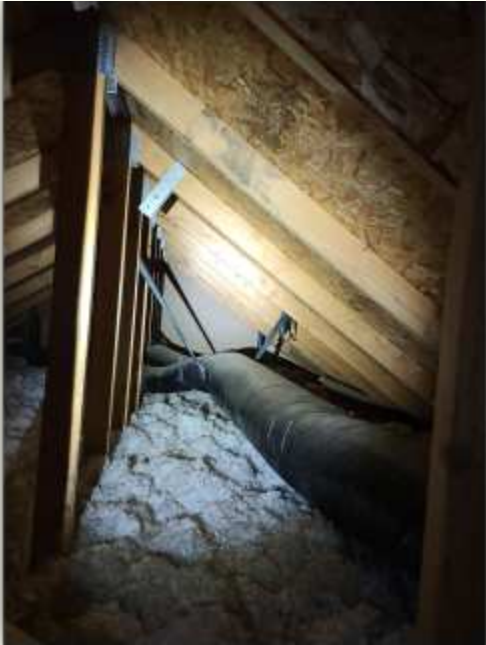
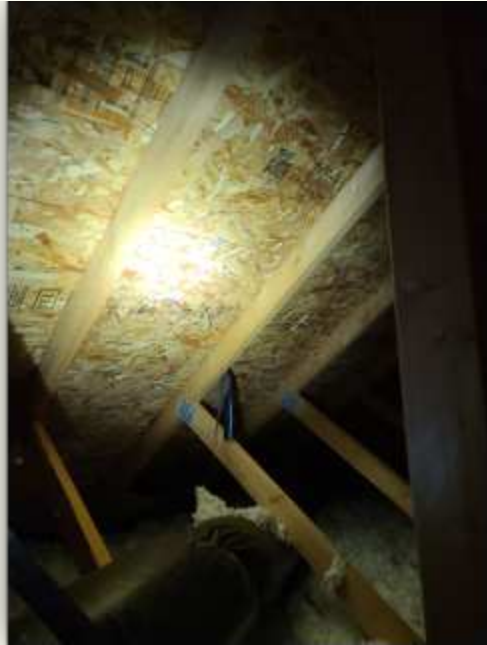
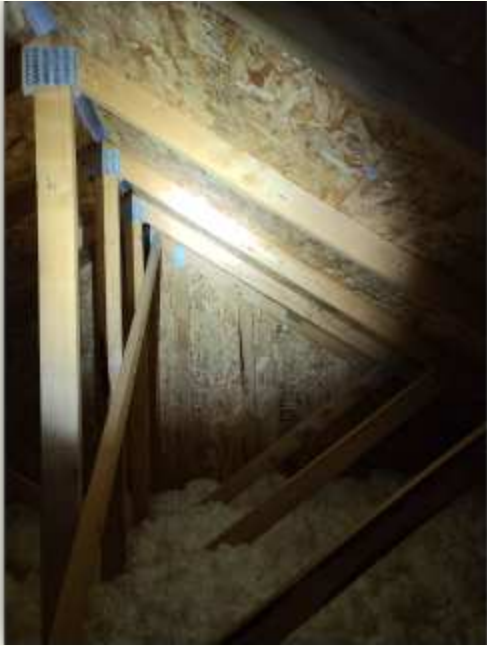
✦ **(A-2) Inspection Notes:** I inspected the attic space today and no red flags were noted regarding prior moisture build-up or relative humidity. Venting appeared unrestricted where visible. Wood has a nice bright color indicating no prior moisture problems with relative humidity or heat migration into the attic.

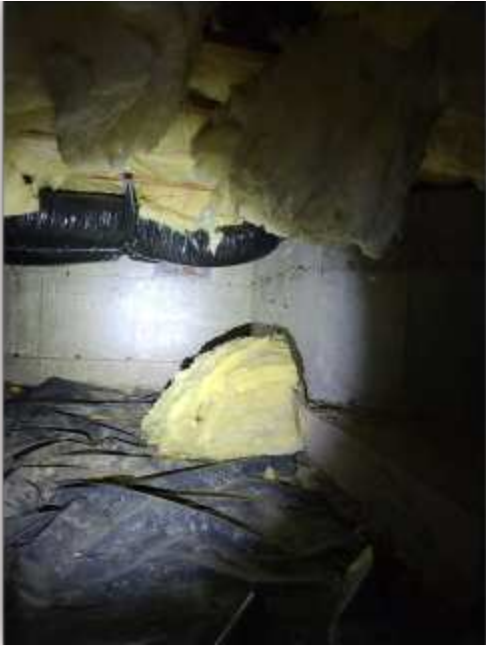
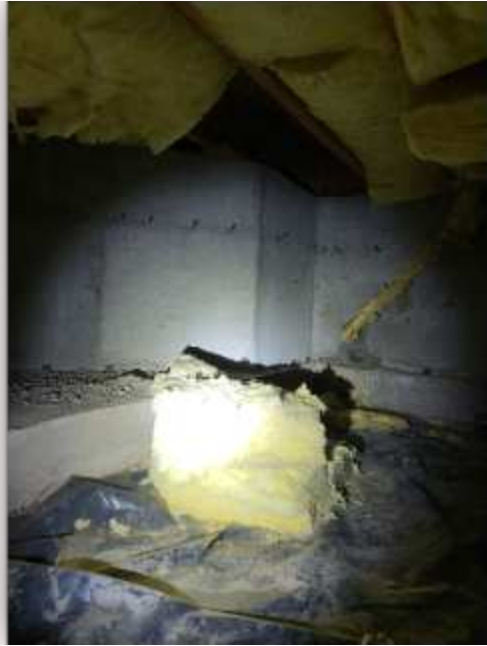
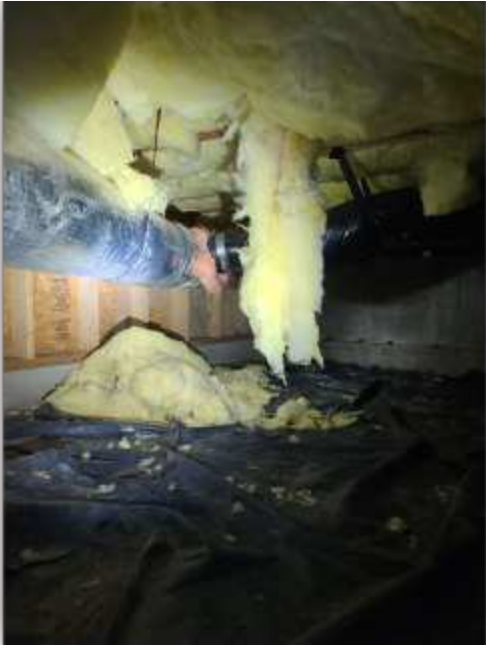
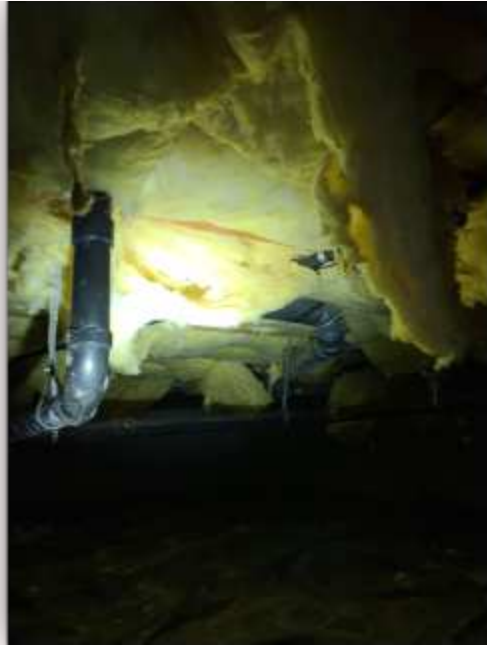
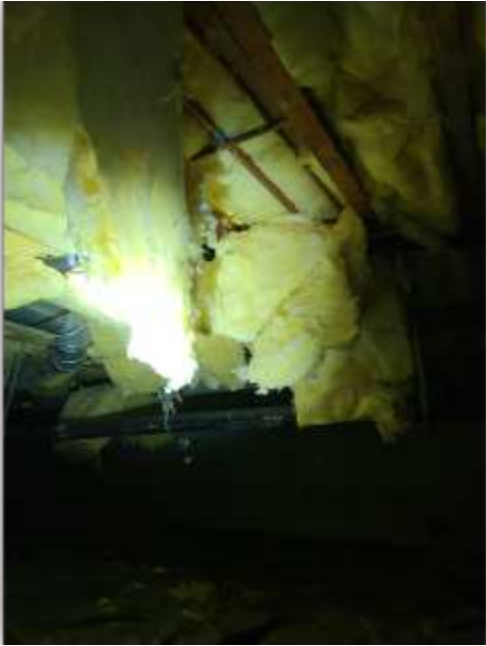
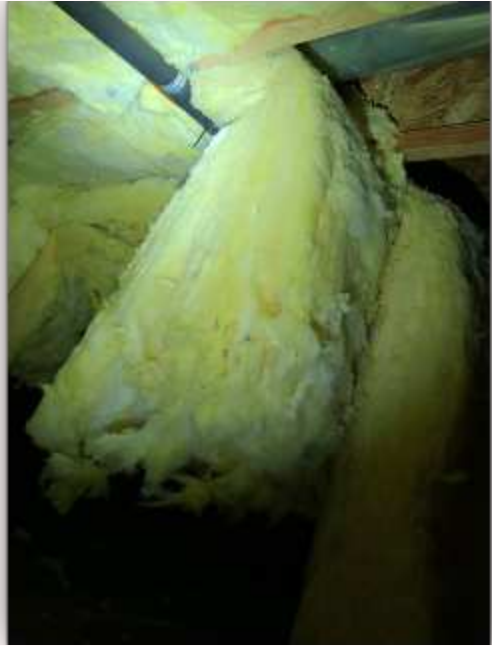
⚠️ 🐭 **(CS3-1) Major Concern:** Overall, numerous repairs are needed to the crawl space below this house. I have made a series of detailed observations in the base of this report and below in this observations but given the extent of repairs I recommend further evaluation of this crawl space by a licensed general contractor who specializes in crawl space clean-up as additional repairs could be needed that are latent or concealed. Examples of observations noted during inspection include:

- Pipe insulation is incomplete on supply piping
- The plastic vapor barrier is rodent damaged and incomplete in places
- The sub-floor insulation is rodent-damaged and requires repair and replacement
- Wood debris should be cleaned from the floor.

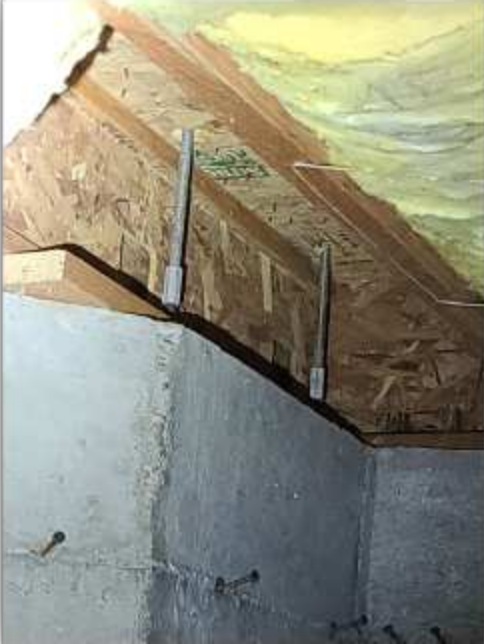
Signs of seismic protection noted during inspection. This inspection is not a cohesive analysis of seismic engineering, but I do look for signs of seismic protection.
