FINAL REPORT Water Quality & Conservation Grant FY21 Coronado Soil and Water Conservation District Restoration of Suela [Ciruela] Lateral Las Acequias de Placitas

PROJECT TITLE: Restoration of Suela [Ciruela] Lateral

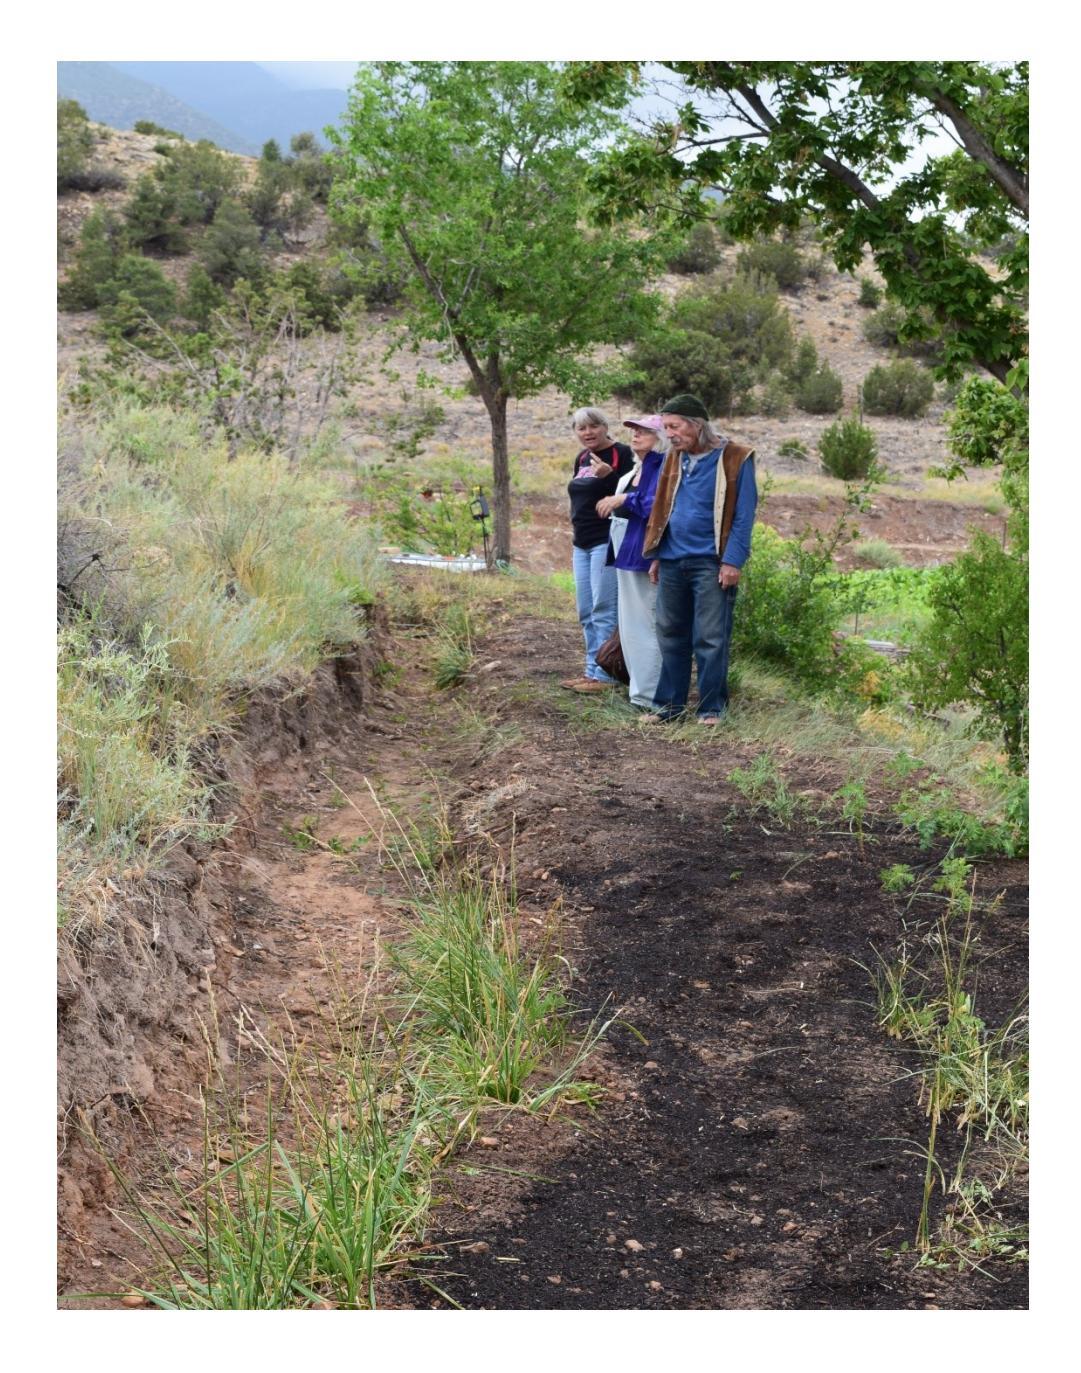
Snow Watson, Carolyn Kennedy and Lynn Montgomery Inspecting Restored Lateral

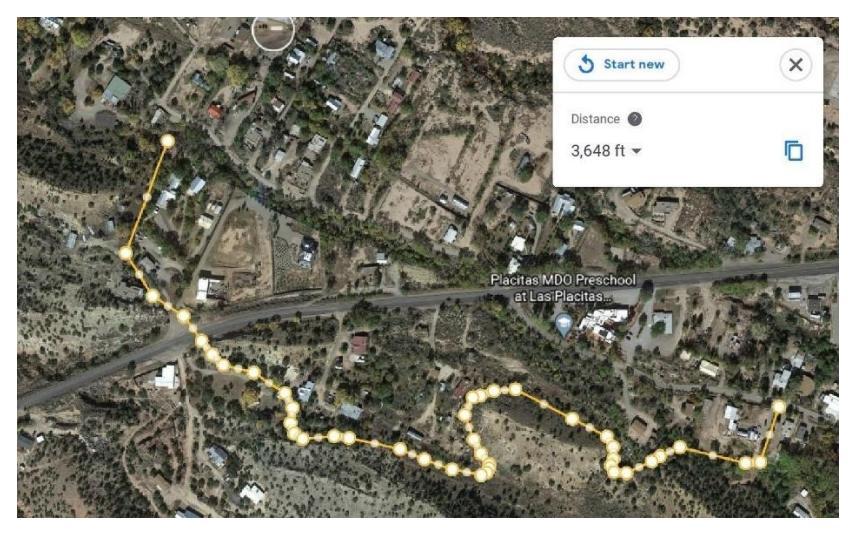
FROM RIGHT (UPHILL) THE SUELA [CIRUELA] LATERAL BEGINS BETWEEN 16 AND 22 PASEO DE SAN ANTONIO, PLACITAS, NEW MEXICO, AT THE CONTROLS. THE ACEQUIA LATERAL TRAVELS THRU THE LOWER REACHES OF PLACITAS AND CROSSES NUMEROUS ARROYOS/WASHES ON ITS WAY. THE ACEQUIA THEN INTERSECTS HIGHWAY 165 AND CONTINUES NORTH THRU SEVERAL PROPERTIES. THE IRRIGATION WATER IS THEN RETURNED TO THE ORIGINAL PATH OF THE SUELA [CIRUELA] ARROYO AS IT TERMINATES.

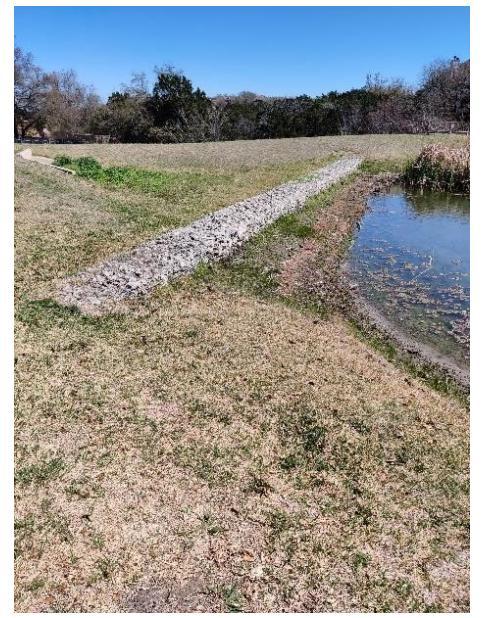
DESIRED GABION DESIGN

The work completed in this report was done as part of phase one of the Suela [Ciruela] Lateral project. Future objectives fall under phase two. These with will build on the work already accomplished. An FY2022 WQ&C grant was applied for and received. The water breaks put in will be updated with gabion blocks for a more permanent fix for sediment collection and flooding of the acequia. Lining the acequia is another objective that will reduce water loss. This will be essential as drought continues.

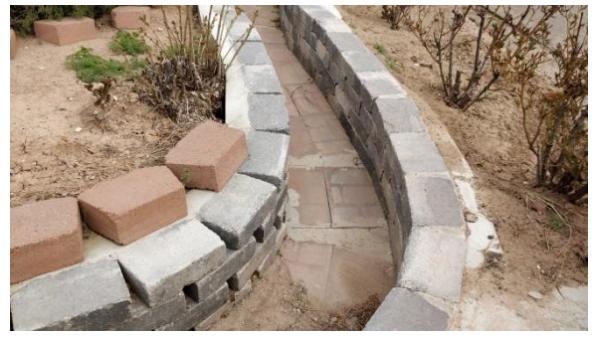
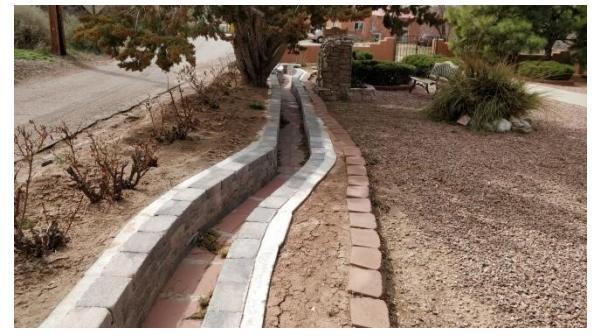
EXAMPLE OF LINED ACEQUIA AT SAN ANTONIO MISSION CHURCH
