Road Safety Audit Report

Location: Bogong High Plans Road, Falls Creek, Victoria
Issue: Proposed Change Above Windy Corner
Audit Stage: Concept Design
Client: Jonathan Spring

Report Issue Date: 12 August 2022

RSA Reference: 12931

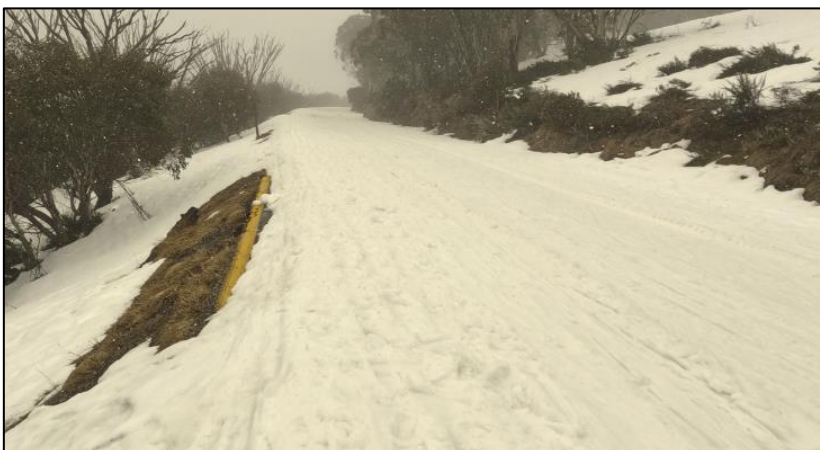
The road cross section of this subject length, south of the Falls Creek centre, is likely to be similar in construction techniques to the section of road leading to Falls Creek from the northern side. It was measured to have a full width of ~6.5m and it likely consists of two 3.2-3.3m lanes for its majority, with narrower sections at some locations (described in the pages to follow). It appeared that the majority of the road length did not have shoulders, with the hinge-point of the cut batter (the 'drop-off') abutting the yellow edge-line. i.e. the road drops away at the edge line. As such, there appeared to be very little room for driver error. The overall width of this section of road + shoulder is approximately 6.5m, whereas a typical road lane width is 3.5m, plus curve widening, with even low-category roads having at least some shoulder.

- Road condition:** Narrow sections of road should be widened to have a consistent minimum road width to support the expected traffic volumes and types of heavy vehicles proposed to use this road (the project currently forecasts a significant increase in visitors using this road and it proposes that minibuses, buses and snow clearing vehicles will share this road. It is also reasonable to expect that freight vehicles, garbage disposal vehicles and sewerage removal trucks will be required to service the ANARE building).

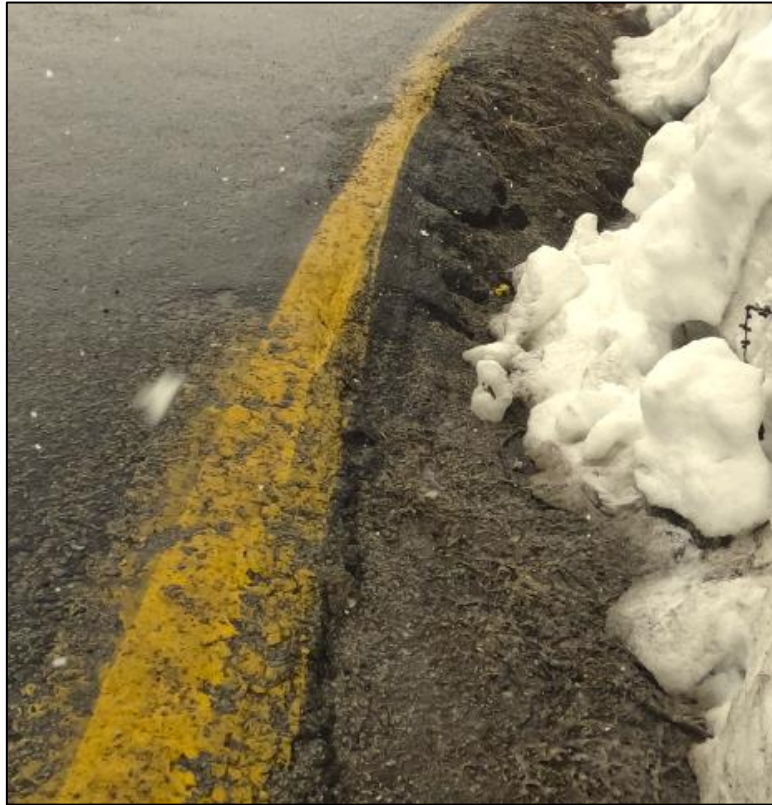
The table drain on the fill side (the hill) couldn't be seen, however, based on the section of road near Windy Corner, it is assumed to *also* be hard up against the edge line.

*The subject section of road in question, under the snow south of Falls Creek, is expected to be similar to the table drain in the image above, which is just north of Windy Corner.

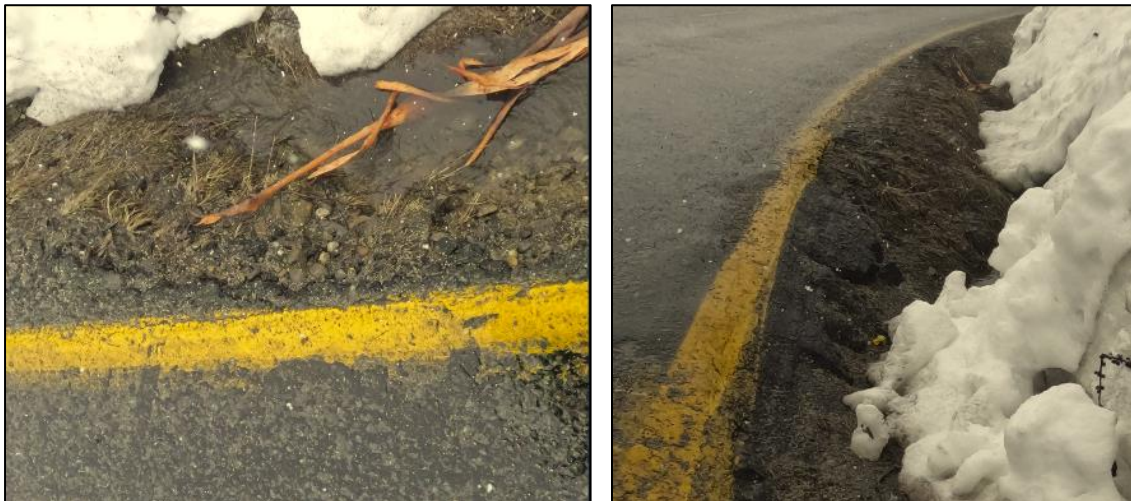
In general, it is likely in winter that the ground under the road surface, and abutting the road edge, has a higher moisture content. This would reduce its structural integrity thereby resulting in a softer pavement and increasing the risk of damage to the road and slippage (subsidence) of the road edges with passing vehicles. This risk of road edge slippages would increase with larger vehicles including buses, snow clearing equipment, freight vehicles and potentially sewerage and garbage collection vehicles.

Images of typical edge of pavement are shown below, taken near Windy Corner.

The pavement condition should also be checked to identify weak areas that are at high risk of slips. As an example, a typical stabilisation + safety barrier approach is shown below.

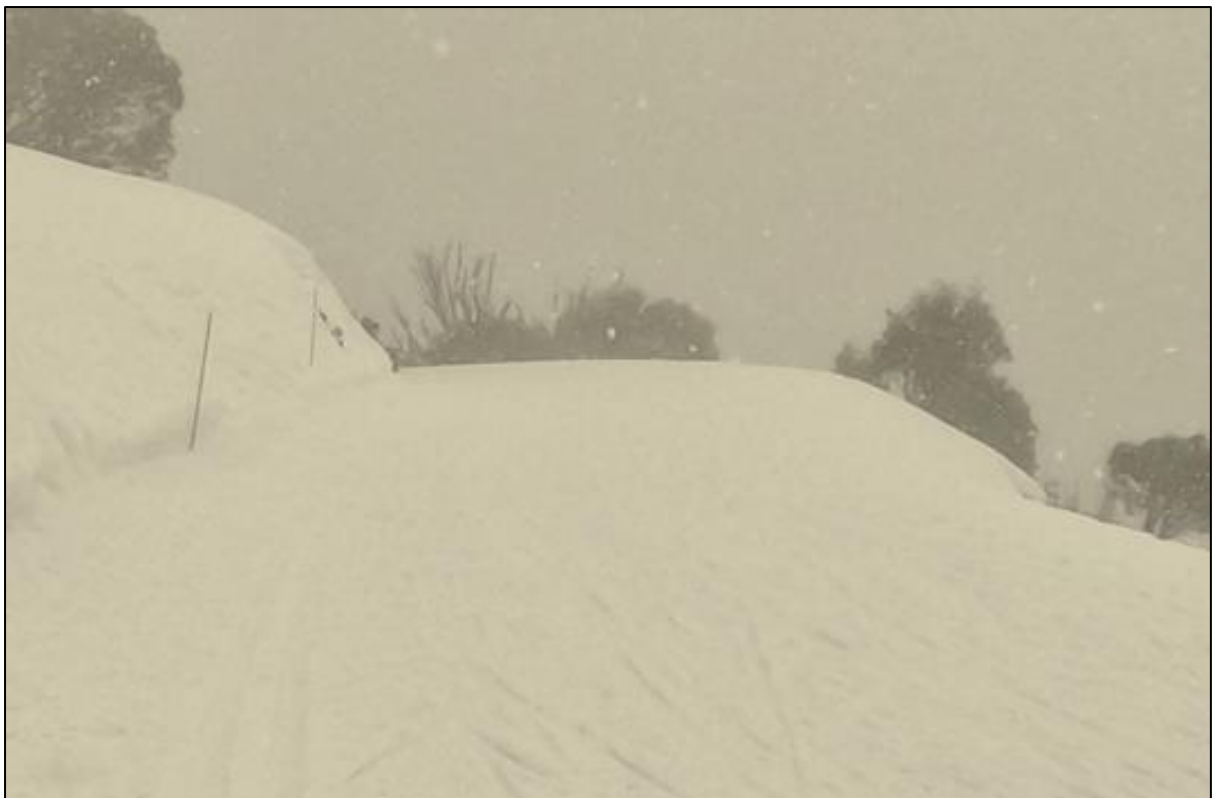
Looking north

Other narrower road section is the first corner south of Windy Corner, estimated at 6m.

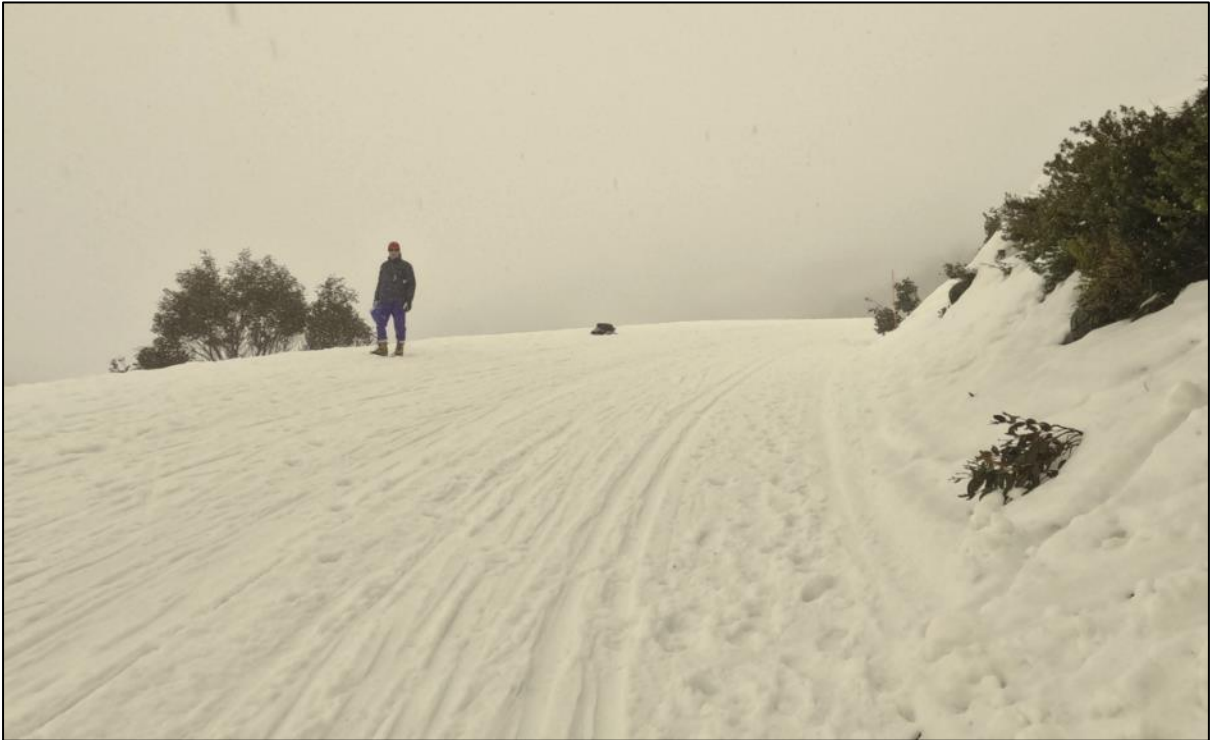
At the first curve

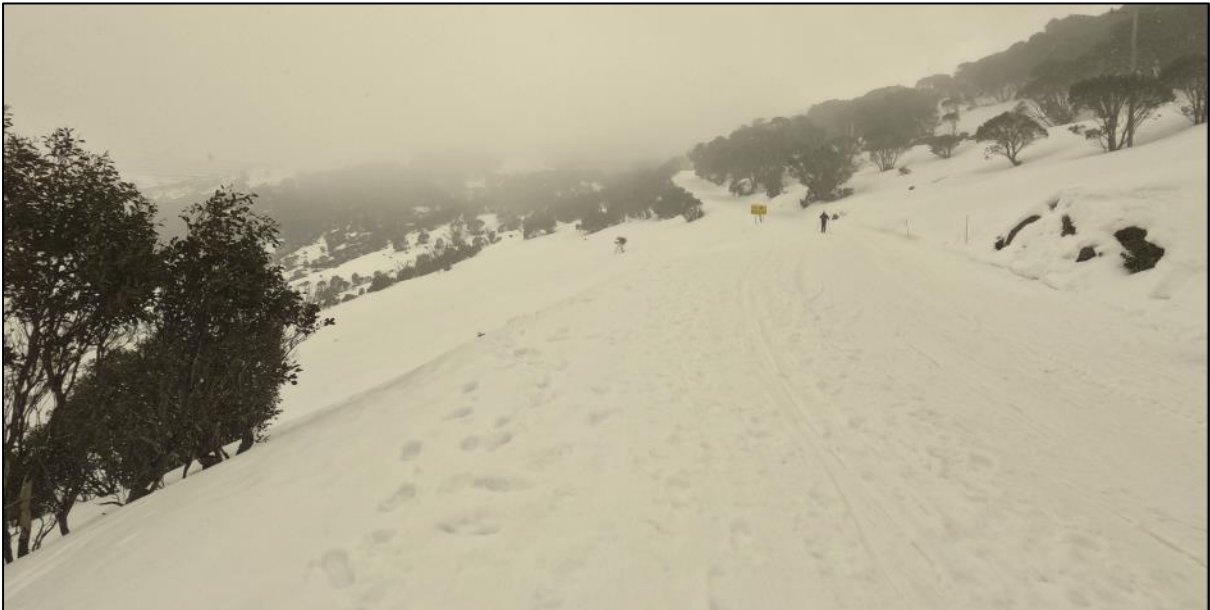
It's understood that the edge of the road has subsided in the area below (adjacent to the existing sign), just north of the Nordic Bowl. This section has a reduced width of approximately 5.5 to 6m (conservative estimate).

Towards the area of the road that has slipped

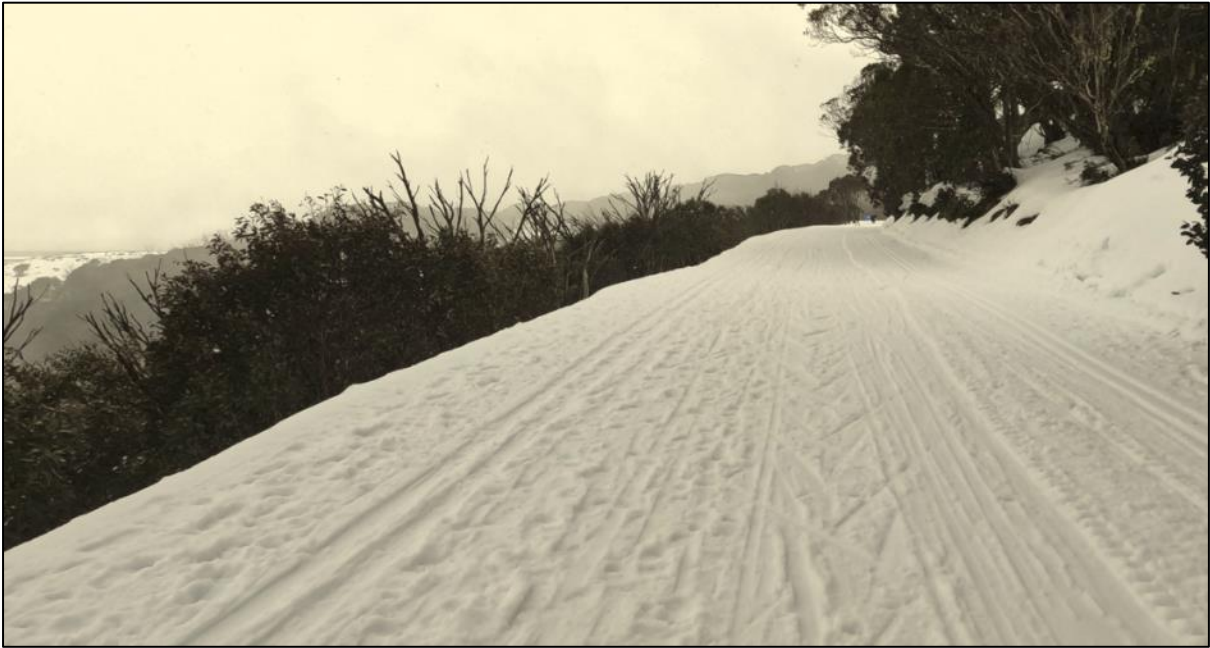
Past the road that has slipped and towards the 'Nordic Bowl' intersection

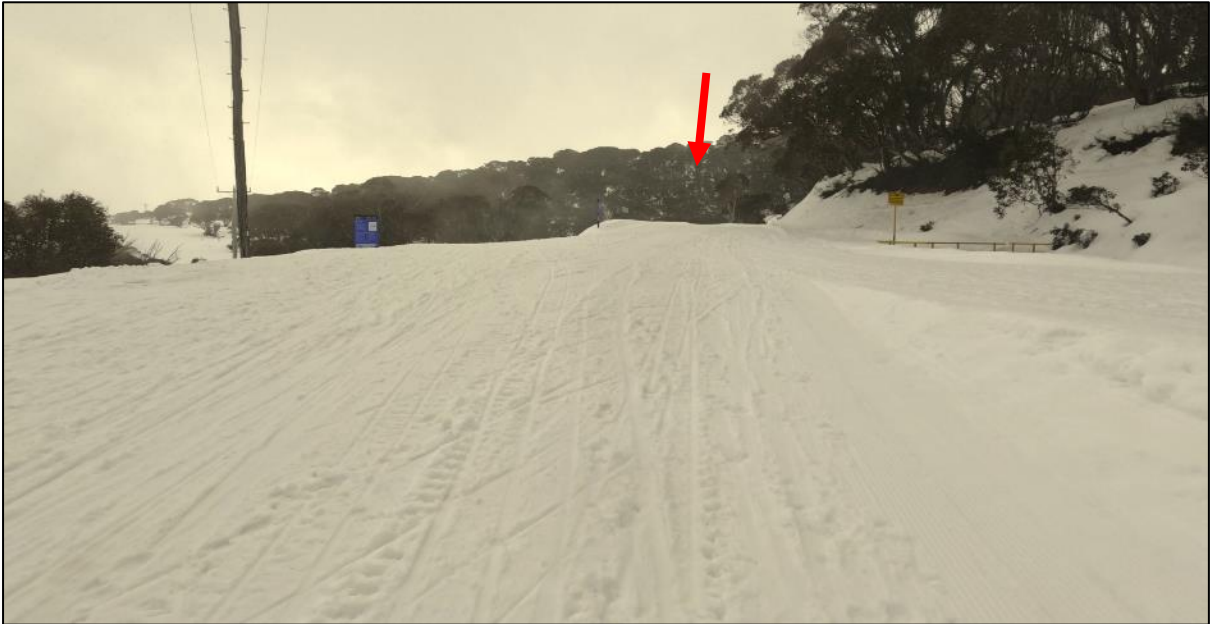
At the bowl intersection with the trail on the right and the bowl area off to the left with the road continuing as per arrow

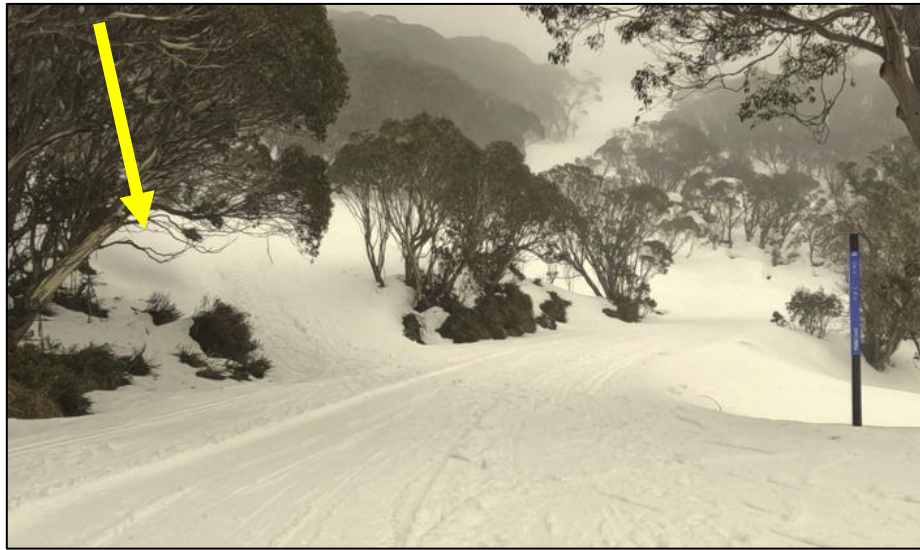
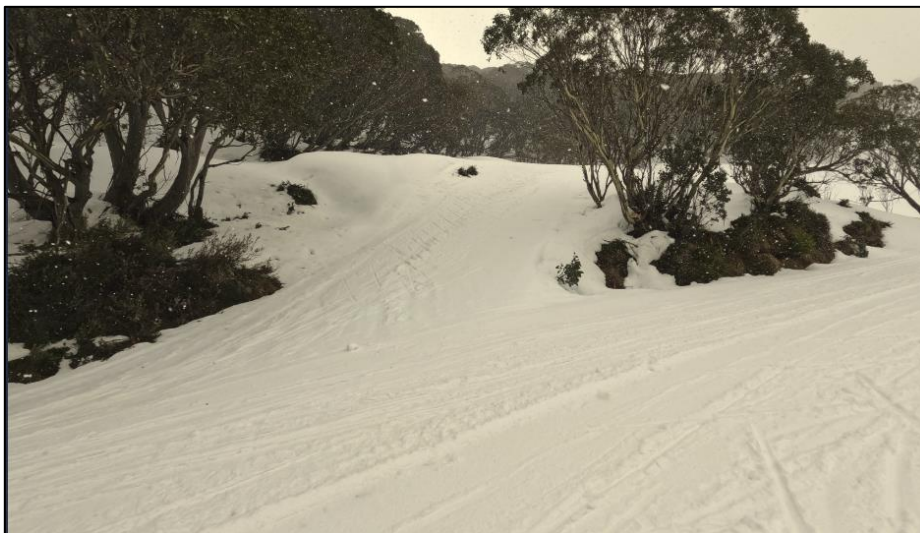
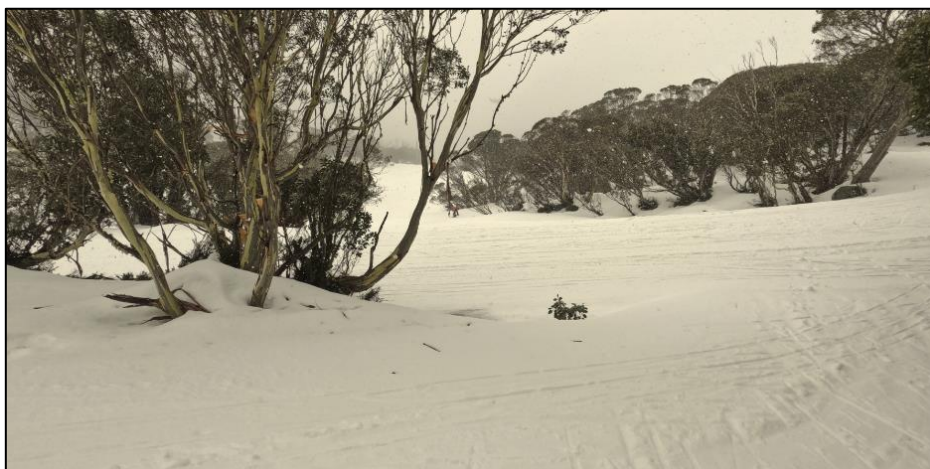
A typical intersection with a cross-country ski trail is shown below. It has a steep approach and limited sight distance until right at the road. It is assumed to be unlikely that this trail could remain open if the road is cleared as the associated risks would be high.

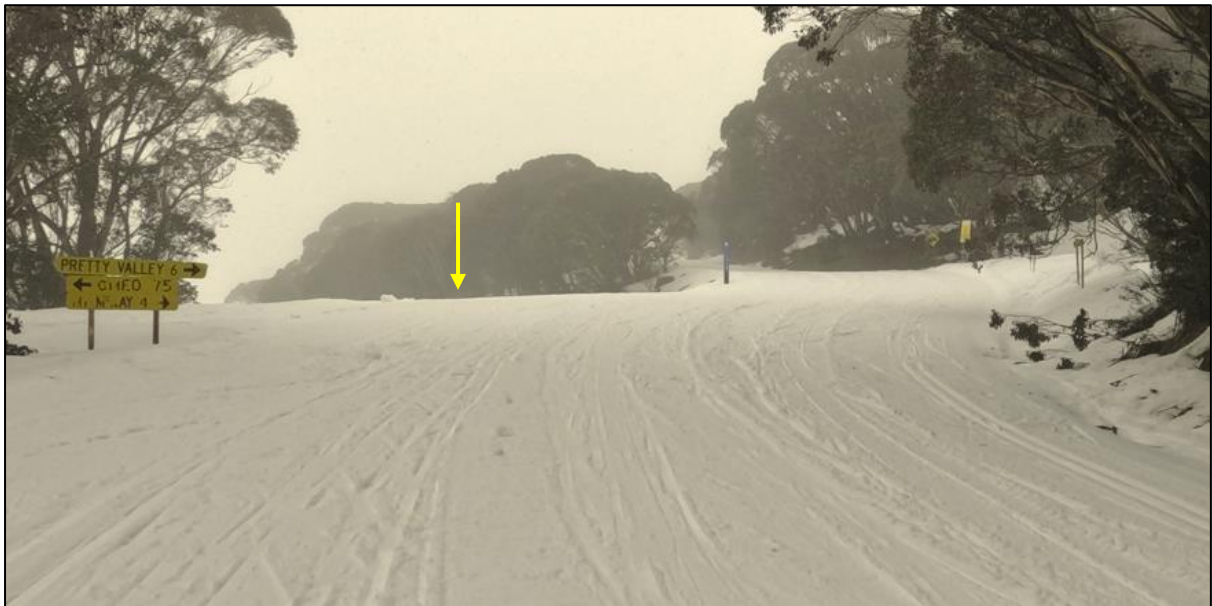
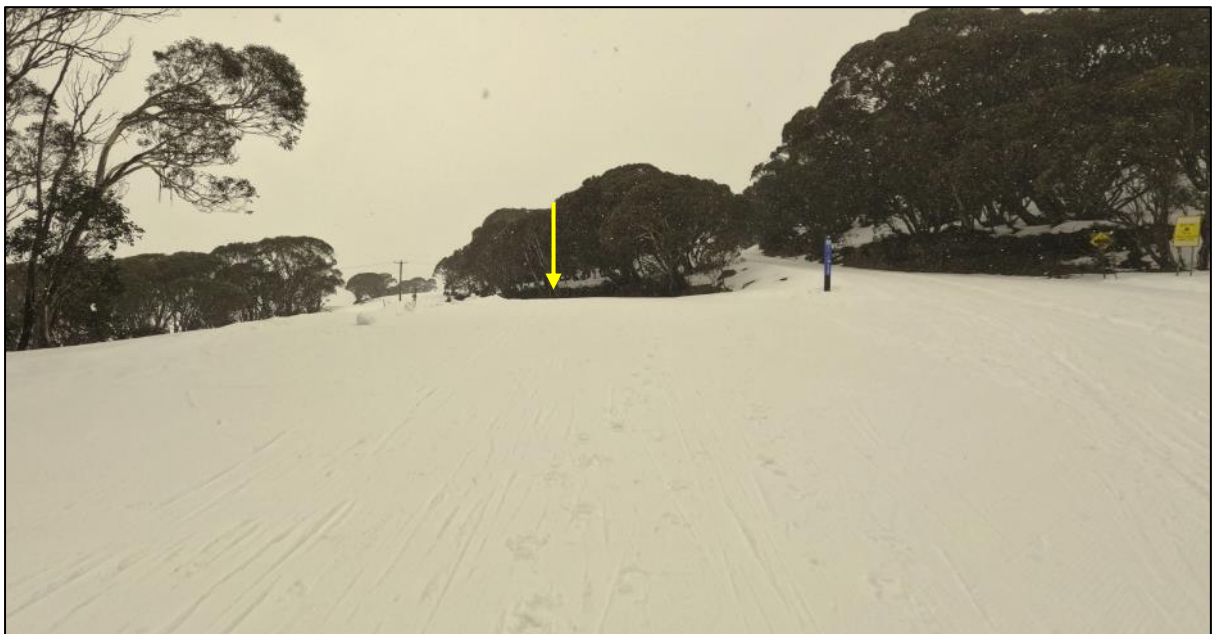
Another key intersection apart from the bowl, with a skier-only trail (in winter), is where Mount McKay Road (to AGL corner) splits off to the right, with the road continuing left as per arrows.

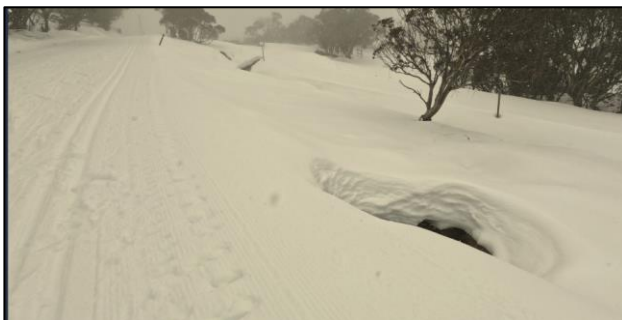
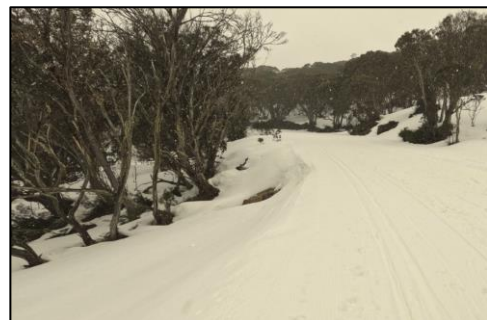
Typical roadside features that could result in occupant injury from point hazards or vehicles overturning included: the steep batters which were mostly 2(h):1(v) at their flattest, and as steep as 1:1; longitudinal drains at the bottom of embankments; deep holes formed from transverse road culverts; and trees of diameter 200mm+. The steep batters of 1:1 likely increase the risk of road edge slippage due to reduced structural support at those locations.

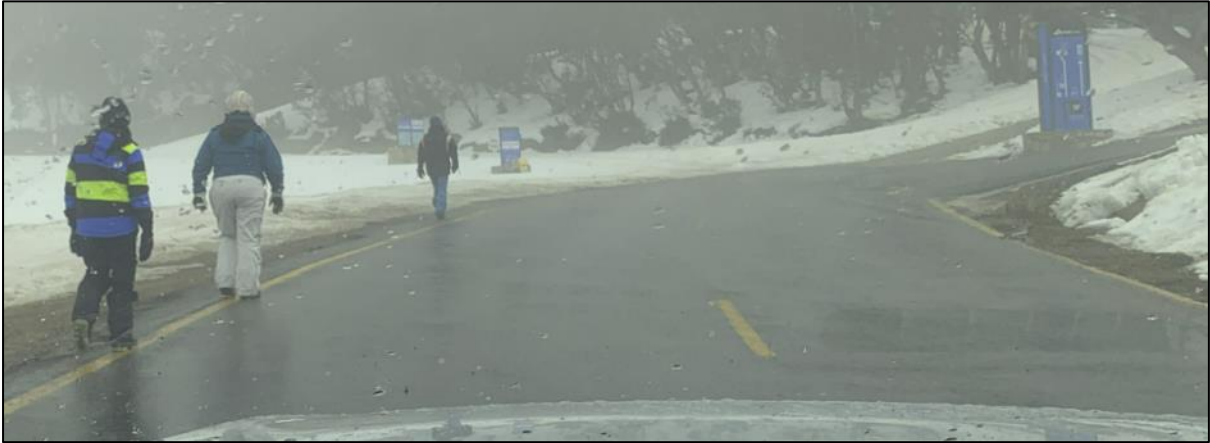
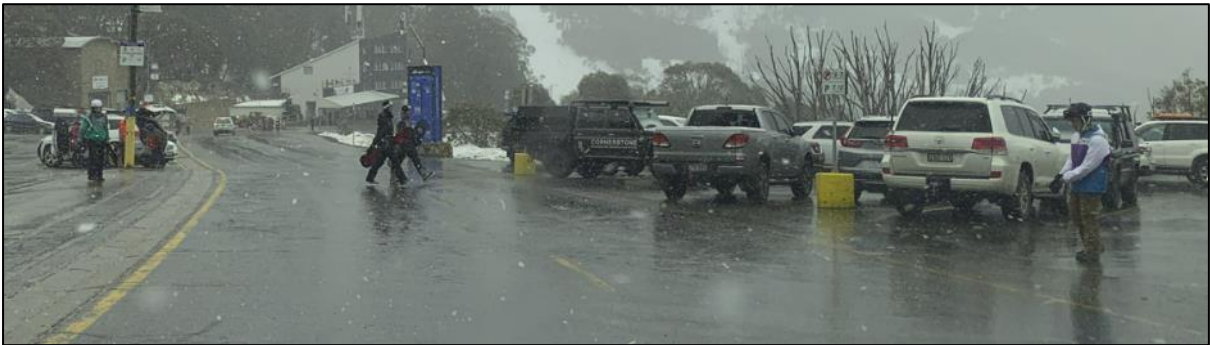
People seemed comfortable walking on and across the road between in and around Falls Creek village including the Windy Corner area. It is understood to increase significantly during school holidays and weekends with more visitors to the resort.

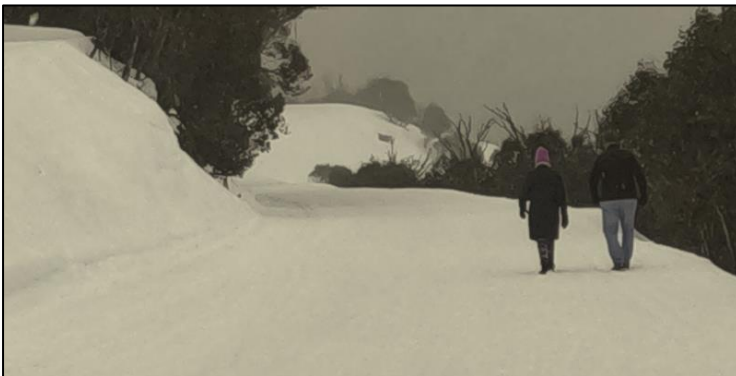
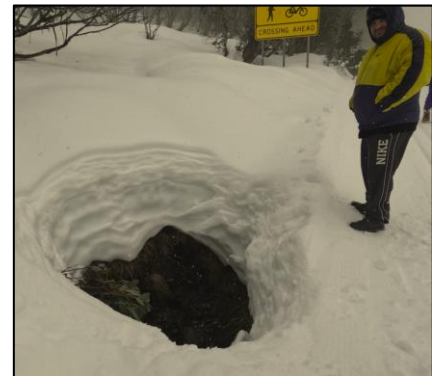
People were also observed walking on BHP road between Windy Corner and the Dam.

Therefore it is reasonable to expect that people will continue to walk on the (proposed) 'snow-cleared' section of BHP road between Windy Corner and the Dam. The ANARE project information confirms that shuttle-buses will be available for skiers and walkers to access the Bowl and ANARE building however it is highly likely, based on the current user behaviour at Falls Creek, that many people won't wait for a bus (and therefore walk), or would simply prefer to walk on BHP road from Windy Corner to the Dam regardless of buses. It is proposed that skiers could access the Bowl via the aqueduct trail. However, it is unknown whether the majority would do this rather than walking on BHP road.

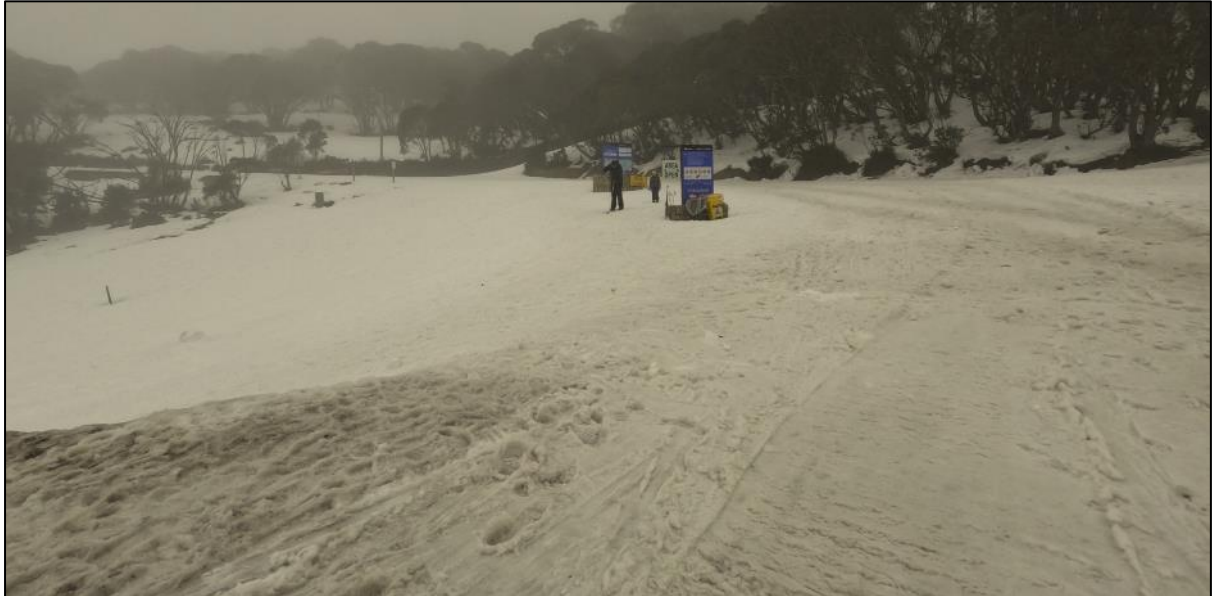
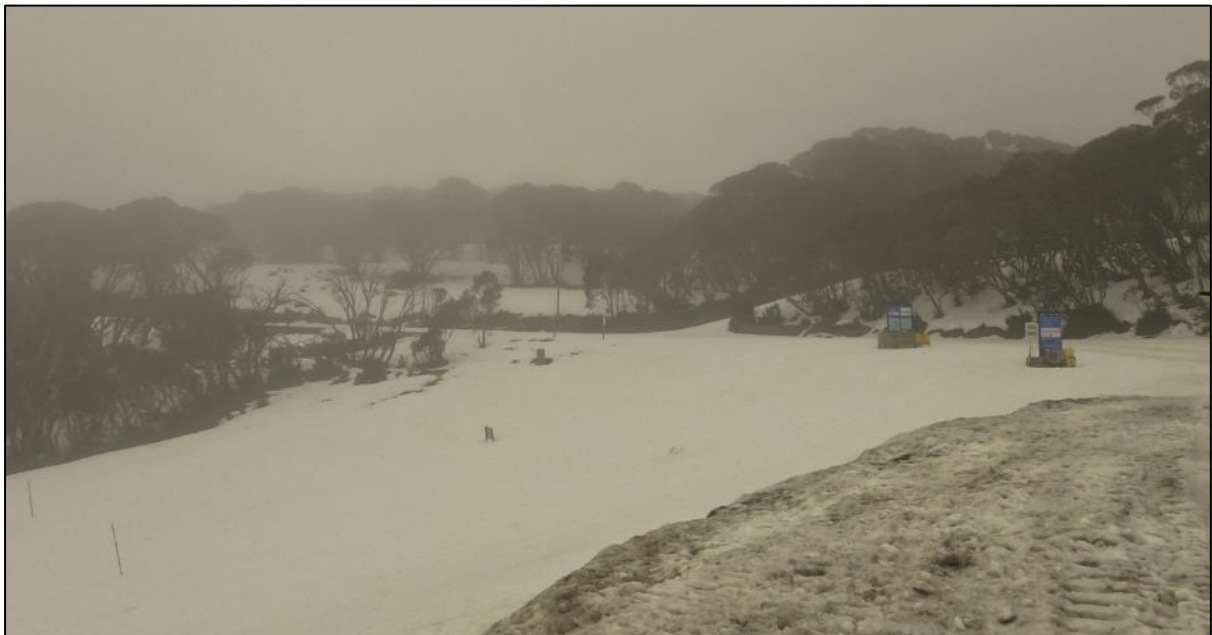
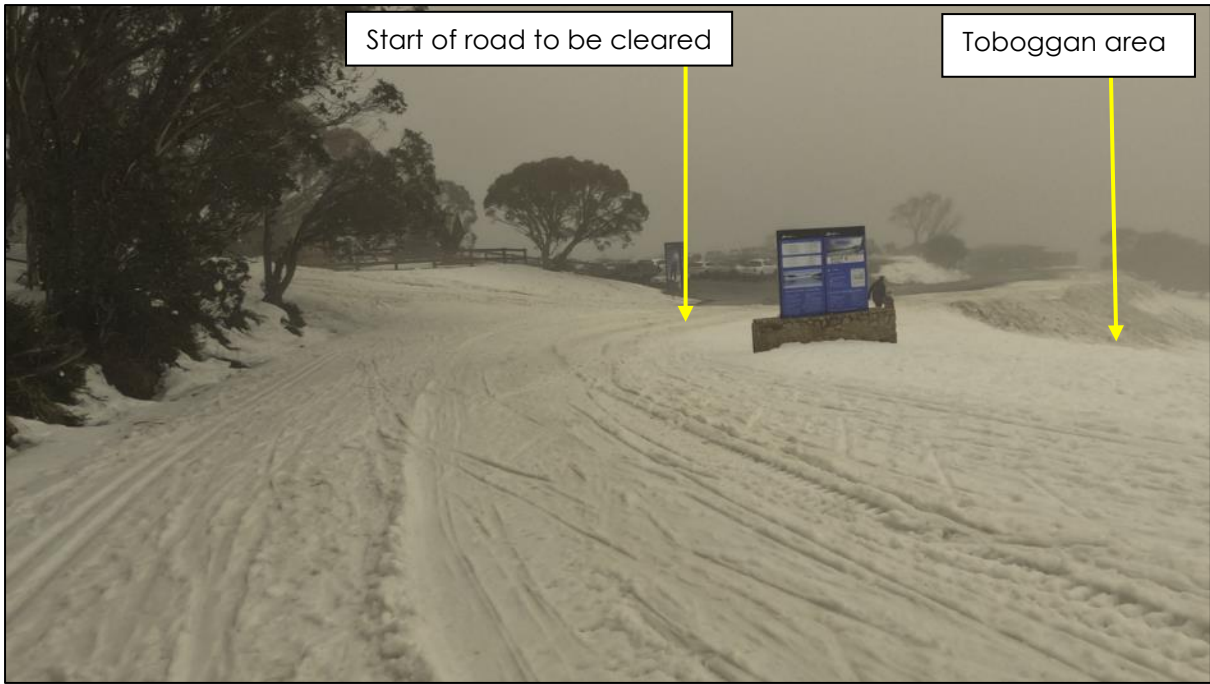
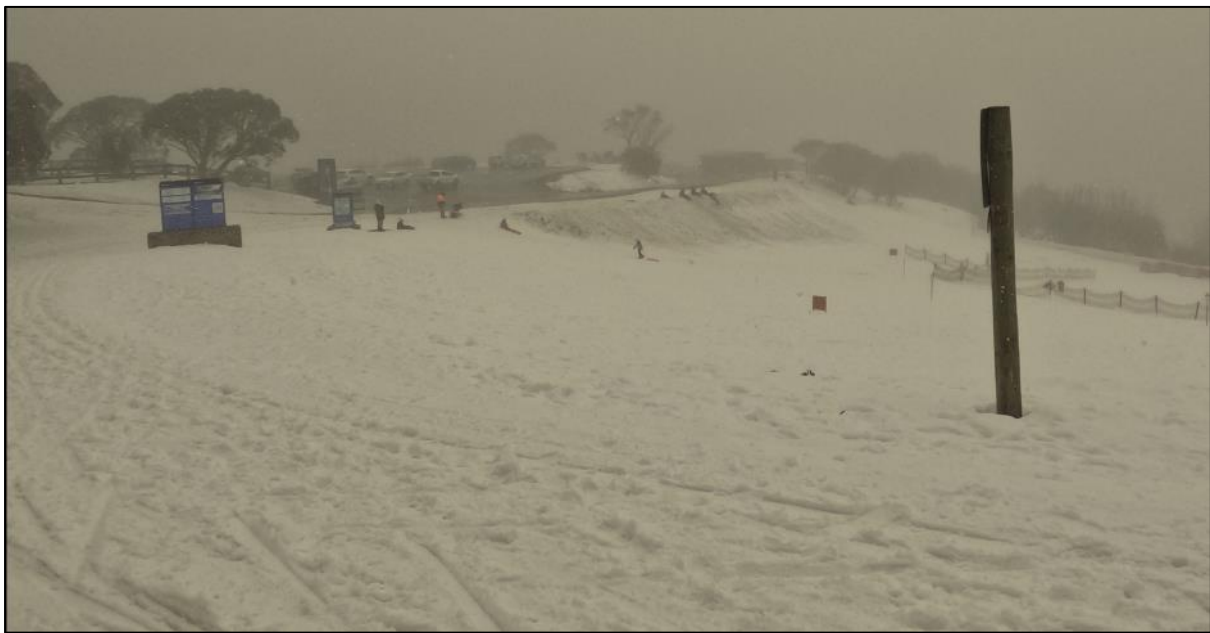
A major toboggan area is right at the commencement of the section of road proposed to be cleared of snow. i.e. it abuts Windy Corner. There appears to be conflicting publicly available information about whether this sheltered toboggan area will be moved to the exposed slopes adjacent to BHP road on the approach to the ANARE building. This audit is therefore assessing the risks of maintaining the toboggan area where it is currently situated.

There will be significantly more traffic, including heavy vehicles, travelling past this toboggan area where people, including many children, are mingling, playing and crossing the road.

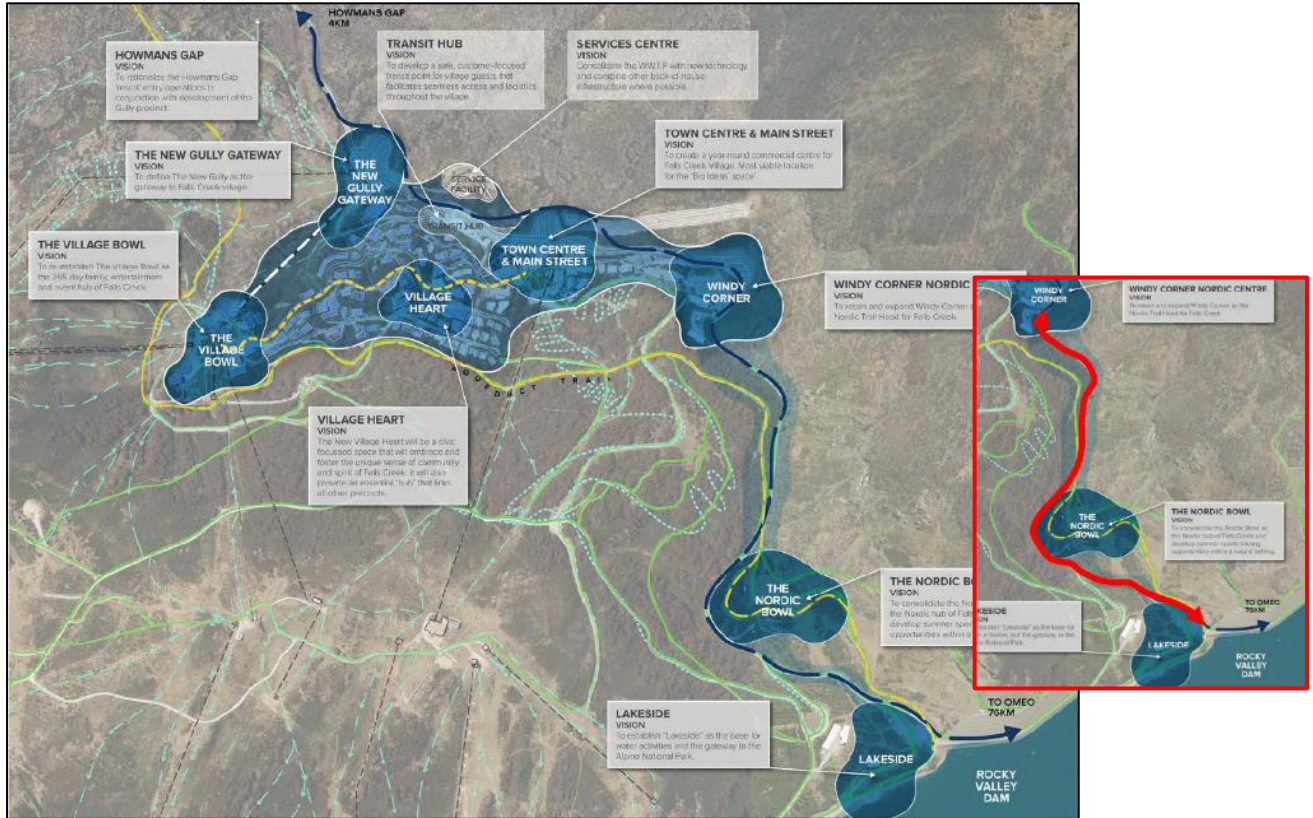
The subject section of road is situated above Falls Creek at an altitude of ~1600m. This area is more exposed, and based on local knowledge, it is subject to harsher weather with strong winds and reduced visibility caused by snow storms and low hanging clouds.

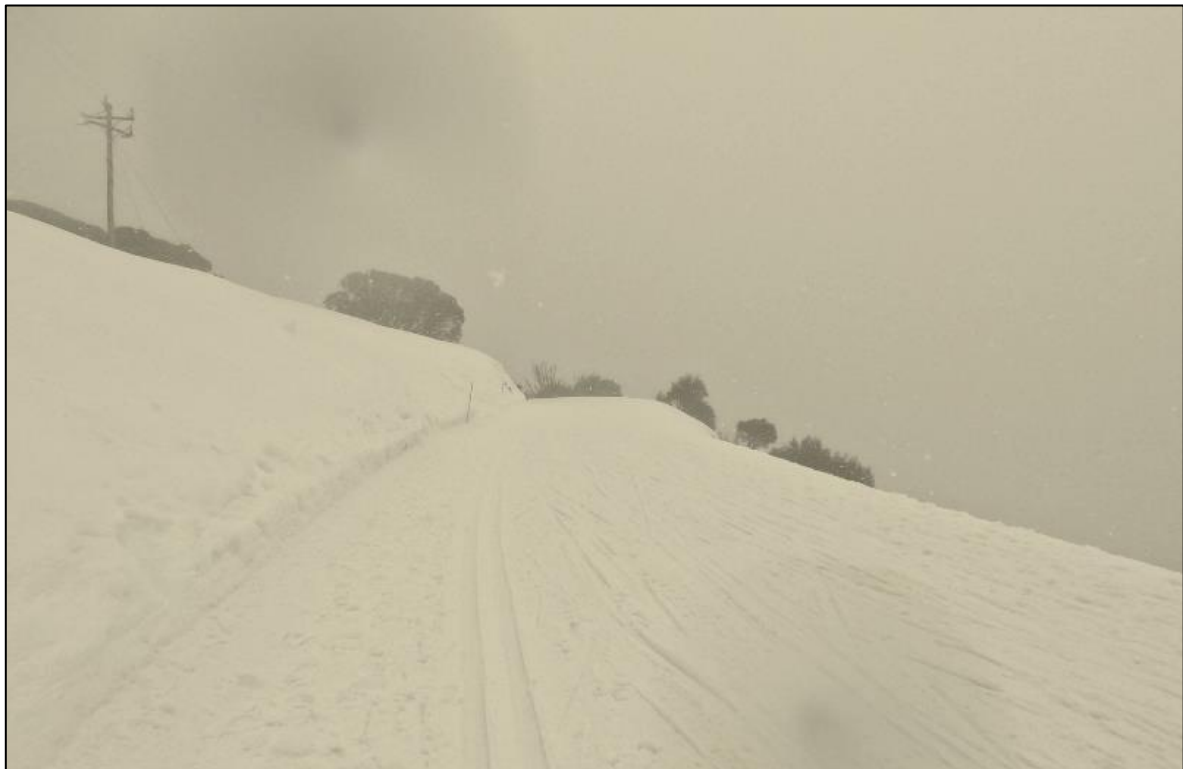
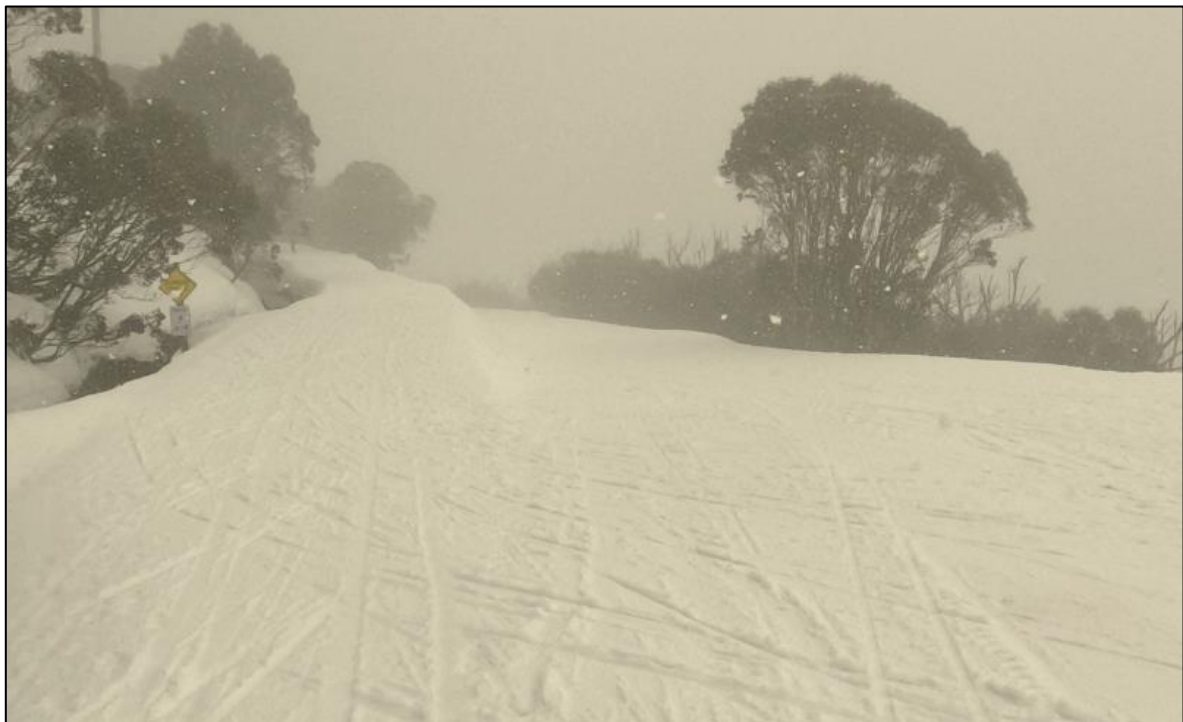
Images below show the subject section of road under snow-fall.

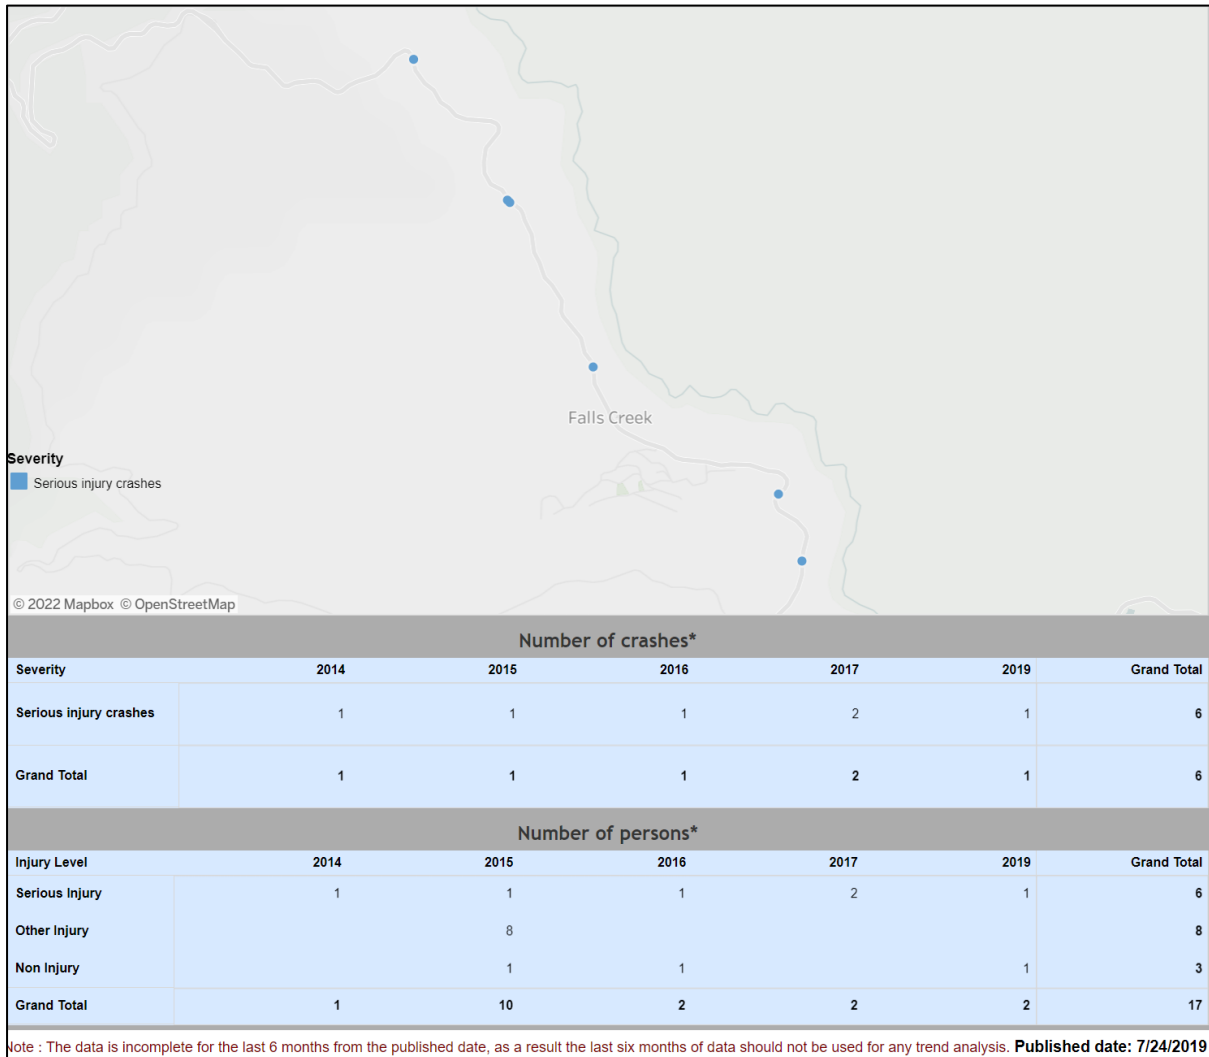
Publicly available *casualty* crash information via Vicroads' web site between 2014 and 2019 (latest available) indicates six crashes, two of which are in the subject section south of Falls Creek. One of these crashes is the mini-bus crash noted previously.
