The Brooks-Park Arts and Nature Center Building Conditions Report

Prepared for:
The Town of East Hampton
159 Pantigo Road
East Hampton, NY 11937

Prepared by:
Jan Hird Pokorny Associates, Inc.
39 West 37th Street, Floor 12A
New York, NY 10018
(212) 759-6462

15 March, 2023

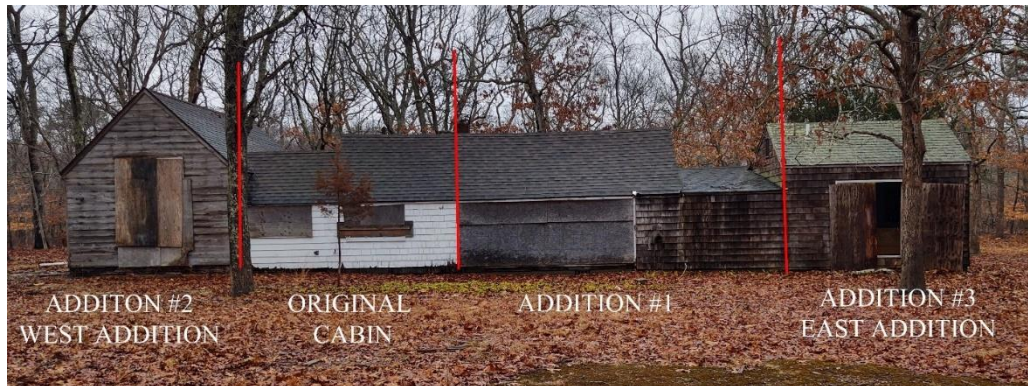
Photo No. 1: The residence as it stands today is comprised of four building campaigns starting with the original cottage moved to the site in the 1950s.

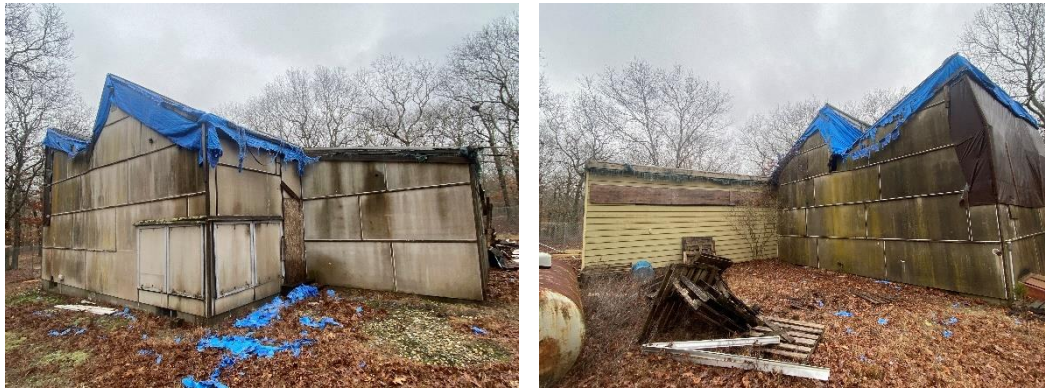
Photo No. 14 and 15: The Brooks Studio was built over two campaigns, the main block clad in Transite panels, and the SE storage wing clad in aluminum siding.

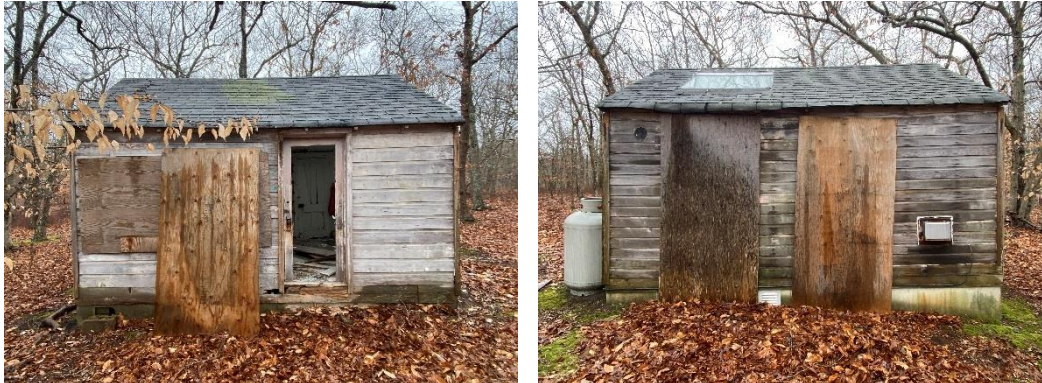
Photo No. 22 and 23: The Charlotte Park Studio is a small one-story cottage structure located northeast of the Brooks Studio.

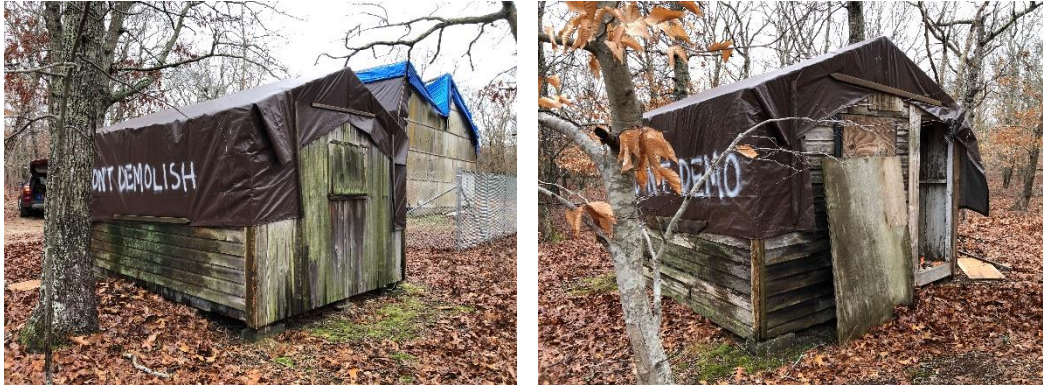
Photo No. 28 and 29: The guest cottage is a small wood framed structure located to the north of the Brook Studio.
