SUBJECT: Supplemental Condition Assessment Report  
Brooks Park Buildings  
128 Neck Path  
Springs, NY  
SCTM# 300-103-8-6  
Purchase Order # 2022-0677

### Brooks Park Cottage Condition Photos

By DB Bennett on 2/9/22

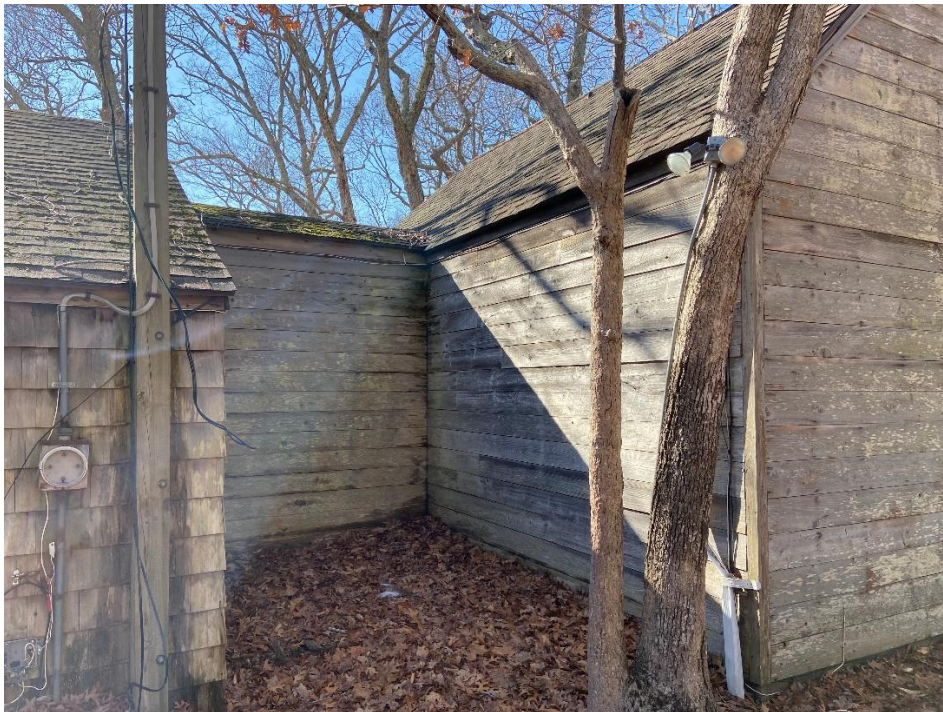
Cottage north elevation

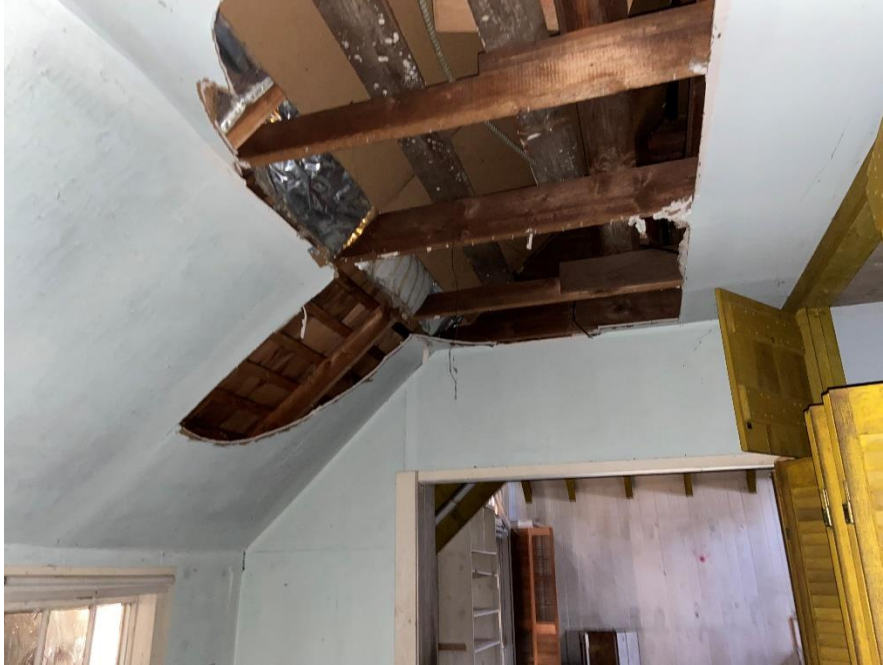
Roof leak above kitchen

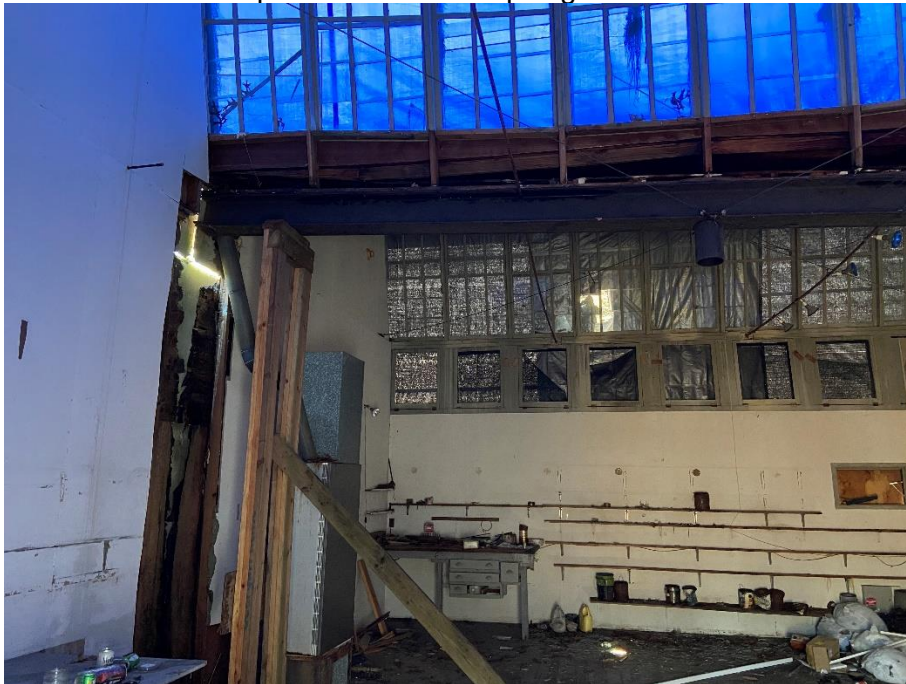
beams Continued water penetration has led to floor decay and failure near the perimeter. Roof supporting posts have dropped through the rotten floor. This has resulted in a steel I-beam that supports the roof to drop several feet and roll. This has led to the upper walls to twist and lean inward in a collapsing motion.

Brooks Studio Parapet roof beam collapsing
