Title (Titre): *IB-DL A-Pillar Inspection (SB-42-022-2019) #5-19*

Reference :	Référence :
SB-42-022-2019 Rev. 1 Inspection of A-pillar at C42 A/B/E-Series with A-pillar passing through fuselage tube Lufttüchtigkeitsanweisung – LTA - Nr.: LSG 19 - 002 - Rev.1

SB-42-022-2019 Rev. 1 Inspection of A-pillar at C42 A/B/E-Series with A-pillar passing through fuselage tube (C42A up to Serial No.: 1604-7449 C42B up to Serial No.: 1503-7383 C42E up to Serial No.: 1804-7529)

Lufttüchtigkeitsanweisung
LTA-Nr.: LSG 19-002 – Rev.1
Datum der Bekanntgabe: 30.07.2019

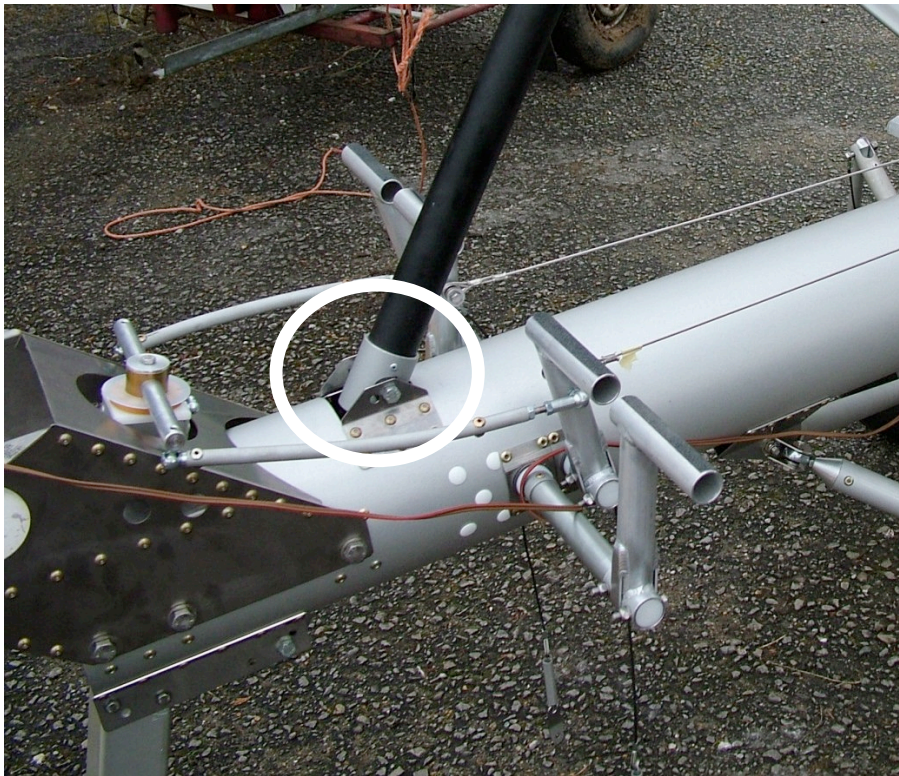
An aircraft with severe cracking of the main fuselage tube emanating from the upper cut-out for the A-pillar was also found to have suffered severe cracking of the A- pillar around its entire circumference. This was hidden within the outer sleeve positioned at the connection between the A- pillar and the upper surface of the main fuselage tube. The load path was maintained by the single small rivet used to locate the outer sleeve on the A- pillar. See Figures 1 & 2.

It is believed that the cracking was a result of excessive loads placed upon the A- pillar due to the near-failure of the main fuselage tube. One other similar historical case is known to have occurred abroad, on an aircraft known to have suffered landing gear damage.

However, it is also possible that the cracking may also be related to fatigue due to flexing of the A- pillar at this point. Therefore inspection on high-hours aircraft is recommended, as well as those which have suffered damage which could have applied excessive loads to the A- pillar.

Action :	Action :
Visual inspection must be taken, in case of damage: The A pillar must be replaced by a new A pillar. See the repair action recommended by the manufacturer. The repairs must be accomplished or supervised by a competent technician	Une inspection visuelle est à effectuer, en vue de déceler tout début de criques ou défaut de rivetage de fixation de la colonne A. En cas de d'anomalies décelées, il convient : <ul style="list-style-type: none"> - De remplacer la colonne A par une nouvelle colonne d'origine constructeur. - De prendre connaissance des instructions de réparation recommandées par le constructeur Ces travaux doivent être menés ou supervisés par un technicien compétent.

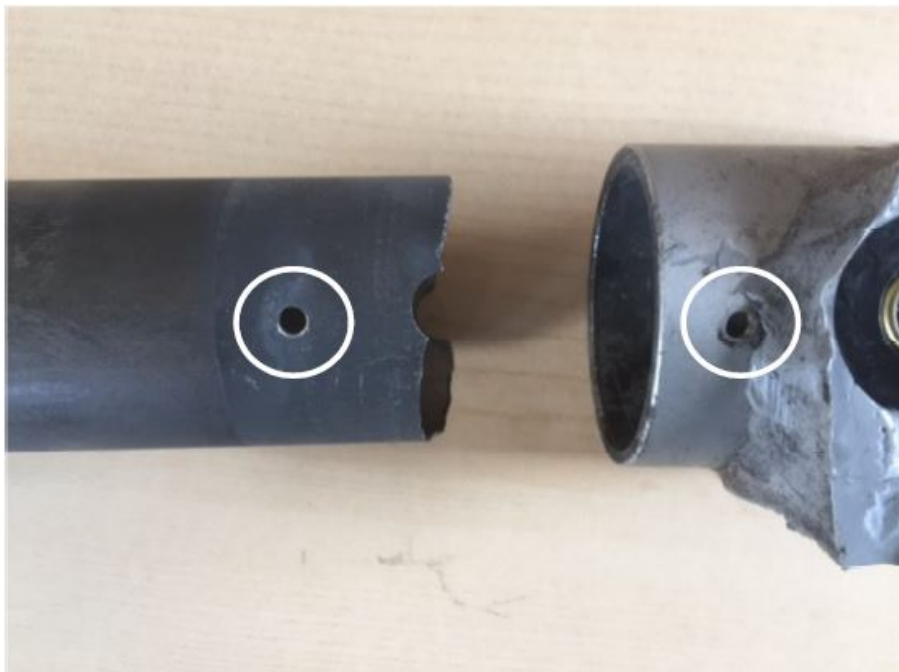
Figure 2: Failed A- pillar removed from outer sleeve part on right of picture. Circled holes show location of the rivet which was holding the parts together.
