# Home Inspection Report

5420 Cheyenne Dr, Kelseyville , CA 95451

Monday October 5, 2020

Dustin Wallace Home Inspections & Construction  
16496 Main St.  
Lower Lake, CA 95457  
(707) 293-6307  
dustinjameswallace1985@gmail.com

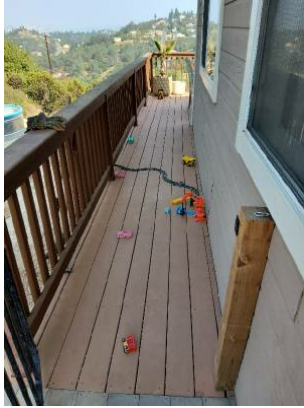
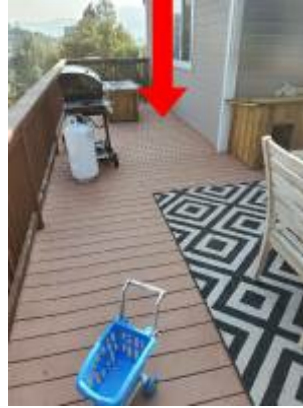
This is normal for all "composite" where you see "rolling" or sagging between joist for Trex planking, this is intended for heat purposes, rather normal redwood or fur would be splitting if untreated.

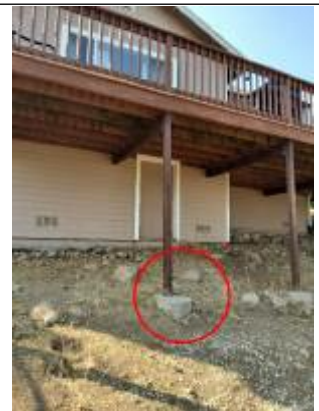
They were off on the concrete pour on the 4x4 posts luckily the footing is on appropriate side to be off on do to "fall"

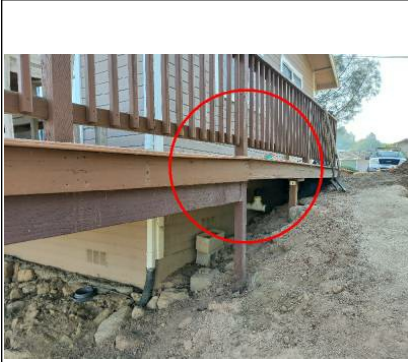
The arrow shows where house is level with a short tie in on the deck and after shows a settlement of the 4x4 posts. This clearly is just a common situation with being on a hillside. The house did not move the deck has dealt with some movement but very common with any hillside house.

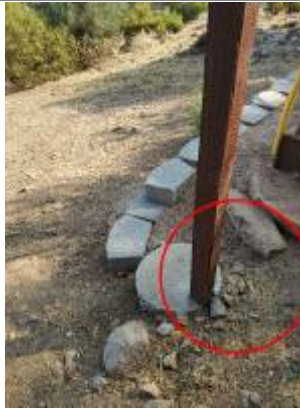
This should not be an issue as this is referred to a couple photos before that movement of the post would be going downhill not uphill so its not going to have much movement but i would suggest the lateral bracing but by no means do I require it. No general contractors put in lateral bracing while doing new construction this is always something that is done after when settling has occurred. This house was built 13 years ago so the settling has reached its point where lateral bracing would be a smart idea.

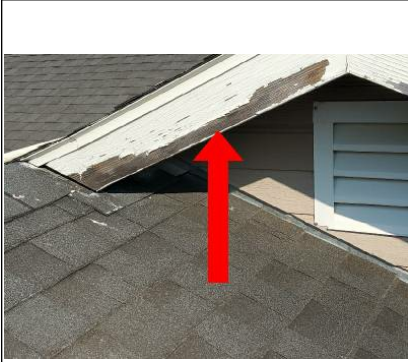
Sun side of the house just needs to be sanded and repainted

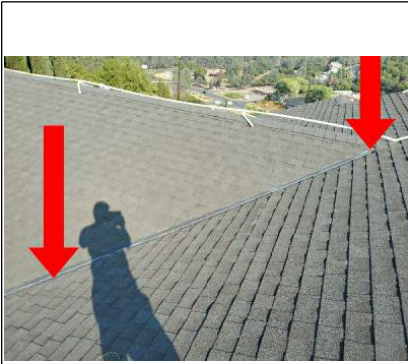
PVC Sprinklers are not to be of concerned as no damage has been observed on the roof even if they have been ran for "Potential Fire"

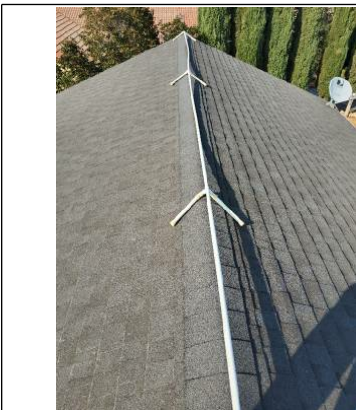
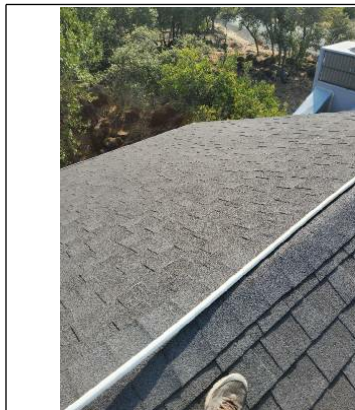
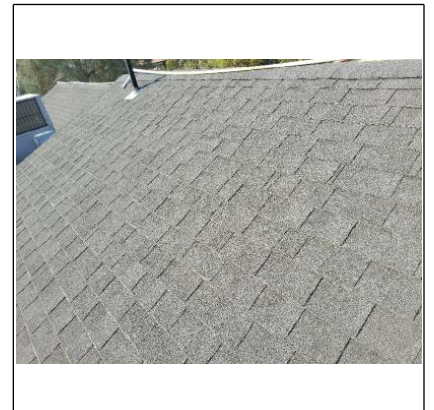
**Comments** I have mentioned in the beginning of the report of the condition of the roof over the garage. Since the garage is not a "living area" I would be less concerned of adding another layer of roofing. Luckily this house is 13 years old, a second layer of composition roofing can be installed directly over up to the ridge. The ridge would have to be pulled off and replaced but the shade side of the house is in fine condition. I believe the back portion the back master bedroom has about five years left.

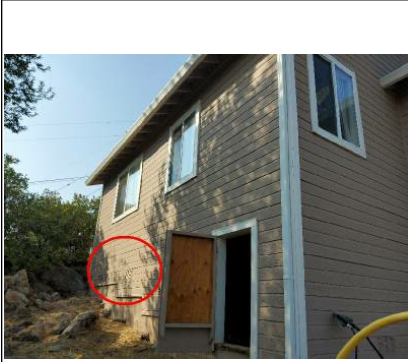
I wish i took a better picture up close of the quality trim job but its on video. the butt joints on the lap siding is what i took notice. You always want to leave a little gap most chalk for expansion / contraction however he flashed it at each three boards for expansion and contraction movements very smart. no worry of leaks and also allows the boards to breath and not buckle.

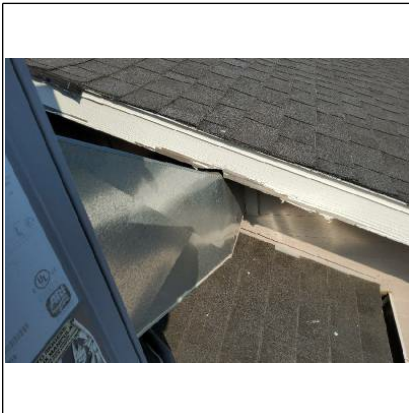
Most contractors do not install fascia boards on the rafter tails instead the rafter tails are attached to the gutter. I knew right away he was a good builder when i one I saw the valley flashing and the installing of the fascia on the rafter tails. these keep them in line and is not required by builders but new the importance of it, almost no one in Lake County does this.

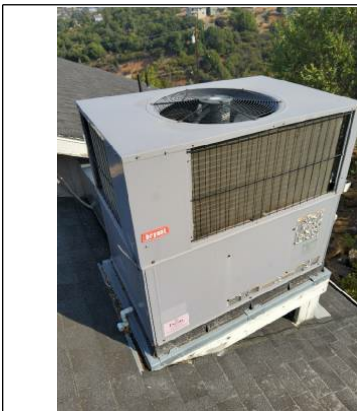
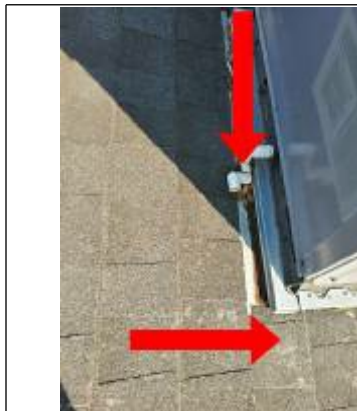
there is flashing so there is no way of condensation getting into the unit, but would recommend extending pvc with cuppling and running a 90 turn on side of unit

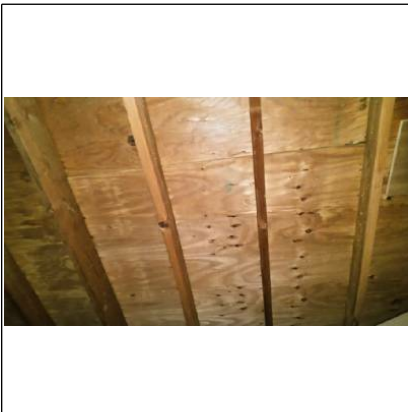
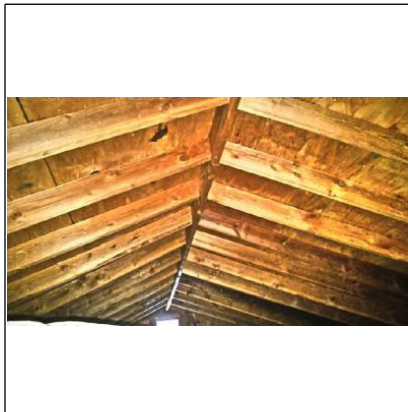
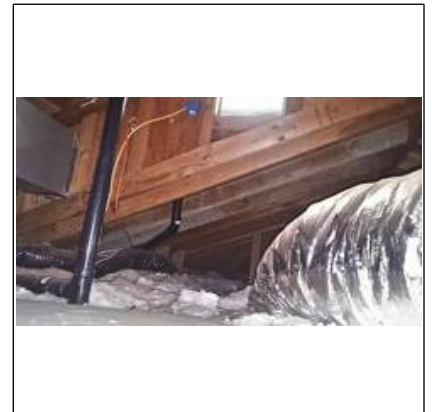
- Comments** Vapor barrier is not required at the time of construction of this house in the gable attic area. This roof is a cut and stack roof which is very hard to do for most. Almost everyone would get engineered trusses for this house. Cut and stacking a roof is the hardest part to do in construction and this is a fine quality clean job.

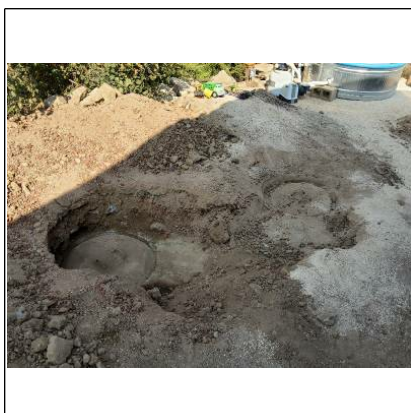
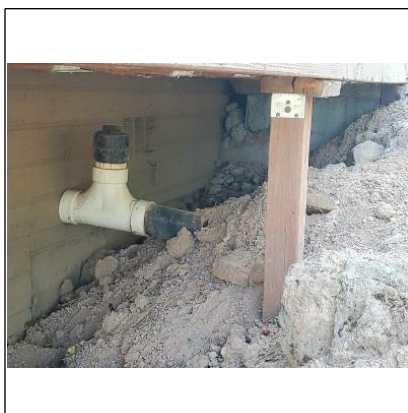
**Comments** Was examined and reported in good condition from septic inspector

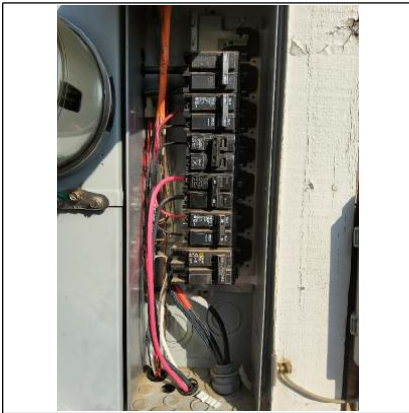
**Comments** All 110 but 220 dryer not needed to upgrade

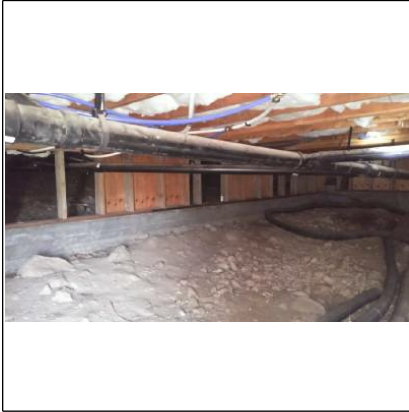
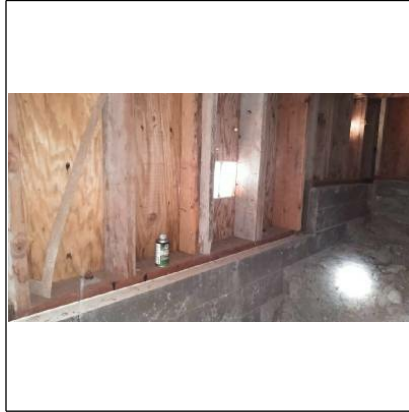
**Comments** This foundation is beyond satisfactory. Most builders would do a post and pier with girder for the middle portions of the house. There are full stem walls like the parameter foundation (Exterior of the house) along with being sheared! this house is not going anywhere with this quality craftsmanship on this foundation.
