# Home Inspection Report

5330 Lakeshore Blvd #16, Lakeport, CA 95453

Tuesday August 15, 2023

3233

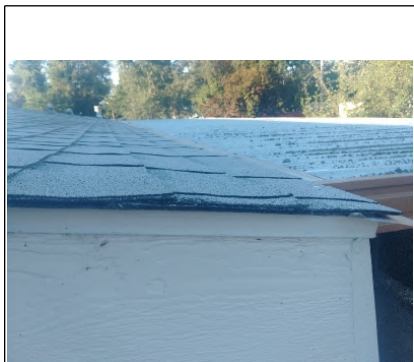
1-layer is properly installed over a starter roll.

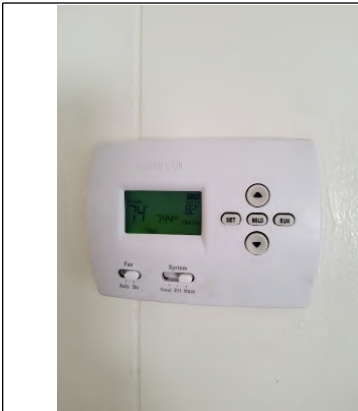
Thermostat shows proper operation on "Heat" setting.

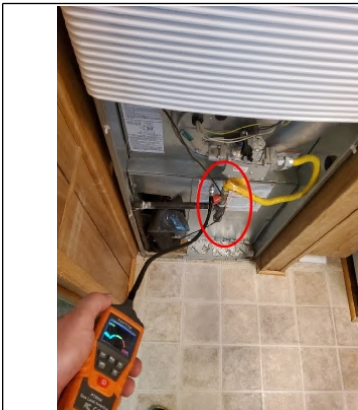
No leaks were detected at shut off valve.

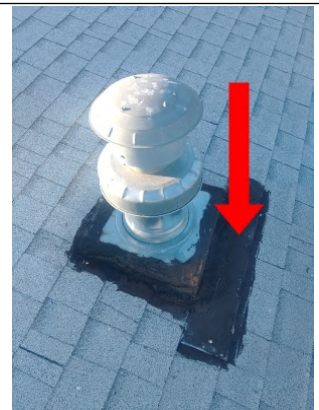
Henry's roof sealant was applied for flashing. This would have to be reapplied every 3-years I would recommend resealing it with a much better product like Black Jack Rubr-Coat.

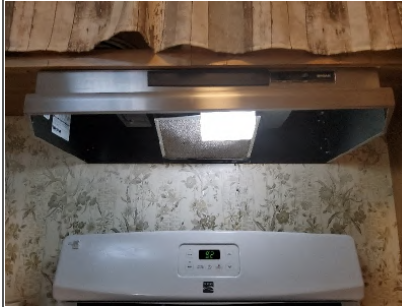
**Comments**    1. Exhaust fan is noisy and should be repaired by an Appliance Specialist.

Exhaust fan is noisy and should be repaired by an Appliance Specialist.

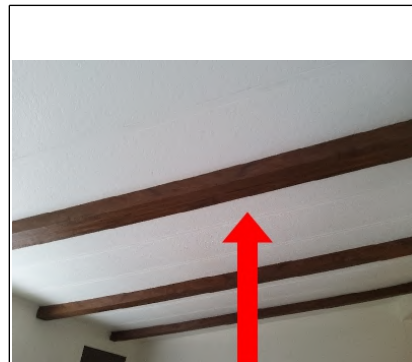
Dips in the ceiling are cosmetic these beams are not structural as there are spanning joist members above them that meet at the ridge point.

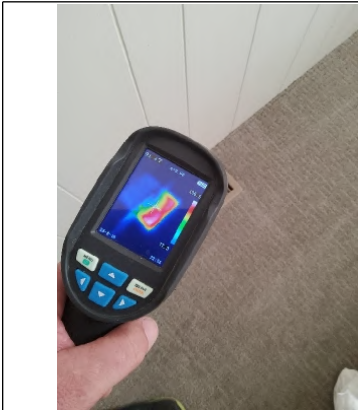
Thermal Imager shows proper "Heat" distribution through vent along with properly sealed ducting at the register.

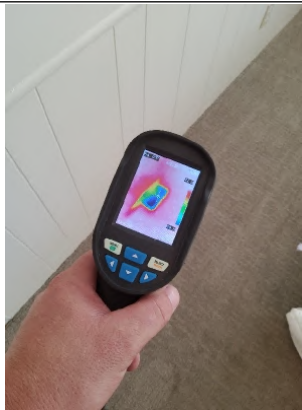
Thermal Imager shows proper "Cool" distribution through vent along with properly sealed ducting at the register.

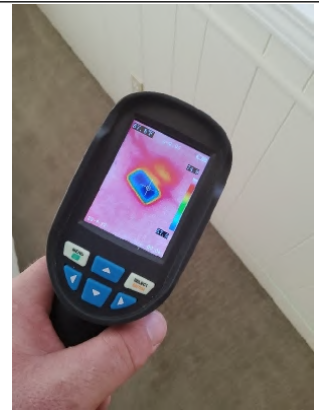
Thermal Imager shows proper "Cool" distribution through vent along with properly sealed ducting at the register.

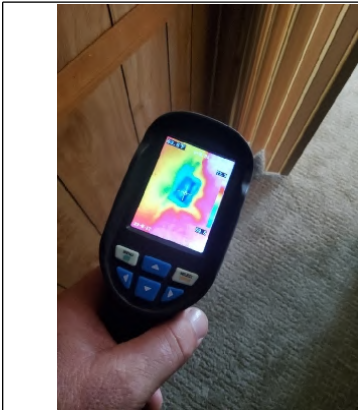
Thermal Imager shows proper "Cool" distribution through vent along with properly sealed ducting at the register.

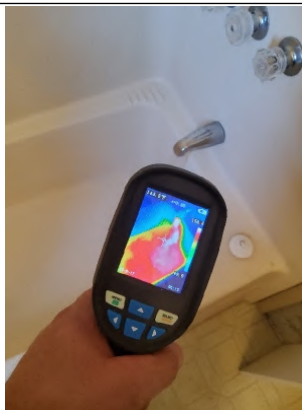
Thermal Imager shows hot water is present through spout.

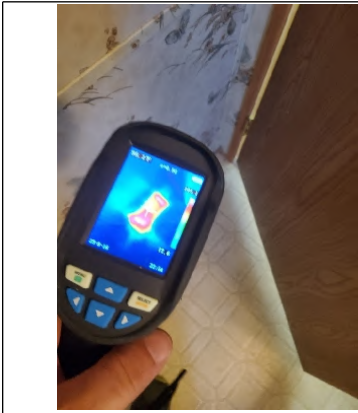
Thermal Imager shows proper "Heat" distribution through vent along with properly sealed ducting at the register.

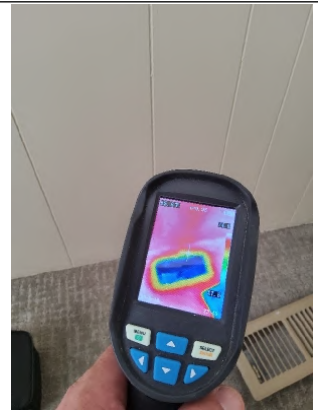
Thermal Imager shows proper "Cool" distribution through vent along with properly sealed ducting at the register.

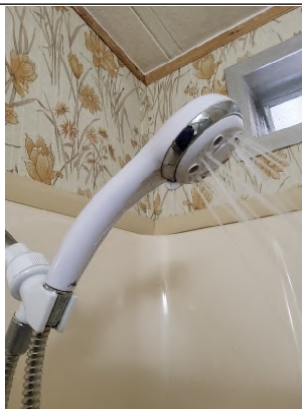
Shower head has a leak. Recommend having repaired or replaced by a Licensed Plumber.

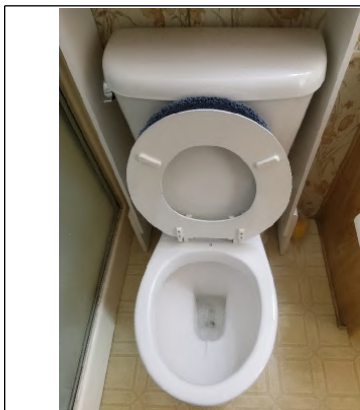
**2. Toilet is loose at the base. Recommend properly fastening to the floor by a Licensed Plumber.**

Toilet is loose at the base.  
Recommend properly fastening to the floor by a Licensed Plumber.
