Home Inspection Report

20462 Powder Horn Dr., Hidden Valley Lake, CA 95467

Tuesday June 23, 2020

Dustin J. Wallace Construction and Home Inspections
16496 Main St.
Lower Lake, CA 95457
(707) 293-6307
dustinjameswallace1985@gmail.com

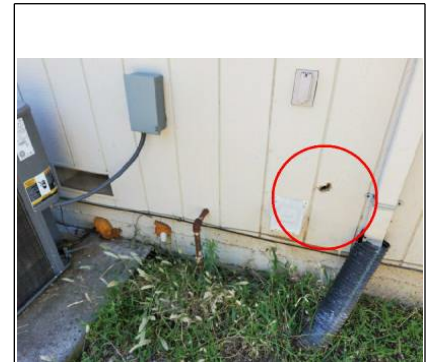
Massive hole in the wall needs to be chalked or spray insulation

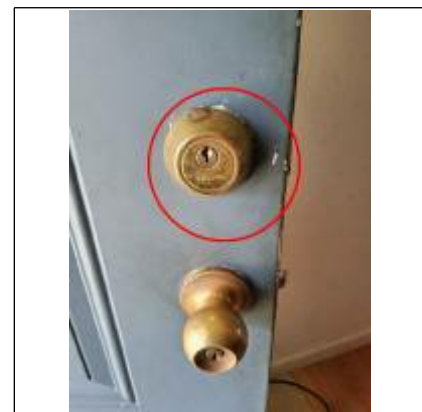
Not installed correctly.
