**DUSTIN WALLACE**  
Home Inspections  
& Construction

## Home Inspection Report

706 Ketch Court, Clearlake Oaks, CA 95423

Saturday October 10, 2020

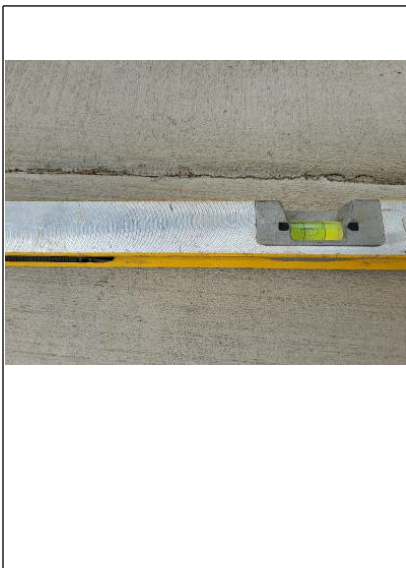
over an 1 1/2 inch fall at four feet towards the houuse. This will erode the hardie lap siding especially since the skirt board has no sheer.

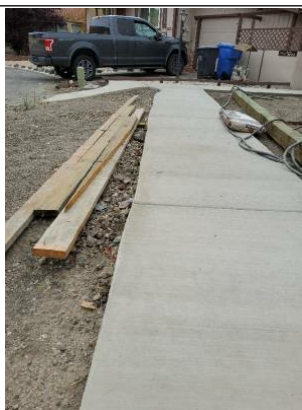
Was there ever a drain tile installed? after the house was put in place? Especially got gutter downspouts?

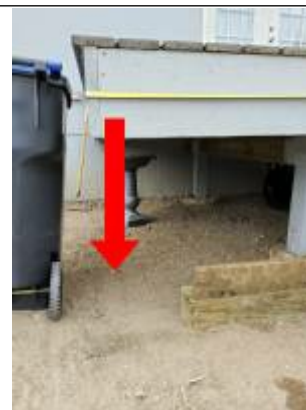
no support for rim especially if this is not tied into the house rim.

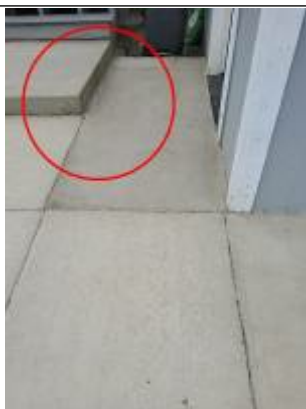
Terrible botch finish concrete job

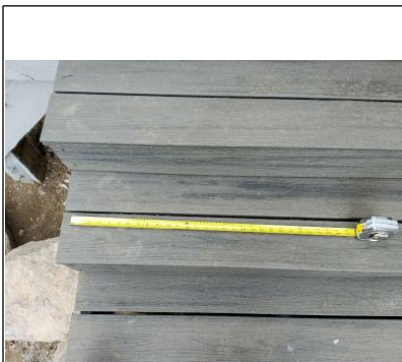
Steps on back deck need to be 16 on center risers. This is two feet which would work for standard 2x6 wood decking but not Trex.

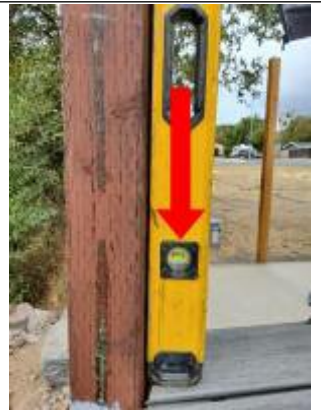
This is almost an inch out of level and this was considered not the worst post.

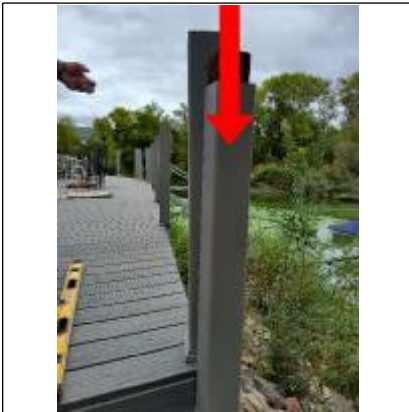
Extremely out of level look at the post compared next to it.

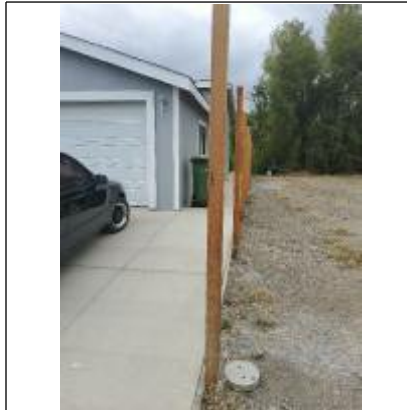
These are doug fur posts and should not be installed in dirt. also this contractor clearly did not run a string line for these posts.

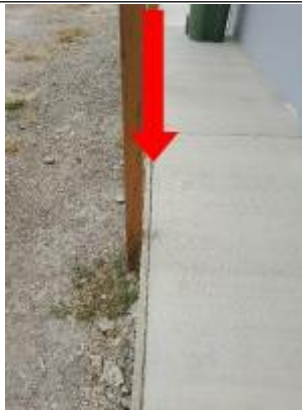
If you see in person and view this arrow u will see how far out this slab is as well as the posts.

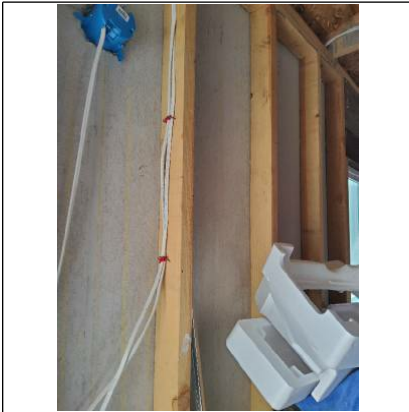
No shear! this is the garage where you can also see no vapor barrier.

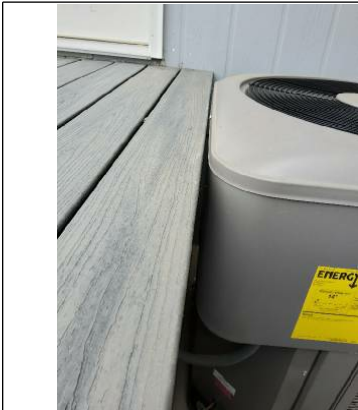
Model serial number all covered which makes service merely impossible along with inability to access unit.

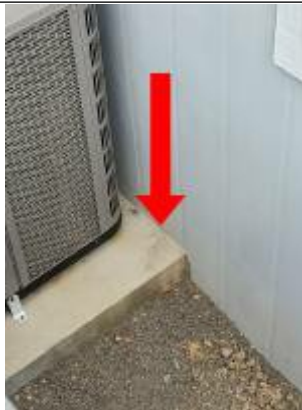
Concrete pad poured refer to next photo after to show otherside of wall.

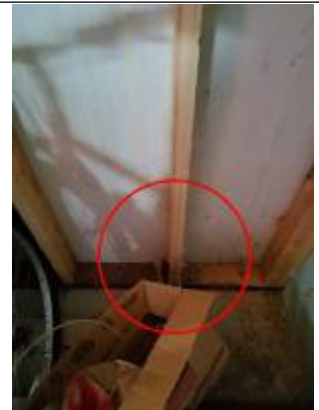
Interior side of wall no block support or shear for illegal paf
