Home Inspection Report

19064 Coyle Springs Rd , Hidden Valley Lake, CA 95467

Sunday August 6, 2023

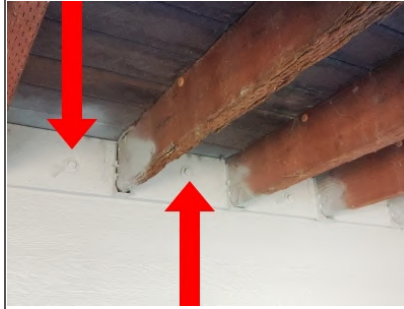
The deck is structurally sound. Galvanized 5/8" lags are placed every joist bay on the deck ledger to properly fasten to rim member of the home.

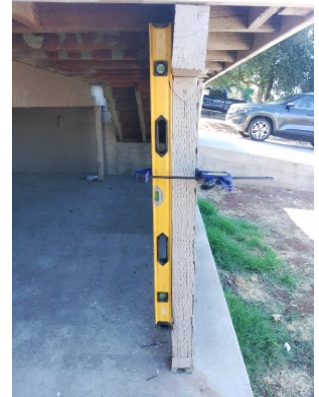
Column is slightly leaning but is of no structural concern.

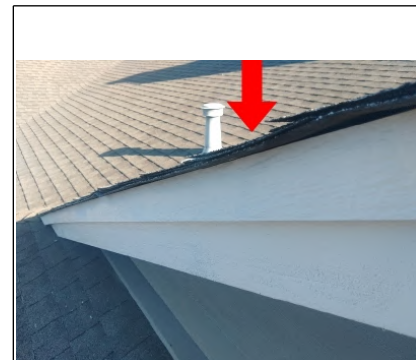
1-Layer of asphalt shingles are installed over a starter roll.

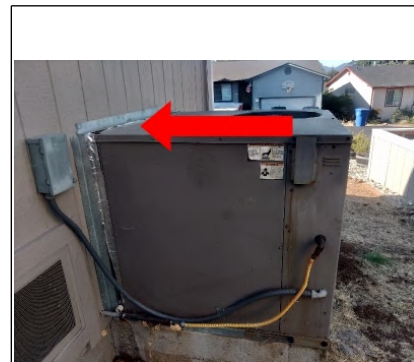
Recommend additional HVAC tape be applied

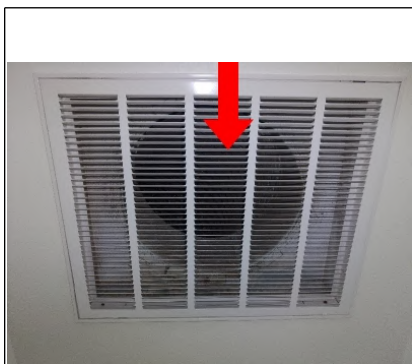
Missing cold air return filter

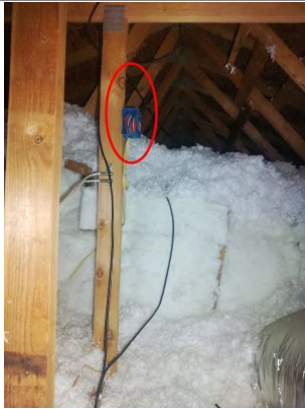
Recommend solid junction box be installed.

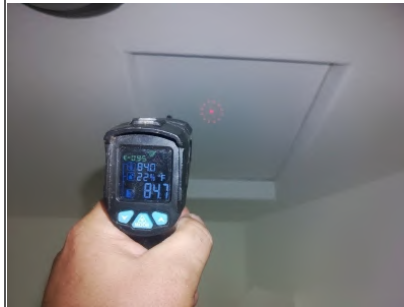
Thermal Reader shows 84.7 Degrees F on attic access lid.

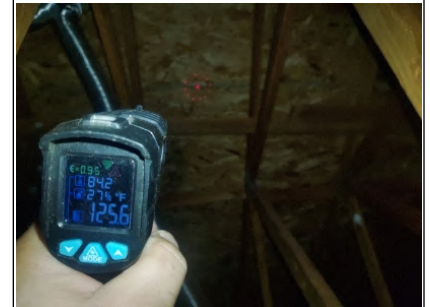
Thermal Reader shows 125.6 Degrees F at the OSB sheathing this shows there is proper ventilation and a moderate heat index.

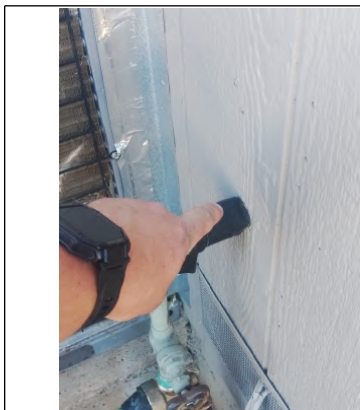
Copper line is slightly loose to siding. Recommend having properly fastened.

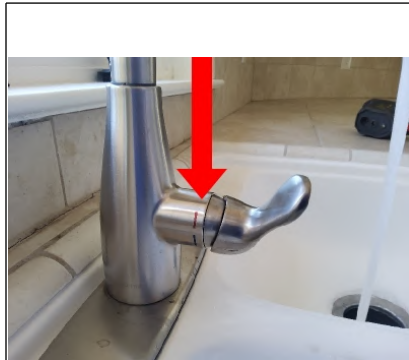
Comments **1. Hot and cold water lines are backwards. Recommend having a Licensed Plumber switch flex line water supply lines to correct locations.**

Hot and cold water lines are backwards. Recommend having a Licensed Plumber switch flex line water supply lines to correct locations.

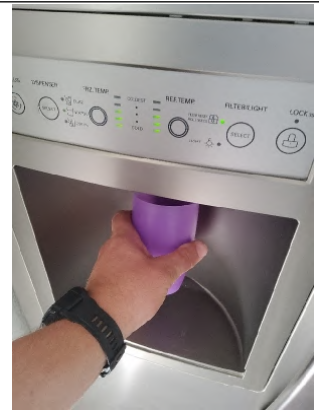
Water is currently not turned on for Ice Machine to properly operate or test.

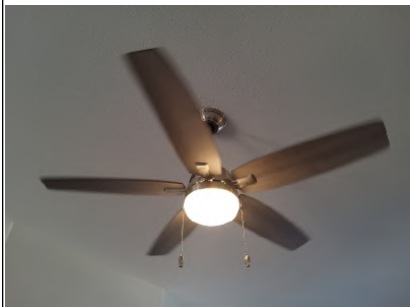
Ceiling fan shows proper operation.

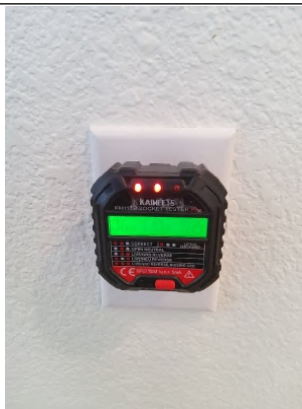
Electrical outlet shows proper operation, grounding and polarity.

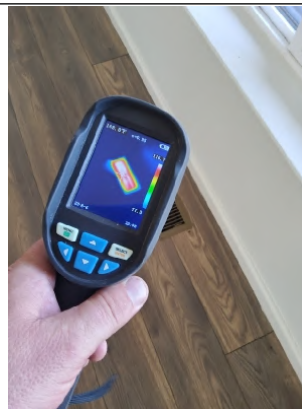
Thermal Imager shows proper "Heat" distribution through vent along with properly sealed ducting at the register.

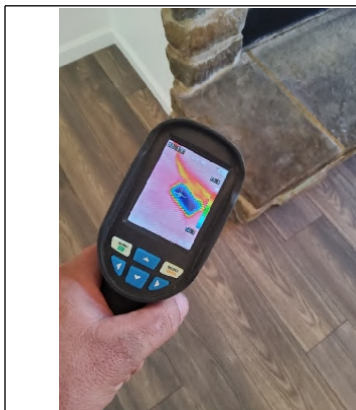
Thermal Imager shows proper "Cool" distribution through vent along with properly sealed ducting at the register.

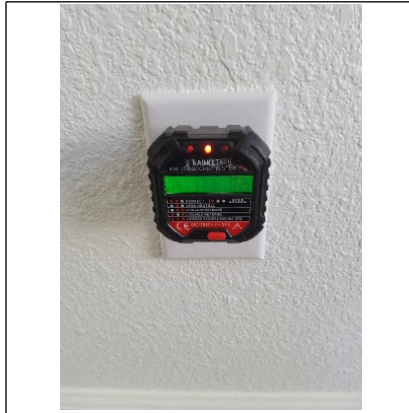
Electrical outlet shows proper operation, grounding and polarity.

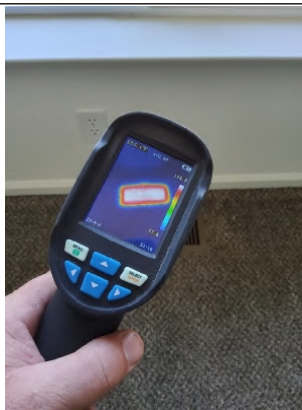
Thermal Imager shows proper "Heat" distribution through vent along with properly sealed ducting at the register.

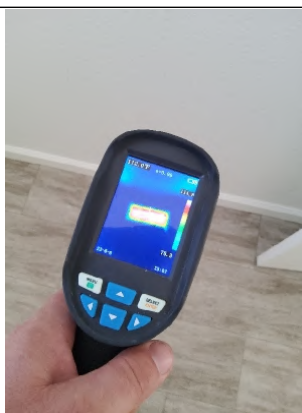
Thermal Imager shows proper "Heat" distribution through vent along with properly sealed ducting at the register.

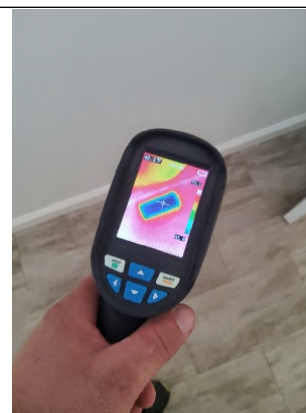
Thermal Imager shows proper "Cool" distribution through vent along with properly sealed ducting at the register.

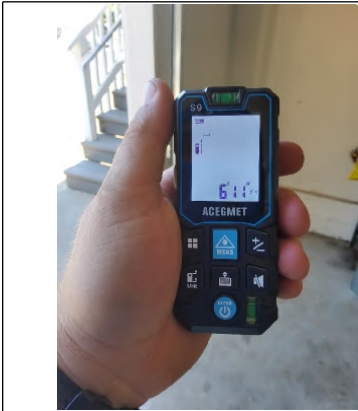
Garage Door opening measures 6'11" high.
