Home Inspection Report

2255 Will O View Circle, Lakeport, CA 95453

Wednesday August 30, 2023

This inspection is a Certified Roof Inspection from Dustin Wallace General Contractor Home Inspections CSLB#1052482. Home Inspectors are NOT licensed for Roof Certifications unless they also carry either a C39 Roofing Contractors License or a General B Contractors License. In these roof inspections the roof conditions (as well as the material used) are examined as well as flashing, plumbing vents, storm collars, the examination of gutter conditions (if present), the degree of water run off in the subterranean area (if crawl space is present) and most importantly structural (conditions of rafters, truss members, header beams, etc) if an attic is present then thermal readings are calculated to do determine if extra ventilation is needed. PLEASE REFER TO "REPORT SECTION" FOR A COMPLETE DIAGRAM BREAKDOWN WITH REGARDS TO THIS ROOF INSPECTION.

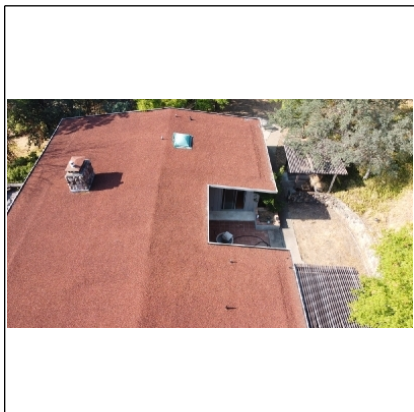
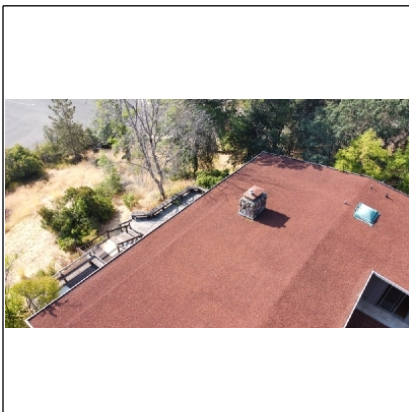
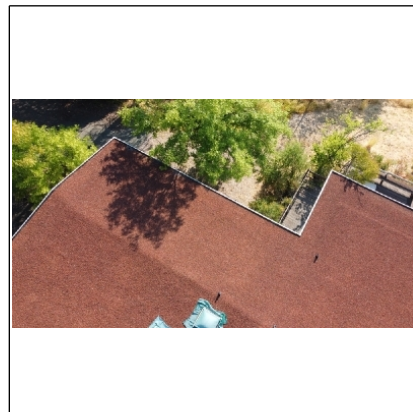
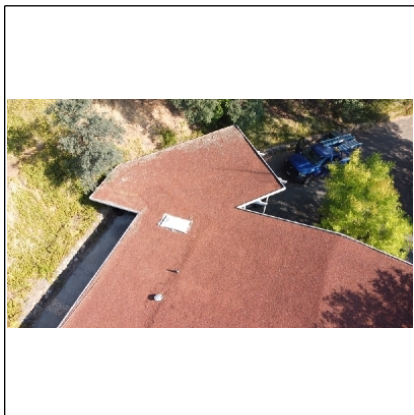
Flashing 1

Comments **1. The most common locations where water will intrude as well as locations that require the most attention are each corner of the roof. These locations should be resealed as evidence shows water has intruded causing damage on the fascia members and through the planking.**

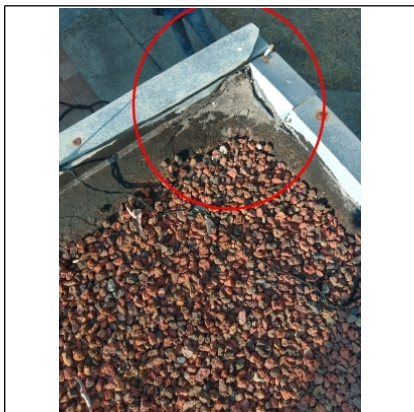
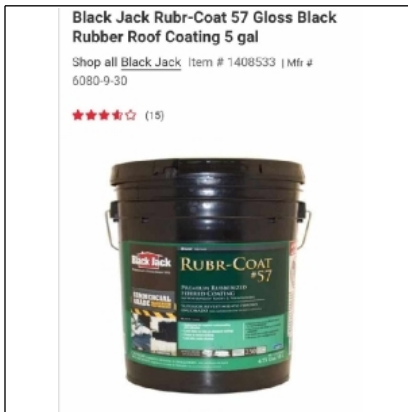
- Roof #1** Satisfactory Marginal (Living Area) Poor (Overhang) Curling Cracking Ponding
 Burn Spots Broken/Loose Tiles/Shingles Nail popping Granules missing Alligatoring
 Blistering Missing Tabs/Shingles/Tiles Moss buildup Exposed Underlayment Cupping
 Incomplete/Improper Nailing Recommend roofer evaluate Evidence of Leakage

These locations that are in red are the most concerning locations with regards to water intrusion, moisture damage and improper pitch and flashing.

This is a significant dip on the overhang where the tongue and groove planking shows moisture staining and disconnection. This area has had an issue with ponding and does not have proper pitch to the downspout.

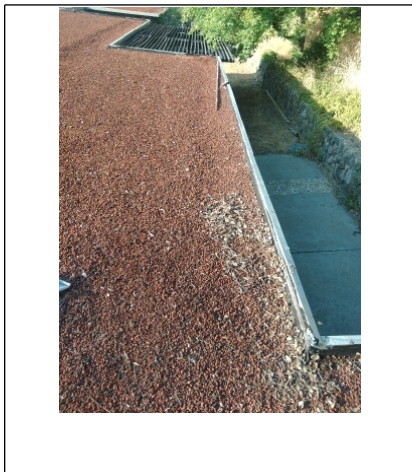
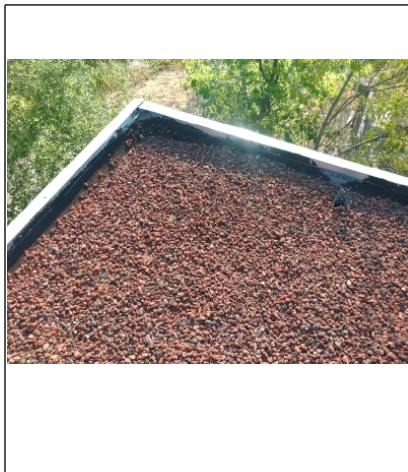
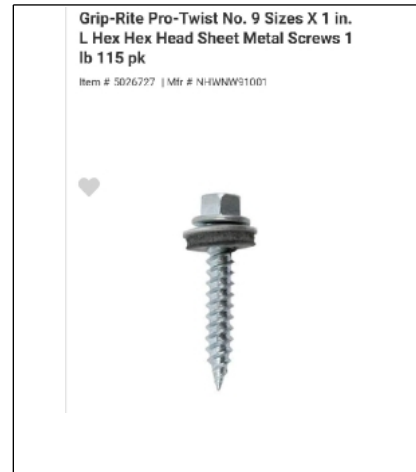
Rusted nails have allowed water to intrude through the fascia.

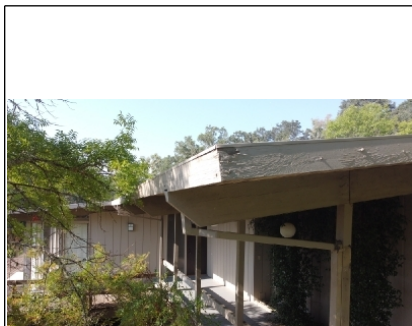
Moisture damage is evident on fascia from excessive ponding. This also could be in relation to the downspout needed to be cleaned.

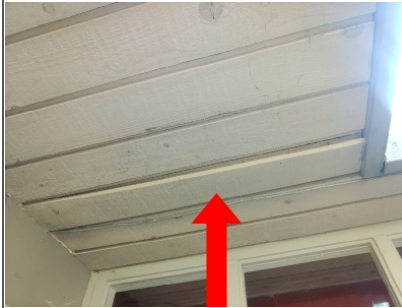
Another concern is that after this long winter and now this summer these exposed T and G planking members have shrunk. These are 1-1/2" wide T and G planks.

Disconnected planking member.

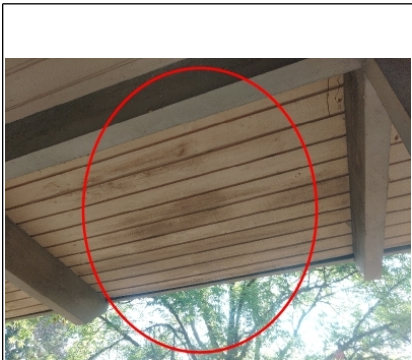
Significant bowing is evident on the T and G planking at the front portion of the overhang.

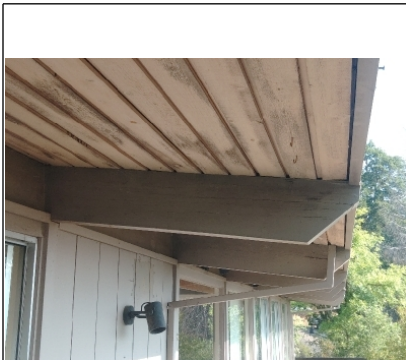
Significant bowing is evident on the T and G planking at the front portion of the overhang.
