# Home Inspection Report

16289 Ponderosa Dr., Cobb, CA 95426

Saturday February 29, 2020

Dustin J. Wallace Construction and Home Inspections  
16496 Main St.  
Lower Lake, CA 95457  
(707) 293-6307  
dustinjameswallace1985@gmail.com

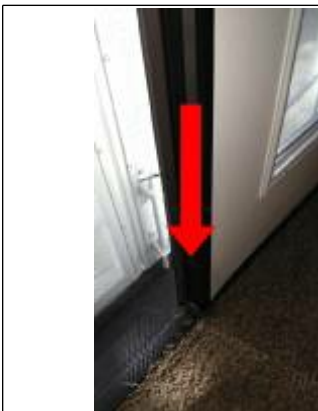
Door Stopper makes it hard to open. Possibly do to new carpet being installed.
