Home Inspection Report

18279 Hidden Valley Road, Hidden Valley Lake , CA 95467

Monday August 14, 2023

Dustin Wallace General Contractor Home Inspections
16496 Main St.
Lower Lake, CA 95457
(707) 293-6307
dustinjameswallace1985@gmail.com

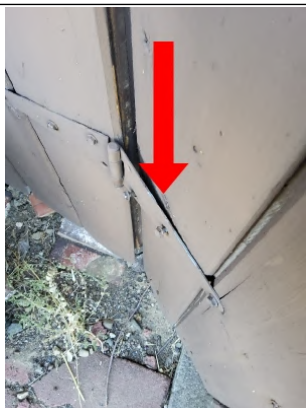
Loose gate hinge

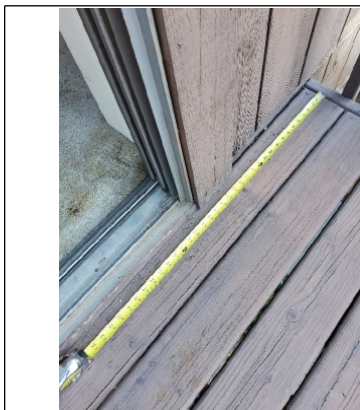
Joist layout is 32" on center which exceeds the minimum layout requires of 1-1/2" standard tread wood member layout.

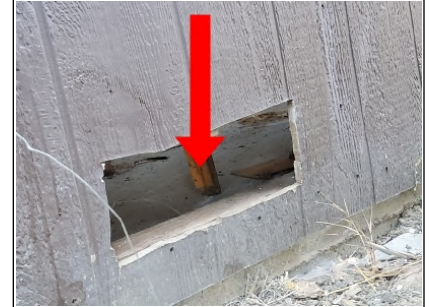
Rodent intrusion location. Recommend putting a new exterior vent cover on

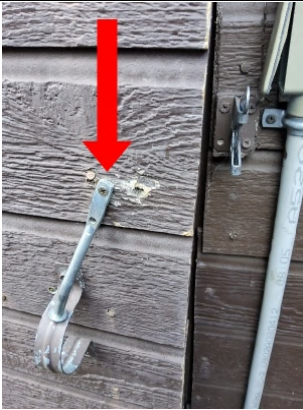
Missing screw on gate latch.

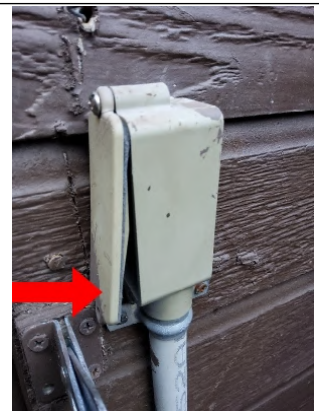
Missing screw on conduit cover.

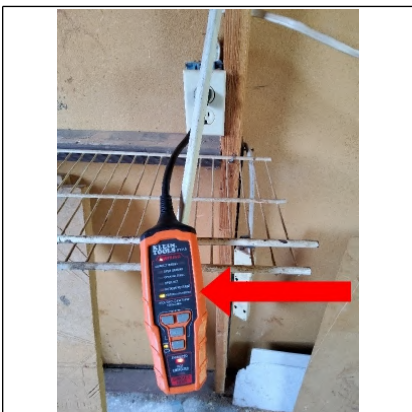
Electrical outlet has reverse polarity. Recommend having further evaluated and repaired by a Licensed Electrician.

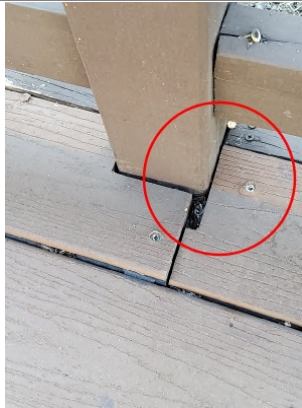
Poor quality work

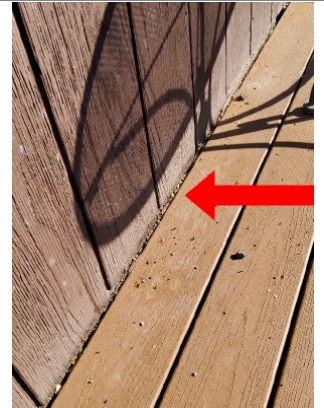
No flashing was installed on the ledger board prior to installing the Trex composite deck.

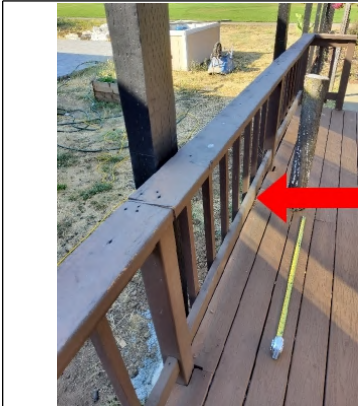
Railing is loose and should be properly refastened to the rim member of the deck but is also not required to have.

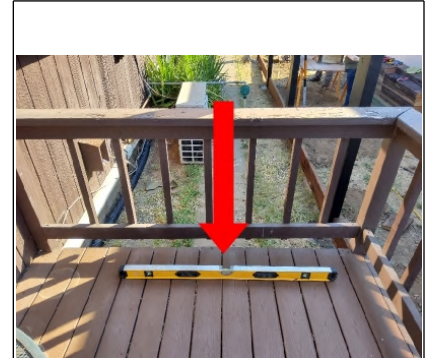
4' level is placed on top of the deck to show the deck is leaning towards the home.

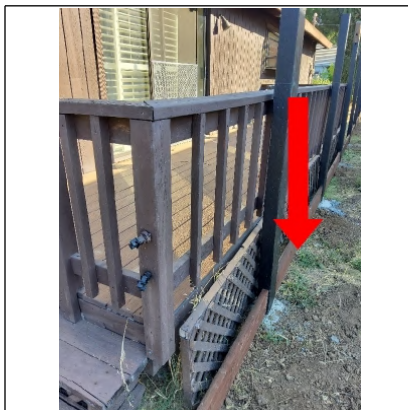
2. The deck is currently installed over the neighbors property line. Recommend contacting Hidden Valley Lake Association for proper deck set backs if an answer cannot be provided contact the Lake County Building Department.

The deck is currently installed over the neighbors property line. Recommend contacting Hidden Valley Lake Association for proper deck set backs if an answer cannot be provided contact the Lake County Building Department.

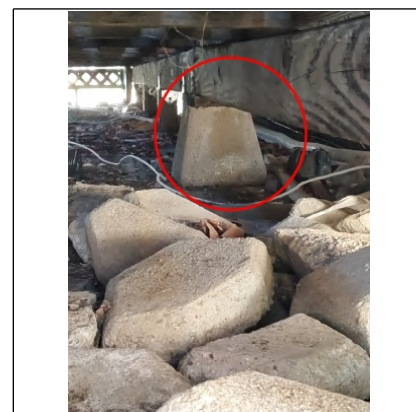
No footing appears to be present below pier blocks.

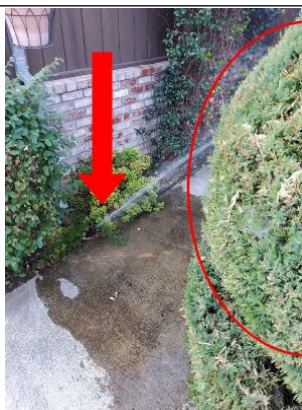
There is a rip in the irrigation line. However, this could be in purpose to water this bush.

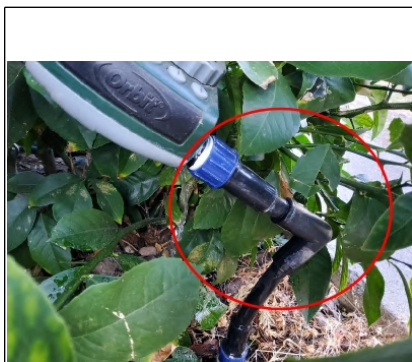
Leak on irrigation line

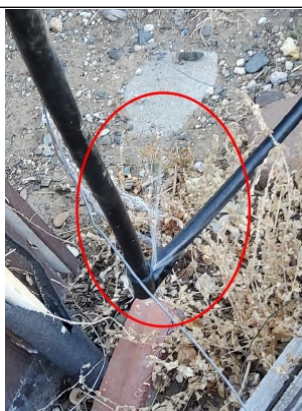
Damaged irrigation line

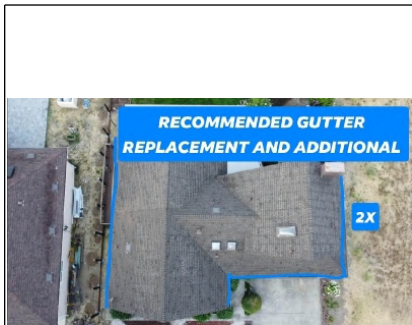
Recommended gutter replacement locations.

Comments **1. Recommend having all gutters and downspouts noted on the drone diagram replaced by a Licensed Gutter Specialist.**

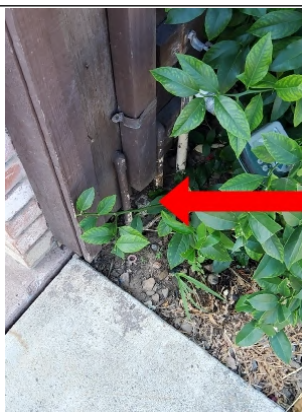
Missing downspout elbow

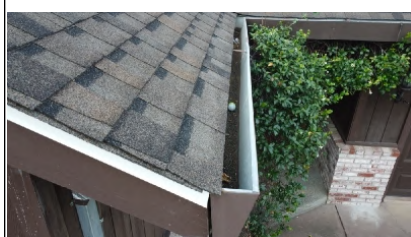
Gutter run has significant rust.

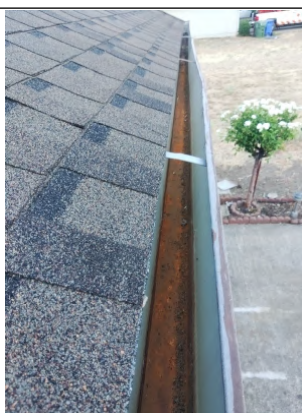
Gutter run has significant rust.

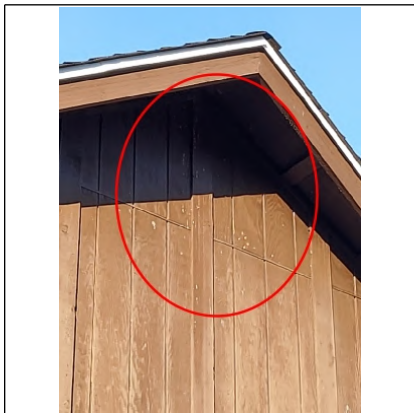
Woodpecker holes are evident on siding.

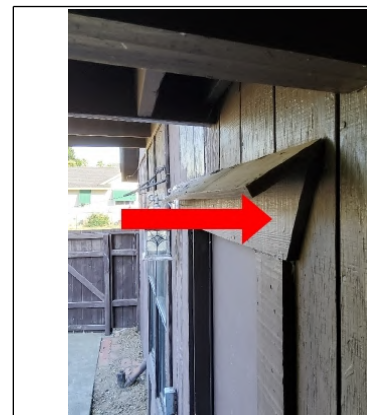
Recommend removing existing top trim member and install galvanized flashing above the existing casing trim.

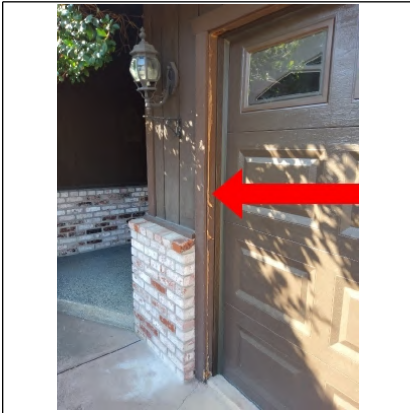
Recommend additional paint be applied on trim members.

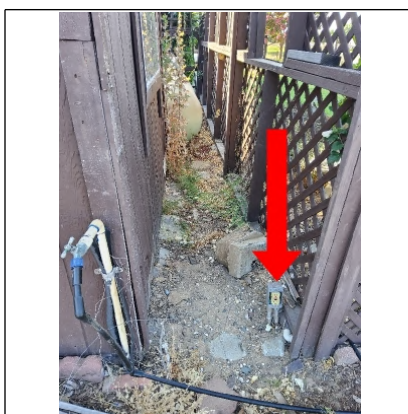
Missing exterior cover

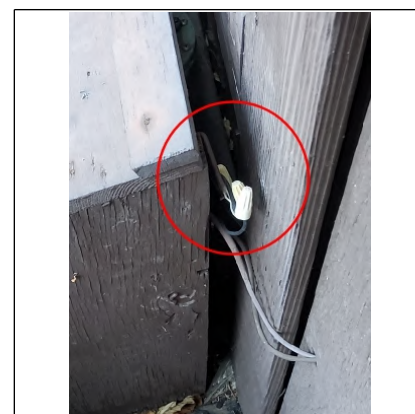
Exposed low voltage wires. Recommend having installed in a solid exterior junction box.

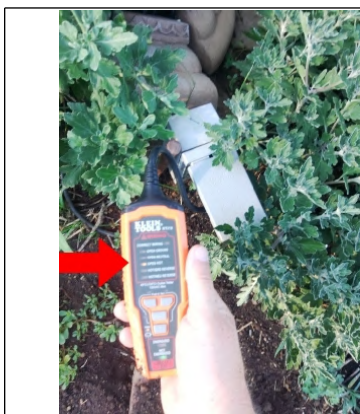
Electrical outlet is inoperable. Recommend having further evaluated and repaired by a Licensed Electrician.

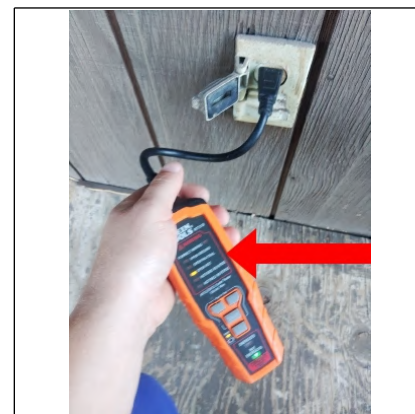
Electrical outlet is inoperable. Recommend having further evaluated and repaired by a Licensed Electrician.

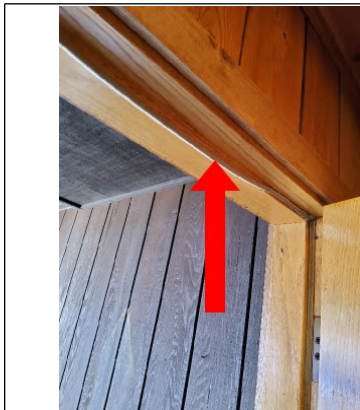
Recommend replacing weatherstripping.

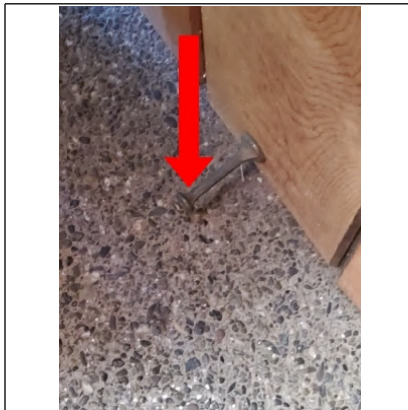
Missing rubber stopper on door stop.

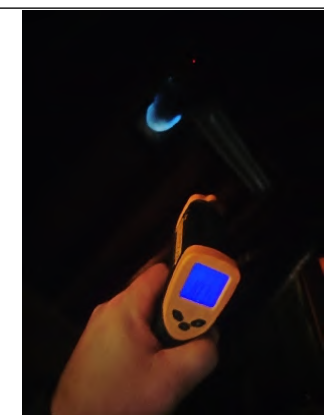
Thermal Reader shows 107.7 Degrees F at the roof vent location this shows there is proper ventilation and a satisfactory heat index.

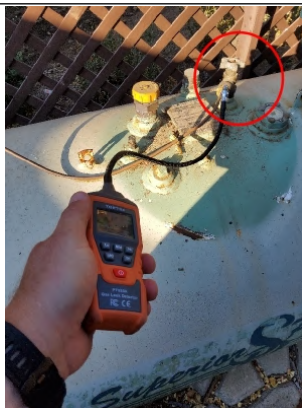
No leaks were detected on shut off valve.

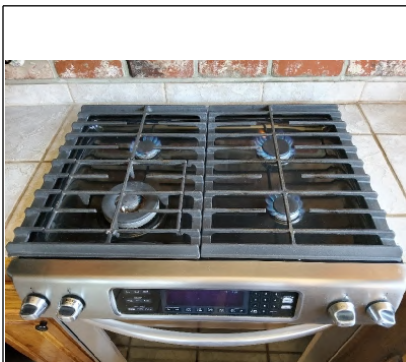
3 of the 4 burners show proper operation on the stove top.

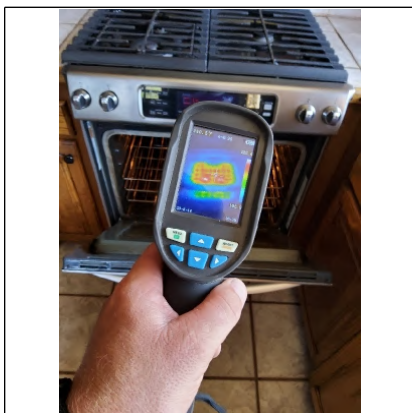
Thermal Imager shows oven properly operates.

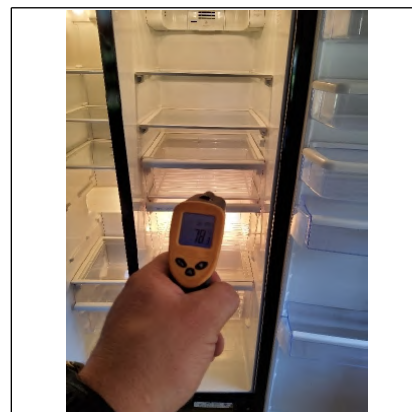
Thermal Reader shows 56.1 degrees F on freezer. This is most likely just on a high setting as its not being used.

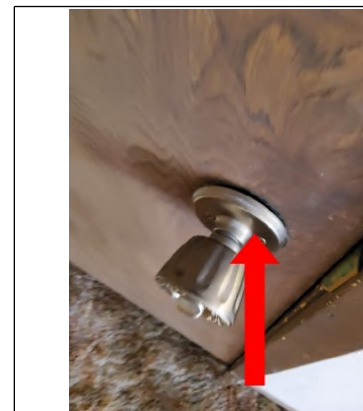
Loose door handle

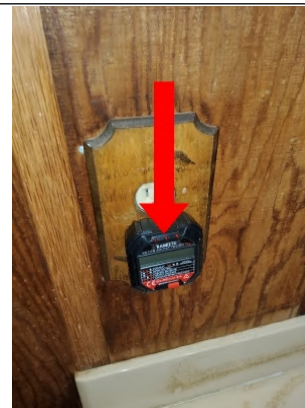
Electrical outlet is inoperable. Recommend having further evaluated and repaired by a Licensed Electrician.

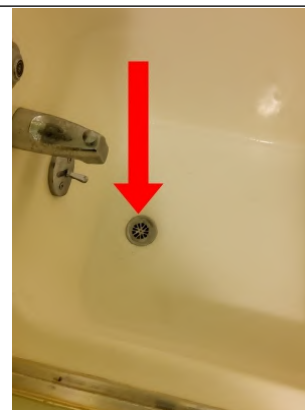
Drain is clogged

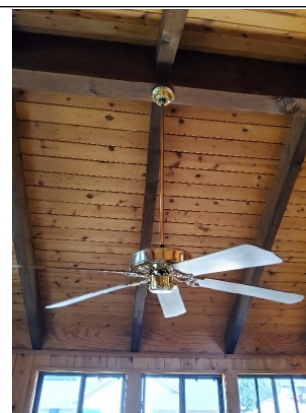
Comments **1. Ceiling fan is both loose and inoperable. Recommend having repaired by a Licensed Electrician.**

Ceiling fan is both loose and inoperable. Recommend having repaired by a Licensed Electrician.

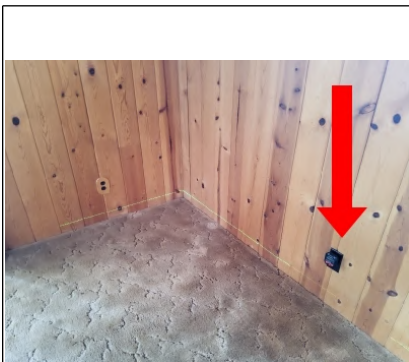
Electrical outlet is inoperable. Recommend having further evaluated and repaired by a Licensed Electrician.

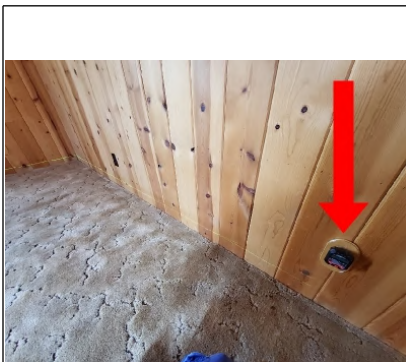
Electrical outlet is inoperable. Recommend having further evaluated and repaired by a Licensed Electrician.

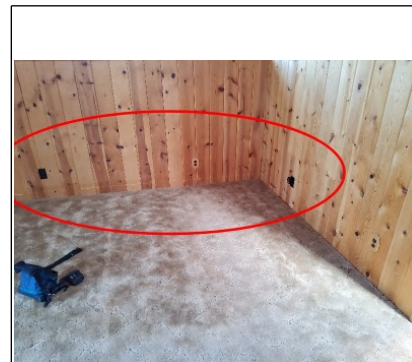
2. Noted Electrical Outlets are inoperable. Recommend having further evaluated and repaired by a Licensed Electrician.

Noted electrical outlets are inoperable. Recommend having further evaluated and repaired by a Licensed Electrician.

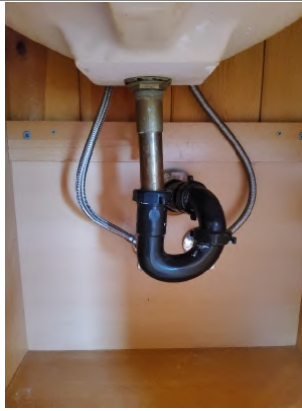
Sink drain line is not straight. Recommend having repaired by a Licensed Plumber.

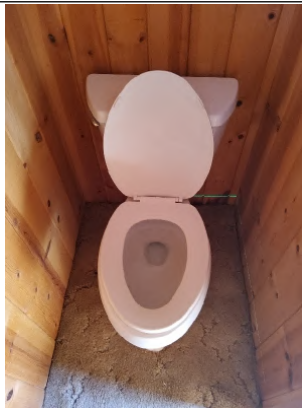
Toilet is loose at the base. Recommend having properly fastened to the floor from a Licensed Plumber.

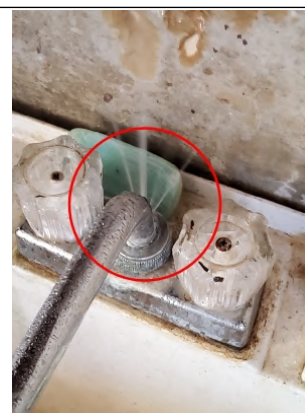
Comments **1. Recommend having damaged leaking faucet replaced by a Licensed Plumber.**

Recommend having damaged leaking faucet replaced by a Licensed Plumber.

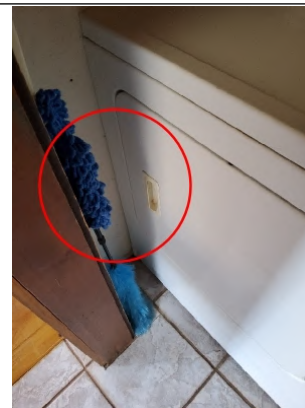
Dryer door will not open properly at its current location.

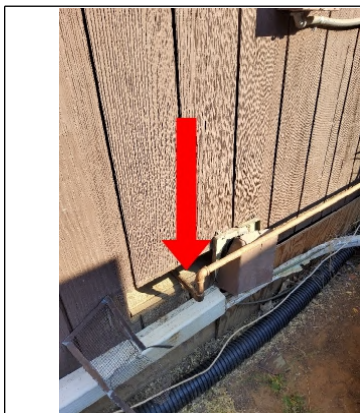
Comments 1. Recommend sealing off open vent location.

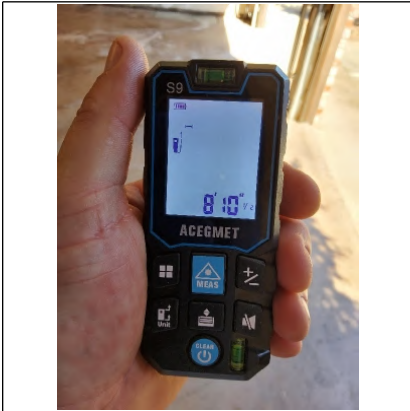
Garage opening measures 8'10" wide.

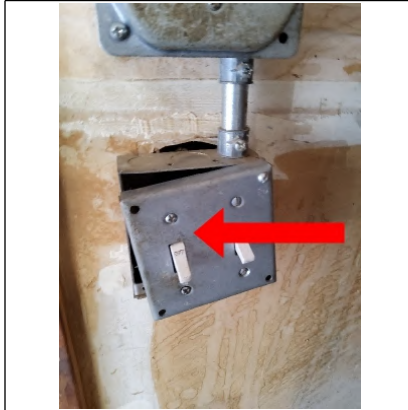
Loose switch cover
