Home Inspection Report

18961 Coyle Springs Rd., Hidden Valley Lake, CA 95467

Wednesday January 25, 2023

This inspection is a Certified Roof Inspection from Dustin Wallace General Contractor Home Inspections CSLB#1052482. Home Inspectors are NOT licensed for Roof Certifications unless they also carry either a C39 Roofing Contractors License or a General B Contractors License. In these roof inspections the roof conditions (as well as the material used) are examined as well as flashing, plumbing vents, storm collars, the examination of gutter conditions (if present), the degree of water run off in the subterranean area (if crawl space is present) and most importantly structural (conditions of rafters, truss members, header beams, etc) if an attic is present then thermal readings are calculated to do determine if extra ventilation is needed. PLEASE REFER TO "REPORT SECTION" FOR A COMPLETE DIAGRAM BREAKDOWN WITH REGARDS TO THIS ROOF INSPECTION.

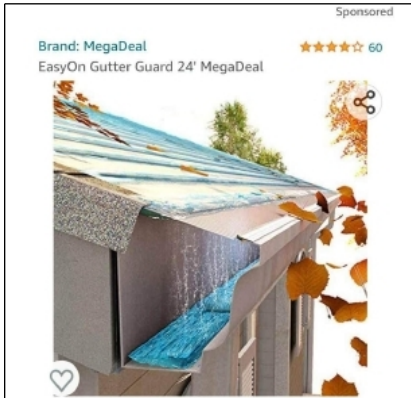
Excessive amounts of leaves are evident in gutter run. Recommend having gutters cleaned and possibly installing gutter covers at this location.

This gutter cover is a good option for that gutter run EasyOn Gutter Guard 24'

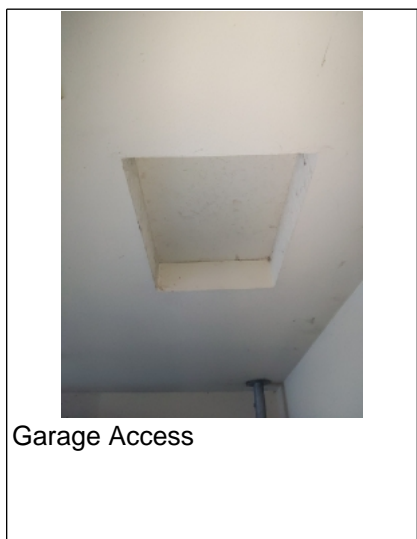
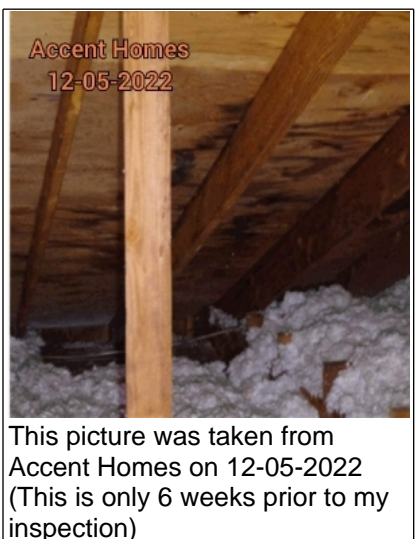
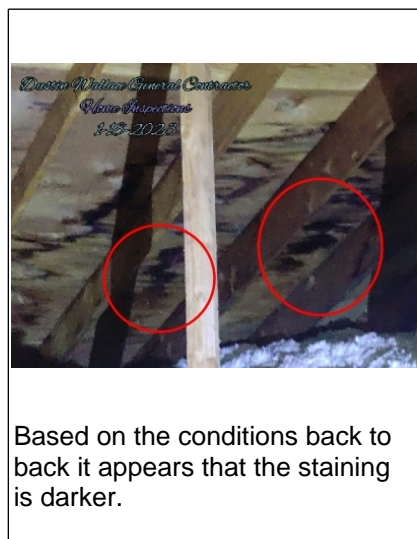
The largest concern with regards to roof conditions appears to be at the the valley location on the california hip that covers the rear deck. When walking the roof, I only felt one location that had possibly delaminated sheathing as it had a "bounce" and was in the area of concern (Refer to "Report Section: Roof"). Since no nail holes appear to be present I believe that water may have gotten passed the roof sheathing that is underneath the upper shingles and there possibly is not a proper underlayment with regards to protecting water from seeping into the sheathing itself. The extent is unknown until the section is opened up for further review. I believe being that it is a valley location with a good pitch there would not be extended noticeable damage on the loose insulation as there is no standing water causing a large amount of water droplets. With regards to the other water stains that are evident on the rafters without physically testing them I cannot determine the age but from the appearance themselves they do appear to be recent.

I have contacted Lucerne Roofing with regards to this and have submitted this report to Lucerne Roofing for a deeper evaluation and possible roof repair bid. This is only a roof inspection and based on the conditions and concerns I would recommend a repair bid if needed be provided by Lucerne Roofing. I recommend them coming back out and reexamining the attic again after these pictures have been taken and further evaluating the areas of concern to provide a proper bid or repairs if needed.
