# Home Inspection Report

9472 Yaquima Drive, Kelseyville, CA 95451

Wednesday July 22, 2020

Dustin J. Wallace Construction and Home Inspections  
16496 Main St.  
Lower Lake, CA 95457  
(707) 293-6307  
dustinjameswallace1985@gmail.com

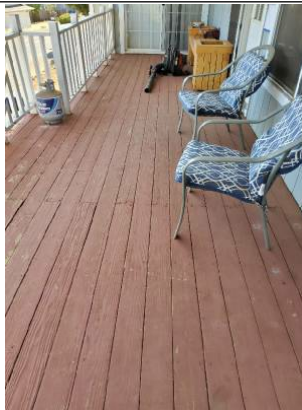
Deck could be repainted but is cosmetic

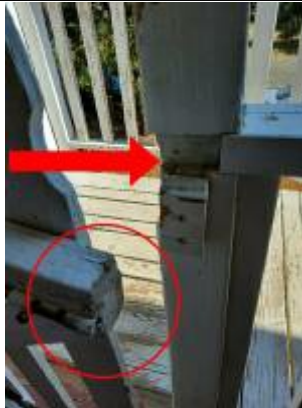
gate is sagging change out latch to a standard gate latch.

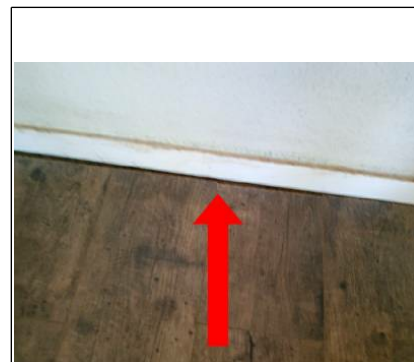
**Comments** Hardwood floor not properly installed. Install quarter round to baseboard to hide end cuts of flooring

install quarterround throughout house where ending cuts of hardwood floor are exposed.
