# Home Inspection Report

15208 Harbor Lane, Clearlake, CA 95422

Monday August 21, 2023

3233

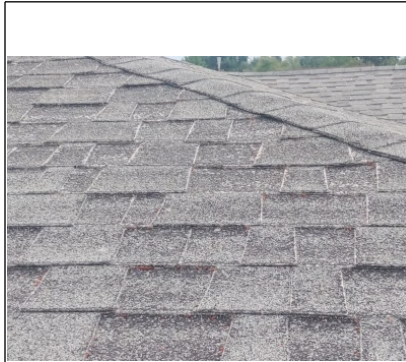
Reference section #2 with regards to worst conditioned shingle location. (Refer to diagram for locations)

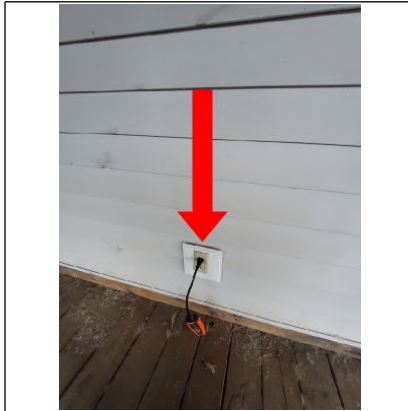
Recommend replacing electrical outlet with a GFCI and installing an exterior cover.

**Comments**    **1. Recommend replacing exterior open grounded electrical outlet with a GFCI as well as install exterior cover plate.**

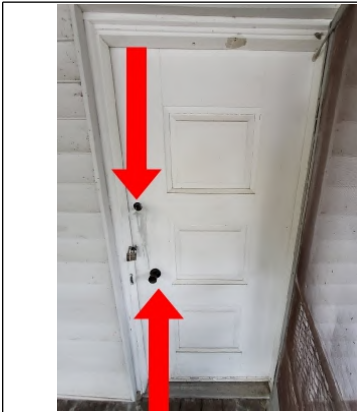
Recommend replacing door handle and deadbolt.

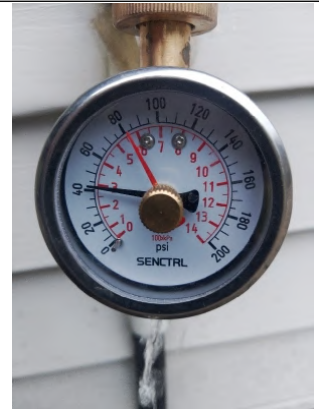
Water at shut off location is 41 PSI which is a satisfactory water pressure. The ideal water pressure for a house is between 40 to 65 psi.

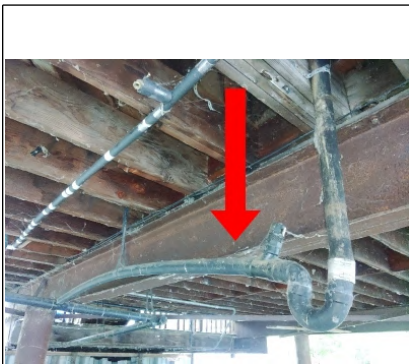
**Comments** **1. Noted ABS drain line must have a minimum 1/4" fall per ft. Recommend having properly pitched by a Licensed Plumber.**

ABS drain line must have a minimum 1/4" fall per ft. Recommend having properly pitched by a Licensed Plumber.

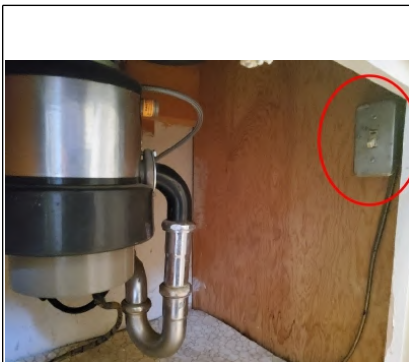
Garbage disposal shows proper operation when testing.

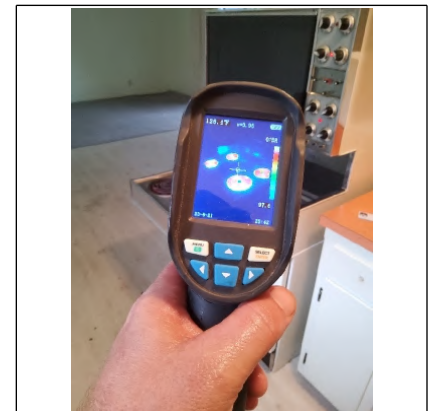
Thermal Imager shows all burners show proper operation.

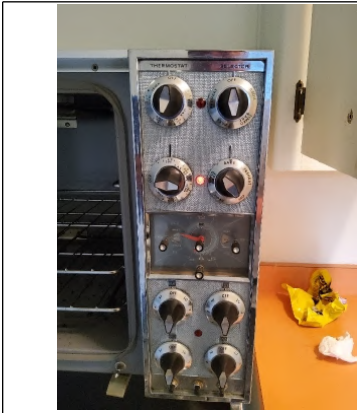
Oven dials show proper operation.

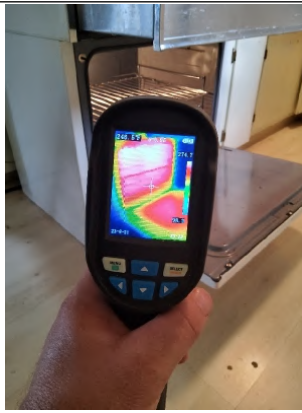
Thermal Imager shows oven properly operates.

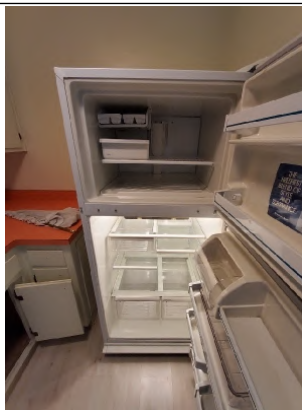
Refrigerator was plugged in and operable and unplugged after testing.

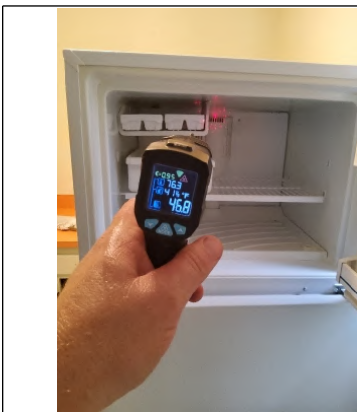
Refrigerator was only plugged in for 30 minutes but does show proper operation. (46.8 Degrees F in freezer)

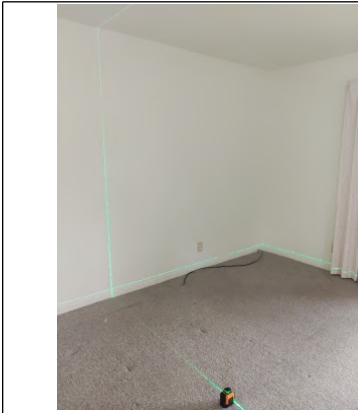
Laser level shows walls are plumb and floor is level.

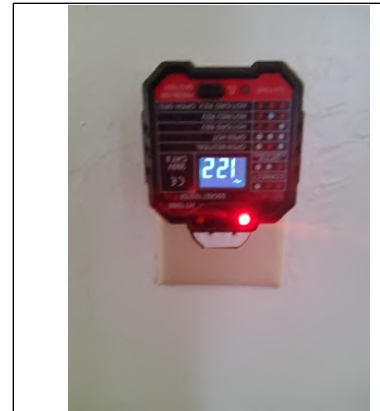
Electrical outlet is not grounded but shows proper operation.

**Comments** **1. Electrical outlets do not have proper grounding. Recommend replacing with GFCI's. This wont provide grounding but will eliminate electrical shock at the outlet.**

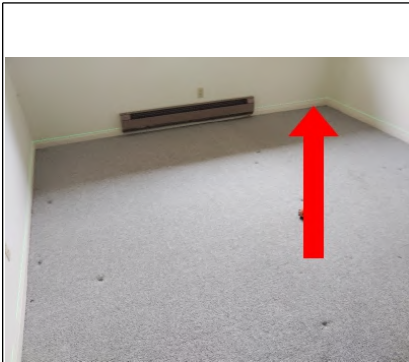
Laser level shows floor has a 1" slope at noted location.
