“Full” Reserve Study

Sun Country Maintenance Association Cle Elum, WA

Report #: 27561-0

Date Prepared: September 24, 2015

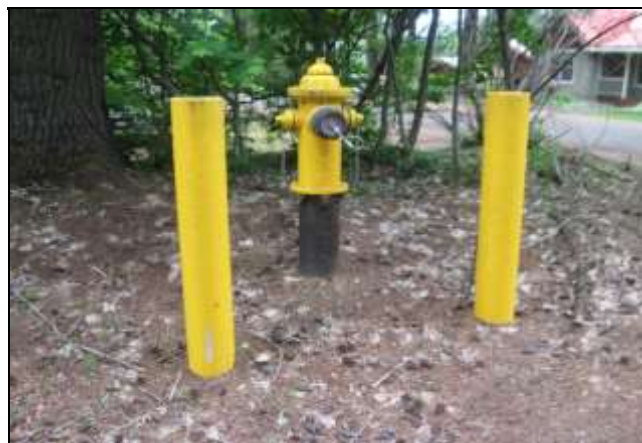
Comp # : 950 Fire Hydrants - Replace Quantity: ~ (26) hydrants

Evaluation : Functional condition assumed, no problems reported.

Although long lasting, eventual replacement will be needed based on typical deterioration. Cyclical replacement of hydrants is factored below, timed to coincide with main line replacement for cost efficiency..

Useful Life:
60 years

Remaining Life:
55 years

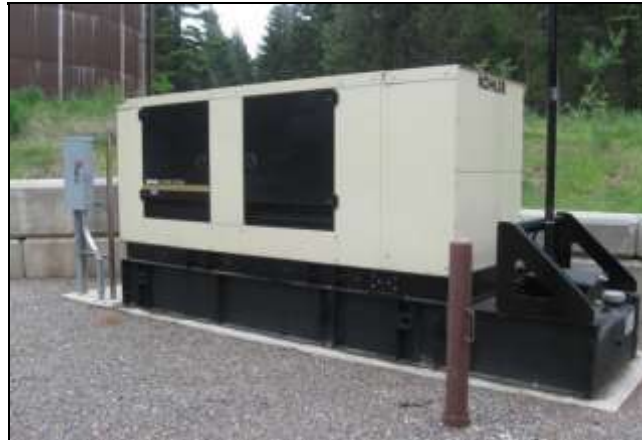
Comp # : 960 Gas Generator - Replace

Evaluation : Kohler Power Systems 150 generator is reported to be in functional condition.

Useful Life:
40 years

Remaining Life:
35 years

Best to plan for regular cycles of replacement at roughly the 40-year mark of life as indicated below.
