<b>Steam reformer – Eddy Current Report</b> <b>Reliability Analysis</b>	<b>Report: RPT-002</b> <b>Revision: 0</b> <b>Date: April 6<sup>th</sup>, 2025</b> <b>By: O.Olatte</b>
--	--	--

This report details a reliability analysis to the reformer status based on Eddy current inspection results report to the catalyst tubes installed in the Reformer US-01-103-R-0100, located at VertGTL plant in Lake Charles, LA. As an additional antecedent, is considered a report based on a LOTIS inspection report from 2004, issued by LENA (Linde) in 2013 as preparation to the reformer inspection and works made in 2014.

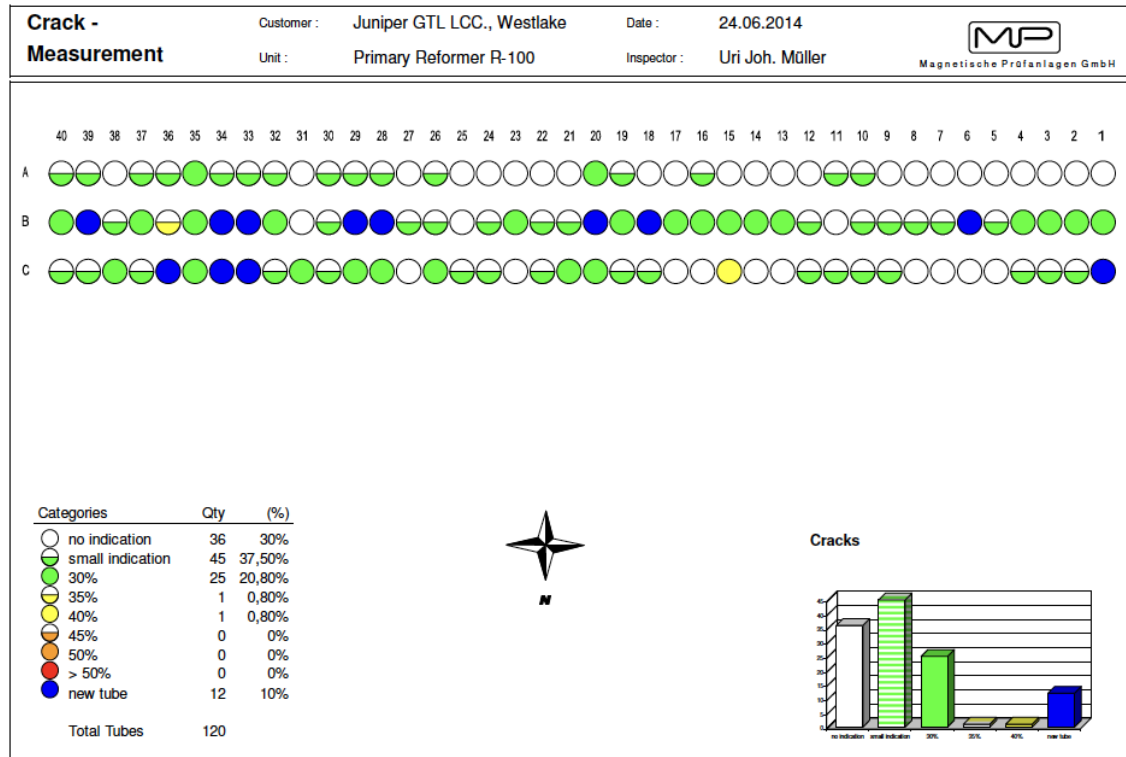
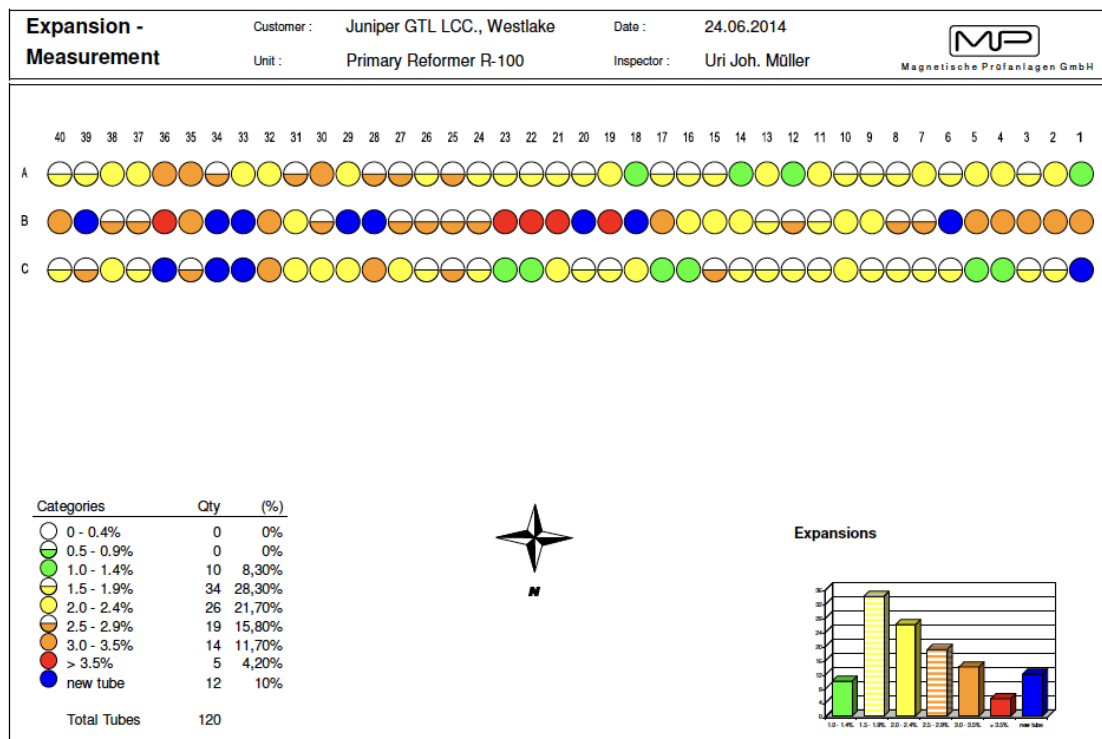
Juniper GTL, Westlake, LA  
Reformer R-100, Inspection June 2014  
Row-A (South), Tubes #1 - #40

Additional to the information provided on the EC inspection report, the following may be deducted from the results of the inspection:

<b>Tubes with SMALL indications:</b>	<b>45</b>
<b>Tubes with 30% of thickness damaged:</b>	<b>25</b>
<b>Tubes with 35% of thickness damaged:</b>	<b>1</b>
<b>Tubes with 40% of thickness damaged:</b>	<b>1</b>
<b>Tubes with 45% of thickness damaged:</b>	<b>0</b>
<b>Tubes with 50% of thickness damaged:</b>	<b>0</b>
<b>Tubes with more than 50% of thickness damaged:</b>	<b>0</b>
<b>72 out of 120 tubes present damage</b>	<b>60.0%</b>
<b>Max damage registered is 40% of the thickness</b>	
<b>37.5%</b>	<b>Show small damage detectable by Eddy Current</b>

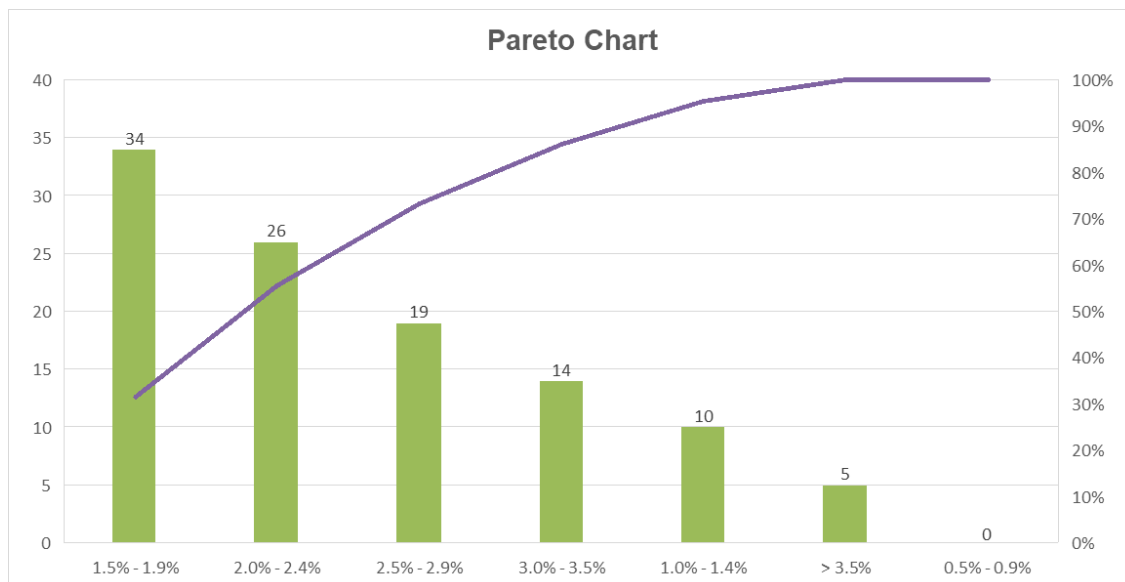
<b>15.8%</b>	<b>Tubes are over 3.0% of expansion</b>
<b>37.5%</b>	<b>Tubes are between 2.0% and 2.9% of expansion</b>
<b>36.7%</b>	<b>Tubes are between 1.0% and 1.9% of expansion</b>
<b>10%</b>	<b>Tubes with damage not detected</b>

Maximum expansion detected	4.40%	B	36		
Tubes with max expansion	1				
Minimum expansion detected	1.20%	A	18	C	4
Tubes with min expansion	2

It can be observed that the great part of the tubes today are in the range between 1.0% y 2.9% with a distribution quite normal. See figure below.

This reveals that there is a great number of tubes that are progressing to 3% and above expansion. It can be seen that the tubes over 3% tend to be greater than those with no damage detected, insinuating a growing tendency of these tubes. This transition depends on temperature, time and transients in service. This applies despite the number of tubes removed and replaced.

As presented on the Pareto chart, the tubes 3% or above in diameter expansion have to be replaced to avoid an unexpected and expensive reformer shutdown.
