## RELIABILITY REPORT

Title: Reliability Study on a Reformer

Author: SOIL Ingeniería

Steam Methane Reformer (MW Kellogg)

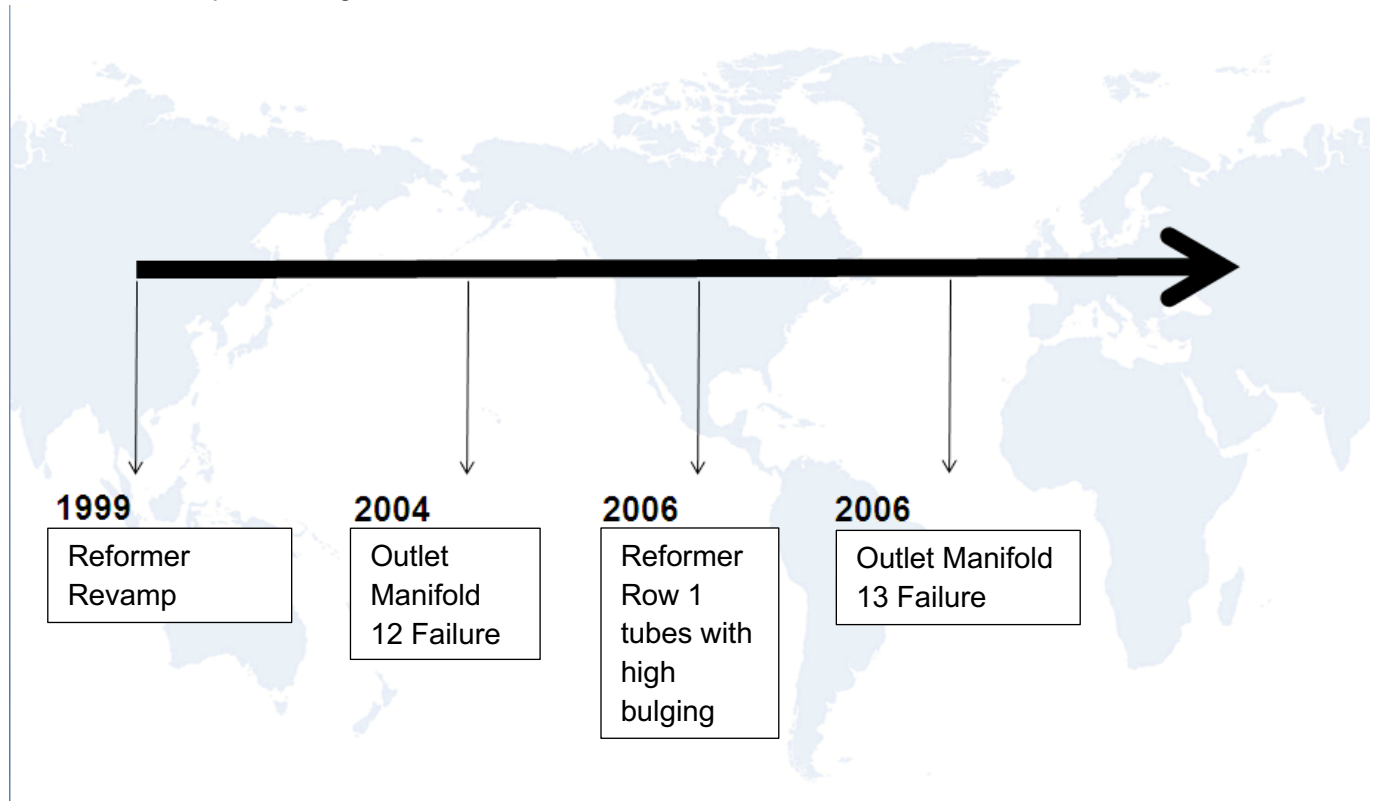
Post-1999 revamp: Three significant events have occurred in the reformer.

Manifold 12 failure (2004): Several severe cracks were found, mainly around the weld between the manifold and the weldolet, propagating toward adjacent weldolets. Collateral damage occurred to tubes 35–39, with lesser cracking on tubes 40–45. Repair consisted of replacing only the damaged section, which remains in service. Failure analysis attributed the cause to creep cracking from stress relief of high residual stresses due to welding.

2006 Turnaround: LOTIS inspection found seven tubes exceeding 3% expansion (removal criterion), with microstructural analysis indicating prolonged exposure to high temperatures. Tube 2/41 showed complete disappearance of secondary carbides; temperature ranking based on carbide density: T2/41 > T10/38 > T10/37 > T11/52.

- Row 2 tube 41, 17.95%
- Row 10 tube 35, 3.12%
- Row 10 tube 36, 3.20%
- Row 10 tube 37, 3.25%
- Row 10 tube 38, 15.96%
- Row 13 tube 52, 3.36%
- Row 11 tube 52, 5.43%
- Riser 6 bulging close to 3% (2,92%)

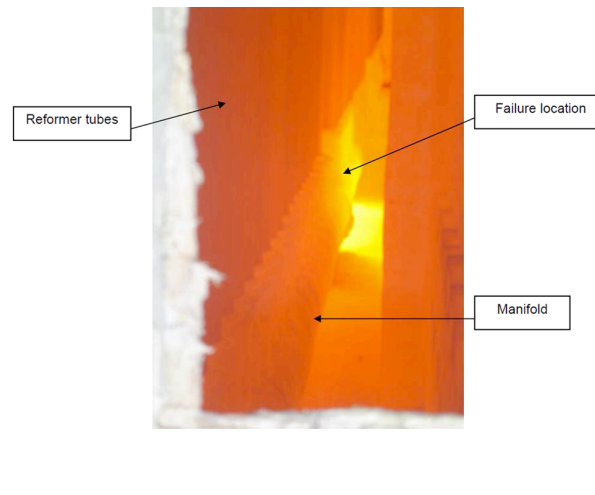
Manifold 13 failure (2006): Occurred during plant restart. Analysis showed end-of-life creep failure due to combined temperature, pressure, and material strength factors. Microstructure was as expected but showed aging from high-temperature exposure.

The manifold 13 failure was caused by high temperature, as was the case for tube expansions. Manifold 12's failure is likely linked to fabrication defects and possibly spring misadjustment rather than temperature. It is possible other manifolds have defects and have experienced high-temperature operation.

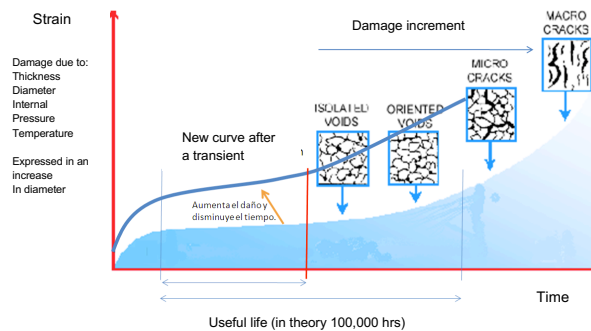
High temperatures reduce material properties, shortening service life. Rapid heating/cooling cycles accelerate damage. Thermal stresses during heating can reach four to five times the yield strength at service temperature if expansion/contraction is restricted. Damage relief occurs via creep; pre-existing creep damage leads to cracking or failure.

Steady State: Temperature and Pressure constant. Damage Rate constant

Transients: Changes in Temperature and/or Pressure not constant. Damage accelerated. Curve moves up. Magnitude depends on time and the changes in temperature. Accumulative damage non-reversible.
