| | <b>Field Assessment Report</b><br><b>Steam Methane Reformer</b><br><b>US-01-101-R-0100</b> | <b>Date: 03/17/2025</b><br><b>Inspector: O. Olatte</b><br><b>Page 1 of 14</b> |

| <b>Scope of the assessment:</b> | | | | | | | External Visual Inspection in as found condition | | | | | | |

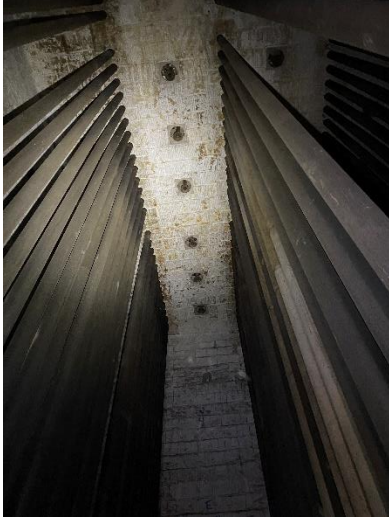
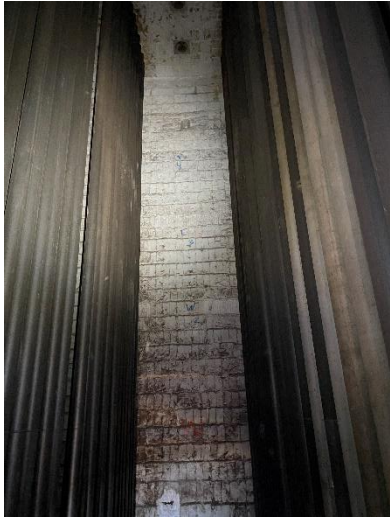
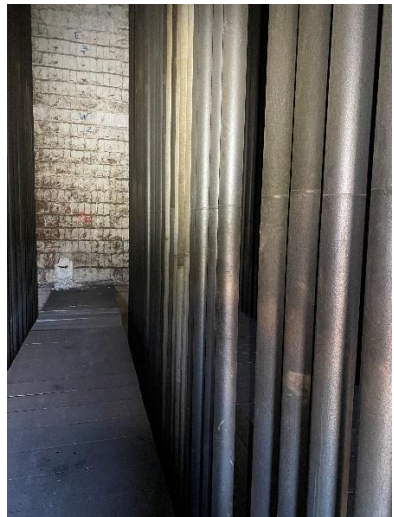
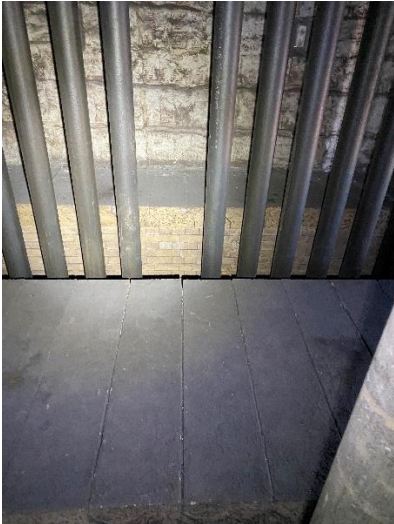
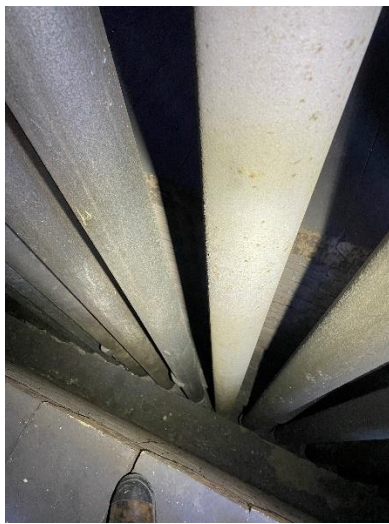
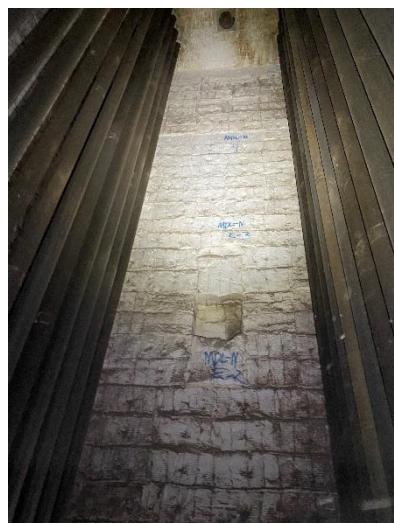
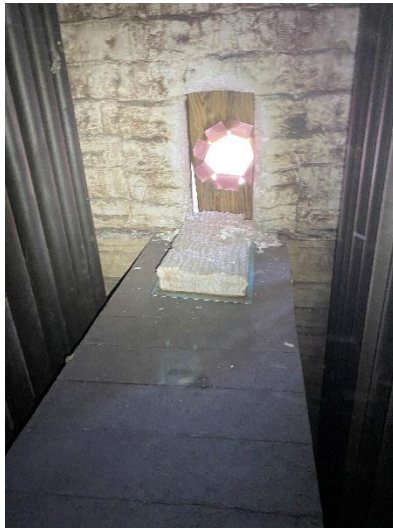
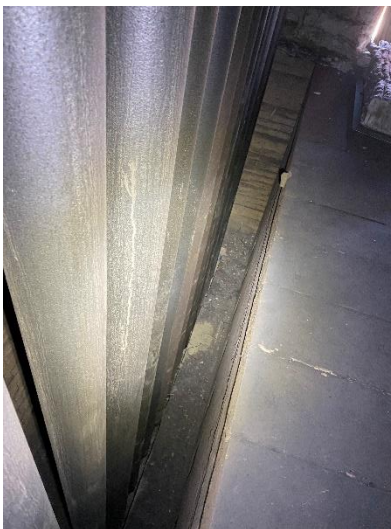
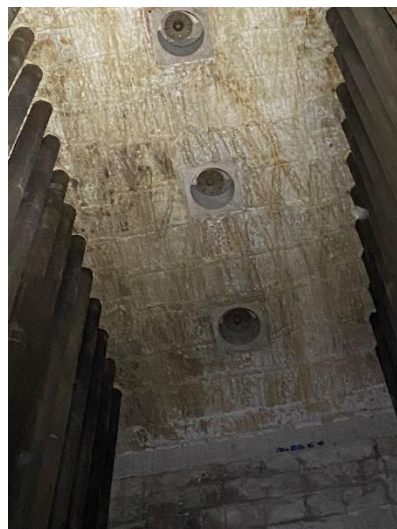
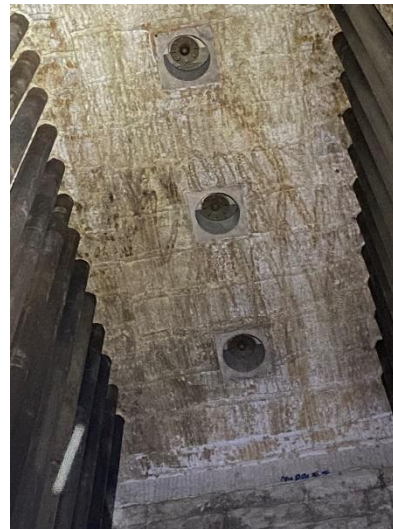
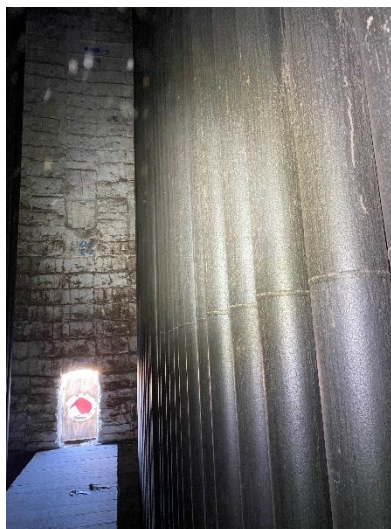
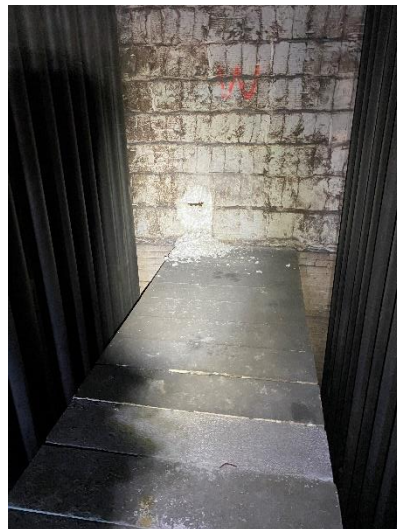
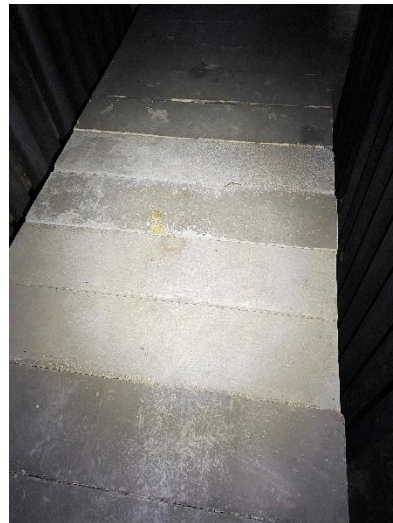
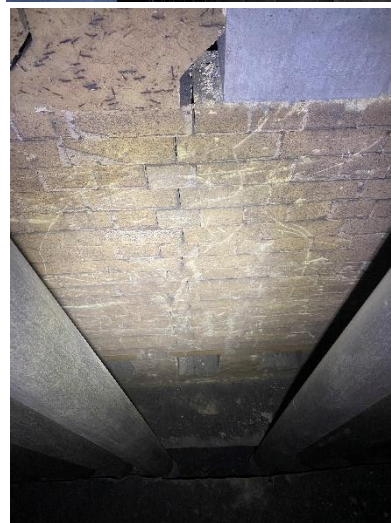
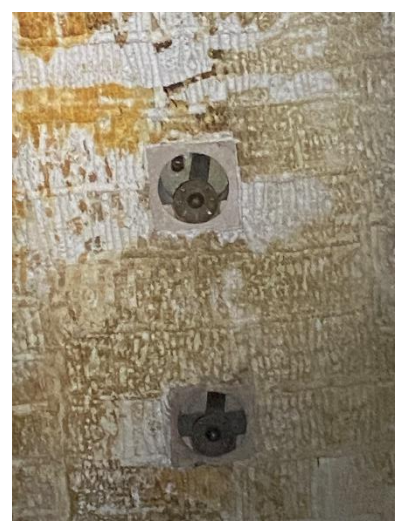
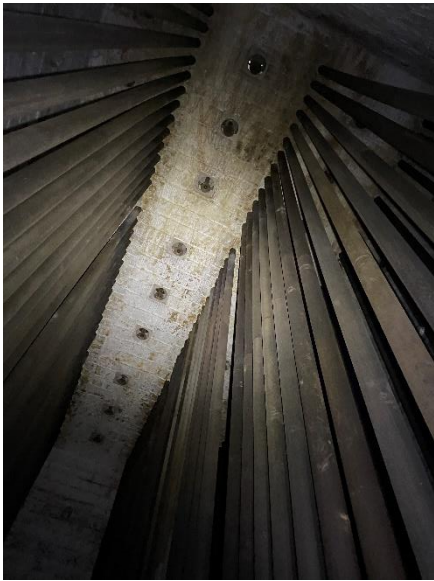
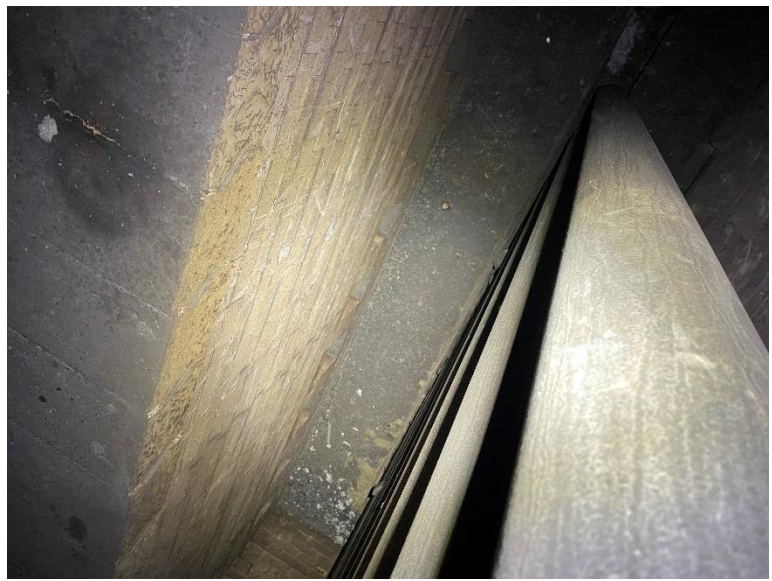
### Radiant box

| <p><b>Radiant:</b> in general, inside the radiant section all components look in good condition.</p> <ul style="list-style-type: none"> <li>• It was observed that six catalyst tubes have been replaced. No bulging observed in the tubes' walls.</li> <li>• Some tunnel slabs present cracking but integrity is maintained. Other slabs have been replaced recently. Tunnels walls are straight, with expansion joint in good condition. No cracking on the walls.</li> <li>• Insulation on walls it is in good visual condition. There is one area where a insulation block was damaged probably by fauna.</li> <li>• Insulation on the roof looks also in good condition but in some areas of the reformer it presents brown marks.</li> <li>• Peep doors are in good condition and functional.</li> <li>• Arch burners from inside the box (tunnels top standing) look in good condition.</li> <li>• External walls show paint worn out. Joints between wall pannels are corroded and, in some cases, flora is growing.</li> </ul> | | | | | | | | | | | | | |

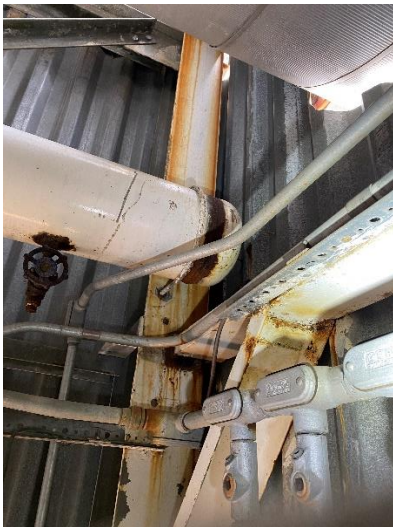
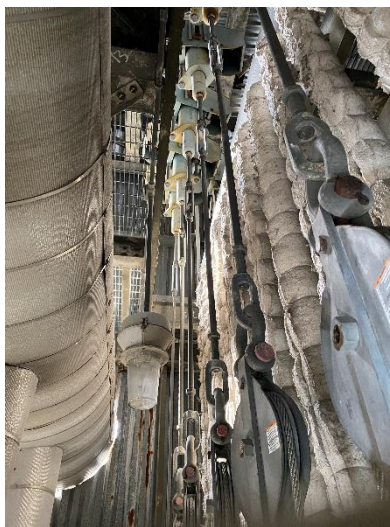
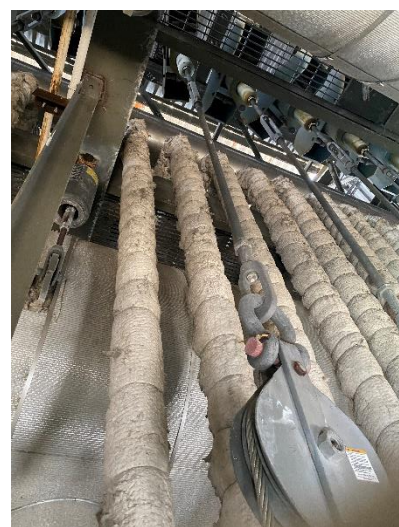
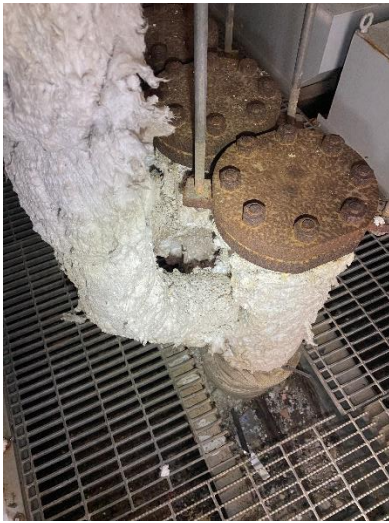
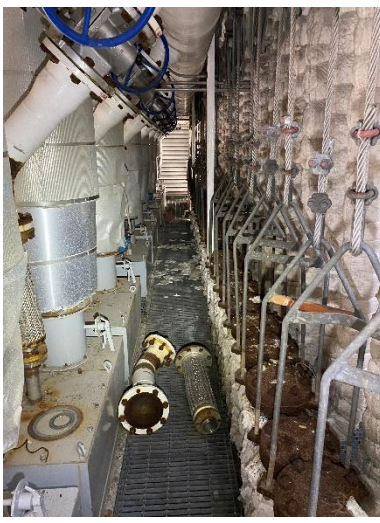
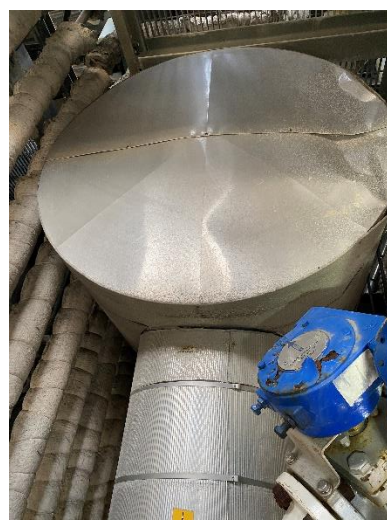
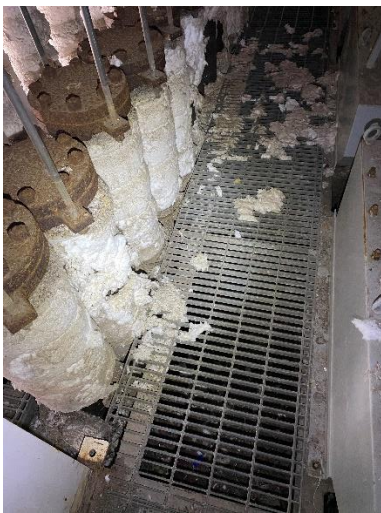
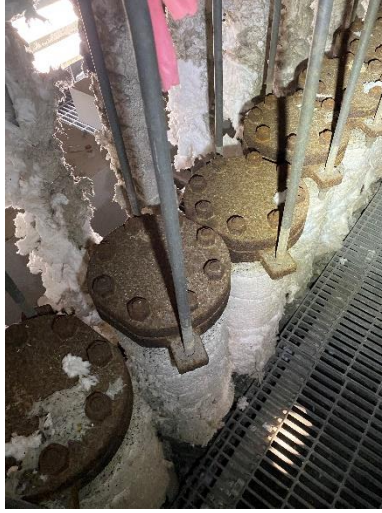
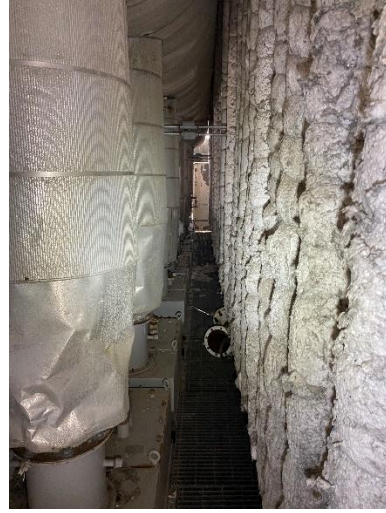
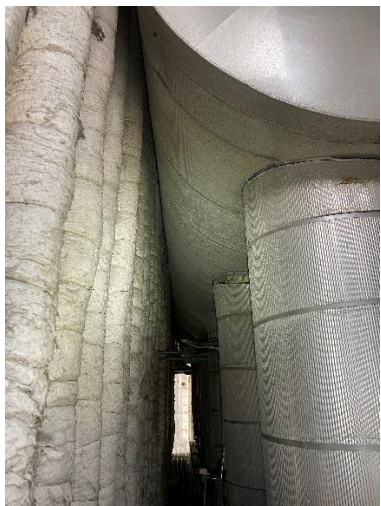
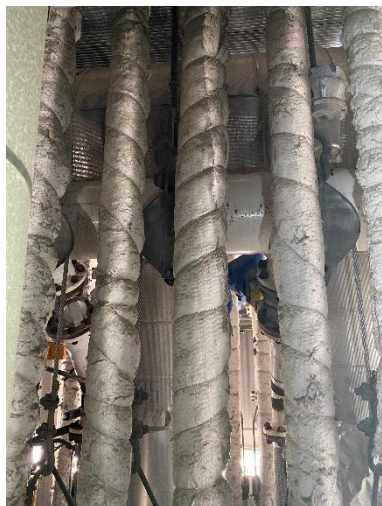
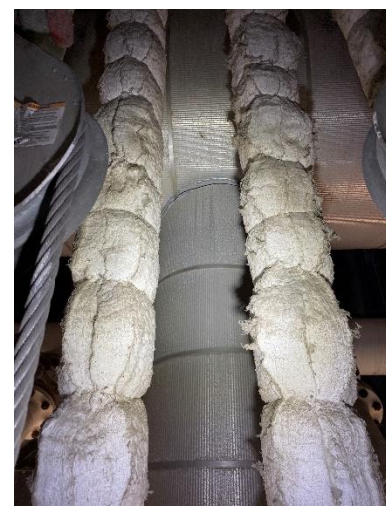
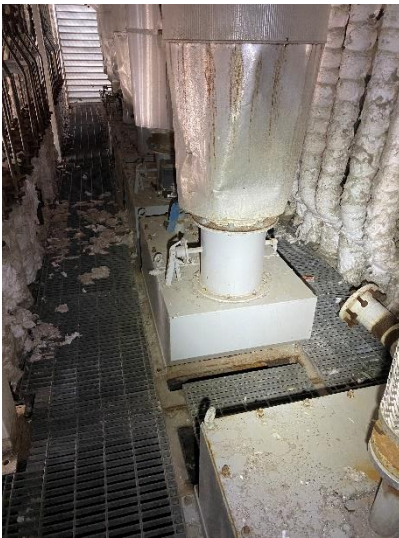
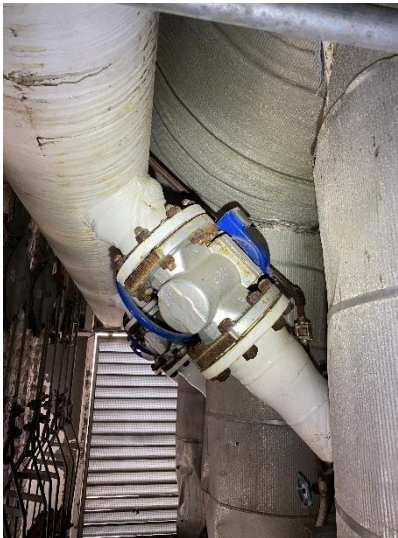
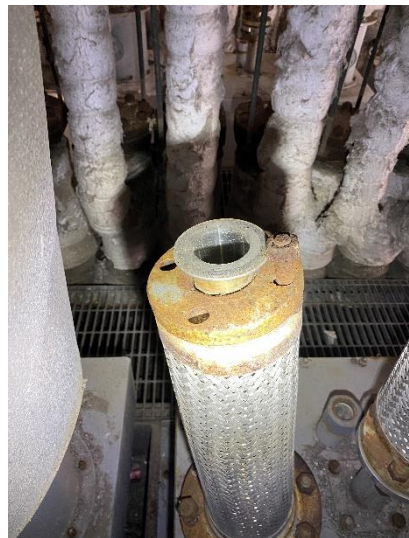
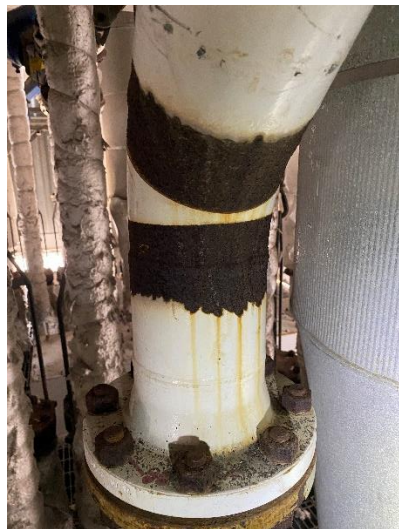
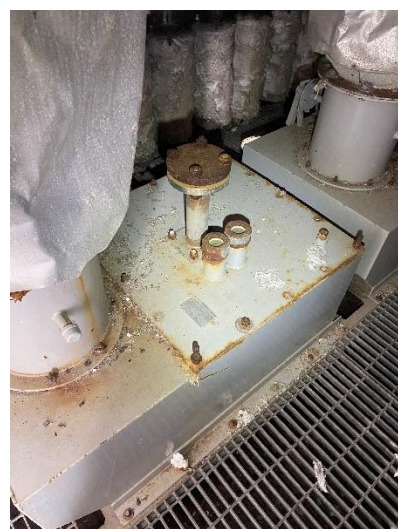
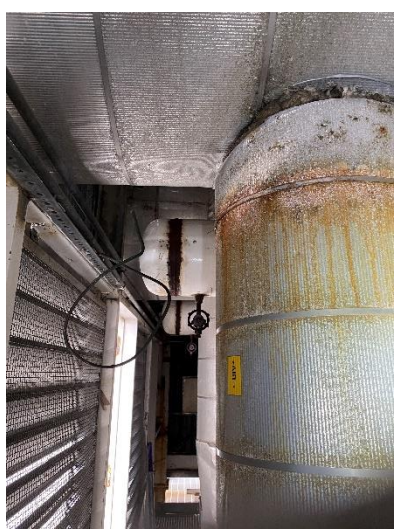
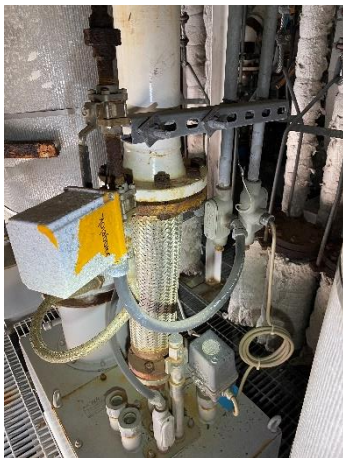
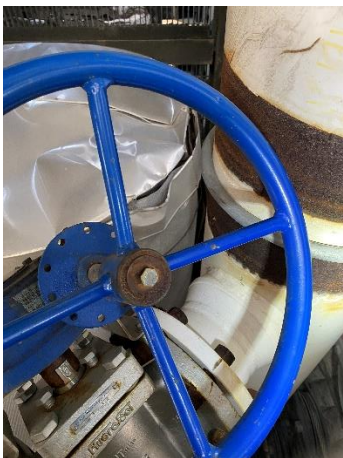
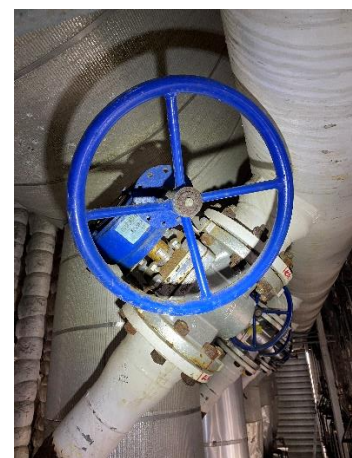
### Penthouse

**Penthouse:** General condition is good, no great damage observed.

- Burners show good conditions. Valves operative, lightning pipe in good condition and air dampers operatives.
- Gas pipe in good condition. Welds present corrosion that most likely was there before reformer shutdown. Insulation visually is in good condition.

- Air plenums and ducts are in good condition. Insulation is in good condition. Some damage apparently due to the action of the local fauna.
- Instrumentation is in apparently good condition. Unknown operational condition.

- Inlet pigtails in good visual condition. Insulation in place but not fully functional. It looks damaged by water or excessive humidity.
- Tubes tops with insulation in place. Top tube flanges show high temperature oxidation.

- The tube's support system seems to be operative and with no apparent damage.
- Tubes' constant springs with no apparent damage other than superficial oxidation.

- Fuel gas Piping and process gas piping insulation jacketing is in great extent in good condition. Some sections are missing or damaged, allowing water to filter inside.

- No CUI observed affecting piping during this inspection.
- Some rainwater leaks ran through the structure columns corroding trusses and other structural parts.

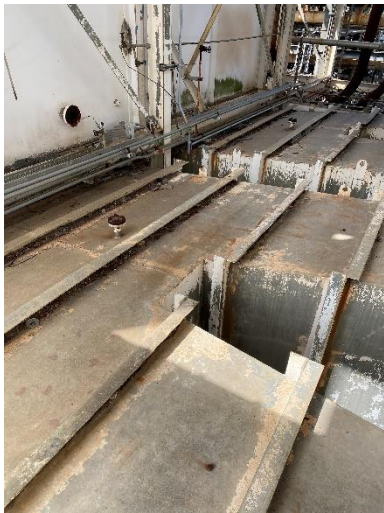
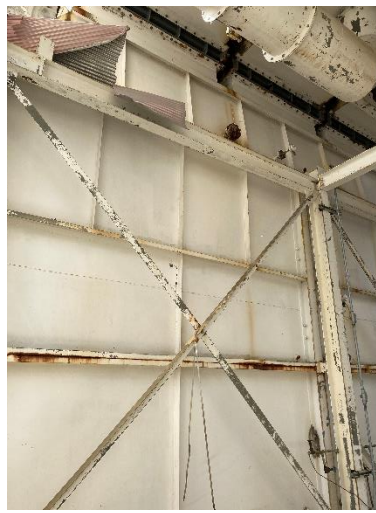
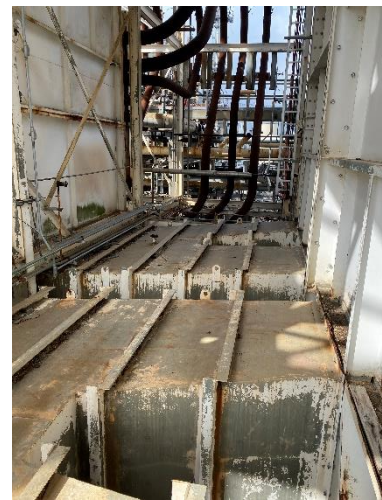
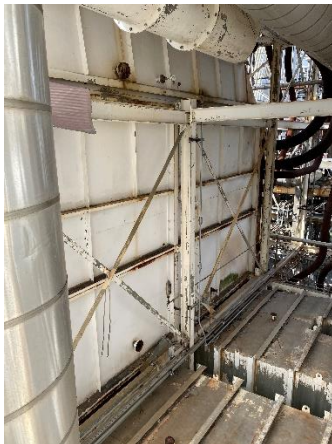
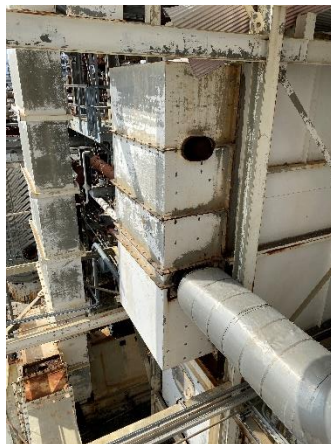
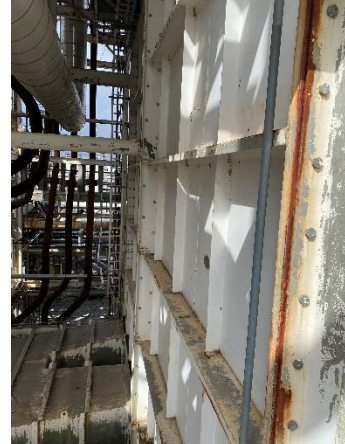
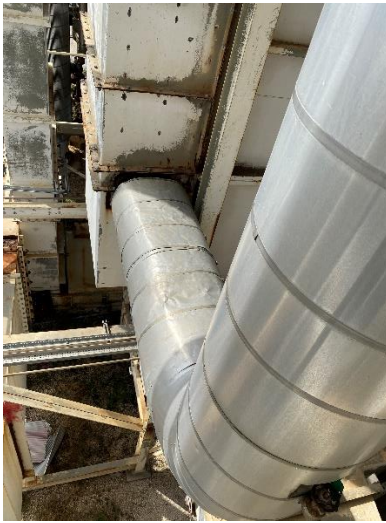
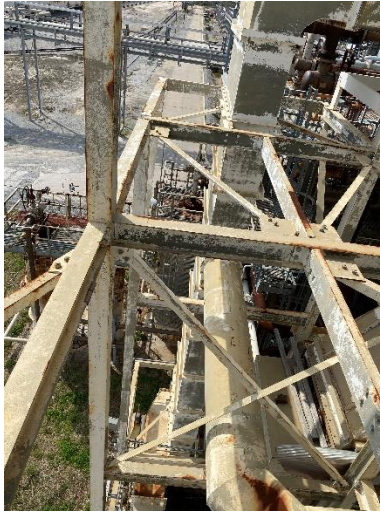
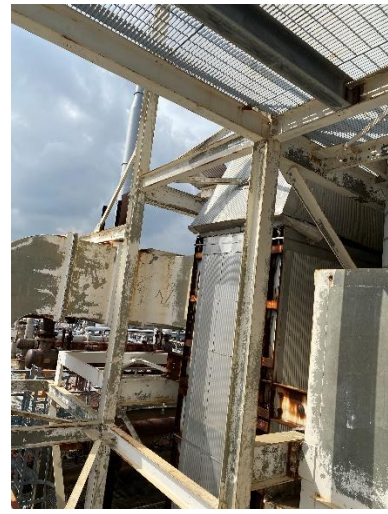
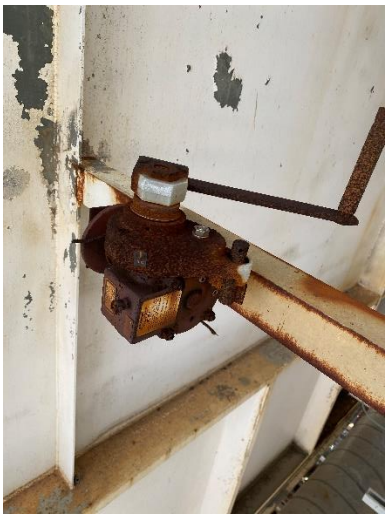
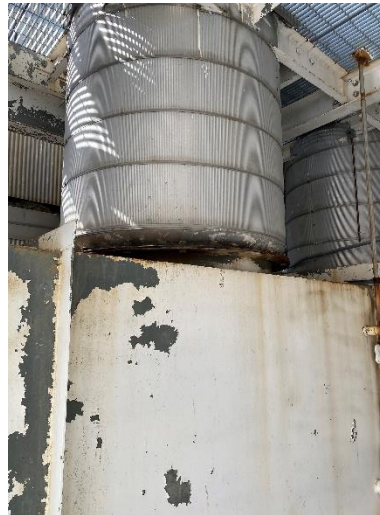
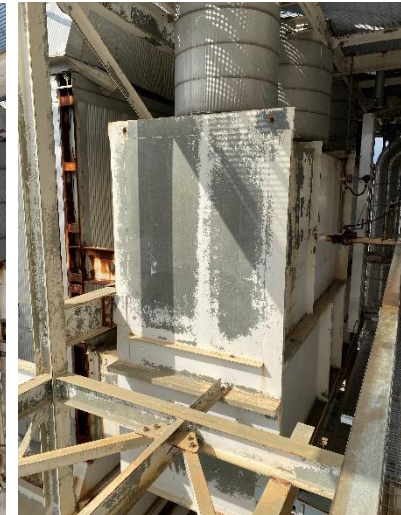
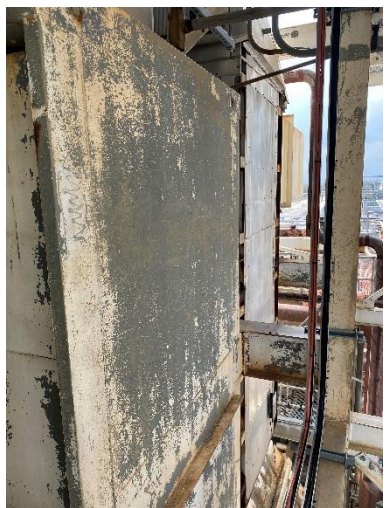
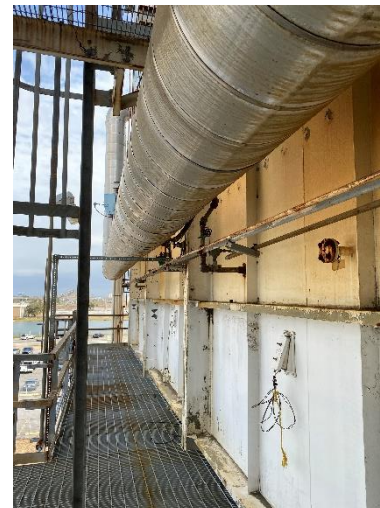
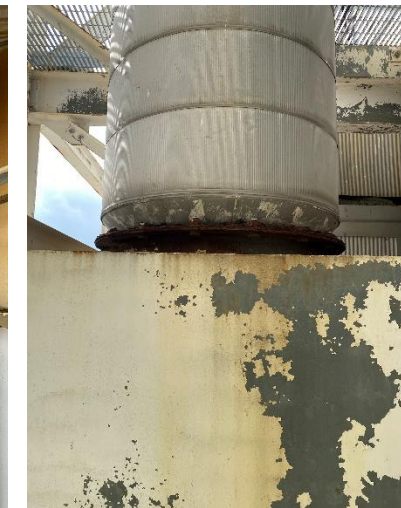
**Convection:**

- Modules panel walls with paint worn out.
- Corrosion in flanges in joints between panels.
- Insulation jacketing debris, likely from the ID Fan in trapped in some structures.
- The roof plate of transition ducts is with paint worn out. No evident signs of corrosion or mechanical damage.
- Mixed feed piping shows insulation lost and corroded.
- Internal inspection of pipeline 104-PRS-02760-8"-6CJ1S01-HC-X" accessing through the space left by check valve C506CJ500 removed, show material corrosion.
- Mixed feed inlet pipe presents areas with no insulation and corroded.
- Mixed feed coil outlet pipe shows insulation in good condition but it is suspected of CUI.

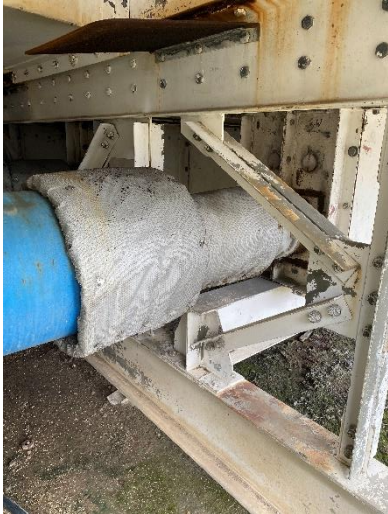
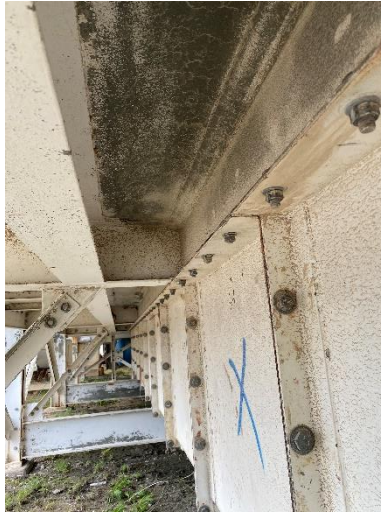
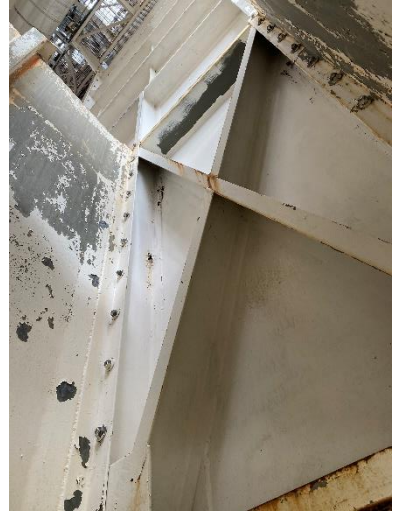
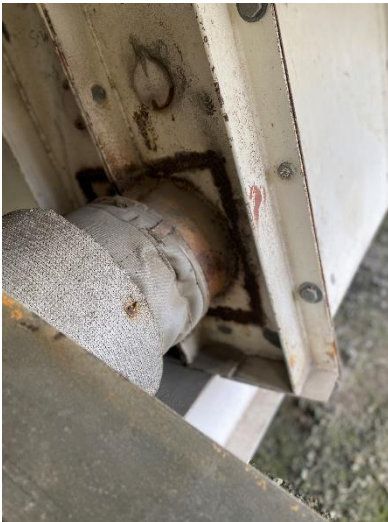
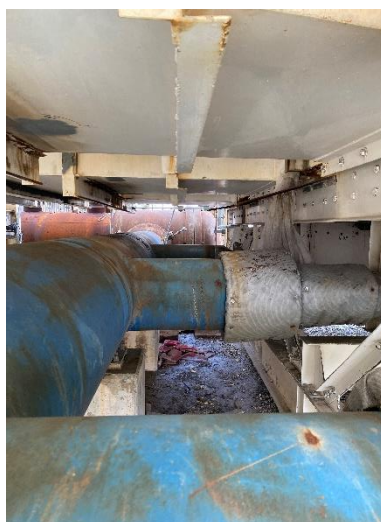
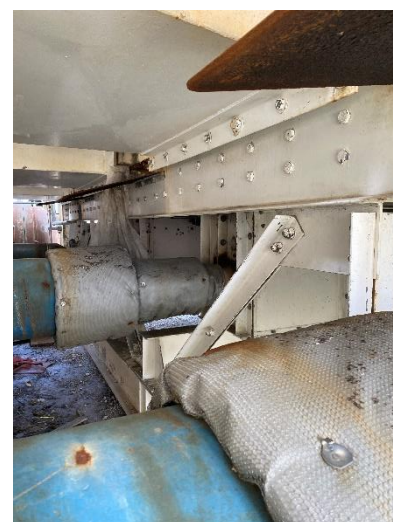
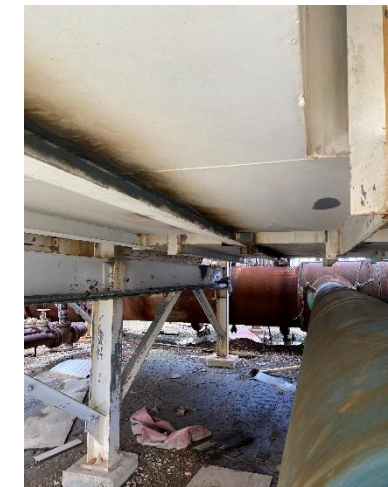
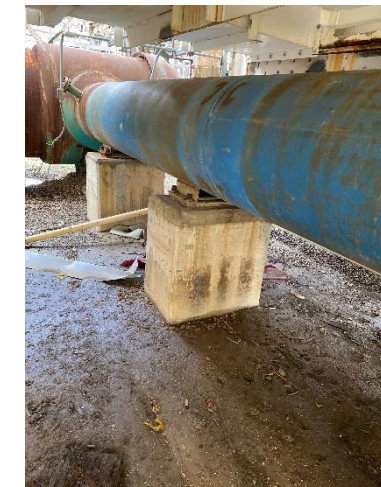
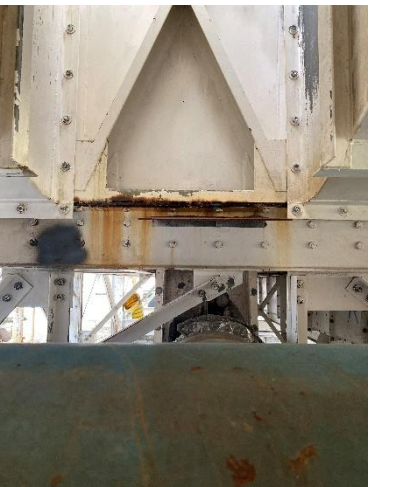
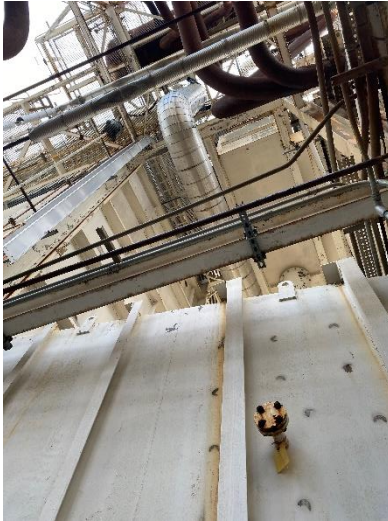
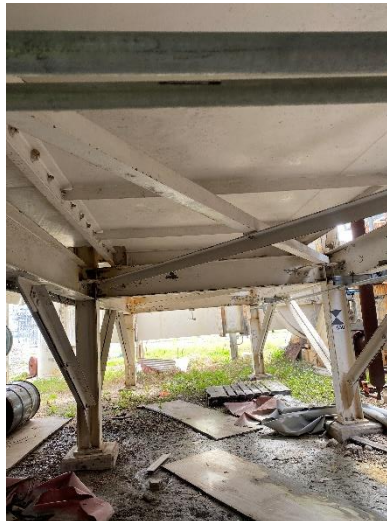
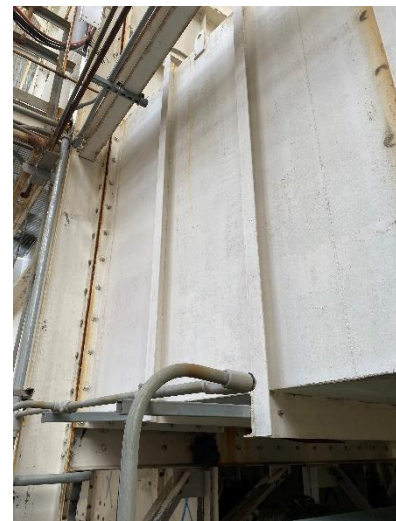
**Bottom section of the reformer:**

- All outlet pigtail boxes are in good conditions.
- Paint worn out.
- Pipes connected to the collector pipe are in good condition and insulation is installed and observed in good condition as well.
- Floor plates are in good condition. No major corrosion was observed.
- Flanges in joints between panels or modules present heavy corrosion.
- Collector paint worn out.
- Collector does not show dents or major damage. No evident signs of overheating.
- Area or collector connecting to the WHB HE-0110 oxidized.
- Collector supportation and foundations are in good condition.
- Piping connecting outlet manifolds to collector pipe is in good condition and insulation in place.
