NORTHERN TERRACE HOA
Association #: 01.01.1741

Level 1 -- Full Reserve Study with Site Visit

Date of Site Inspection: **07/31/2024**

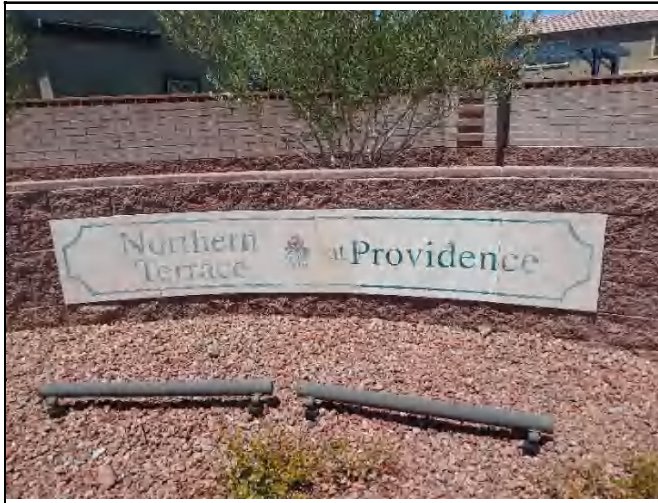
Comp #: 1.113 Monument Signs - Replace

Quantity:	14 Monument Signs	Original Service Date:	2009
Unit Cost:	\$5,000.00	Useful Life:	20
% of Unit Cost:	100.0%	Rem. Useful Life Adjustment:	0
Total Cost:	\$70,000.00	Remaining Useful Life:	4
Cost Source:	GeoReserves Database	Next Scheduled Year:	2029
Description:	Monument signs can come in a wide range of sizes, materials, and designs. However, over time they will eventually need to be updated to maintain appearance and to keep a current look. Whether this includes a general refurbishment or a complete replacement, the cost and useful life of this project can vary depending on what type of look the association wishes to obtain. Any minor repairs should be done regularly as an operating expense.		
Evaluation:	No major appearance concerns noted. The Remaining Useful Life is based on both age and overall condition.		
General Notes:	6 Northern Terrace Monuments 1 The Club Monument 2 Brookline Monuments 1 Concord Monument 1 Concord & Claremont Monument 1 Montclair Monument 1 Salem Monument 1 Westcott Monument

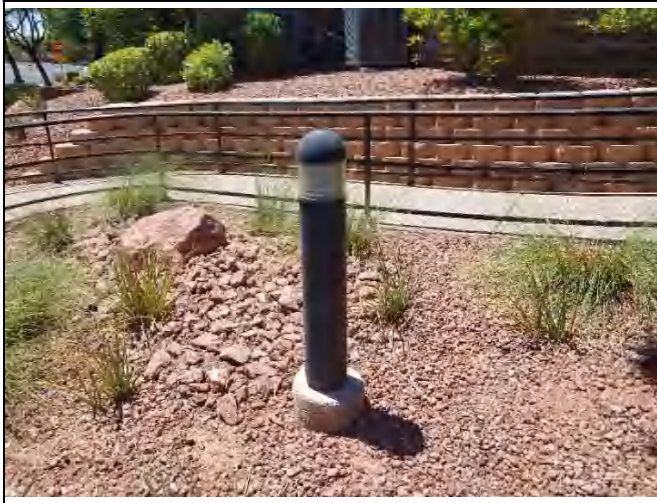
Comp #: 1.217 Bollard Lights - Replace

Quantity:	8 Bollard Lights	Original Service Date:	2009
Unit Cost:	\$1,000.00	Useful Life:	24
% of Unit Cost:	100.0%	Rem. Useful Life Adjustment:	0
Total Cost:	\$8,000.00	Remaining Useful Life:	8
Cost Source:	GeoReserves Database	Next Scheduled Year:	2033
Description:	This component includes replacing the bollard light fixtures located throughout the community. These bollard lights should be replaced every 20 to 25 years to maintain appearance and functionality standards.		
Evaluation:	One of these bollard lights appear to be broken. Otherwise, no problems noted.		
General Notes:

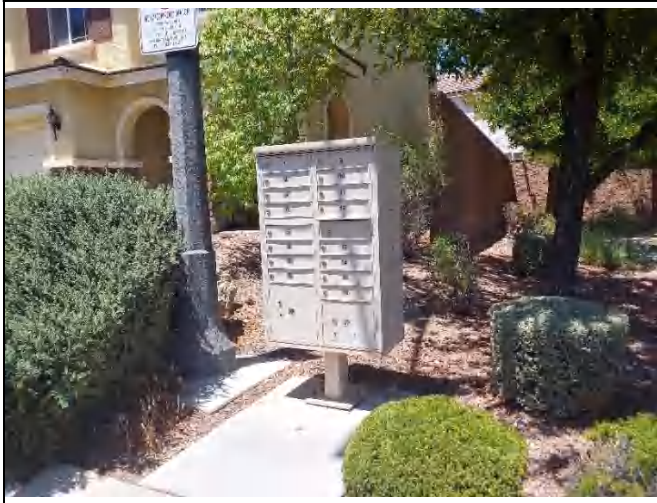
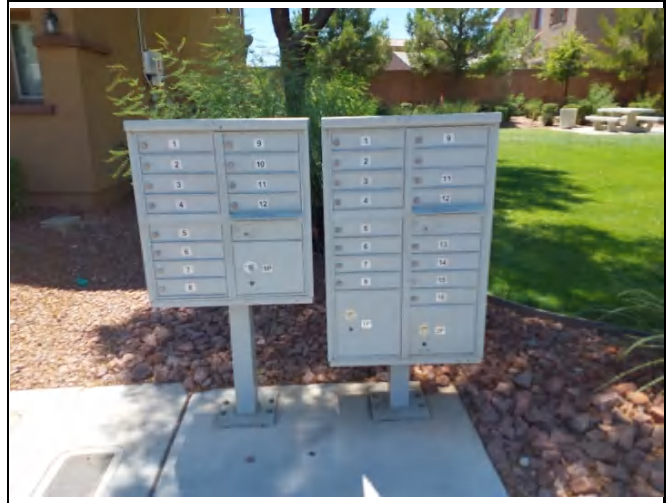
Comp #: 1.220 Mailbox CBUs - Replace

Quantity:	69 CBUs	Original Service Date:	2009
Unit Cost:	\$2,750.00	Useful Life:	20
% of Unit Cost:	100.0%	Rem. Useful Life Adjustment:	0
Total Cost:	\$189,750.00	Remaining Useful Life:	4
Cost Source:	GeoReserves Database	Next Scheduled Year:	2029
Description:	Current standard Cluster Box Units (CBU's) are usually made of a heavy duty aluminum and stainless steel hardware. In certain associations, the local post office may be responsible for these CBUs. Should the association be responsible, we recommend funding to replace these units every 20 years. Some of the paint may fade or peel, and other minor issues may arise which can be addressed as an operating expense.		
Evaluation:	Usually these CBUs will show some minor cosmetic issues such as faded or peeling paint. However, no major functionality problems were noted at time of site visit.		
General Notes:	Quantity breakdown: 34 Large CBUs 35 Small CBUs

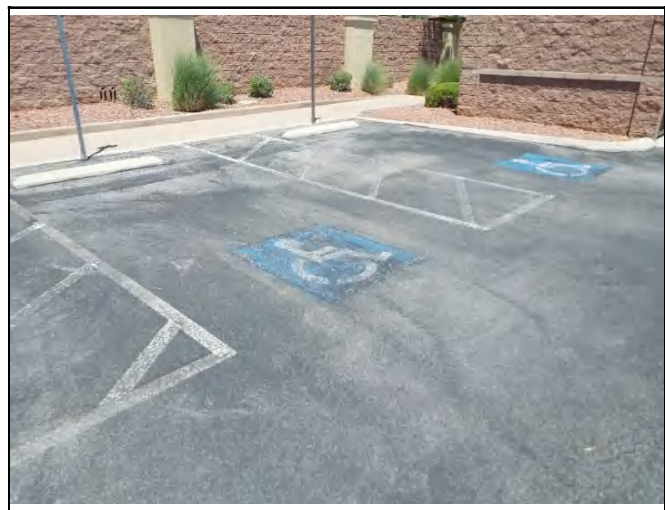
Comp #: 1.311 Asphalt - Parking Stripes & Other Markings - Repaint

Quantity:	1,357,000 Sq. ft.	Original Service Date:	2020
Unit Cost:	\$0.03	Useful Life:	4
% of Unit Cost:	100.0%	Rem. Useful Life Adjustment:	1
Total Cost:	\$40,710.00	Remaining Useful Life:	0
Cost Source:	GeoReserves Database	Next Scheduled Year:	2025
Description:	This component funds to repaint the curbs and asphalt stripes and other markings. This project should be done every 2 to 5 years or as necessary.		
Evaluation:	The parking lot markings are faded and should be repainted in the near future to maintain appearance standards.		
General Notes:

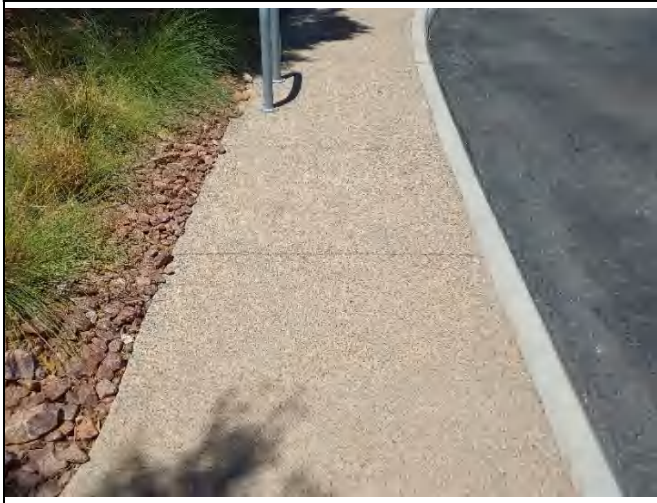
Comp #: 1.402 Concrete - Repair

Quantity:	1 Allowance	Original Service Date:	2022
Unit Cost:	\$36,000.00	Useful Life:	5
% of Unit Cost:	100.0%	Rem. Useful Life Adjustment:	0
Total Cost:	\$36,000.00	Remaining Useful Life:	2
Cost Source:	GeoReserves Database	Next Scheduled Year:	2027
Description:	This component funds for repairs to the association maintained sidewalks, walkways, curbs, and other concrete areas. These repairs should be made every five to ten years depending on the quantity and age of community. Any tripping hazards should be addressed when they arise. This cost schedule can be adjusted as necessary.		
Evaluation:	No major spalling or delamination noted. We recommend inspecting and repairing any minor cracks or issues annually.		
General Notes:

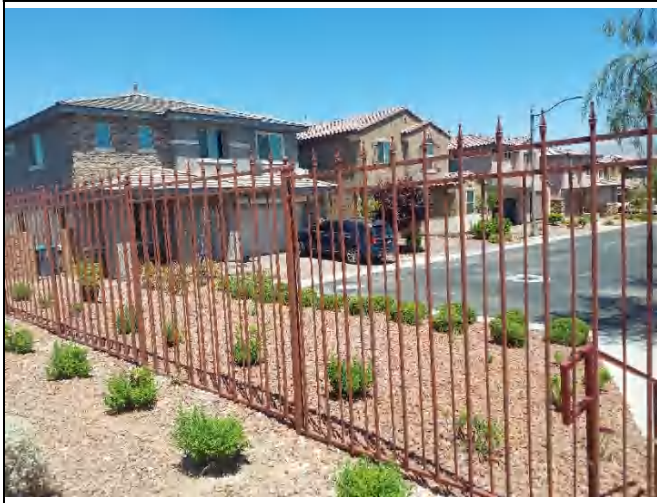
Comp #: 1.536 Wrought Iron Fencing - Replace

Quantity:	1,300 Linear ft.	Original Service Date:	2009
Unit Cost:	\$65.00	Useful Life:	36
% of Unit Cost:	100.0%	Rem. Useful Life Adjustment:	0
Total Cost:	\$84,500.00	Remaining Useful Life:	20
Cost Source:	GeoReserves Database	Next Scheduled Year:	2045
Description:	Although this fencing is referred to as wrought iron, it is typically hollow metal that has been rolled and made to give a classic wrought iron look. With regular painting and maintenance, this fencing should last approximately 30 to 40 years.		
Evaluation:	No major rusting, bent areas or other damage noted.		
General Notes:

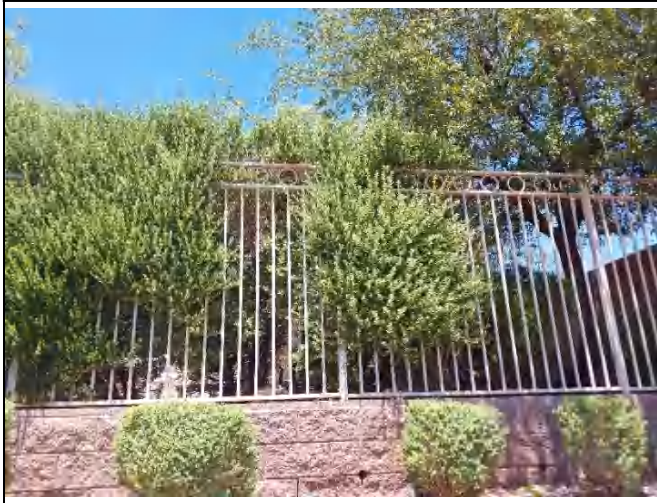
Comp #: 1.539 Wrought Iron Fencing - Repaint

Quantity:	1,300 Linear ft.	Original Service Date:	2021
Unit Cost:	\$15.00	Useful Life:	6
% of Unit Cost:	100.0%	Rem. Useful Life Adjustment:	0
Total Cost:	\$19,500.00	Remaining Useful Life:	2
Cost Source:	GeoReserves Database	Next Scheduled Year:	2027
Description:	This component includes painting the metal fencing, along with making any repairs to bent or rusted areas. This project should be performed every 6 years or when necessary to maintain appearance and ensure the fence realizes a full useful life. Different paint materials and techniques will determine the actual useful life and may result in adjusting this schedule.		
Evaluation:	No significant rusting or faded paint noted.		
General Notes:

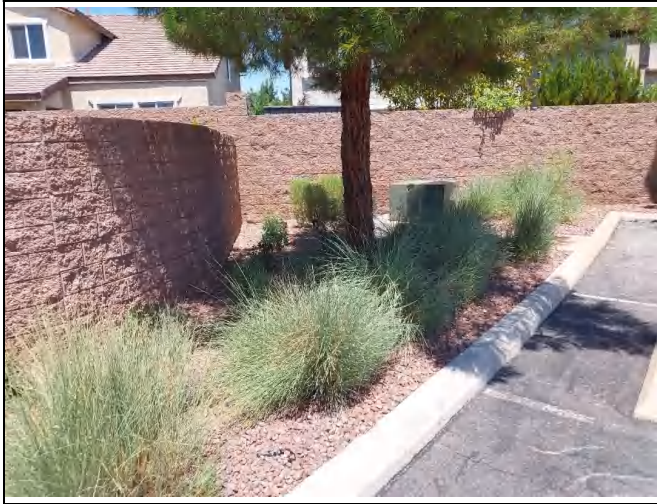
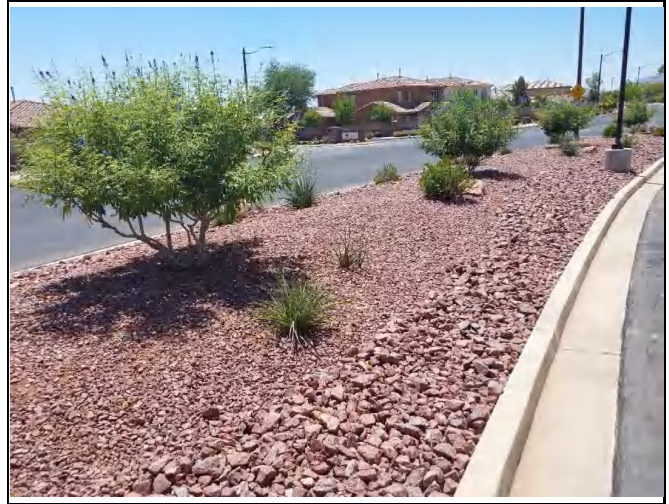
Comp #: 2.602 Landscaping - Renovate

Evaluation:	No major appearance concerns noted. This landscaping should be maintained on a regular basis and the association should work with the landscaper to determine any specific areas of improvement that go beyond the normal maintenance contract.		
General Notes:

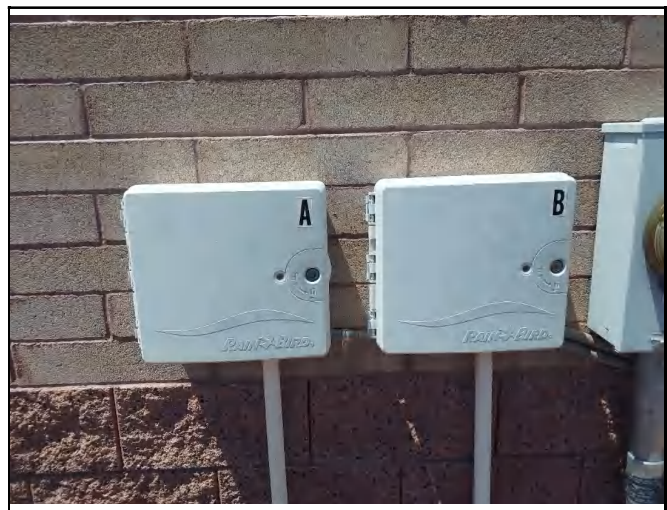
Comp #: 2.637 Irrigation System - Refurbish

Quantity:	1 Irrigation System	Original Service Date:	2019
Unit Cost:	\$200,000.00	Useful Life:	16
% of Unit Cost:	100.0%	Rem. Useful Life Adjustment:	0
Total Cost:	\$200,000.00	Remaining Useful Life:	10
Cost Source:	GeoReserves Database	Next Scheduled Year:	2035
Description:	This component includes replacing and updating the irrigation system. This includes any individual parts such as the irrigation lines, clocks, valves, backflow devices and any other related costs. This work should be done every 6 years or when necessary.		
Evaluation:	No problems reported.		
General Notes:

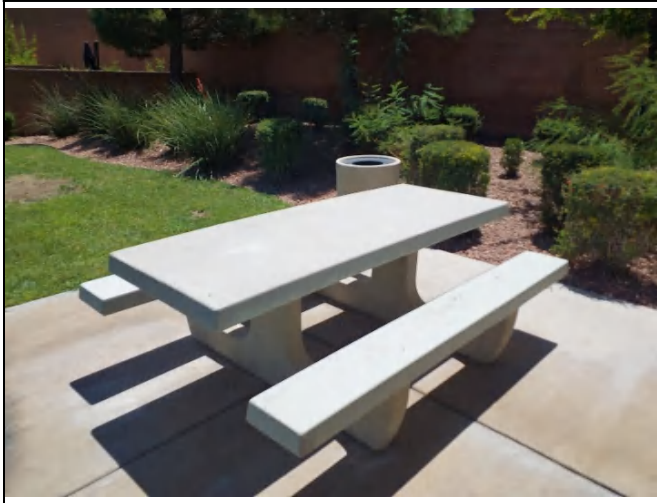
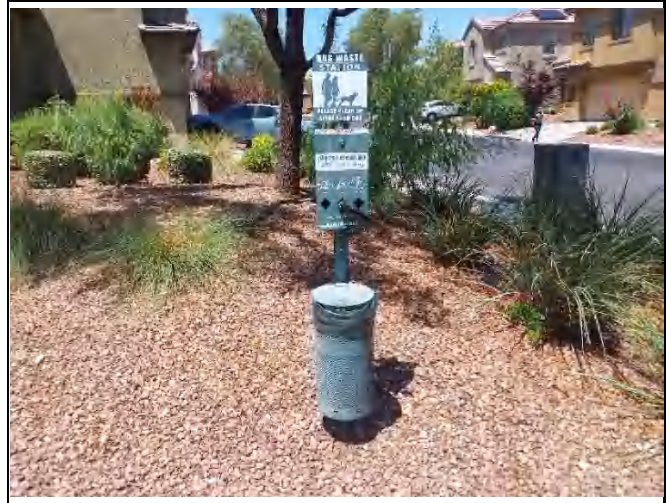
Comp #: 2.811 Park Furniture - Replace

Quantity:	1 See Detail	Original Service Date:	2020
Unit Cost:	\$8,000.00	Useful Life:	5
% of Unit Cost:	100.0%	Rem. Useful Life Adjustment:	0
Total Cost:	\$8,000.00	Remaining Useful Life:	0
Cost Source:	GeoReserves Database	Next Scheduled Year:	2025
Description:	This component includes replacing all of the outdoor furniture items commonly referred to as park furniture. This includes any tables, benches, trash receptacles, and other related items. This component funds to make replacements every 5 years.		
Evaluation:	Remaining life is based on current schedule.		
General Notes:	3 Benches 21 Pet Waste Stations 2 Picnic Tables 3 Trash Receptacles

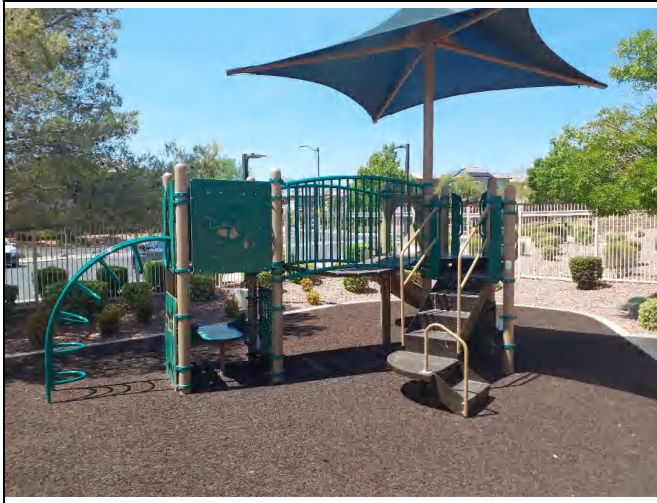
Comp #: 2.901 Play Structure - Replace

Quantity:	1 Play Structure	Original Service Date:	2009
Unit Cost:	\$35,000.00	Useful Life:	24
% of Unit Cost:	100.0%	Rem. Useful Life Adjustment:	0
Total Cost:	\$35,000.00	Remaining Useful Life:	8
Cost Source:	GeoReserves Database	Next Scheduled Year:	2033
Description:	This component includes replacing the play structure. It may be possible to renovate and refurbish this structure depending on the condition. The price and useful life will vary greatly depending on several factors such as size, material, quality, and amenities. The board should consult with a qualified professional to determine the best course of action for this community. It is recommended that these play structures be inspected by a qualified professional every few months or as recommended.		
Evaluation:	No problems with this play structure noted.		
General Notes:

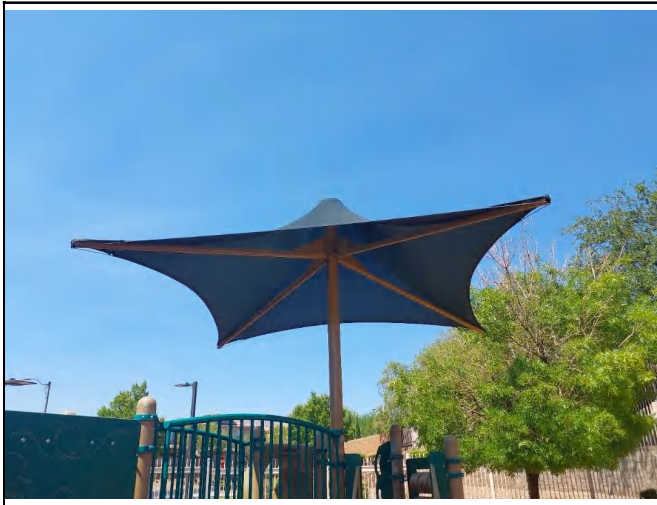
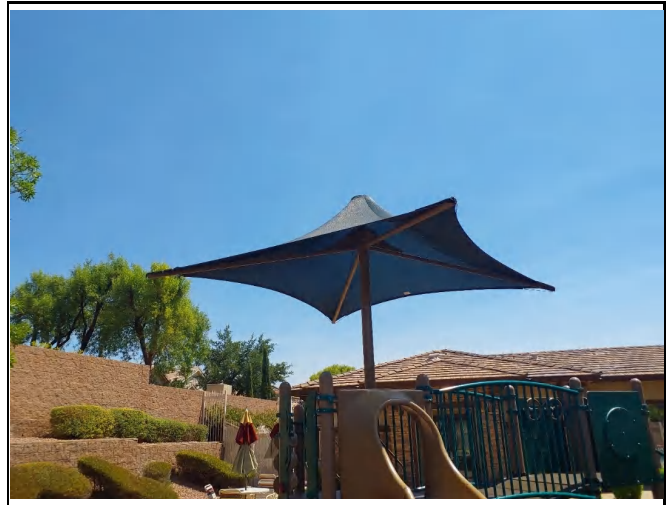
Comp #: 2.906 Play Structure Shade Canopy - Replace

Quantity:	1 Canopy	Original Service Date:	2019
Unit Cost:	\$2,500.00	Useful Life:	8
% of Unit Cost:	100.0%	Rem. Useful Life Adjustment:	0
Total Cost:	\$2,500.00	Remaining Useful Life:	2
Cost Source:	GeoReserves Database	Next Scheduled Year:	2027
Description:	This component funds to replace the shade cover. This should be replaced every 8 years.		
Evaluation:	No problems noted.		
General Notes:

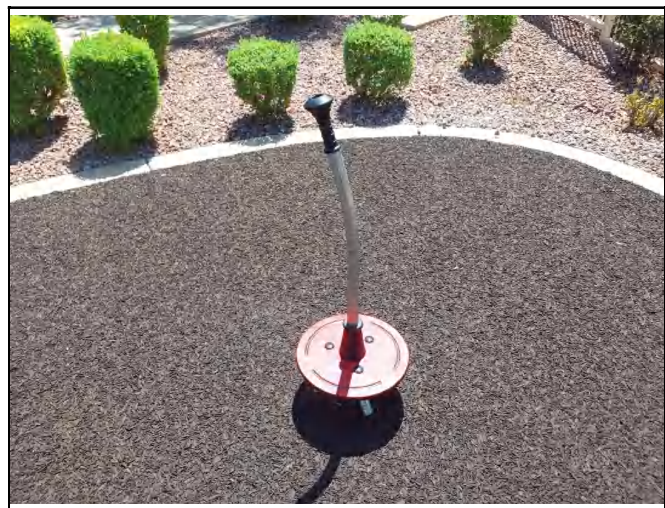
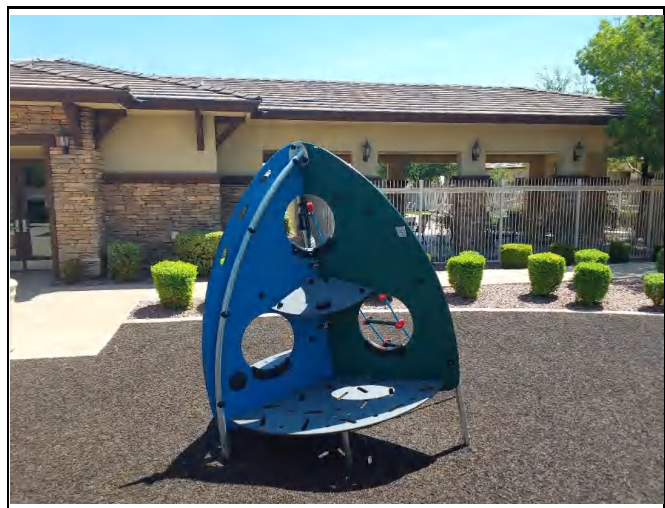
Comp #: 2.934 Play Toys - Replace

Quantity:	1 Allowance	Original Service Date:	2024
Unit Cost:	\$9,000.00	Useful Life:	8
% of Unit Cost:	100.0%	Rem. Useful Life Adjustment:	0
Total Cost:	\$9,000.00	Remaining Useful Life:	7
Cost Source:	GeoReserves Database	Next Scheduled Year:	2032
Description:	This component funds to replace the miscellaneous play toys. These toys all have different cost and useful life estimates, however this study funds to make replacements every 8 years. The association should work with a qualified professional to ensure a proper maintenance schedule.		
Evaluation:	These toys have recently been replaced.		
General Notes:	1 Spinner 1 Climber

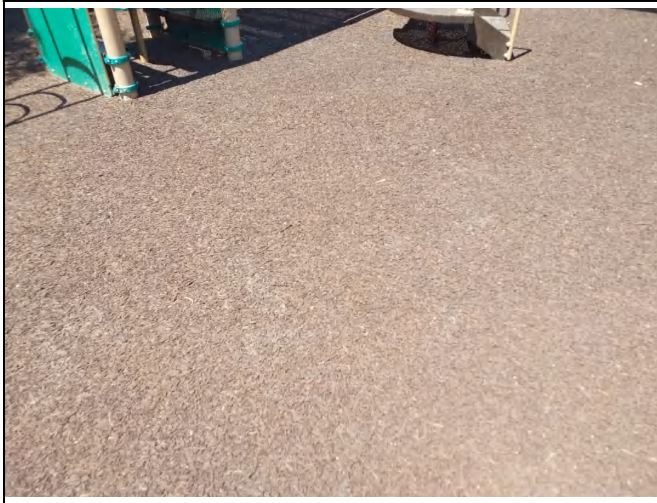
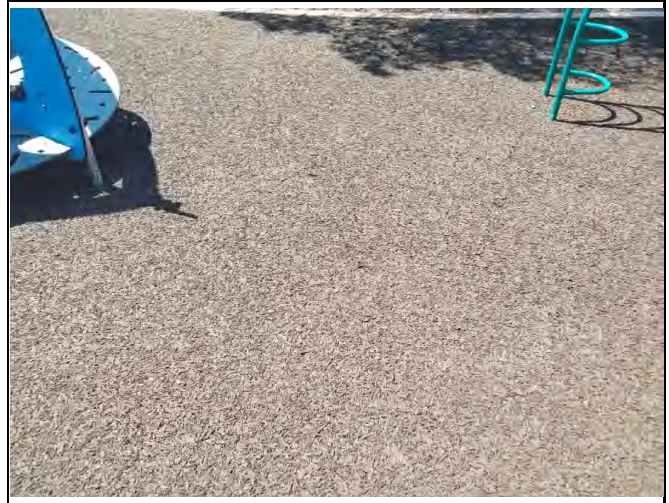
Comp #: 2.935 Safety Padding - Replace

Quantity:	1,300 Sq. ft.	Original Service Date:	2024
Unit Cost:	\$25.00	Useful Life:	21
% of Unit Cost:	100.0%	Rem. Useful Life Adjustment:	0
Total Cost:	\$32,500.00	Remaining Useful Life:	20
Cost Source:	GeoReserves Database	Next Scheduled Year:	2045
Description:	This component includes replacing the play structure safety padding. This includes excavating and hauling the existing padding, installing the new padding, and any other related costs. New technology and materials are frequently released to the market that can affect the cost and useful life. Furthermore, the useful life of this safety padding is dependent on the amount of use and maintenance. The board should consult with an expert to create a maintenance plan and determine the right material for the community.		
Evaluation:	No major problems noted but this safety padding should be regularly inspected by a qualified professional and this remaining life and cost estimate can be adjusted as necessary.

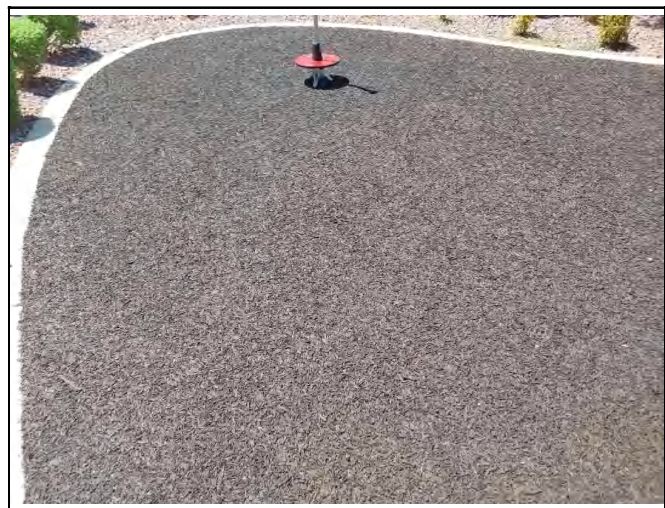
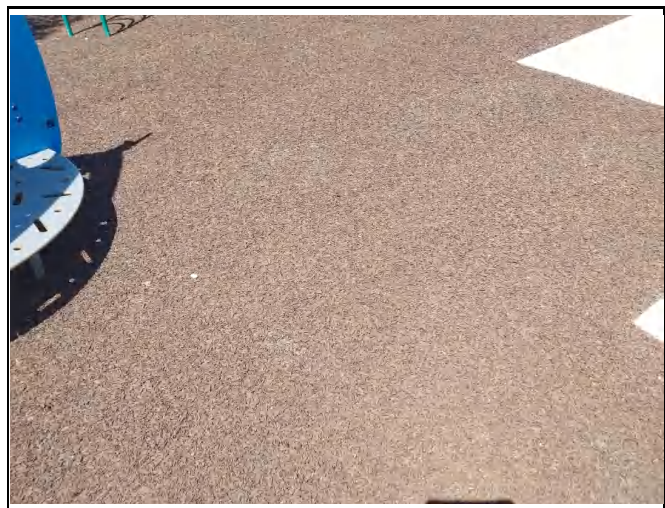
Comp #: 2.937 Safety Padding - Seal

Quantity:	1,300 Sq. Ft.	Original Service Date:	2024
Unit Cost:	\$2.00	Useful Life:	3
% of Unit Cost:	100.0%	Rem. Useful Life Adjustment:	0
Total Cost:	\$2,600.00	Remaining Useful Life:	2
Cost Source:	GeoReserves Database	Next Scheduled Year:	2027
Description:	This component includes sealing and making any other necessary repairs to the play structure safety padding. This work should be done every 3 years, or as recommended by a qualified professional.		
Evaluation:	This work should be done regularly to ensure safety and functional standards.		
General Notes:

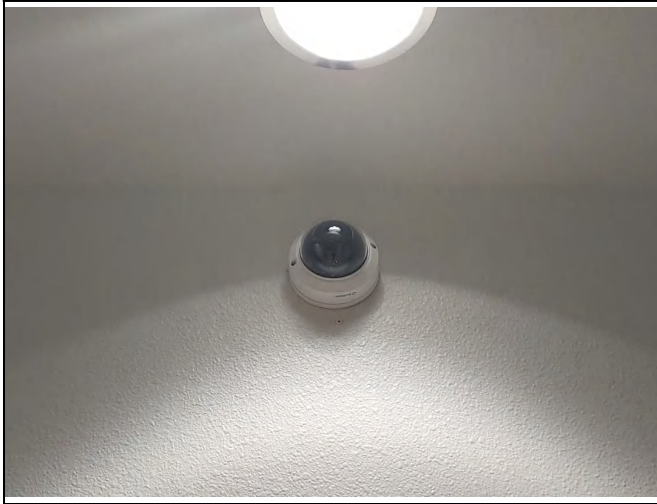
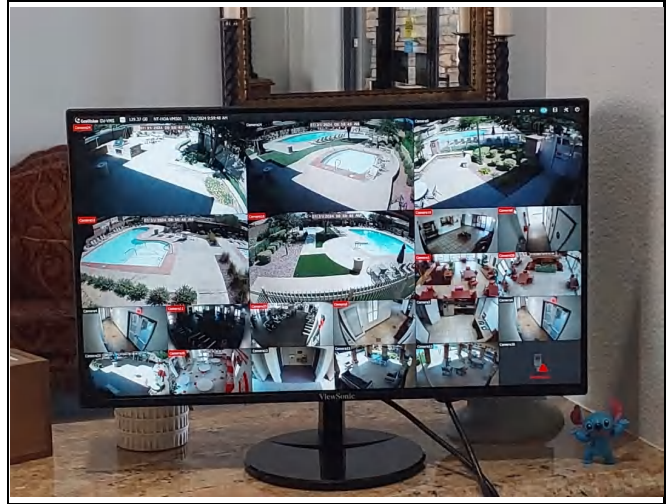
Comp #: 3.236 Camera System - Replace

Quantity:	1 Camera System	Original Service Date:	2020
Unit Cost:	\$20,000.00	Useful Life:	10
% of Unit Cost:	100.0%	Rem. Useful Life Adjustment:	0
Total Cost:	\$20,000.00	Remaining Useful Life:	5
Cost Source:	GeoReserves Database	Next Scheduled Year:	2030
Description:	This component includes updating and replacing the camera system. This system should be replaced approximately every 10 years to keep up with current technology.		
Evaluation:	No problems noted.		
General Notes:

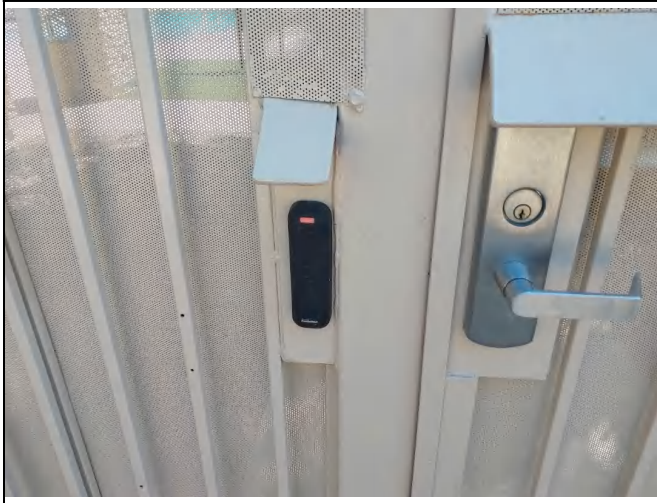
Comp #: 3.728 Pedestrian Gate FOB System - Replace

Quantity:	1 FOB System	Original Service Date:	2016
Unit Cost:	\$15,000.00	Useful Life:	10
% of Unit Cost:	100.0%	Rem. Useful Life Adjustment:	-1
Total Cost:	\$15,000.00	Remaining Useful Life:	0
Cost Source:	GeoReserves Database	Next Scheduled Year:	2025
Description:	This component funds to replace the Key FOB system. The lifespan of these systems is 10 to 15 years on average. However, this largely depends on the quality of the lock, frequency of use, and environmental conditions.		
Evaluation:	No problems noted. Remaining life is based on current schedule and plans for additional FOB readers.		
General Notes:	The association is in talks about adding FOB readers at the clubhouse front entrance.

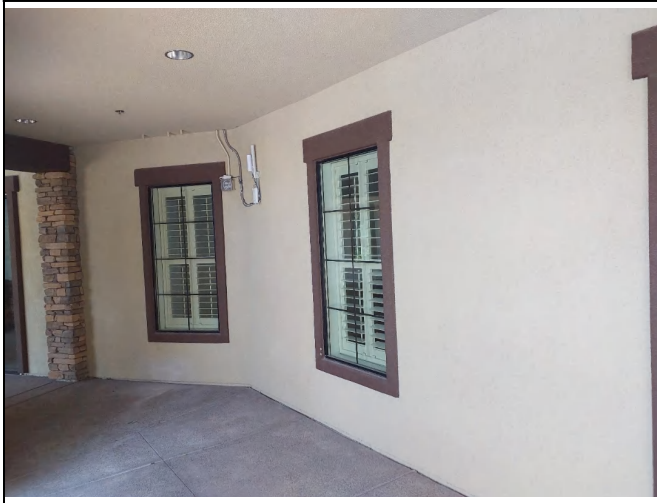
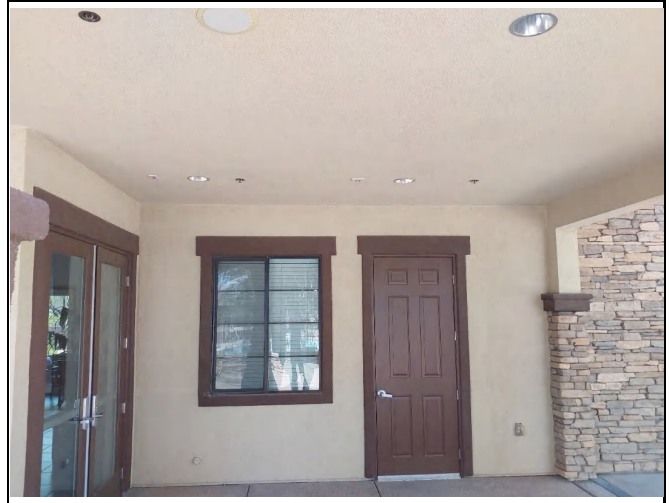
Comp #: 3.1606 Clubhouse Building - Exterior Siding Repaint

Quantity:	1 Clubhouse	Original Service Date:	2019
Unit Cost:	\$20,000.00	Useful Life:	10
% of Unit Cost:	100.0%	Rem. Useful Life Adjustment:	0
Total Cost:	\$20,000.00	Remaining Useful Life:	4
Cost Source:	GeoReserves Database	Next Scheduled Year:	2029
Description:	This component funds to repaint the stucco surfaces and make any related repairs. There are several different scopes of work that can be performed for this project. Painting can be done with acrylic, elastomeric, or other types of paint. Also, a fog coating can be performed depending on the age and condition of stucco. This component funds to repaint the stucco every 10 to 12 years, but input should be provided by a stucco and/or paint professional at the time this project is scheduled to occur		
Evaluation:	No problems noted.		
General Notes:

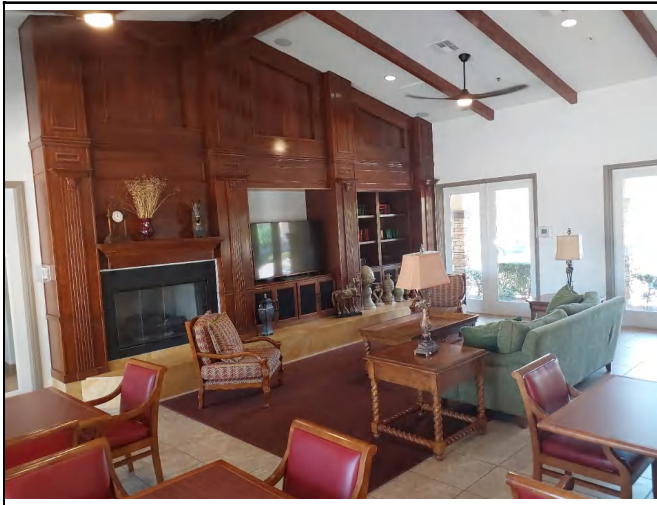
Comp #: 3.1609 Clubhouse Building - Interior Remodel

Quantity:	1 Allowance	Original Service Date:	2009
Unit Cost:	\$100,000.00	Useful Life:	25
% of Unit Cost:	100.0%	Rem. Useful Life Adjustment:	1
Total Cost:	\$100,000.00	Remaining Useful Life:	10
Cost Source:	GeoReserves Database	Next Scheduled Year:	2035
Description:	This component includes a general update and remodel to the clubhouse interior. This includes painting, replacing the floor, replacing any furniture and appliances, and any other related work. Not all of this work needs to be done at one time. This component funds for a general allowance for projects to occur every 20 to 25 years or when necessary.		
Evaluation:	No major problems or appearance concerns noted.		
General Notes:

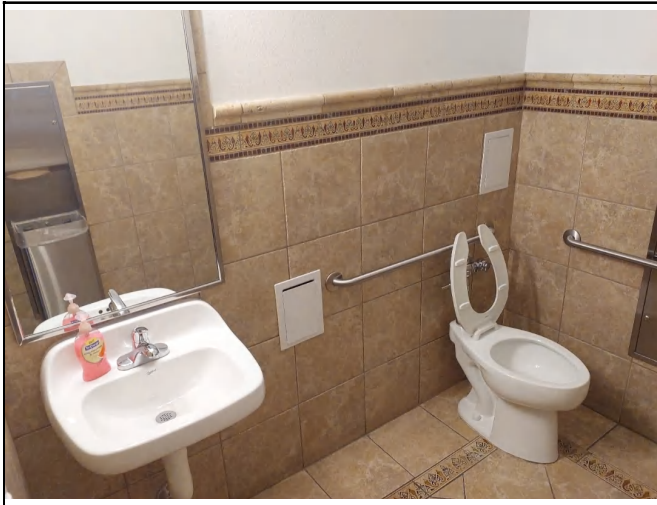
Comp #: 3.1610 Restroom - Remodel

Quantity:	2 Restrooms	Original Service Date:	2009
Unit Cost:	\$12,500.00	Useful Life:	20
% of Unit Cost:	100.0%	Rem. Useful Life Adjustment:	2
Total Cost:	\$25,000.00	Remaining Useful Life:	6
Cost Source:	GeoReserves Database	Next Scheduled Year:	2031
Description:	This component funds to remodel the restrooms. This includes replacing the fixtures, floor and wall tile, as well as any plumbing and electrical work and other related costs. These restrooms should be remodeled every 20 to 25 years to maintain appearance and functionality standards.		
Evaluation:	No problems noted.		
General Notes:	2 Smaller Restrooms

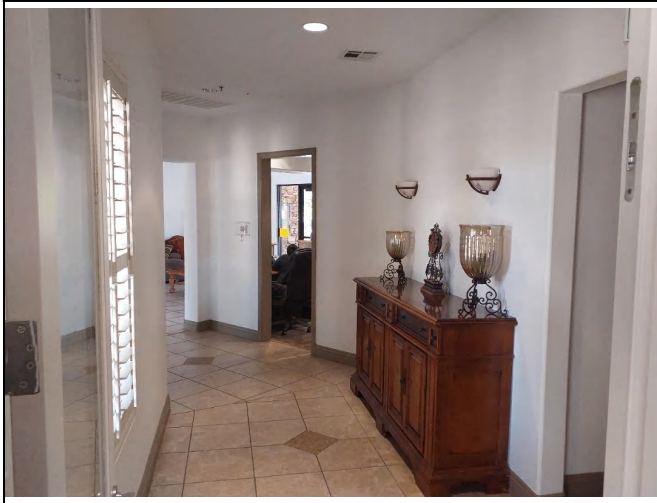
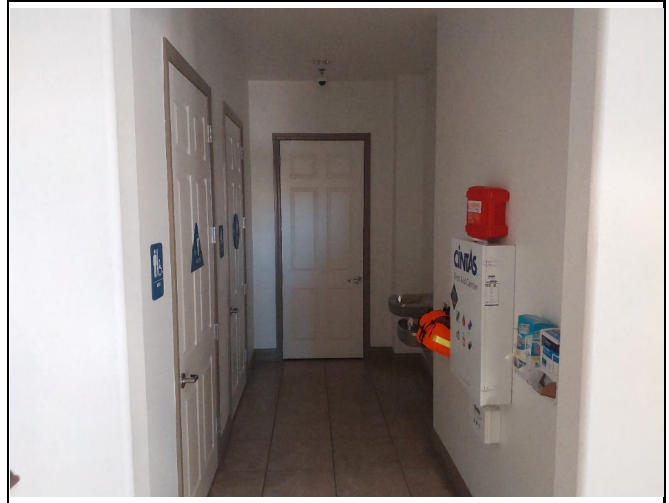
Comp #: 3.1611 Clubhouse Building - Interior General Repair

Quantity:	1 Project	Original Service Date:	2020
Unit Cost:	\$10,000.00	Useful Life:	5
% of Unit Cost:	100.0%	Rem. Useful Life Adjustment:	0
Total Cost:	\$10,000.00	Remaining Useful Life:	0
Cost Source:	GeoReserves Database	Next Scheduled Year:	2025
Description:	This component includes minor updates and replacements to the clubhouse interior. This includes projects also in the major remodel component such as painting, replacing items and other repairs that may need to be done in-between the major remodel project.		
Evaluation:	No problems noted. Remaining life is based on current schedule.		
General Notes:

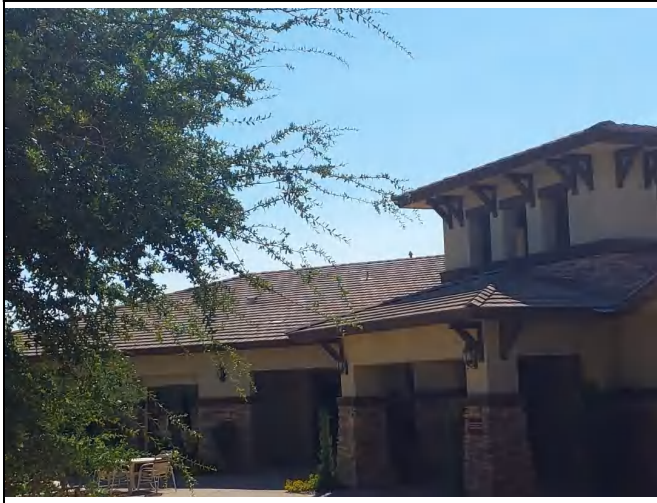
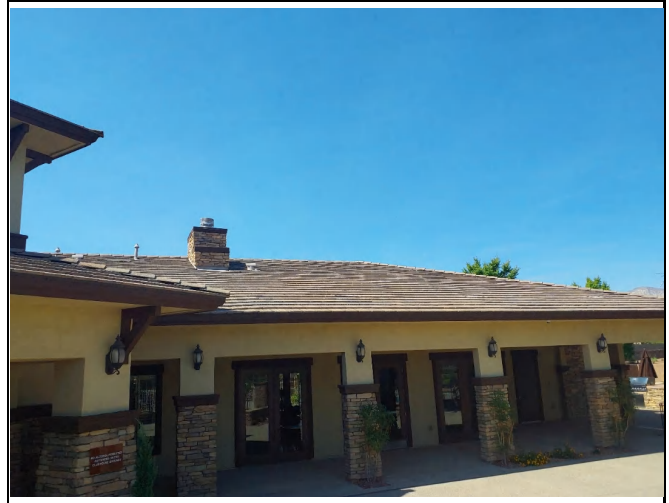
Comp #: 3.1802 Clubhouse Building - Roof Re-Stack

Quantity:	13,800 Sq.ft.	Original Service Date:	2022
Unit Cost:	\$5.50	Useful Life:	30
% of Unit Cost:	100.0%	Rem. Useful Life Adjustment:	0
Total Cost:	\$75,900.00	Remaining Useful Life:	27
Cost Source:	GeoReserves Database	Next Scheduled Year:	2052
Description:	This component includes replacing the underlayment underneath the tile roof. It is this underlayment that offers the protection from water damage other elements. This project is known as a roof re-stacking, and should be expected to occur approximately every 25 to 30 years. In addition, regular maintenance, repairs, and inspections should occur on an annual basis as an operating expense.		
Evaluation:	No access to roof underlayment. These roofs should be inspected regularly and this remaining life should be adjusted as necessary.		
General Notes:

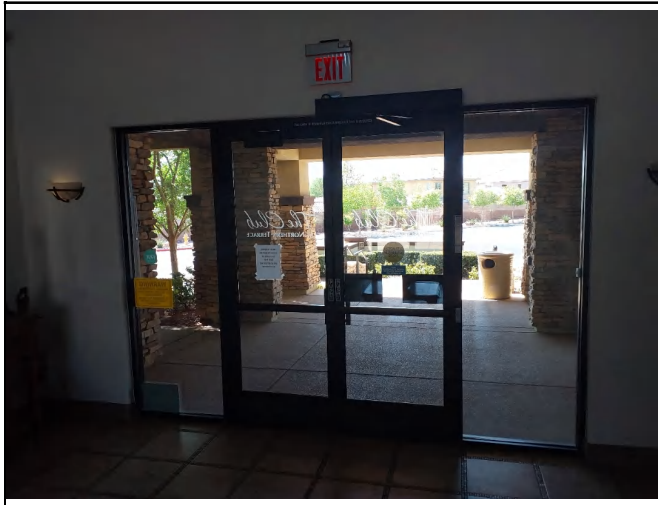
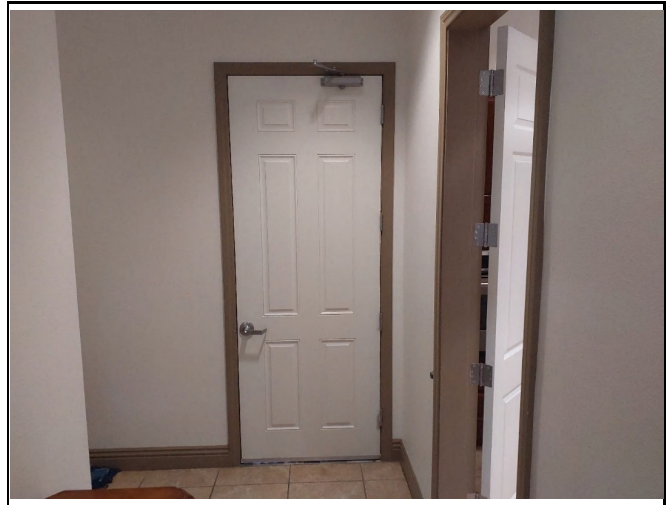
Comp #: 3.2215 Clubhouse Doors - Replace

Quantity:	1 See Detail	Original Service Date:	2009
Unit Cost:	\$40,000.00	Useful Life:	30
% of Unit Cost:	100.0%	Rem. Useful Life Adjustment:	0
Total Cost:	\$40,000.00	Remaining Useful Life:	14
Cost Source:	GeoReserves Database	Next Scheduled Year:	2039
Description:	This component funds to replace the clubhouse doors. These doors have different useful lives depending on the manufacturing process, materials, weather, and amount of traffic they receive. This study funds to make any necessary replacements every 30 years.		
Evaluation:	No problems noted.		
General Notes:	36 Glass Doors (Including the sealed doors in the lounge room) 11 Wooden Doors

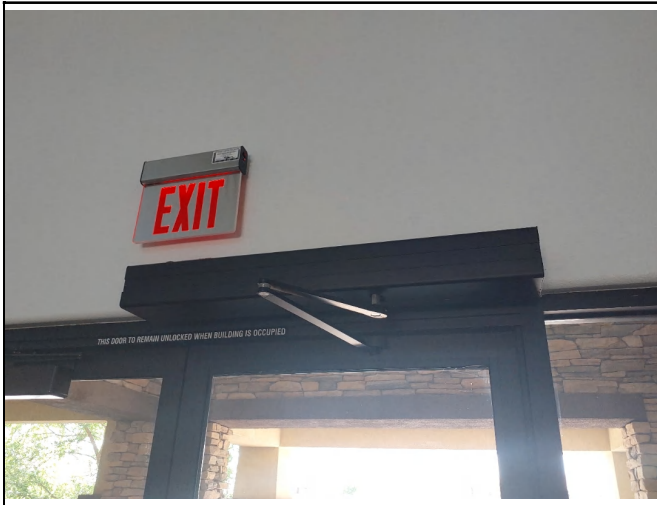
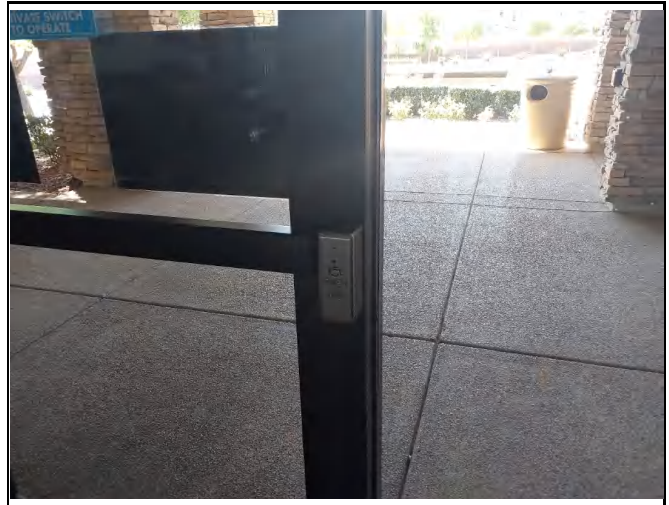
Comp #: 3.2229 Door Automatic Open Equipment - Replace

Quantity:	1 Door System	Original Service Date:	2019
Unit Cost:	\$15,000.00	Useful Life:	10
% of Unit Cost:	100.0%	Rem. Useful Life Adjustment:	0
Total Cost:	\$15,000.00	Remaining Useful Life:	4
Cost Source:	GeoReserves Database	Next Scheduled Year:	2029
Description:	This Component funds to replace the automatic door opening equipment. Specialized equipment such as this can be difficult to determine a proper cost schedule. This study funds for this equipment to be replaced every 10 years, but should be adjusted as necessary.		
Evaluation:	Doors were functioning normally at time of site inspection.		
General Notes:

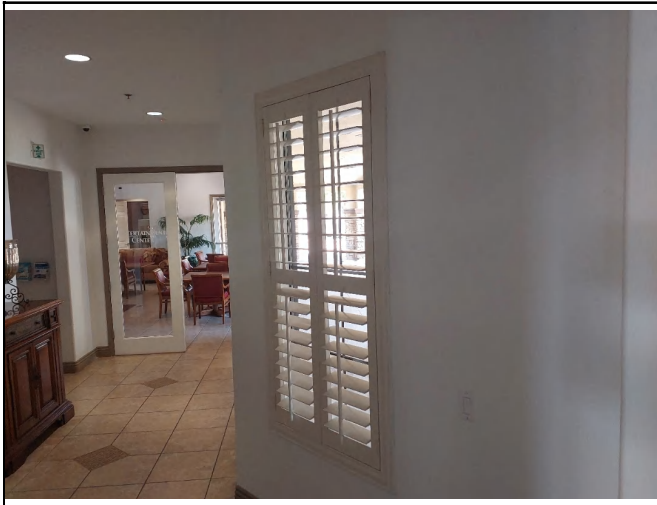
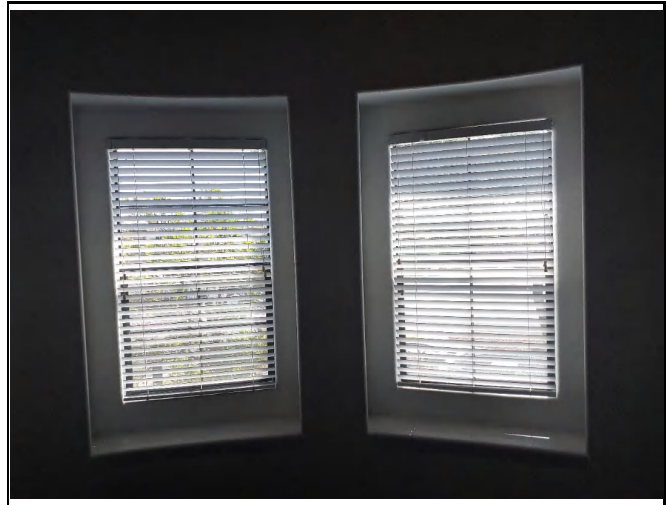
Comp #: 3.2238 Windows - Replace

Quantity:	1 Windows	Original Service Date:	2009
Unit Cost:	\$75,000.00	Useful Life:	40
% of Unit Cost:	100.0%	Rem. Useful Life Adjustment:	0
Total Cost:	\$75,000.00	Remaining Useful Life:	24
Cost Source:	GeoReserves Database	Next Scheduled Year:	2049
Description:	This component funds to replace the clubhouse windows. These windows should be replaced every 30 to 40 years to maintain energy efficiency. This cost schedule can be adjusted as necessary.		
Evaluation:	No problems noted.		
General Notes:	13 Windows

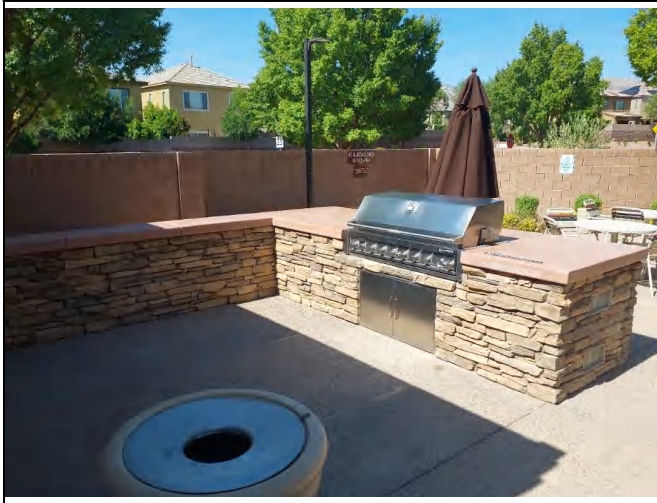
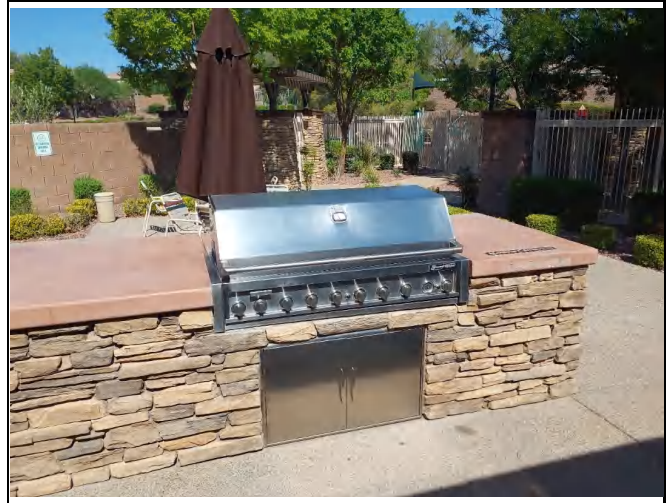
Comp #: 3.2321 Exterior Kitchen Counters & Cabinets - Replace

Quantity:	1 Counter Top	Original Service Date:	2009
Unit Cost:	\$10,000.00	Useful Life:	30
% of Unit Cost:	100.0%	Rem. Useful Life Adjustment:	-1
Total Cost:	\$10,000.00	Remaining Useful Life:	13
Cost Source:	GeoReserves Database	Next Scheduled Year:	2038
Description:	This component funds to replace the outdoor counter. These counter should be replaced every 20 to 30 years.		
Evaluation:	No problems noted.		
General Notes:

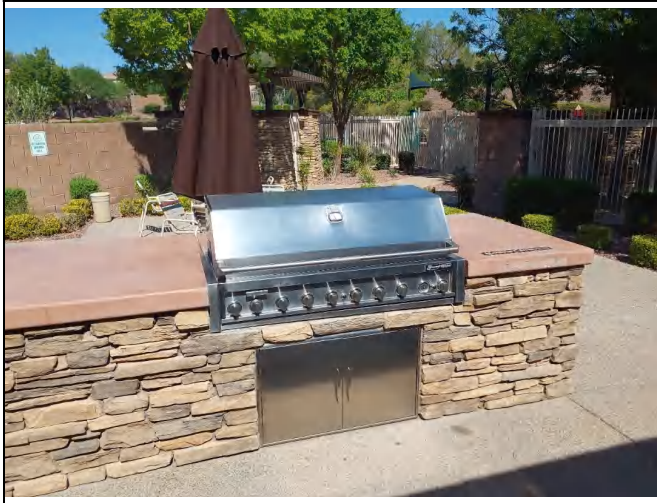
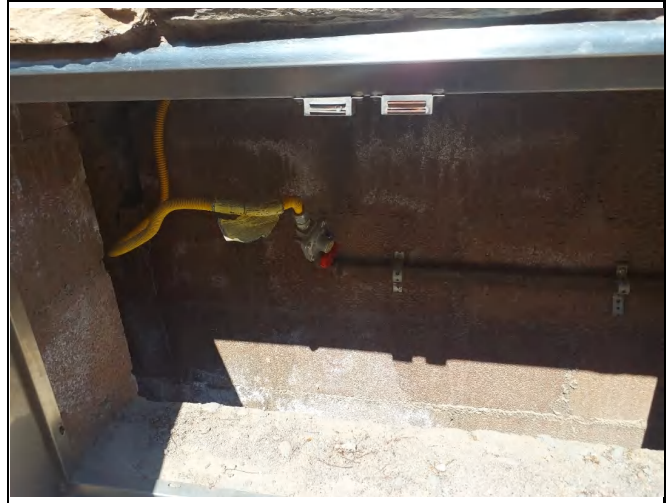
Comp #: 3.2324 Exterior Kitchen Barbecue Grill - Replace

Quantity:	1 Grill	Original Service Date:	2009
Unit Cost:	\$5,000.00	Useful Life:	10
% of Unit Cost:	100.0%	Rem. Useful Life Adjustment:	6
Total Cost:	\$5,000.00	Remaining Useful Life:	0
Cost Source:	GeoReserves Database	Next Scheduled Year:	2025
Description:	This component funds to replace the exterior barbecue grill. These barbeques should be replaced every 10 years or when necessary to ensure safety and functionality standards.		
Evaluation:	Remaining life is based on current age.		
General Notes:

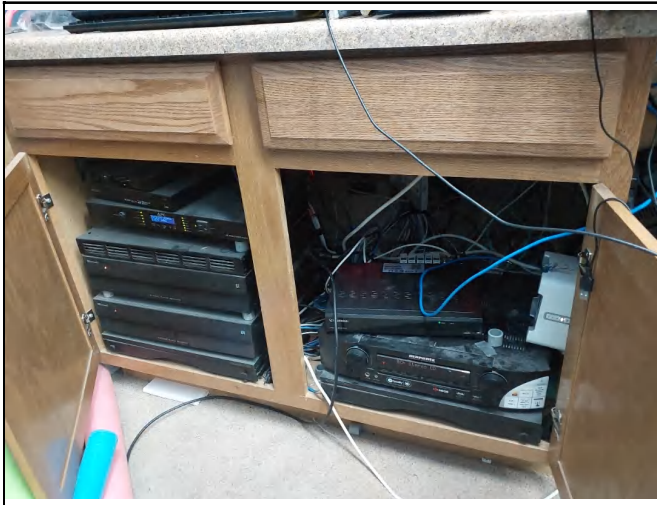
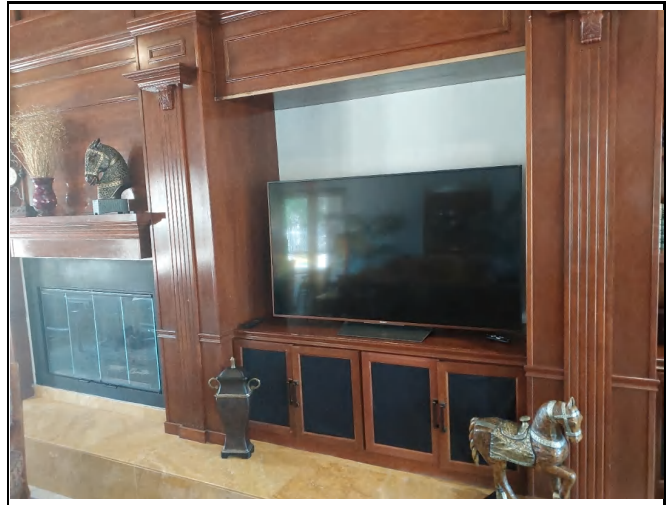
Comp #: 3.2418 Audio & Visual Equipment - Replace

Quantity:	1 Allowance	Original Service Date:	2017
Unit Cost:	\$5,000.00	Useful Life:	10
% of Unit Cost:	100.0%	Rem. Useful Life Adjustment:	0
Total Cost:	\$5,000.00	Remaining Useful Life:	2
Cost Source:	GeoReserves Database	Next Scheduled Year:	2027
Description:	This component funds to replace the audio and visual equipment located in the clubhouse. This includes the sound system, all of the televisions, and other related items. No expectation to replace all of these items at one time. Individual items can be replaced as an operating expense and major updates should be done every 10 years		
Evaluation:	No problems reported.		
General Notes:

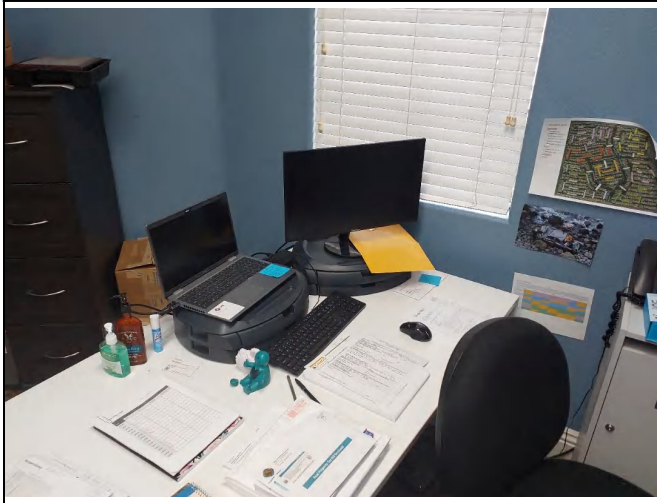
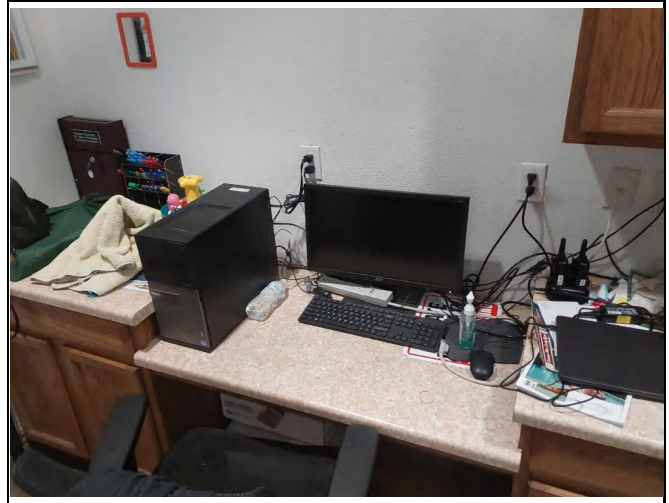
Comp #: 3.2439 Office Computer Equipment - Replace

Quantity:	1 Allowance	Original Service Date:	2022
Unit Cost:	\$5,000.00	Useful Life:	5
% of Unit Cost:	100.0%	Rem. Useful Life Adjustment:	0
Total Cost:	\$5,000.00	Remaining Useful Life:	2
Cost Source:	GeoReserves Database	Next Scheduled Year:	2027
Description:	This component funds to replace the computers, printers, and other related items. This items should bereplaced every 5 years		
Evaluation:	No problems reported.		
General Notes:

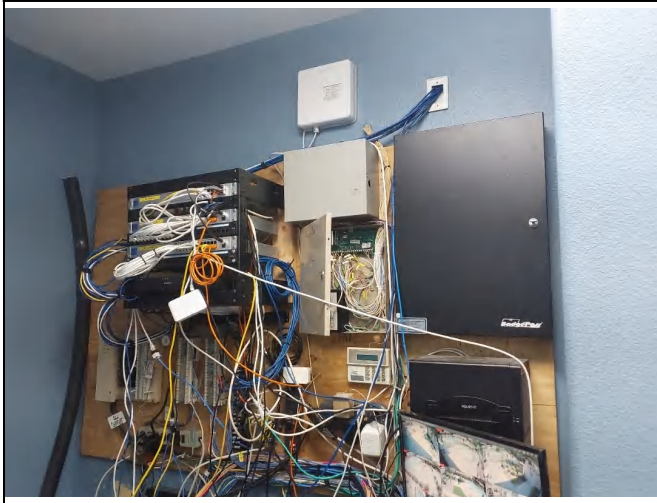
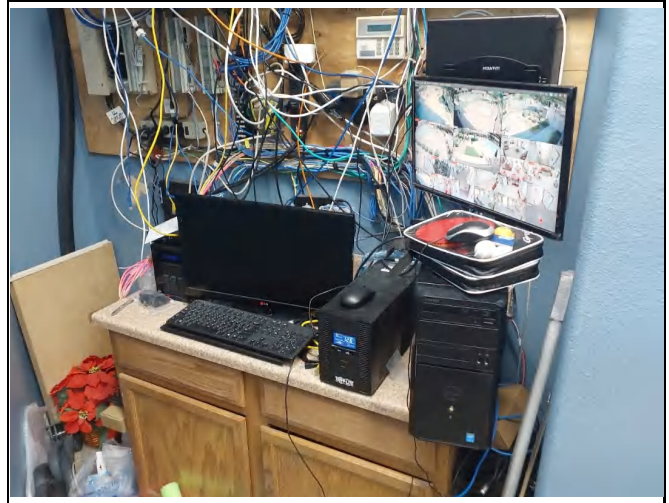
Comp #: 3.2439 Office IT Equipment - Replace

Quantity:	1 See Detail	Original Service Date:	2018
Unit Cost:	\$15,000.00	Useful Life:	10
% of Unit Cost:	100.0%	Rem. Useful Life Adjustment:	0
Total Cost:	\$15,000.00	Remaining Useful Life:	3
Cost Source:	GeoReserves Database	Next Scheduled Year:	2028
Description:	This component funds to replace the IT server, networking equipment, and other related items. This equipment should be updated every 10 years to maintain functionality and current technology standards.		
Evaluation:	No problems noted.		
General Notes:
