NORTHERN TERRACE HOA
Association #: 01.01.1741

Level 1 -- Full Reserve Study with Site Visit

Date of Site Inspection: **07/31/2024**

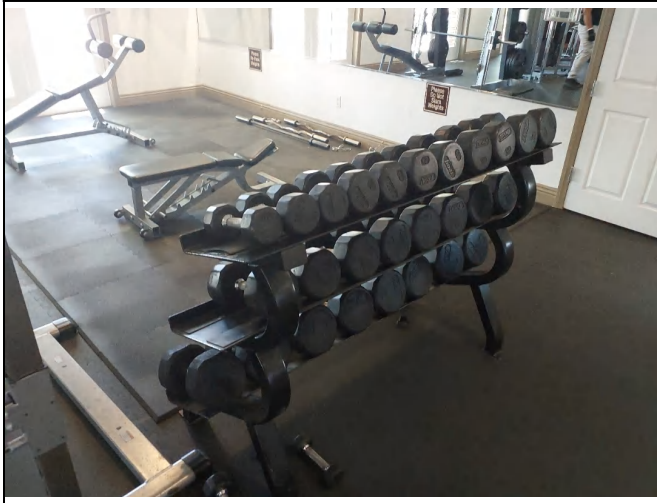
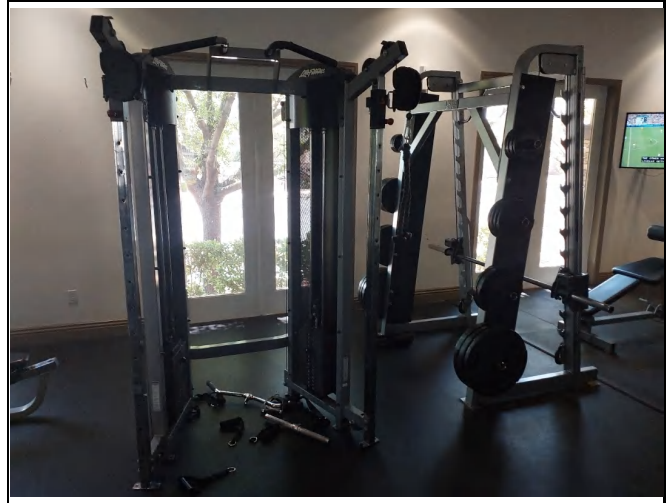
Comp #: 3.2447 Fitness Equipment - Replace

Quantity:	1 See Detail	Original Service Date:	2017
Unit Cost:	\$10,000.00	Useful Life:	10
% of Unit Cost:	100.0%	Rem. Useful Life Adjustment:	0
Total Cost:	\$10,000.00	Remaining Useful Life:	2
Cost Source:	GeoReserves Database	Next Scheduled Year:	2027
Description:	This component funds to replace the fitness equipment, not including the cardio equipment which is funded as another component in this report. This fitness equipment should be replaced every 10 years		
Evaluation:	No problems noted.		
General Notes:	1 Total Body Machine 1 Leg Curl/Extension Machine 2 Smith Machines 1 Pulley Machine 1 Power Stand 1 Dumbbell Rack 4 Benches 1 Seated Calf Raise Machine

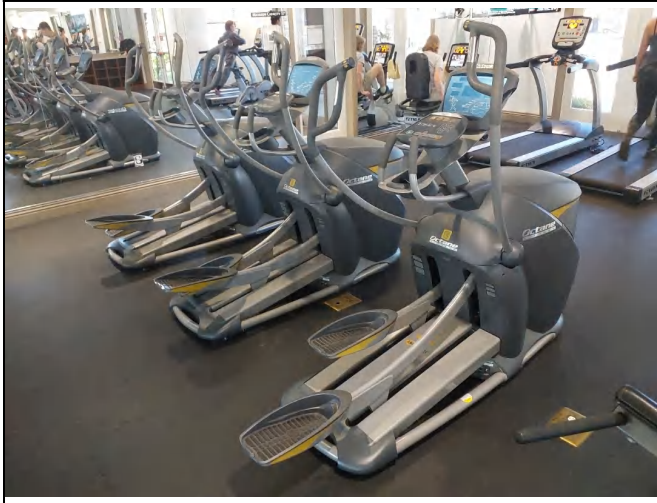
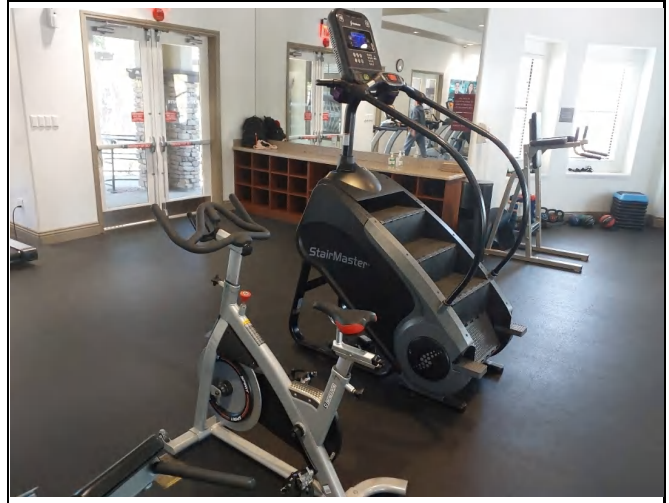
Comp #: 3.2448 Cardio Equipment - Replace

Quantity:	1 See Detail	Original Service Date:	2021
Unit Cost:	\$12,000.00	Useful Life:	5
% of Unit Cost:	100.0%	Rem. Useful Life Adjustment:	0
Total Cost:	\$12,000.00	Remaining Useful Life:	1
Cost Source:	GeoReserves Database	Next Scheduled Year:	2026
Description:	This component funds to replace the cardio equipment. This cardio equipment should be replaced every 5 years.		
Evaluation:	No problems noted.		
General Notes:	3 Ellipticals 3 Exercise Bikes 1 Stair Master 4 Treadmills

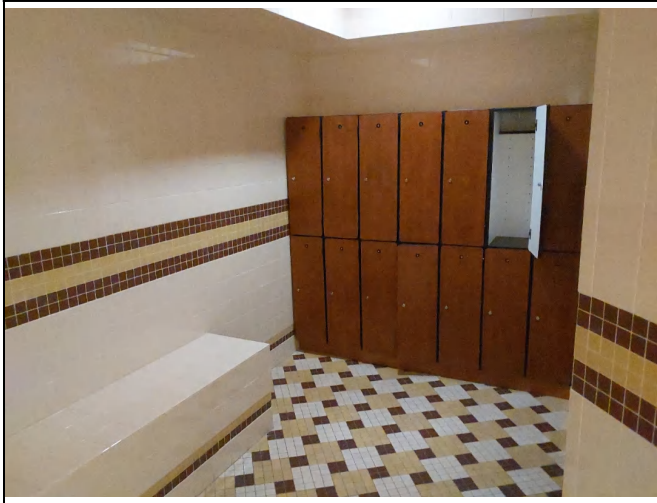
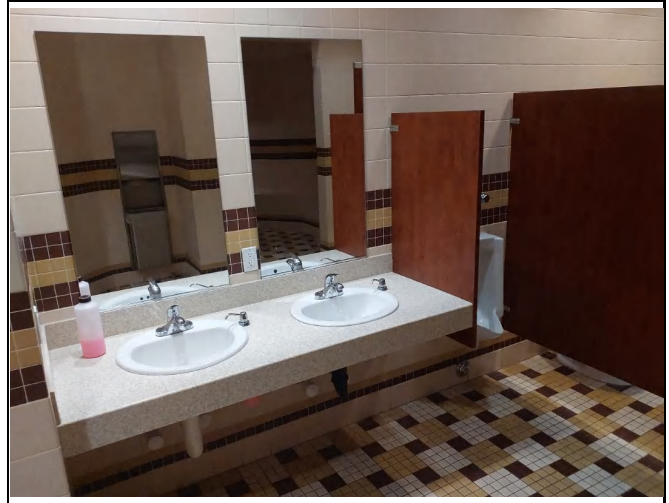
Comp #: 3.2501 Large Restrooms/Locker Rooms - Remodel

Quantity:	2 Restrooms	Original Service Date:	2009
Unit Cost:	\$65,000.00	Useful Life:	20
% of Unit Cost:	100.0%	Rem. Useful Life Adjustment:	2
Total Cost:	\$130,000.00	Remaining Useful Life:	6
Cost Source:	GeoReserves Database	Next Scheduled Year:	2031
Description:	This component funds to remodel the restrooms. This includes replacing the fixtures, floor and wall tile, as well as any plumbing and electrical work and other related costs. These restrooms should be remodeled every 20 years to maintain appearance and functionality standards.		
Evaluation:	No problems noted.		
General Notes:

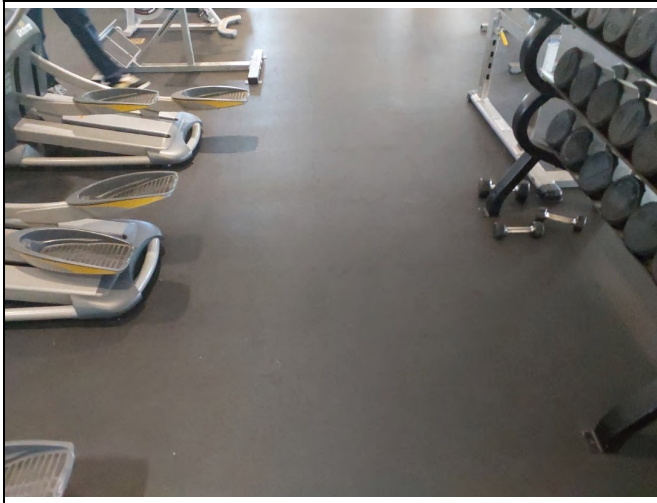
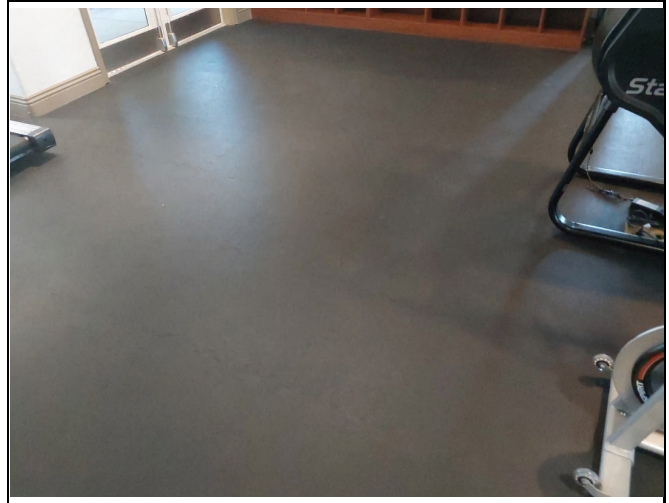
Comp #: 3.2539 Gym Floor - Replace

Quantity:	1 Gym Floor	Original Service Date:	2019
Unit Cost:	\$13,500.00	Useful Life:	15
% of Unit Cost:	100.0%	Rem. Useful Life Adjustment:	0
Total Cost:	\$13,500.00	Remaining Useful Life:	9
Cost Source:	GeoReserves Database	Next Scheduled Year:	2034
Description:	This component funds to replace the gym floor. This gym floor should be replaced every 15 years		
Evaluation:	No problems noted.		
General Notes:

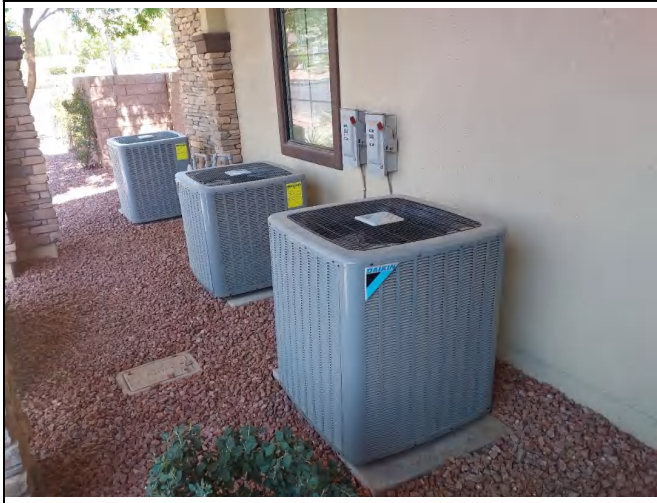
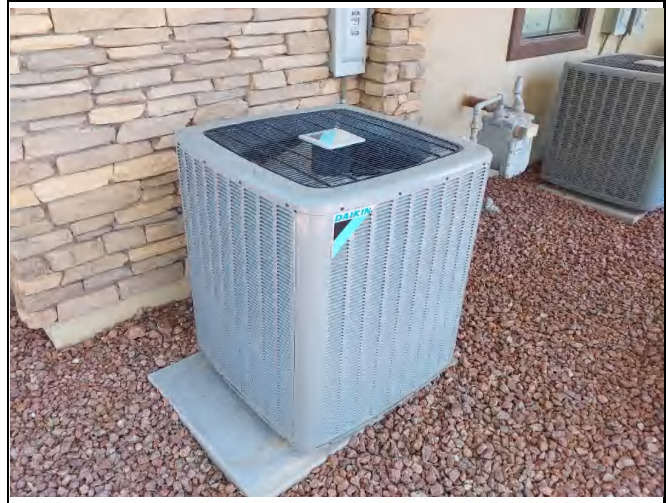
Comp #: 3.2601 HVAC System - Replace

Quantity:	1 System	Original Service Date:	2022
Unit Cost:	\$75,000.00	Useful Life:	15
% of Unit Cost:	100.0%	Rem. Useful Life Adjustment:	1
Total Cost:	\$75,000.00	Remaining Useful Life:	13
Cost Source:	GeoReserves Database	Next Scheduled Year:	2038
Description:	This component funds to replace the HVAC system. This includes the air conditioner unit, furnace, and any related work such as ductwork or other repairs. This system should be replaced every 15 years or when necessary.		
Evaluation:	Remaining life is based on current age.		
General Notes:

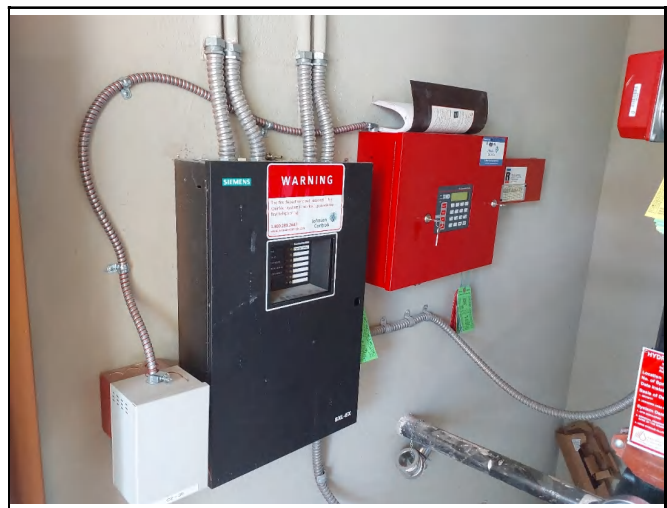
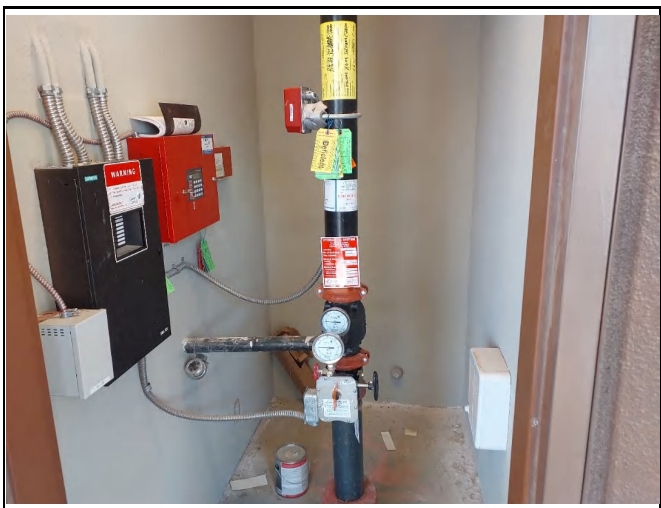
Comp #: 3.2714 Fire Protection System - Renovate

Quantity:	1 Fire System	Original Service Date:	2023
Unit Cost:	\$20,000.00	Useful Life:	10
% of Unit Cost:	100.0%	Rem. Useful Life Adjustment:	0
Total Cost:	\$20,000.00	Remaining Useful Life:	8
Cost Source:	GeoReserves Database	Next Scheduled Year:	2033
Description:	This component funds to make major updates to the fire protection system. It has a useful life of 10 years. The system should be inspected annually and reported to adjust cost schedule.		
Evaluation:	No problems reported.		
General Notes:

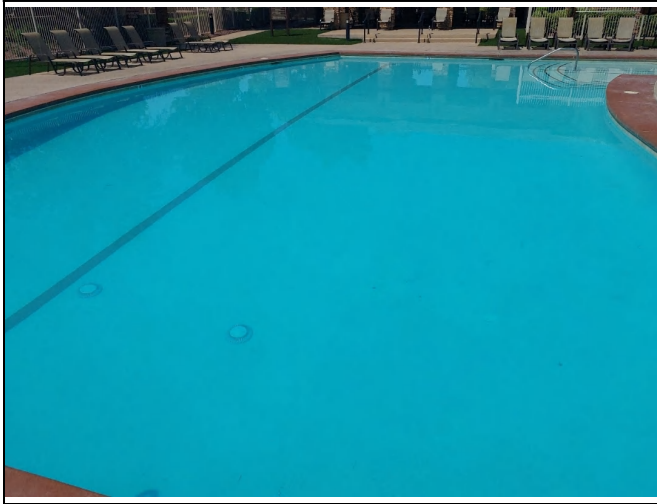
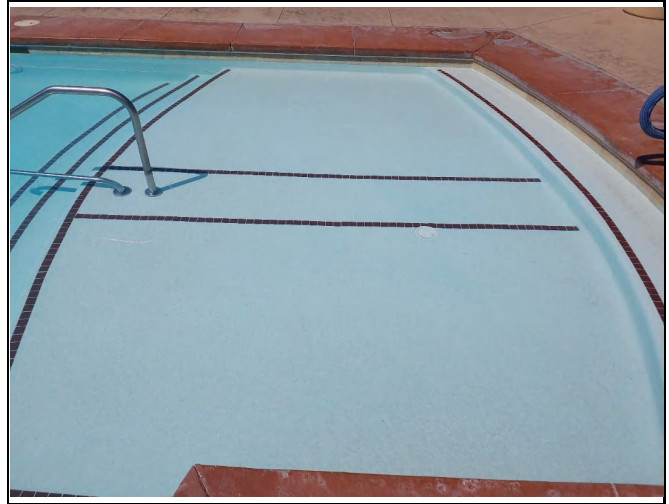
Comp #: 4.1201 Family Pool - Re-Plaster

Quantity:	1 Pool	Original Service Date:	2021
Unit Cost:	\$25,000.00	Useful Life:	12
% of Unit Cost:	100.0%	Rem. Useful Life Adjustment:	0
Total Cost:	\$25,000.00	Remaining Useful Life:	8
Cost Source:	GeoReserves Database	Next Scheduled Year:	2033
Description:	There are generally two main issues with the surface of a pool that will create the need for a replaster. The first is stains and other discoloration with the surface of the pool. While this is a cosmetic concern and not related to any structural issues, the look of the pool may be important in keeping a clean and inviting environment. The other issues is structural, as the plaster is the waterproof layer that protects the concrete and rest of the shell of the pool. Minor spots may be repaired, but a complete replaster should occur when necessary. A typical useful life is 12 to 15 years, but that may be adjusted depending on the amount of use, repairs made, and condition of the water. Additional information can be found at blog.poolcenter.com , nspf.org , and apsp.org .

Evaluation:	No significant staining or other issues noted.		
General Notes:

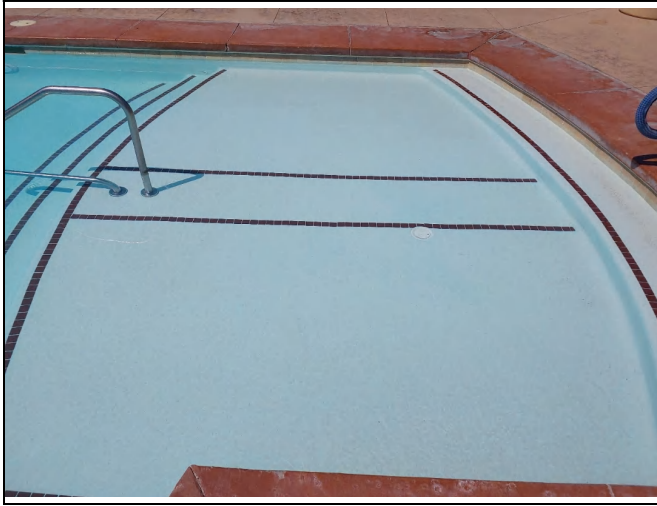
Comp #: 4.1203 Family Pool - Repair

Quantity:	1 Pool	Original Service Date:	2021
Unit Cost:	\$5,000.00	Useful Life:	6
% of Unit Cost:	100.0%	Rem. Useful Life Adjustment:	-2
Total Cost:	\$5,000.00	Remaining Useful Life:	0
Cost Source:	GeoReserves Database	Next Scheduled Year:	2025
Description:	This component funds for a general allowance to make any repairs to the pool above the normal pool maintenance. This work is scheduled to be done every five to six years but can occur whenever necessary.		
Evaluation:	Some minor repairs may be necessary.		
General Notes:

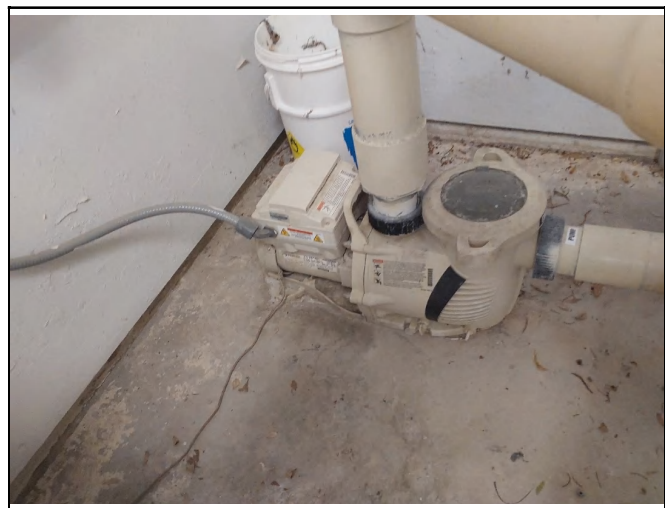
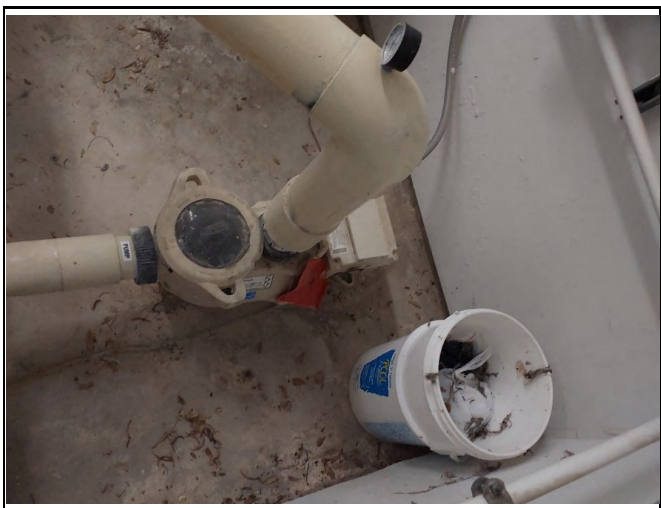
Comp #: 4.1212 Family Pool Pump - Replace

Quantity:	1 Pump	Original Service Date:	2020
Unit Cost:	\$4,500.00	Useful Life:	12
% of Unit Cost:	100.0%	Rem. Useful Life Adjustment:	0
Total Cost:	\$4,500.00	Remaining Useful Life:	7
Cost Source:	GeoReserves Database	Next Scheduled Year:	2032
Description:	This component includes replacing the pool pump. These standard pool/spa pumps have a useful life of approximately 10 to 12 years. Occasionally the motors or other individual parts should be replaced or repaired as an operating expense.		
Evaluation:	No problems noted.		
General Notes:

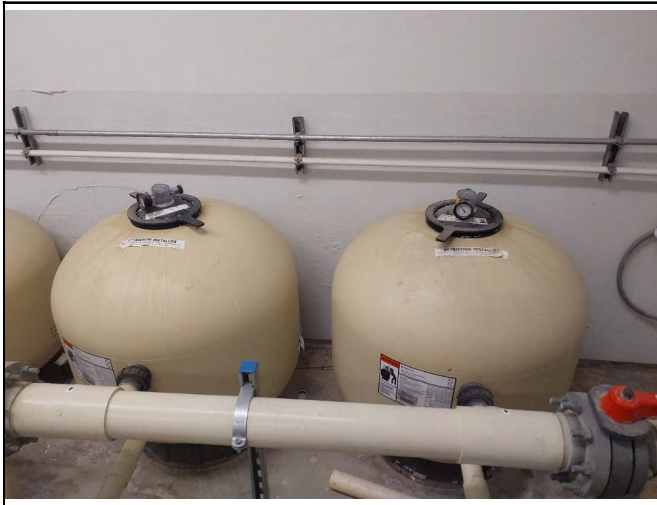
Comp #: 4.1213 Family Pool Filters - Replace

Quantity:	2 Filters	Original Service Date:	2022
Unit Cost:	\$5,000.00	Useful Life:	15
% of Unit Cost:	100.0%	Rem. Useful Life Adjustment:	0
Total Cost:	\$10,000.00	Remaining Useful Life:	12
Cost Source:	GeoReserves Database	Next Scheduled Year:	2037
Description:	There are two types of pool filters, cartridge filters and sand filters. The cartridges and sand should be replaced regularly as an operating expense, approximately every other year or more frequently depending on use. This component is for the filter housing which should be replaced when it begins to leak. Sometimes only individual parts may need to be replaced, which may be significant enough to justify a reserve expense. With regular cartridge replacement and maintenance, the filter housing should last approximately 15 years.		
Evaluation:	No leaks or other problems with the filter noted.		
General Notes:

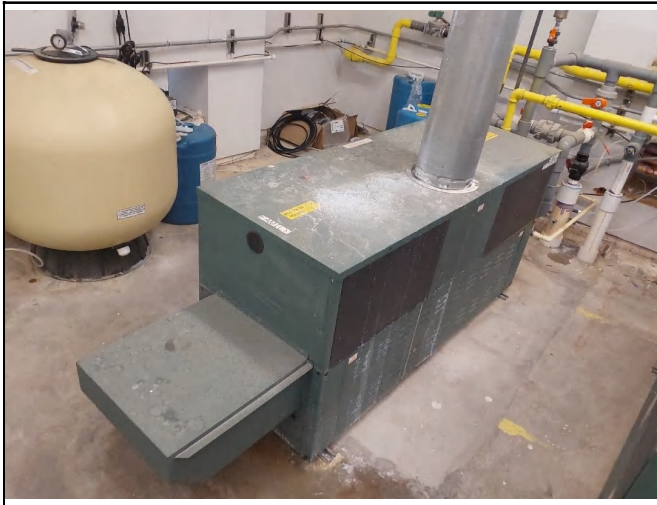
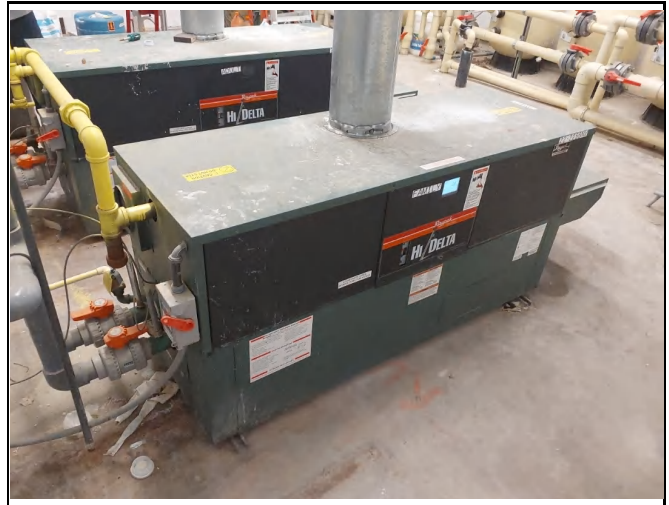
Comp #: 4.1215 Family Pool Heater - Replace

Quantity:	1 Heater	Original Service Date:	2022
Unit Cost:	\$12,000.00	Useful Life:	10
% of Unit Cost:	100.0%	Rem. Useful Life Adjustment:	0
Total Cost:	\$12,000.00	Remaining Useful Life:	7
Cost Source:	GeoReserves Database	Next Scheduled Year:	2032
Description:	This component includes replacing the pool heater. A standard pool heater has a typical useful life of 10 to 12 years. Certain parts may be replaced as an operating expense if necessary.		
Evaluation:	No problems with this pool heater noted.		
General Notes:

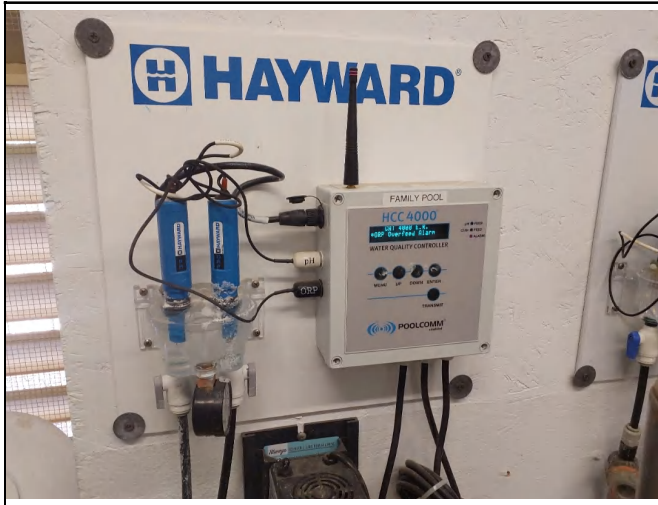
Comp #: 4.1217 Family Pool Chemical Controller System - Replace

Quantity:	1 System	Original Service Date:	2022
Unit Cost:	\$7,000.00	Useful Life:	15
% of Unit Cost:	100.0%	Rem. Useful Life Adjustment:	0
Total Cost:	\$7,000.00	Remaining Useful Life:	12
Cost Source:	GeoReserves Database	Next Scheduled Year:	2037
Description:	This component funds to replace the automated chemical controller system for the pool. This system should be replaced every 10 to 15 years or as needed.		
Evaluation:	No problems noted.		
General Notes:

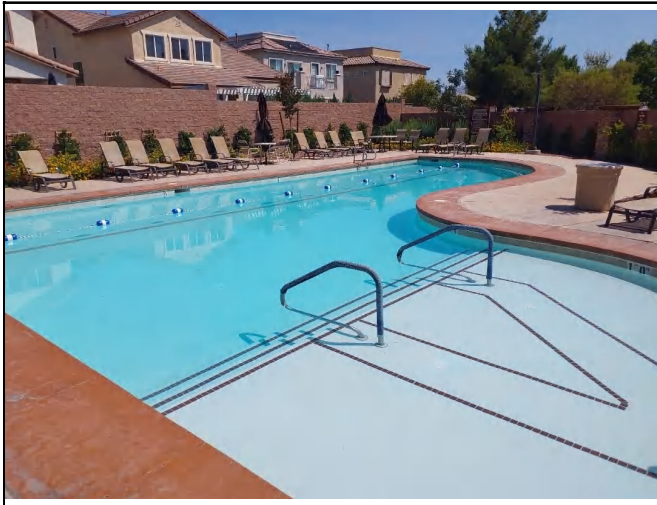
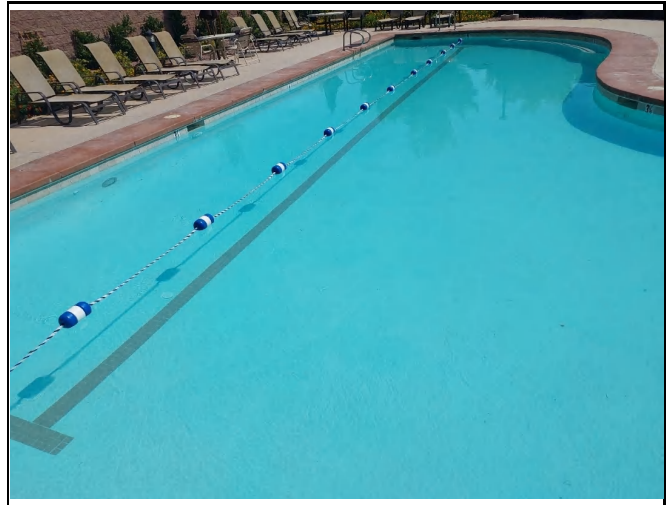
Comp #: 4.1237 Adult Lap Pool - Re-Plaster

Quantity:	1 Pool	Original Service Date:	2021
Unit Cost:	\$25,000.00	Useful Life:	12
% of Unit Cost:	100.0%	Rem. Useful Life Adjustment:	0
Total Cost:	\$25,000.00	Remaining Useful Life:	8
Cost Source:	GeoReserves Database	Next Scheduled Year:	2033
Description:	There are generally two main issues with the surface of a pool that will create the need for a replaster. The first is stains and other discoloration with the surface of the pool. While this is a cosmetic concern and not related to any structural issues, the look of the pool may be important in keeping a clean and inviting environment. The other issues is structural, as the plaster is the waterproof layer that protects the concrete and rest of the shell of the pool. Minor spots may be repaired, but a complete replaster should occur when necessary. A typical useful life is 12 years, but that may be adjusted depending on the amount of use, repairs made, and condition of the water. Additional information can be found at blog.poolcenter.com , nspf.org , and apsp.org .

Evaluation:	No problems noted.		
General Notes:

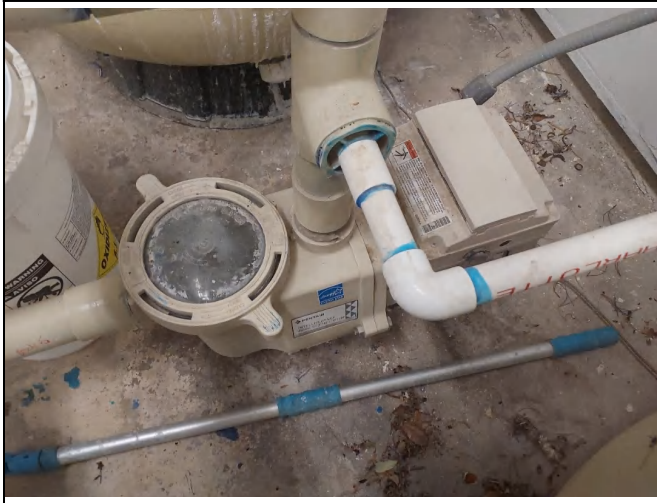
Comp #: 4.1244 Adult Lap Pool Pump - Replace

Quantity:	1 Pump	Original Service Date:	2020
Unit Cost:	\$4,500.00	Useful Life:	12
% of Unit Cost:	100.0%	Rem. Useful Life Adjustment:	0
Total Cost:	\$4,500.00	Remaining Useful Life:	7
Cost Source:	GeoReserves Database	Next Scheduled Year:	2032
Description:	This component includes replacing the pool pump. These standard pool/spa pumps have a useful life of approximately 10 to 12 years. Occasionally the motors or other individual parts should be replaced or repaired as an operating expense.		
Evaluation:	No problems noted.		
General Notes:

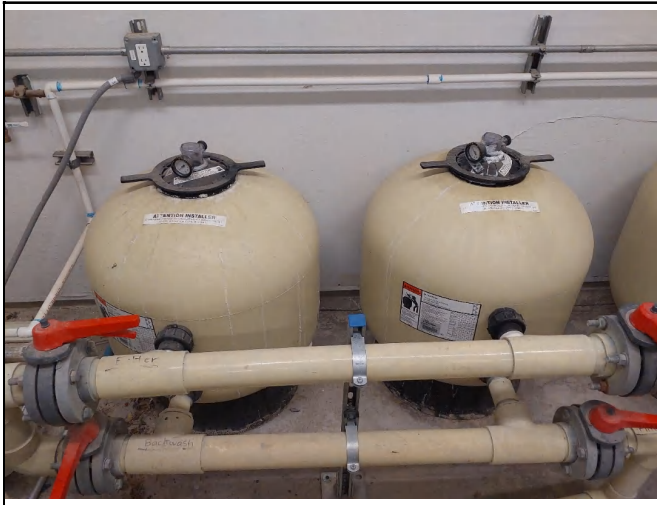
Comp #: 4.1245 Adult Lap Pool Filters - Replace

Quantity:	2 Filters	Original Service Date:	2022
Unit Cost:	\$4,000.00	Useful Life:	15
% of Unit Cost:	100.0%	Rem. Useful Life Adjustment:	0
Total Cost:	\$8,000.00	Remaining Useful Life:	12
Cost Source:	GeoReserves Database	Next Scheduled Year:	2037
Description:	There are two types of pool filters, cartridge filters and sand filters. The cartridges and sand should be replaced regularly as an operating expense, approximately every other year or more frequently depending on use. This component is for the filter housing which should be replaced when it begins to leak. Sometimes only individual parts may need to be replaced, which may be significant enough to justify a reserve expense. With regular cartridge replacement and maintenance, the filter housing should last approximately 15 years.		
Evaluation:	No leaks or other problems with the filter noted.		
General Notes:

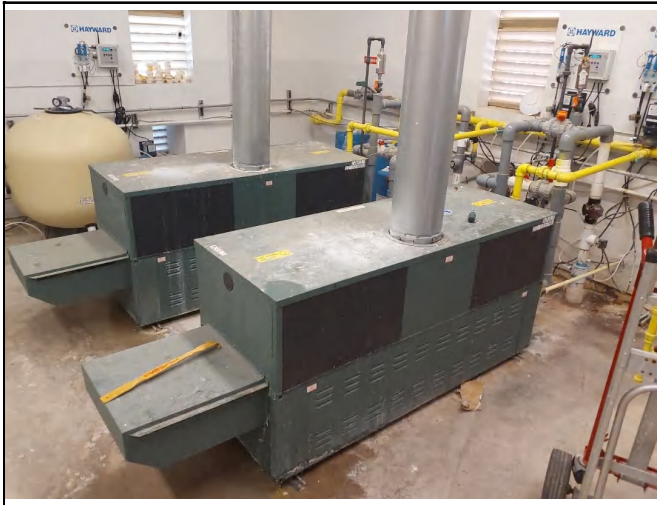
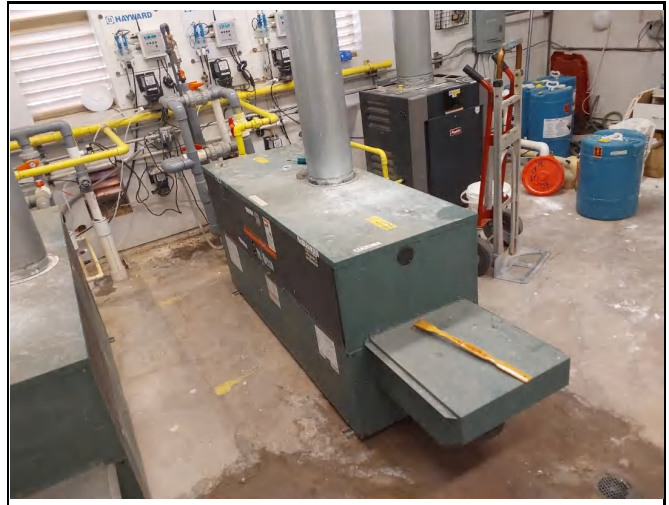
Comp #: 4.1247 Adult Lap Pool Heater - Replace

Quantity:	1 Heater	Original Service Date:	2022
Unit Cost:	\$12,000.00	Useful Life:	10
% of Unit Cost:	100.0%	Rem. Useful Life Adjustment:	0
Total Cost:	\$12,000.00	Remaining Useful Life:	7
Cost Source:	GeoReserves Database	Next Scheduled Year:	2032
Description:	This component includes replacing the pool heater. A standard pool heater has a typical useful life of 10 to 12 years. Certain parts may be replaced as an operating expense if necessary.		
Evaluation:	No problems noted.		
General Notes:

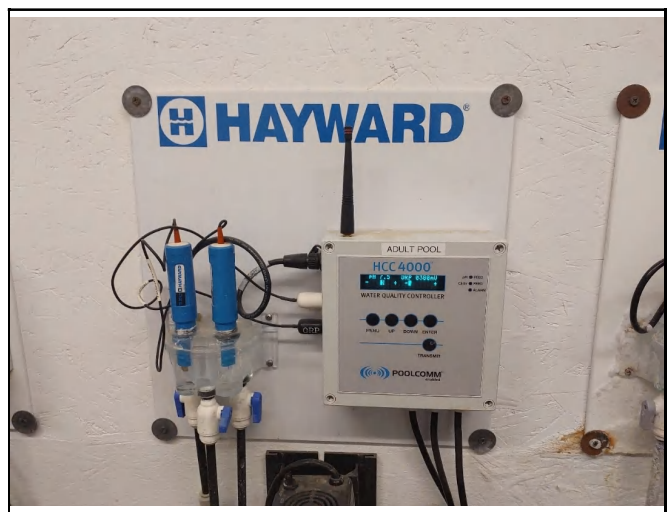
Comp #: 4.1249 Adult Lap Pool Chemical Controller System - Replace

Quantity:	1 System	Original Service Date:	2022
Unit Cost:	\$7,000.00	Useful Life:	15
% of Unit Cost:	100.0%	Rem. Useful Life Adjustment:	0
Total Cost:	\$7,000.00	Remaining Useful Life:	12
Cost Source:	GeoReserves Database	Next Scheduled Year:	2037
Description:	This component funds to replace the automated chemical controller system for the pool. This system should be replaced every 10 to 15 years or as needed.		
Evaluation:	No problems noted.		
General Notes:

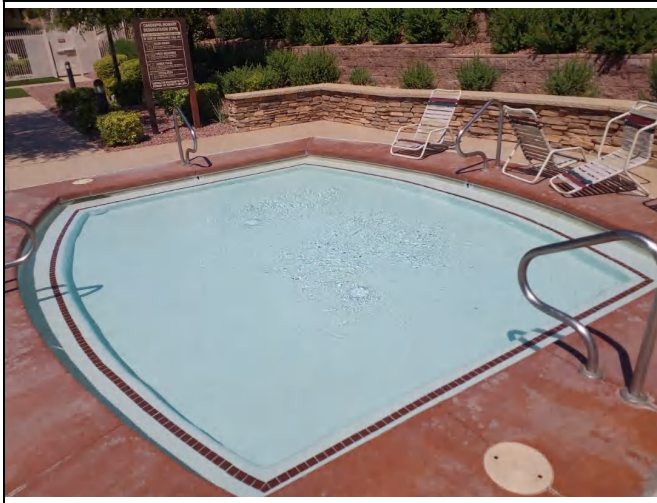
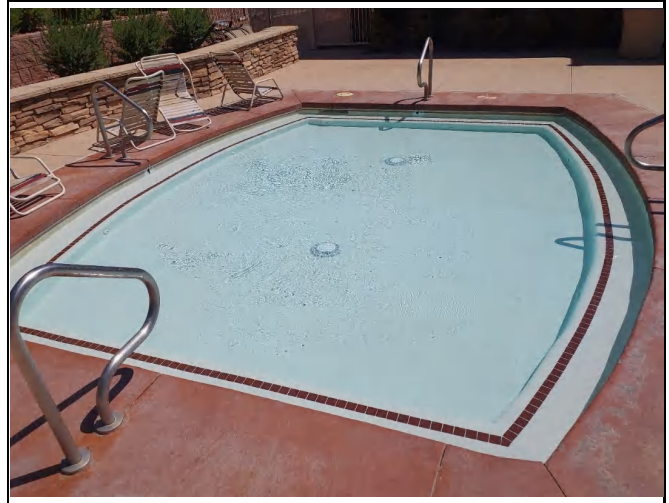
Comp #: 4.1251 Wading Pool - Re-Plaster

Quantity:	1 Wader	Original Service Date:	2018
Unit Cost:	\$8,000.00	Useful Life:	8
% of Unit Cost:	100.0%	Rem. Useful Life Adjustment:	0
Total Cost:	\$8,000.00	Remaining Useful Life:	1
Cost Source:	GeoReserves Database	Next Scheduled Year:	2026
Description:	There are generally two main issues with the surface of a wading pool that will create the need for a replaster. The first is stains and other discoloration with the surface of the wader. While this is a cosmetic concern and not related to any structural issues, the look of the wader may be important in keeping a clean and inviting environment. The other issue is structural, as the plaster is the waterproof layer that protects the concrete and rest of the shell of the wader. Because the surface of the wader is smaller and it receives more use, it has a useful life of approximately 6 years. However, that life may be adjusted depending on the amount of use, repairs made, and condition of the water. Additional information can be found at blog.poolcenter.com , nspf.org , and apsp.org .

Evaluation:	No significant staining or other issues noted.		
General Notes:

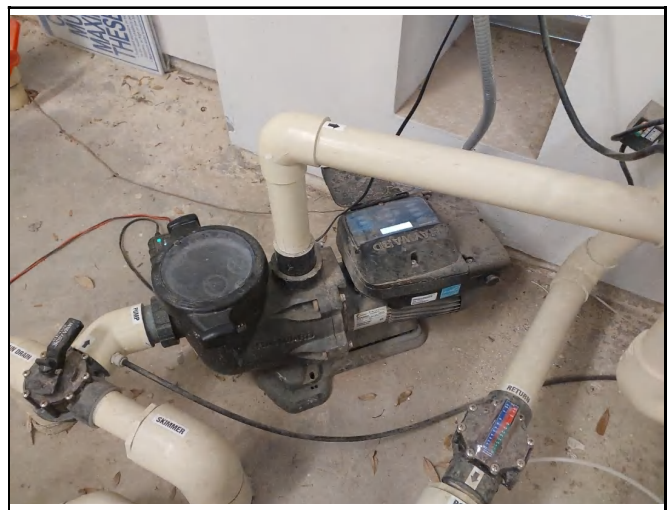
Comp #: 4.1255 Wading Pool Pump - Replace

Quantity:	1 Pump	Original Service Date:	2022
Unit Cost:	\$4,500.00	Useful Life:	12
% of Unit Cost:	100.0%	Rem. Useful Life Adjustment:	0
Total Cost:	\$4,500.00	Remaining Useful Life:	9
Cost Source:	GeoReserves Database	Next Scheduled Year:	2034
Description:	This component includes replacing the pool pump. These standard pool/spa pumps have a useful life of approximately 10 to 12 years. Occasionally the motors or other individual parts should be replaced or repaired as an operating expense.		
Evaluation:	No problems noted.		
General Notes:

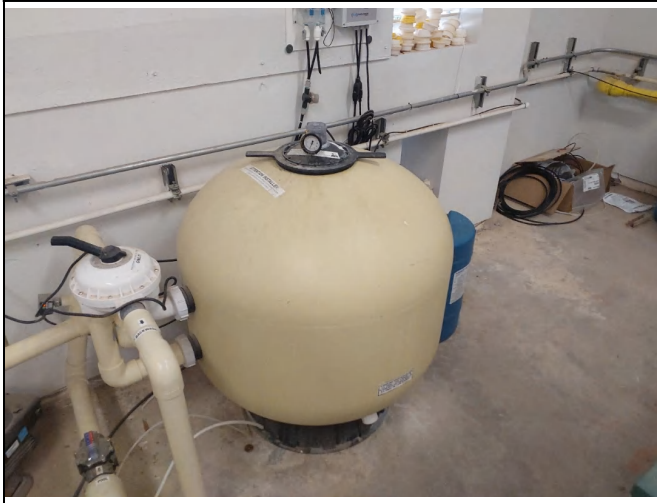
Comp #: 4.1256 Wading Pool Filter - Replace

Quantity:	1 Filter	Original Service Date:	2020
Unit Cost:	\$5,000.00	Useful Life:	15
% of Unit Cost:	100.0%	Rem. Useful Life Adjustment:	0
Total Cost:	\$5,000.00	Remaining Useful Life:	10
Cost Source:	GeoReserves Database	Next Scheduled Year:	2035
Description:	There are two types of pool filters, cartridge filters and sand filters. The cartridges and sand should be replaced regularly as an operating expense, approximately every other year or more frequently depending on use. This component is for the filter housing which should be replaced when it begins to leak. Sometimes only individual parts may need to be replaced, which may be significant enough to justify a reserve expense. With regular cartridge replacement and maintenance, the filter housing should last approximately 15 years.		
Evaluation:	No leaks or other problems with the filter noted.		
General Notes:

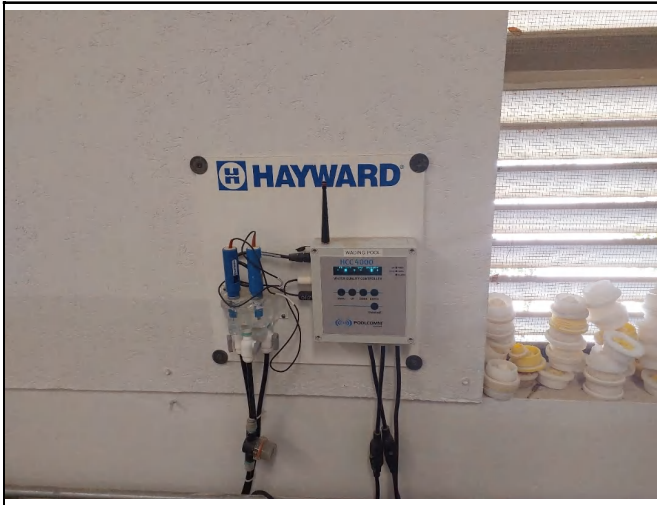
Comp #: 4.1260 Wading Pool Chemical Controller System - Replace

Quantity:	1 System	Original Service Date:	2022
Unit Cost:	\$7,000.00	Useful Life:	15
% of Unit Cost:	100.0%	Rem. Useful Life Adjustment:	0
Total Cost:	\$7,000.00	Remaining Useful Life:	12
Cost Source:	GeoReserves Database	Next Scheduled Year:	2037
Description:	This component funds to replace the automated chemical controller system for the pool. This system should be replaced every 10 to 15 years or as needed.		
Evaluation:	No problems noted.		
General Notes:

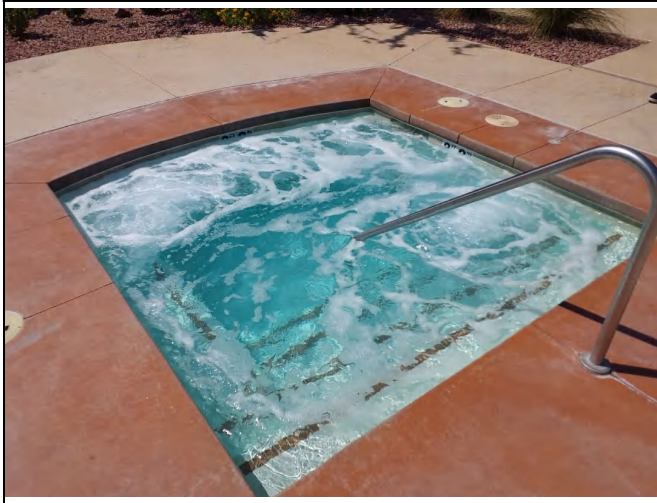
Comp #: 4.1301 Spa - Re-Plaster

Quantity:	1 Spa	Original Service Date:	2019
Unit Cost:	\$6,000.00	Useful Life:	6
% of Unit Cost:	100.0%	Rem. Useful Life Adjustment:	0
Total Cost:	\$6,000.00	Remaining Useful Life:	0
Cost Source:	GeoReserves Database	Next Scheduled Year:	2025
Description:	There are generally two main issues with the surface of a spa that will create the need for a replaster. The first is stains and other discoloration with the surface of the spa. While this is a cosmetic concern and not related to any structural issues, the look of the spa may be important in keeping a clean and inviting environment. The other issue is structural, as the plaster is the waterproof layer that protects the concrete and rest of the shell of the spa. Because the surface of the spa is smaller and it receives more use, it has a useful life of approximately 6 years. However, that life may be adjusted depending on the amount of use, repairs made, and condition of the water. Additional information can be found at blog.poolcenter.com , nspf.org , and apsp.org .

Evaluation:	Remaining life is based on current age.		
General Notes:

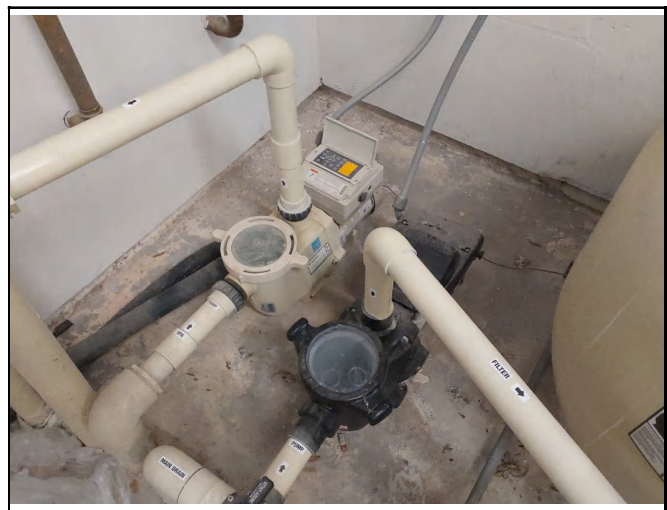
Comp #: 4.1305 Spa Pumps - Replace

Quantity:	2 Pumps	Original Service Date:	2022
Unit Cost:	\$4,500.00	Useful Life:	12
% of Unit Cost:	100.0%	Rem. Useful Life Adjustment:	0
Total Cost:	\$9,000.00	Remaining Useful Life:	9
Cost Source:	GeoReserves Database	Next Scheduled Year:	2034
Description:	This component includes replacing the spa pumps. These standard pool/spa pumps have a useful life of approximately 10 to 12 years. Occasionally the motors or other individual parts should be replaced or repaired as an operating expense.		
Evaluation:	No problems noted.		
General Notes:

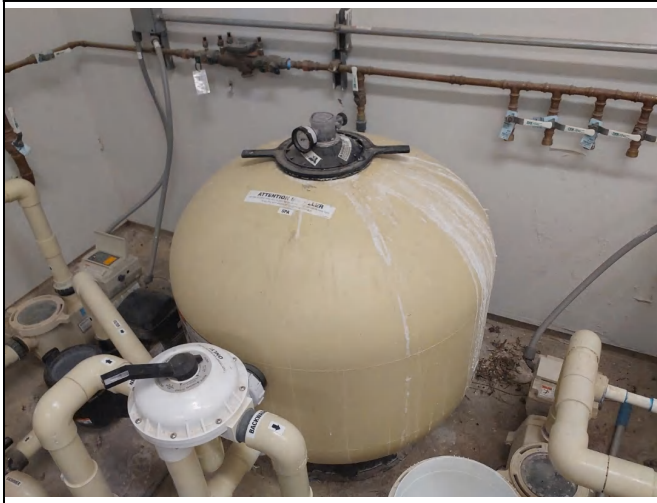
Comp #: 4.1306 Spa Filter - Replace

Quantity:	1 Filter	Original Service Date:	2022
Unit Cost:	\$5,000.00	Useful Life:	15
% of Unit Cost:	100.0%	Rem. Useful Life Adjustment:	0
Total Cost:	\$5,000.00	Remaining Useful Life:	12
Cost Source:	GeoReserves Database	Next Scheduled Year:	2037
Description:	There are two types of spa filters, cartridge filters and sand filters. The cartridges and sand should be replaced regularly as an operating expense, approximately every other year or more frequently depending on use. This component is for the filter housing which should be replaced when it begins to leak. Sometimes only individual parts may need to be replaced, which may be significant enough to justify a reserve expense. With regular cartridge replacement and maintenance, the filter housing should last approximately 15 years.		
Evaluation:	No leaks or other problems with the filter noted.		
General Notes:

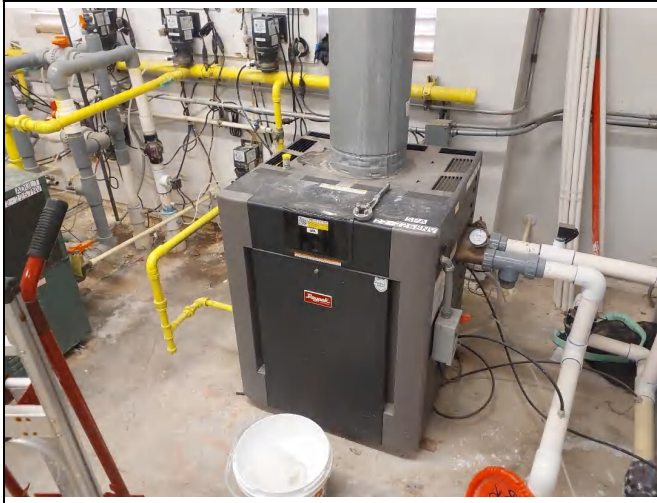
Comp #: 4.1308 Spa Heater - Replace

Quantity:	1 Heater	Original Service Date:	2022
Unit Cost:	\$5,500.00	Useful Life:	10
% of Unit Cost:	100.0%	Rem. Useful Life Adjustment:	0
Total Cost:	\$5,500.00	Remaining Useful Life:	7
Cost Source:	GeoReserves Database	Next Scheduled Year:	2032
Description:	This component includes replacing the spa heater. A standard spa heater has a typical useful life of 8 to 10 years. Certain parts may be replaced as an operating expense if necessary.		
Evaluation:	No problems with this spa heater noted.		
General Notes:

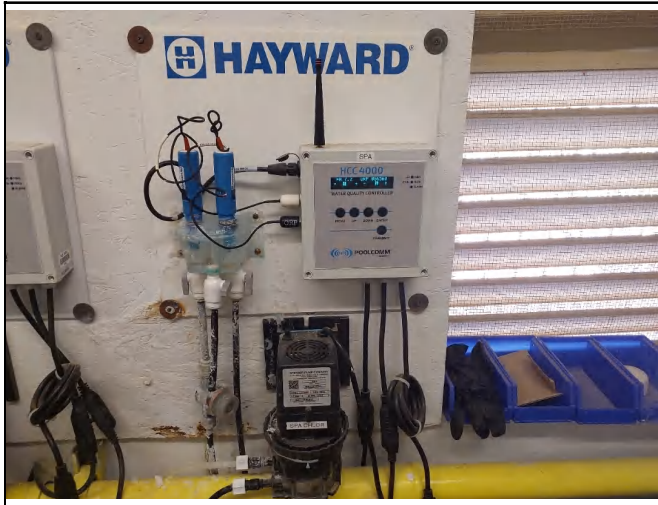
Comp #: 4.1310 Spa Chemical Controller System - Replace

Quantity:	1 System	Original Service Date:	2022
Unit Cost:	\$7,000.00	Useful Life:	15
% of Unit Cost:	100.0%	Rem. Useful Life Adjustment:	0
Total Cost:	\$7,000.00	Remaining Useful Life:	12
Cost Source:	GeoReserves Database	Next Scheduled Year:	2037
Description:	This component funds to replace the automated chemical controller system for the spa. This system should be replaced every 10 to 15 years or as needed.		
Evaluation:	No problems noted.		
General Notes:

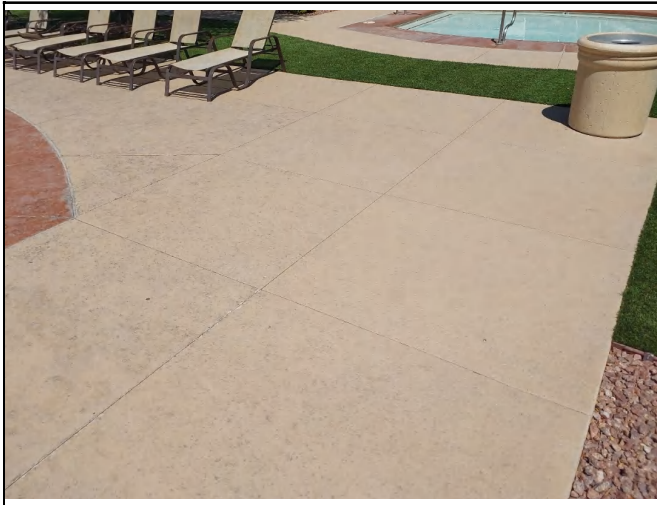
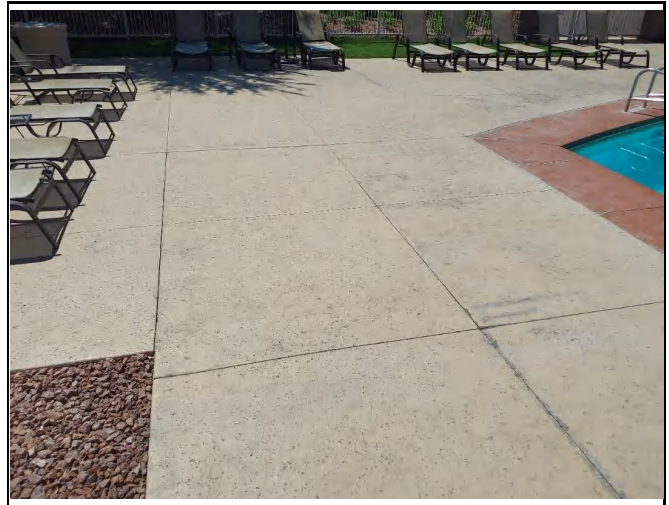
Comp #: 4.1406 Pool Concrete Deck - Resurface

Quantity:	9,500 Sq. Ft.	Original Service Date:	2009
Unit Cost:	\$8.50	Useful Life:	15
% of Unit Cost:	100.0%	Rem. Useful Life Adjustment:	6
Total Cost:	\$80,750.00	Remaining Useful Life:	5
Cost Source:	GeoReserves Database	Next Scheduled Year:	2030
Description:	The purpose of the pool deck is to keep a cool, non-slip surface for barefeet, allow proper drainage, and to protect the underlying concrete. There are many materials available, and most have a similar "Kool" deck style appearance. Because the appearances are so similar it can be difficult to determine the material just by visual inspection. As a general guide, acrylic sealers should be applied every year, silane or siloxane sealers should be applied every three years, and urethane, polyurethane, and epoxy coatings can last over 10 years. This reserve study budgets for major reserve work to be done every 15 years. If coatings need to be applied more frequently, that can usually be done as an operating expense. This cost schedule can be adjusted as necessary based on feedback from the client.

Evaluation:	No problems noted.		
General Notes:

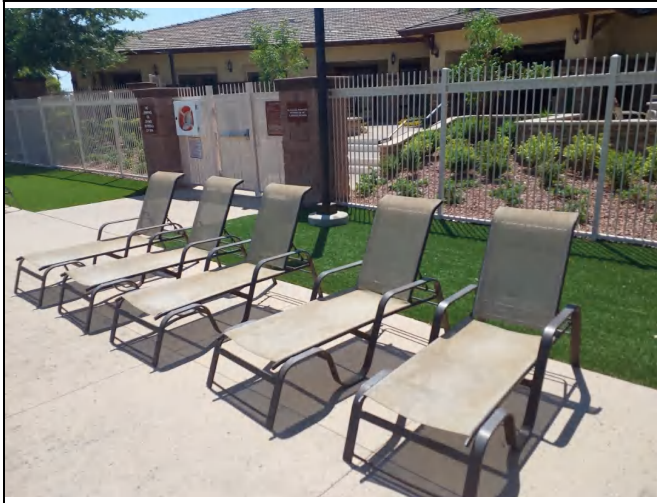
Comp #: 4.1413 Pool Area Furniture - Replace

Quantity:	1 See Detail	Original Service Date:	2020
Unit Cost:	\$45,000.00	Useful Life:	5
% of Unit Cost:	100.0%	Rem. Useful Life Adjustment:	0
Total Cost:	\$45,000.00	Remaining Useful Life:	0
Cost Source:	GeoReserves Database	Next Scheduled Year:	2025
Description:	This component includes replacing the pool furniture. Several conditions affect the life of a piece of pool furniture including the amount of maintenance and care, weather, amount of use, vandalism, and quality of furniture. This study funds to make replacements every 10 years but can be adjusted as necessary.		
Evaluation:	No problems or appearance concerns with this furniture noted.		
General Notes:	64 Chairs 14 Tables 7 Umbrellas 57 Chaise Loungers 12 Trash Receptacles

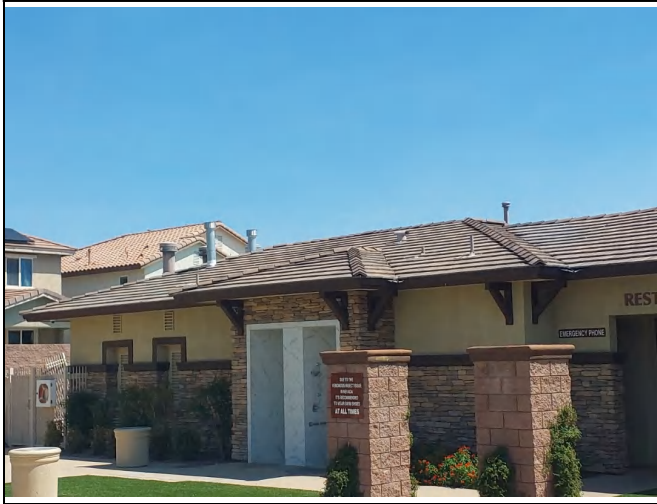
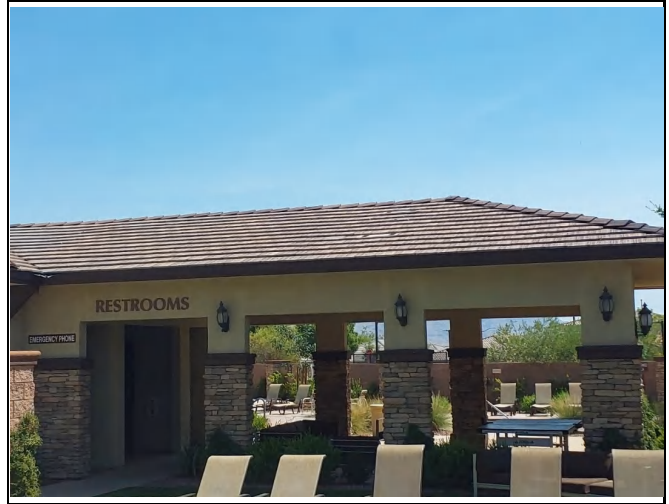
Comp #: 5.1434 Pool Building - Roof Re-Stack

Quantity:	3,500 Sq. Ft.	Original Service Date:	2022
Unit Cost:	\$5.50	Useful Life:	30
% of Unit Cost:	100.0%	Rem. Useful Life Adjustment:	0
Total Cost:	\$19,250.00	Remaining Useful Life:	27
Cost Source:	GeoReserves Database	Next Scheduled Year:	2052
Description:	This component includes replacing the underlayment underneath the tile roof. It is this underlayment that offers the protection from water damage other elements. This project is known as a roof re-stacking, and should be expected to occur approximately every 25 to 30 years. In addition, regular maintenance, repairs, and inspections should occur on an annual basis as an operating expense.		
Evaluation:	No access to roof underlayment. These roofs should be inspected regularly and this remaining life should be adjusted as necessary.		
General Notes:

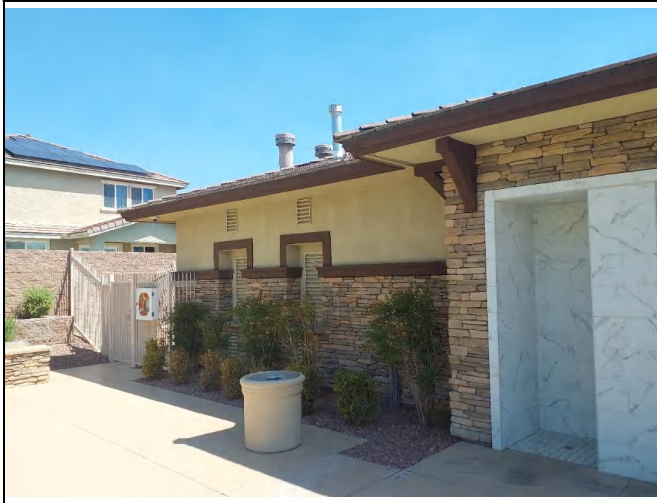
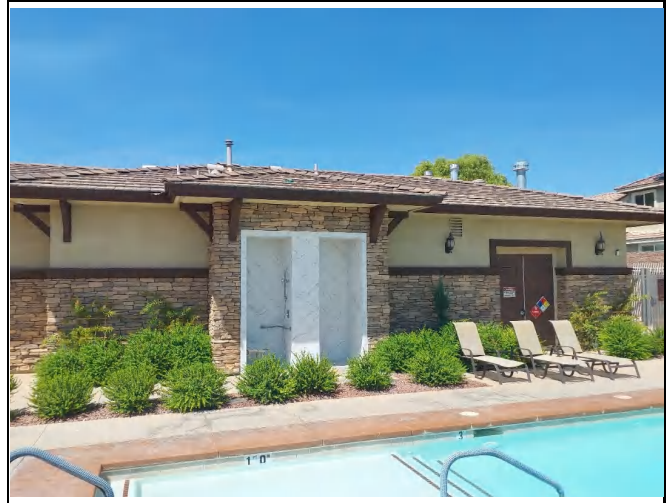
Comp #: 5.1435 Pool Building - Major Repair

Quantity:	1 Pool Building	Original Service Date:	2009
Unit Cost:	\$20,000.00	Useful Life:	20
% of Unit Cost:	100.0%	Rem. Useful Life Adjustment:	0
Total Cost:	\$20,000.00	Remaining Useful Life:	4
Cost Source:	GeoReserves Database	Next Scheduled Year:	2029
Description:	This component funds to make any necessary repairs to the pool building. This work should be scheduled every 20 years or when necessary to maintain functional and appearance standards.		
Evaluation:	No problems noticed.		
General Notes:

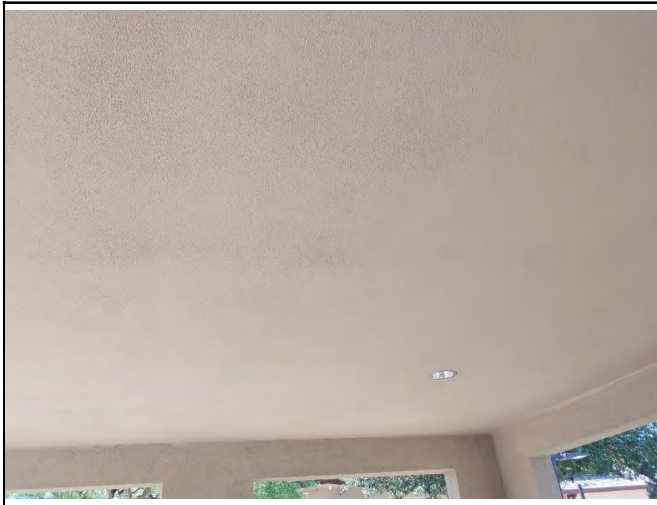
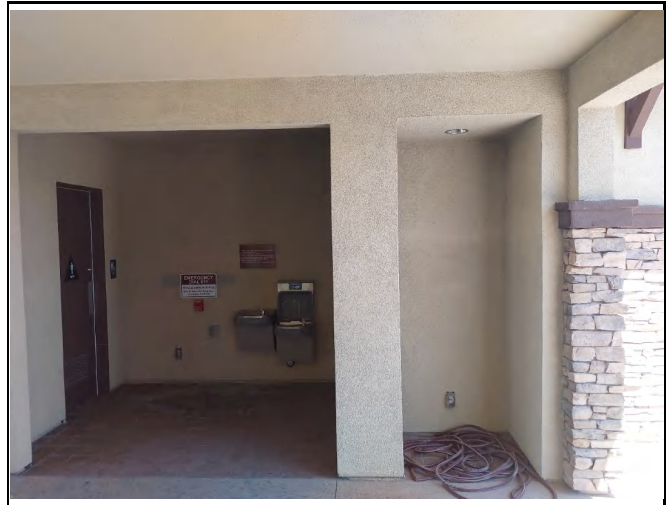
Comp #: 5.1438 Pool Building - Exterior Siding Repaint

Quantity:	1 Pool Building	Original Service Date:	2019
Unit Cost:	\$12,500.00	Useful Life:	10
% of Unit Cost:	100.0%	Rem. Useful Life Adjustment:	0
Total Cost:	\$12,500.00	Remaining Useful Life:	4
Cost Source:	GeoReserves Database	Next Scheduled Year:	2029
Description:	This component funds to repaint the stucco surfaces and make any related repairs to the building exterior. There are several different scopes of work that can be performed for this project. Painting can be done with acrylic, elastomeric, or other types of paint. Also, a fog coating can be performed depending on the age and condition of stucco. This component funds to repaint the stucco every 10 years, but input should be provided by a stucco and/or paint professional at the time this project is scheduled to occur.		
Evaluation:	No appearance concerns noted.		
General Notes:
