NORTHERN TERRACE HOA
Association #: 01.01.1741

Level 1 -- Full Reserve Study with Site Visit

Date of Site Inspection: **07/31/2024**

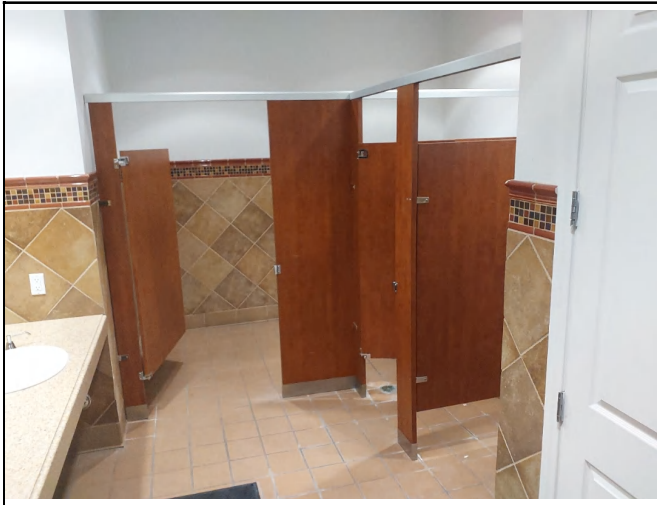
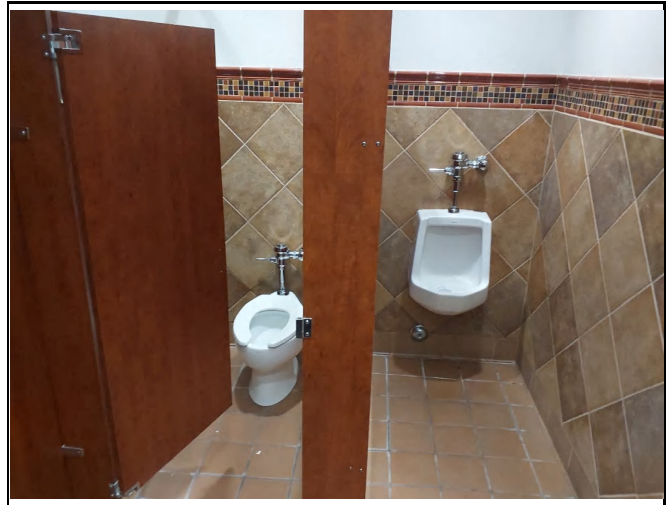
Comp #: 5.1441 Pool Building - Restroom Remodel

Quantity:	2 Restrooms	Original Service Date:	2009
Unit Cost:	\$50,000.00	Useful Life:	30
% of Unit Cost:	100.0%	Rem. Useful Life Adjustment:	0
Total Cost:	\$100,000.00	Remaining Useful Life:	14
Cost Source:	GeoReserves Database	Next Scheduled Year:	2039
Description:	This component funds to remodel the restrooms. This includes replacing the fixtures, floor and wall tile, as well as any plumbing and electrical work and other related costs. These restrooms should be remodeled every 30 years to maintain appearance and functionality standards.		
Evaluation:	No problems noted.		
General Notes:

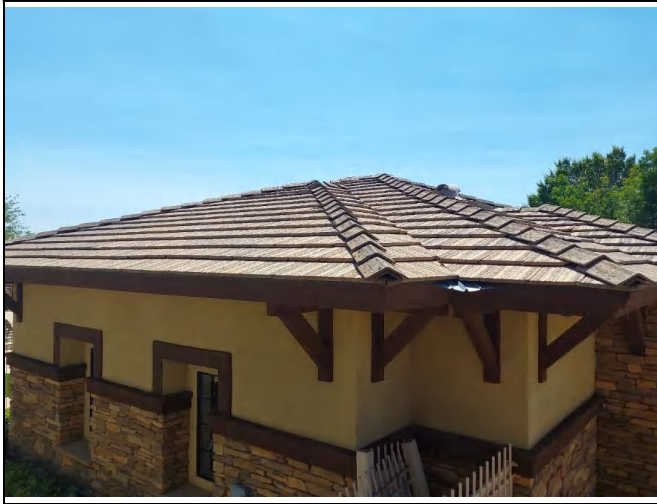
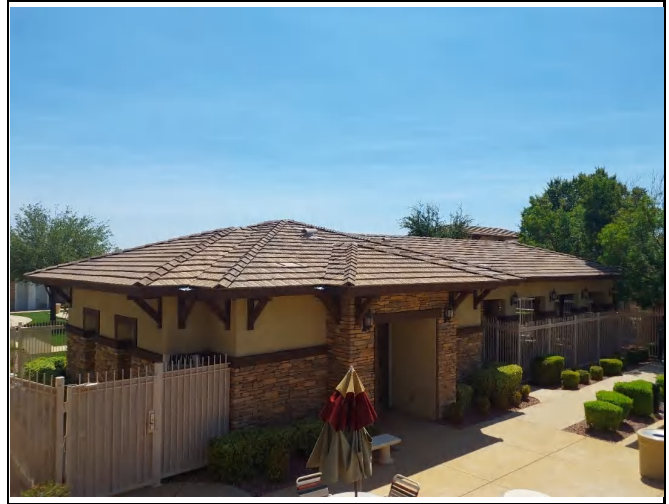
Comp #: 6.1617 Activity Room - Roof Re-Stack

Quantity:	3,000 Sq. Ft.	Original Service Date:	2022
Unit Cost:	\$5.50	Useful Life:	30
% of Unit Cost:	100.0%	Rem. Useful Life Adjustment:	0
Total Cost:	\$16,500.00	Remaining Useful Life:	27
Cost Source:	GeoReserves Database	Next Scheduled Year:	2052
Description:	This component includes replacing the underlayment underneath the tile roof. It is this underlayment that offers the protection from water damage other elements. This project is known as a roof restacking, and should be expected to occur approximately every 25 to 30 years. In addition, regular maintenance, repairs, and inspections should occur on an annual basis as an operating expense		
Evaluation:	No access to roof underlayment. These roofs should be inspected regularly and this remaining life should be adjusted as necessary.		
General Notes:

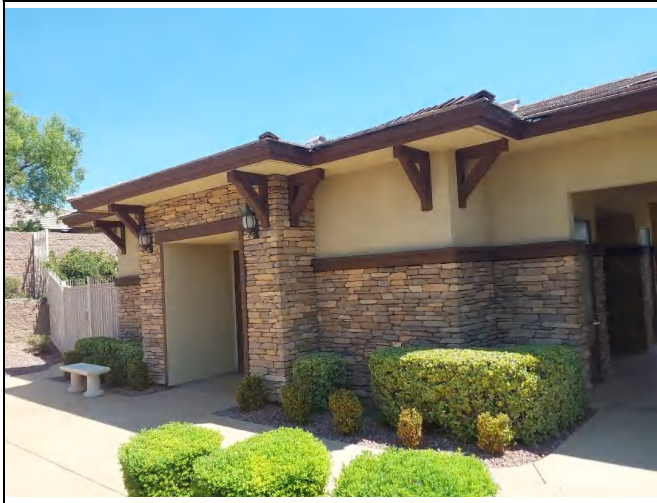
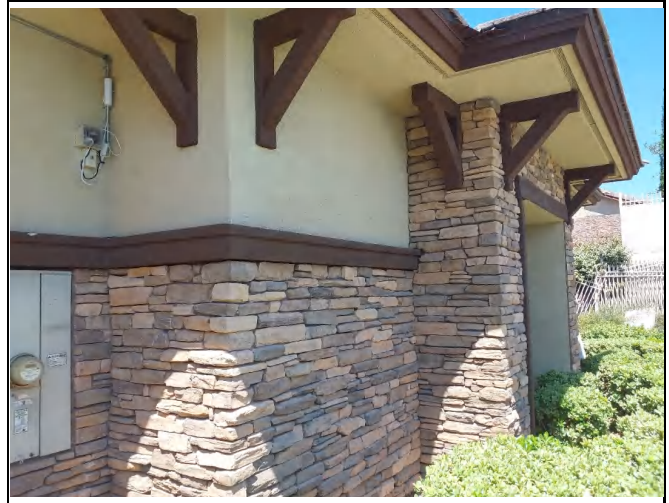
Comp #: 6.1618 Activity Room - Exterior Major Repair

Quantity:	1 Activity Room	Original Service Date:	2009
Unit Cost:	\$20,000.00	Useful Life:	20
% of Unit Cost:	100.0%	Rem. Useful Life Adjustment:	0
Total Cost:	\$20,000.00	Remaining Useful Life:	4
Cost Source:	GeoReserves Database	Next Scheduled Year:	2029
Description:	This component funds to make any necessary repairs to the activity building. This work should be scheduled every 20 years or when necessary to maintain functional and appearance standards.		
Evaluation:	No problems noted.		
General Notes:

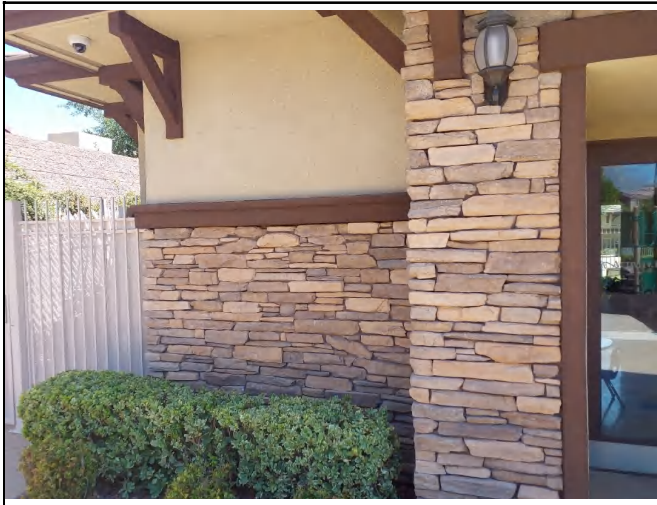
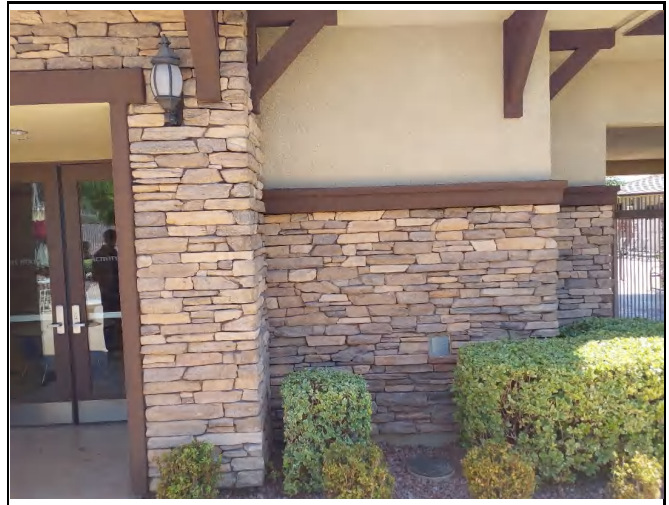
Comp #: 6.1620 Activity Room - Exterior Siding Repaint

Quantity:	1 Activity Room	Original Service Date:	2019
Unit Cost:	\$10,000.00	Useful Life:	10
% of Unit Cost:	100.0%	Rem. Useful Life Adjustment:	0
Total Cost:	\$10,000.00	Remaining Useful Life:	4
Cost Source:	GeoReserves Database	Next Scheduled Year:	2029
Description:	This component funds to repaint the stucco surfaces and make any related repairs. There are several different scopes of work that can be performed for this project. Painting can be done with acrylic, elastomeric, or other types of paint. Also, a fog coating can be performed depending on the age and condition of stucco. This component funds to repaint the stucco every 10 to 12 years, but input should be provided by a stucco and/or paint professional at the time this project is scheduled to occur.		
Evaluation:	No problems noted.		
General Notes:

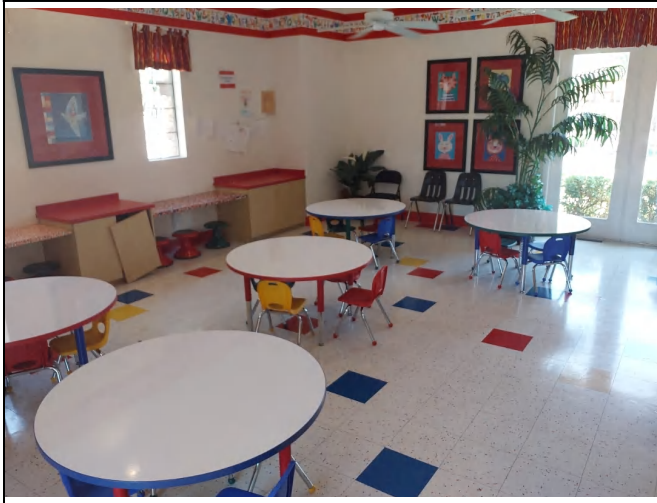
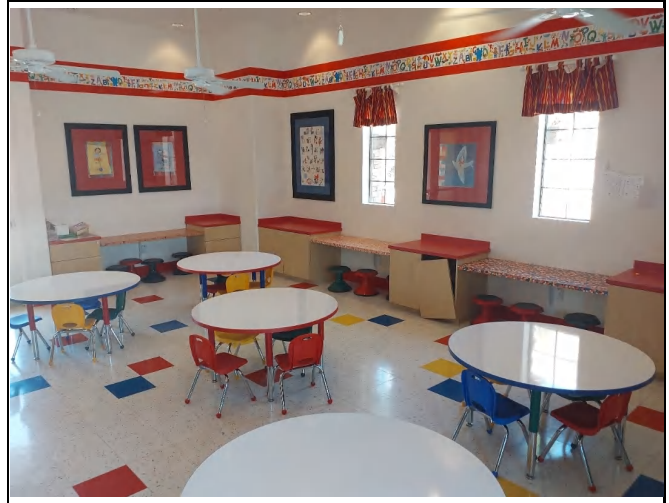
Comp #: 6.1623 Activity Room - Interior Remodel

Quantity:	1 Activity Room	Original Service Date:	2009
Unit Cost:	\$20,000.00	Useful Life:	20
% of Unit Cost:	100.0%	Rem. Useful Life Adjustment:	0
Total Cost:	\$20,000.00	Remaining Useful Life:	4
Cost Source:	GeoReserves Database	Next Scheduled Year:	2029
Description:	This component includes a general update and remodel to the Children's Activity Room. This includes painting, replacing the floor, replacing any furniture and appliances, and any other related work. Not all of this work needs to be done at one time. This component funds for a general allowance for projects to occur every 20 years or when necessary.		
Evaluation:	No problems noted.		
General Notes:

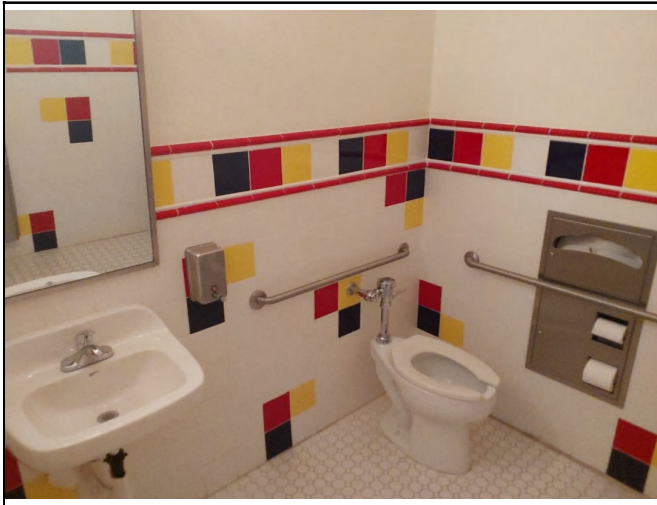
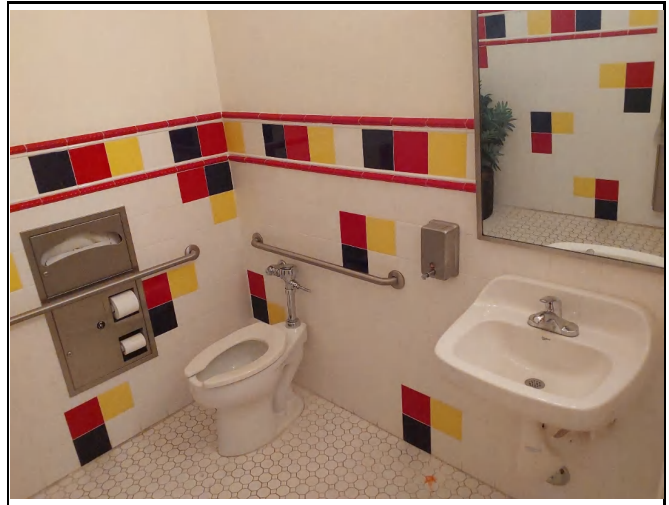
Comp #: 6.1624 Activity Room - Restroom Remodel

Quantity:	2 Restrooms	Original Service Date:	2009
Unit Cost:	\$20,000.00	Useful Life:	20
% of Unit Cost:	100.0%	Rem. Useful Life Adjustment:	0
Total Cost:	\$40,000.00	Remaining Useful Life:	4
Cost Source:	GeoReserves Database	Next Scheduled Year:	2029
Description:	This component funds to remodel the restrooms. This includes replacing the fixtures, floor and wall tile, as well as any plumbing and electrical work and other related costs. These restrooms should be remodeled every 20 years to maintain appearance and functionality standards.		
Evaluation:	No problems noted.		
General Notes:

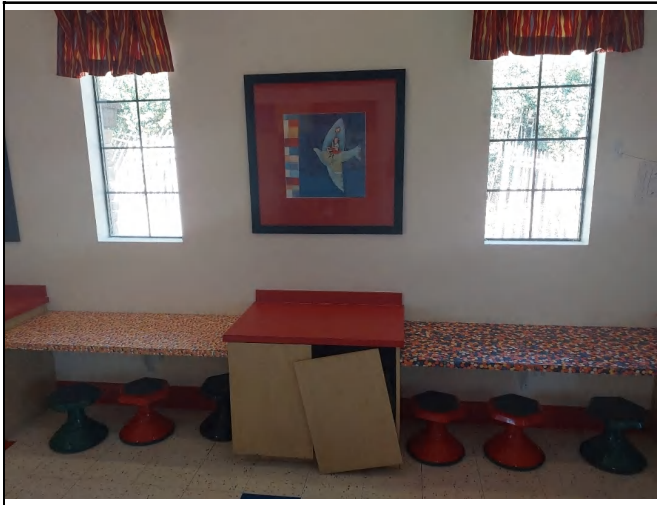
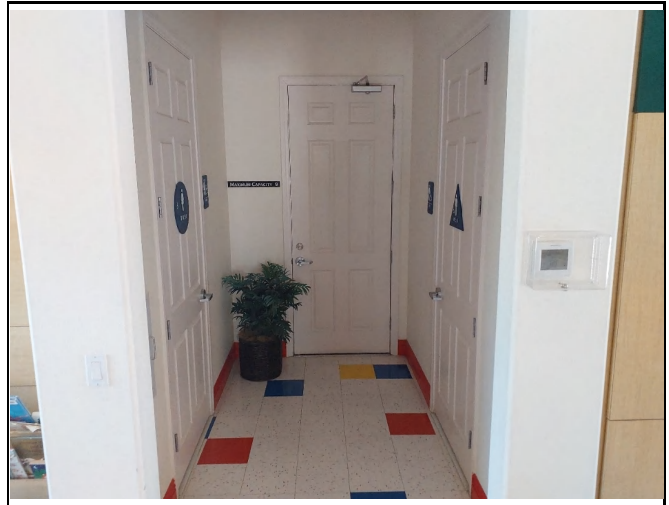
Comp #: 6.1625 Activity Room - Interior General Repair

Quantity:	1 Project	Original Service Date:	2019
Unit Cost:	\$10,000.00	Useful Life:	10
% of Unit Cost:	100.0%	Rem. Useful Life Adjustment:	0
Total Cost:	\$10,000.00	Remaining Useful Life:	4
Cost Source:	GeoReserves Database	Next Scheduled Year:	2029
Description:	This component includes minor updates and replacements to the clubhouse interior. This includes projects also in the major remodel component such as painting, replacing items and other repairs that may need to be done in-between the major remodel project.		
Evaluation:	Some of the cabinets appear damaged. This repair can be made as an operating expense. Otherwise, No problems noted.		
General Notes:

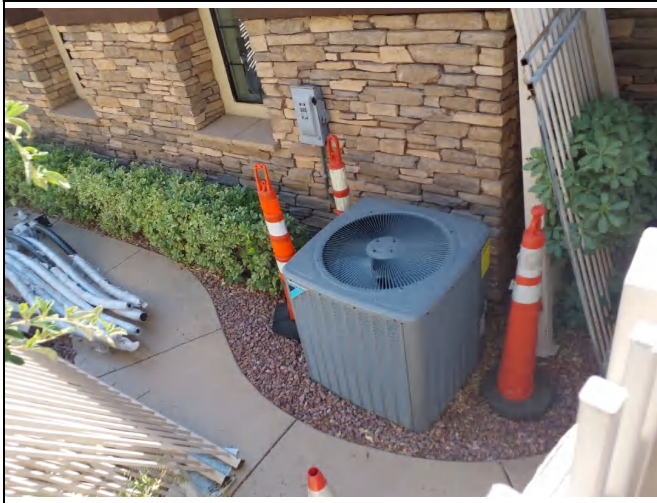
Comp #: 6.2601 Activity Room HVAC System - Replace

Quantity:	1 System	Original Service Date:	2022
Unit Cost:	\$15,000.00	Useful Life:	15
% of Unit Cost:	100.0%	Rem. Useful Life Adjustment:	1
Total Cost:	\$15,000.00	Remaining Useful Life:	13
Cost Source:	GeoReserves Database	Next Scheduled Year:	2038
Description:	This component funds to replace the HVAC system. This includes the air conditioner unit, furnace, and any related work such as ductwork or other repairs. This system should be replaced every 15 years or when necessary.		
Evaluation:	No problems noted.		
General Notes:

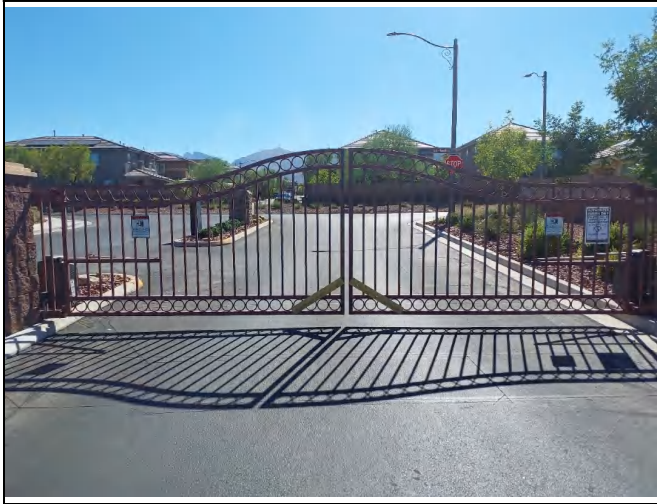
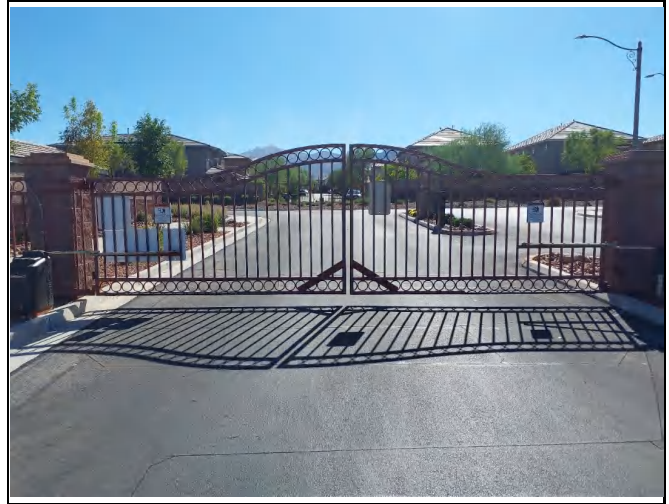
Comp #: 7.701 Vehicle & Pedestrian Gates - Replace

Quantity:	4 Vehicle Gates	Original Service Date:	2009
Unit Cost:	\$4,750.00	Useful Life:	36
% of Unit Cost:	100.0%	Rem. Useful Life Adjustment:	0
Total Cost:	\$19,000.00	Remaining Useful Life:	20
Cost Source:	GeoReserves Database	Next Scheduled Year:	2045
Description:	This component includes replacing the vehicle gates, and any surrounding pedestrian gates or small section of fencing. These gates should last approximately 30 to 40 years before they should be replaced to improve the appearance of the entrance area. Any accidents from cars hitting these gates should be considered an insurance issue and not anormal reserve expense. Additional information can be found at iframe.americanfenceassociation.com .		
Evaluation:	No problems noted.		
General Notes:

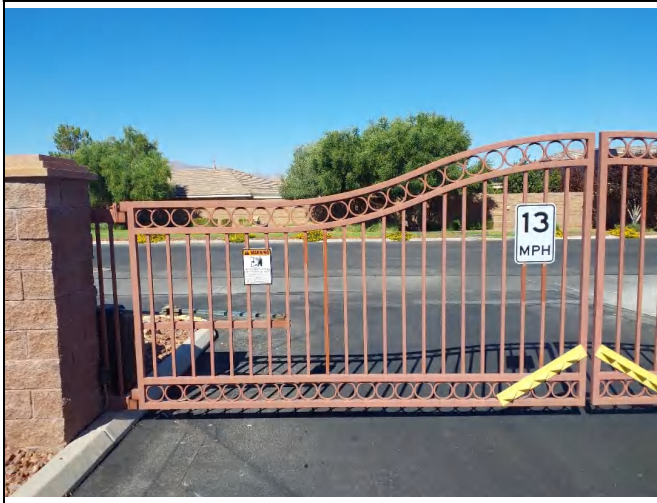
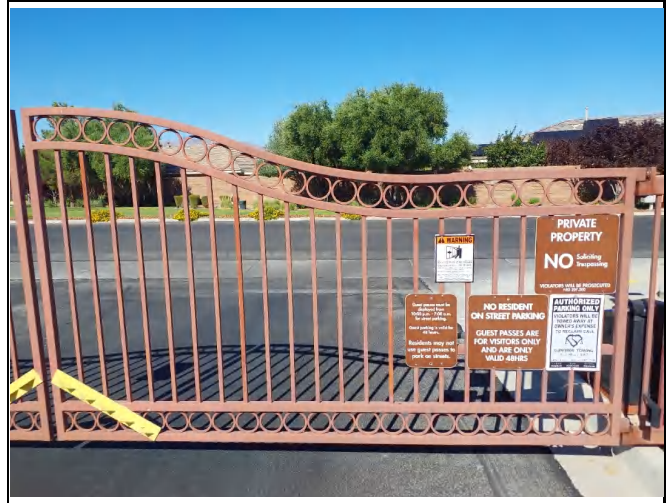
Comp #: 7.702 Vehicle & Pedestrian Gates - Repaint

Quantity:	4 Vehicle Gates	Original Service Date:	2021
Unit Cost:	\$625.00	Useful Life:	6
% of Unit Cost:	100.0%	Rem. Useful Life Adjustment:	0
Total Cost:	\$2,500.00	Remaining Useful Life:	2
Cost Source:	GeoReserves Database	Next Scheduled Year:	2027
Description:	This component includes painting the gates, along with making any repairs to bent or rusted areas. This project should be performed every 6 years or when necessary to maintain appearance and ensure the fence realizes a full useful life. Different paint materials and techniques will determine the actual useful life and may result in adjusting this schedule.		
Evaluation:	No rusting or other appearance concerns such as fading paint noted.		
General Notes:

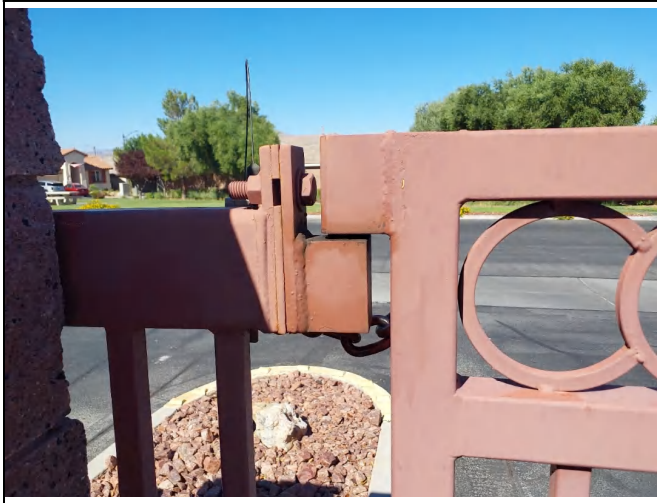
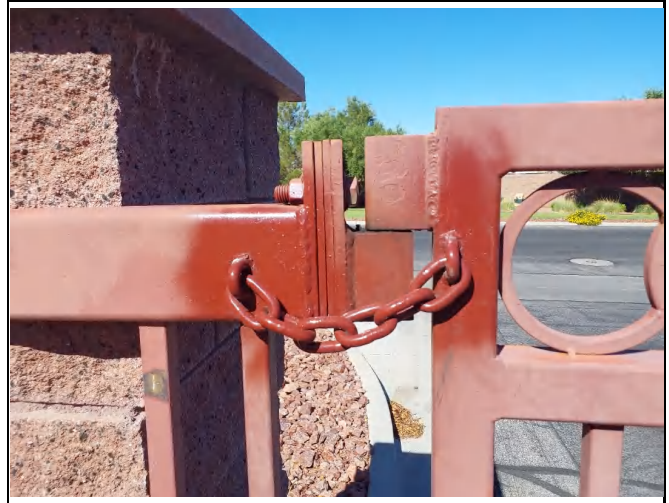
Comp #: 7.705 Vehicle Gate Hardware - Replace

Quantity:	4 Vehicle Gates	Original Service Date:	2009
Unit Cost:	\$1,250.00	Useful Life:	18
% of Unit Cost:	100.0%	Rem. Useful Life Adjustment:	0
Total Cost:	\$5,000.00	Remaining Useful Life:	2
Cost Source:	GeoReserves Database	Next Scheduled Year:	2027
Description:	This component includes the hinges, as well as any other associated costs that go with the gates themselves such as safety edges, magnetic locks, etc. The newer gate hinges are equipped with a zerk grease fitting, which allows the hinge to be greased, which drastically extends its useful life. This component funds to replace all the hinges every 18 years, assuming they currently have the zerk fittings.		
Evaluation:	These gates appear to be opening and closing properly. A regular maintenance plan with frequent inspections are recommended to ensure any issues will be corrected as the arise.		
General Notes:

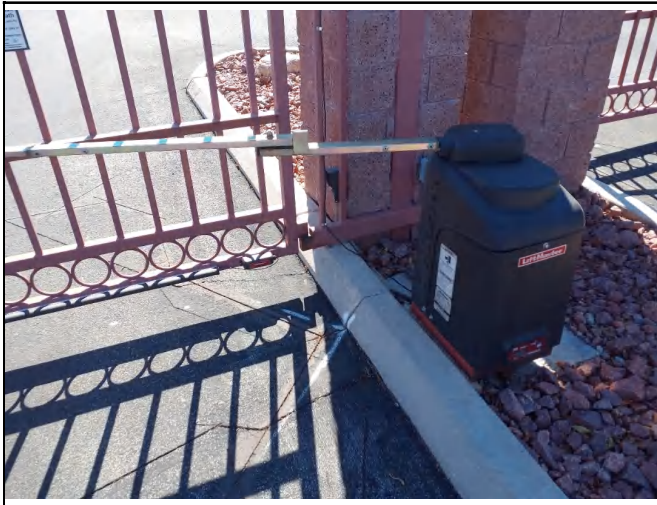
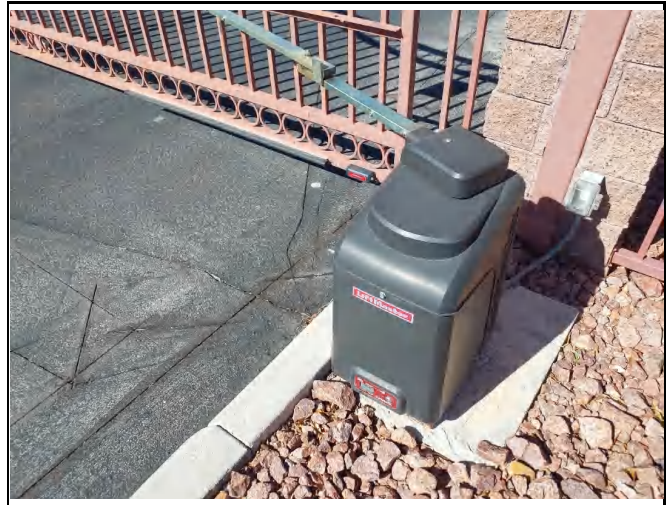
Comp #: 7.715 Vehicle Gate Operators - Replace

Quantity:	4 Gate Operators	Original Service Date:	2021
Unit Cost:	\$6,000.00	Useful Life:	12
% of Unit Cost:	100.0%	Rem. Useful Life Adjustment:	0
Total Cost:	\$24,000.00	Remaining Useful Life:	8
Cost Source:	GeoReserves Database	Next Scheduled Year:	2033
Description:	This component includes replacing the entire gate operator unit. During the normal life of these gate operators certain parts, such as battery backups, circuit boards and motors may need to be repaired or replaced. For most associations, these minor costs should be considered an operating expense. Gate operators should last between 10 to 12 years however the actual life could be longer if individual parts are routinely replaced. Additional information can be found at www.dasma.com .		
Evaluation:	These gate operators were functioning normally at time of site visit with no problems noted.		
General Notes:

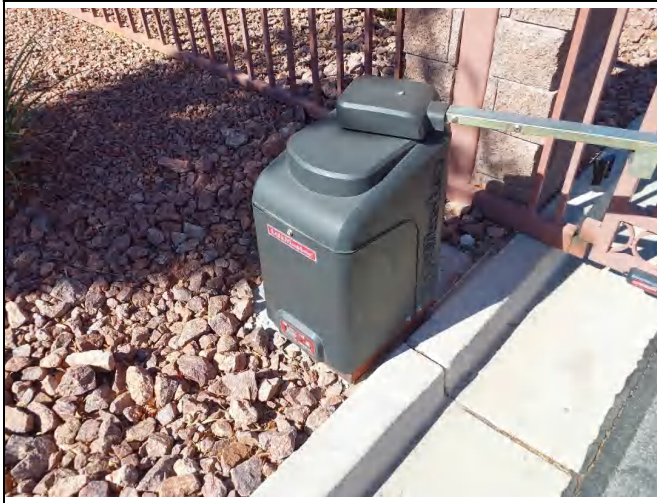
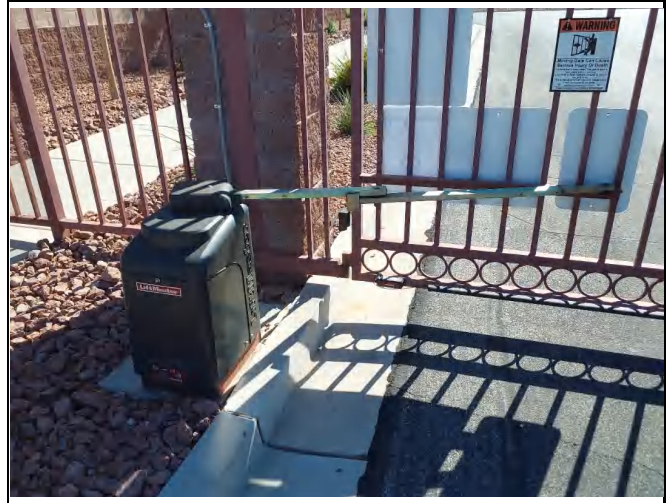
Comp #: 7.716 Vehicle Gate Operators - Repair

Quantity:	4 Gate Operators	Original Service Date:	2021
Unit Cost:	\$600.00	Useful Life:	4
% of Unit Cost:	100.0%	Rem. Useful Life Adjustment:	0
Total Cost:	\$2,400.00	Remaining Useful Life:	0
Cost Source:	GeoReserves Database	Next Scheduled Year:	2025
Description:	There are a variety of parts that are associated with the gate operators. These include the underground gate loops, the gate arms, battery backups, limit cams, photo eye sensors, motors, circuit boards and any other related parts. The useful life and cost estimate of these individual parts can be difficult to predict and usually will fall under the threshold cost that separates a reserve expense from an operating repair cost. However, when grouped together a typical reserve schedule is to have a budget for these types of repairs to occur every 3 to 5 years. A regular maintenance plan that includes frequent inspections is recommended.

Evaluation:	No operational problems noted. This site visit does not include any mechanical testing and maintenance plan with frequent inspections from a trained professional is recommended.		
General Notes:

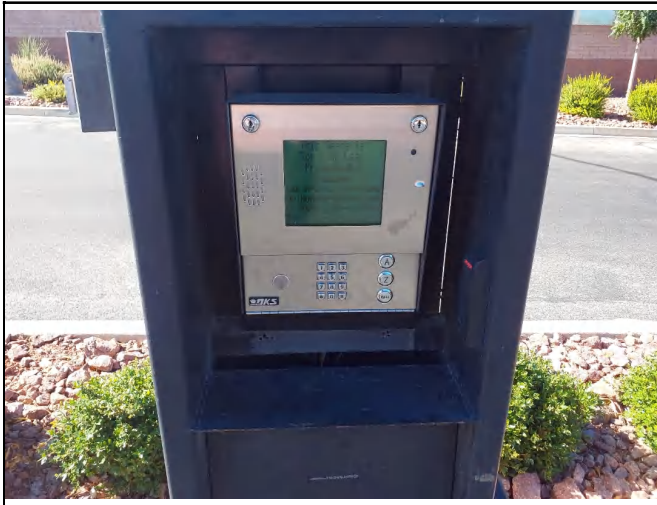
Comp #: 7.722 Vehicle Gate Entrance System - Replace

Quantity:	1 Entrance System	Original Service Date:	2019
Unit Cost:	\$6,000.00	Useful Life:	10
% of Unit Cost:	100.0%	Rem. Useful Life Adjustment:	0
Total Cost:	\$6,000.00	Remaining Useful Life:	4
Cost Source:	GeoReserves Database	Next Scheduled Year:	2029
Description:	This component includes replacing the phone entry system call box. These types of entry systems will be functional for approximately ten years. However, the screens will usually fade and the keypads will receive general wear and tear, sometimes within only three to five years. It may be cost prohibitive to replace individual parts for this type of electrical component. Therefore, some communities may decide to replace the entry system box more frequently to ensure this component is in top working order beyond basic functionality. This reserve study funds for a 10 year useful life but can be adjusted based on the association's specific needs.

Evaluation:	This component is functional with no major problems noted.		
General Notes:

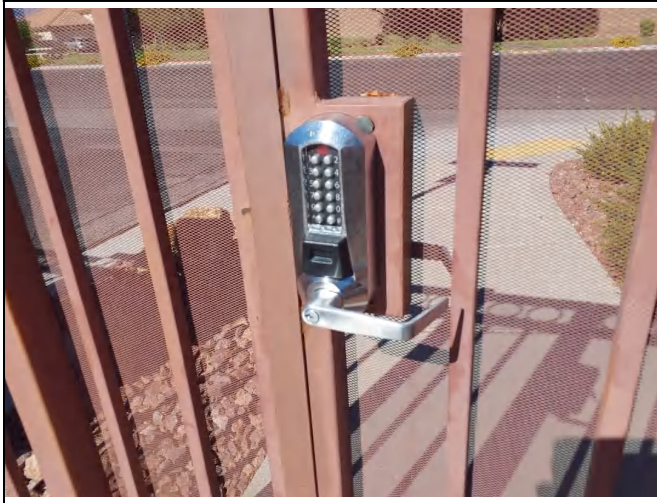
Comp #: 7.727 Pedestrian Gate Keypad Locks - Replace

Quantity:	2 Ped Gate Locks	Original Service Date:	2019
Unit Cost:	\$1,500.00	Useful Life:	10
% of Unit Cost:	100.0%	Rem. Useful Life Adjustment:	0
Total Cost:	\$3,000.00	Remaining Useful Life:	4
Cost Source:	GeoReserves Database	Next Scheduled Year:	2029
Description:	These pedestrian gate locks will have a useful life that varies widely by the amount of use and wear and tear they receive. We recommend budgeting to replace these keypad locks every 10 years but replacement should occur only when necessary.		
Evaluation:	No problems with these keypad locks noted. However this site visit does not open or perform any evasive test of mechanical equipment to determine condition beyond basic functionality.		
General Notes:

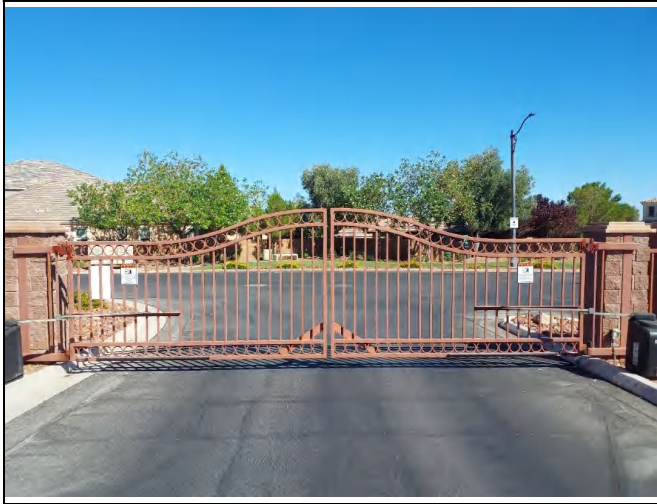
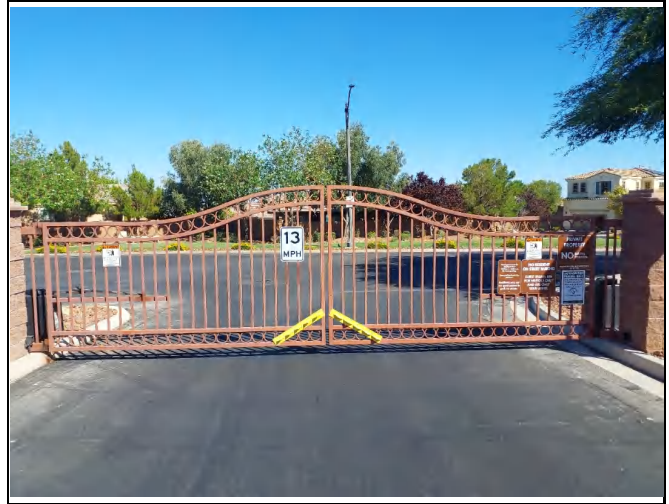
Comp #: 8.701 Vehicle & Pedestrian Gates - Replace

Quantity:	4 Vehicle Gates	Original Service Date:	2009
Unit Cost:	\$4,750.00	Useful Life:	36
% of Unit Cost:	100.0%	Rem. Useful Life Adjustment:	0
Total Cost:	\$19,000.00	Remaining Useful Life:	20
Cost Source:	GeoReserves Database	Next Scheduled Year:	2045
Description:	This component includes replacing the vehicle gates, and any surrounding pedestrian gates or small section of fencing. These gates should last approximately 30 to 40 years before they should be replaced to improve the appearance of the entrance area. Any accidents from cars hitting these gates should be considered an insurance issue and not anormal reserve expense. Additional information can be found at iframe.americanfenceassociation.com .		
Evaluation:	No problems noted.		
General Notes:

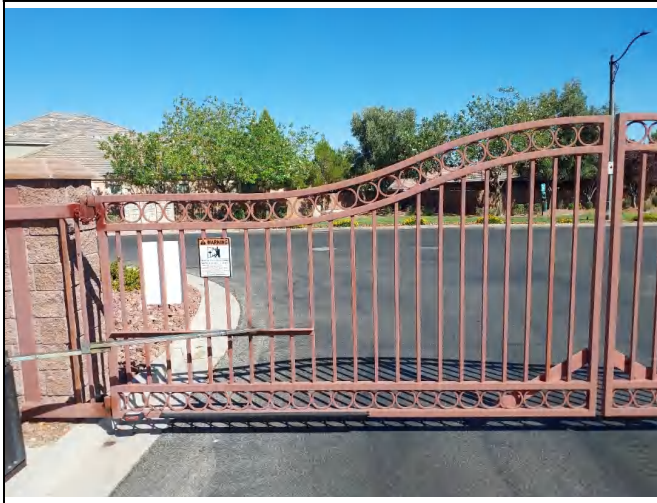
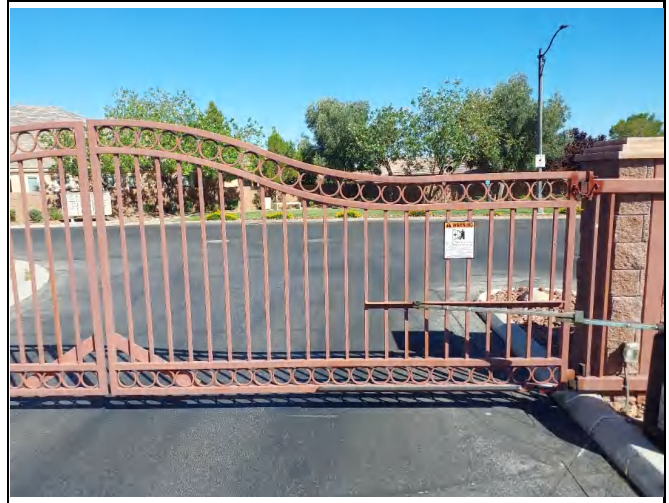
Comp #: 8.702 Vehicle & Pedestrian Gates - Repaint

Quantity:	4 Vehicle Gates	Original Service Date:	2021
Unit Cost:	\$625.00	Useful Life:	6
% of Unit Cost:	100.0%	Rem. Useful Life Adjustment:	0
Total Cost:	\$2,500.00	Remaining Useful Life:	2
Cost Source:	GeoReserves Database	Next Scheduled Year:	2027
Description:	This component includes painting the gates, along with making any repairs to bent or rusted areas. This project should be performed every 6 years or when necessary to maintain appearance and ensure the fence realizes a full useful life. Different paint materials and techniques will determine the actual useful life and may result in adjusting this schedule.		
Evaluation:	No rusting or other appearance concerns such as fading paint noted.		
General Notes:

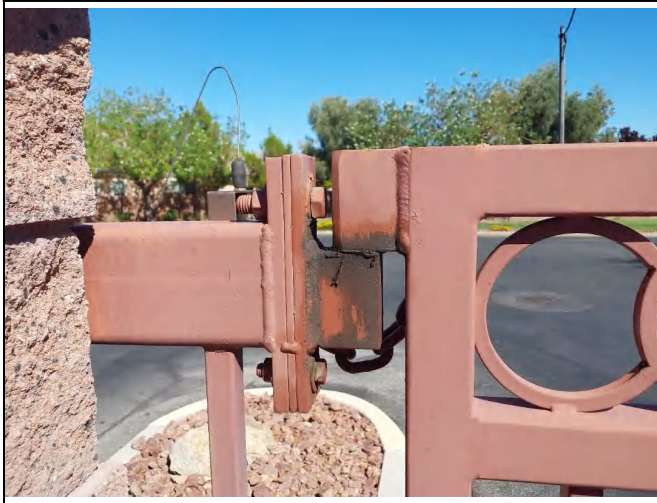
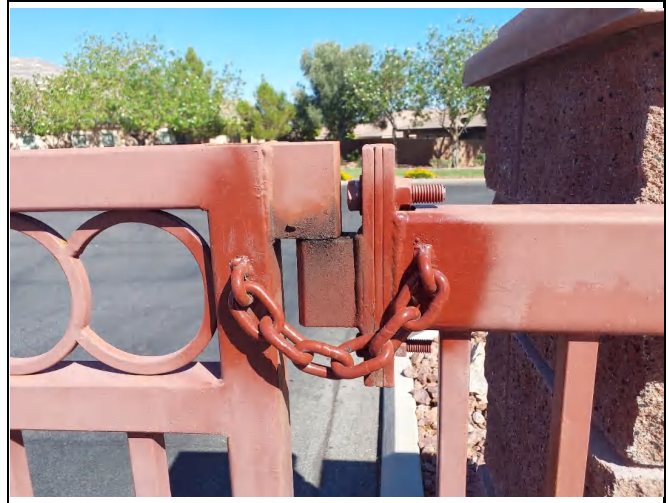
Comp #: 8.705 Vehicle Gate Hardware - Replace

Quantity:	4 Vehicle Gates	Original Service Date:	2009
Unit Cost:	\$1,250.00	Useful Life:	18
% of Unit Cost:	100.0%	Rem. Useful Life Adjustment:	0
Total Cost:	\$5,000.00	Remaining Useful Life:	2
Cost Source:	GeoReserves Database	Next Scheduled Year:	2027
Description:	This component includes the hinges, as well as any other associated costs that go with the gates themselves such as safety edges, magnetic locks, etc. The newer gate hinges are equipped with a zerk grease fitting, which allows the hinge to be greased, which drastically extends its useful life. This component funds to replace all the hinges every 18 years, assuming they currently have the zerk fittings.		
Evaluation:	These gates appear to be opening and closing properly. A regular maintenance plan with frequent inspections are recommended to ensure any issues will be corrected as the arise.		
General Notes:

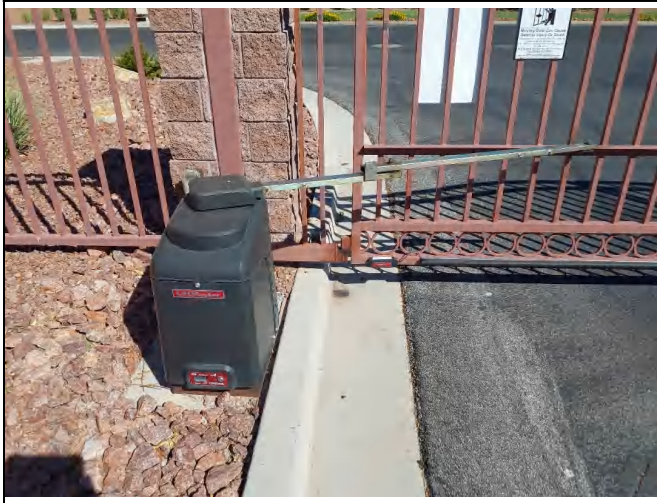
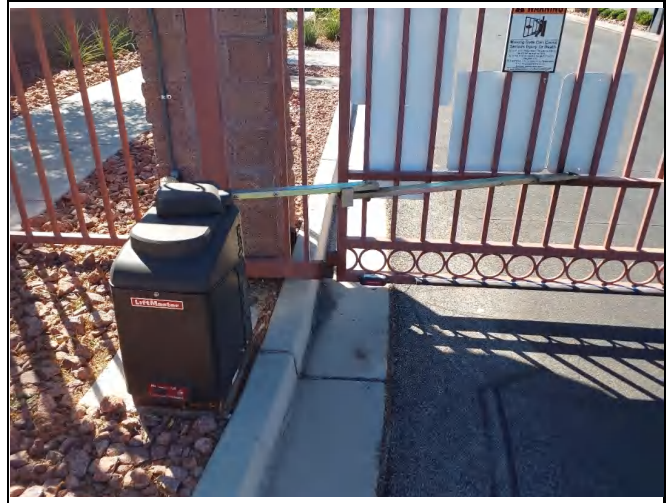
Comp #: 8.715 Vehicle Gate Operators - Replace

Quantity:	4 Gate Operators	Original Service Date:	2021
Unit Cost:	\$6,000.00	Useful Life:	12
% of Unit Cost:	100.0%	Rem. Useful Life Adjustment:	0
Total Cost:	\$24,000.00	Remaining Useful Life:	8
Cost Source:	GeoReserves Database	Next Scheduled Year:	2033
Description:	This component includes replacing the entire gate operator unit. During the normal life of these gate operators certain parts, such as battery backups, circuit boards and motors may need to be repaired or replaced. For most associations, these minor costs should be considered an operating expense. Gate operators should last between 10 to 12 years however the actual life could be longer if individual parts are routinely replaced. Additional information can be found at www.dasma.com .		
Evaluation:	These gate operators were functioning normally at time of site visit with no problems noted.		
General Notes:

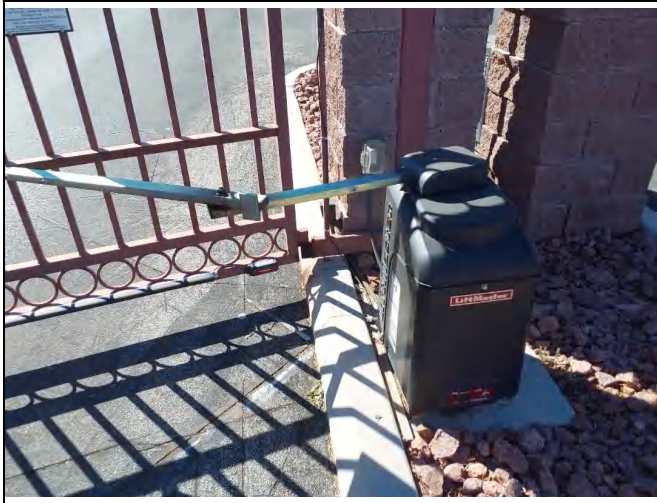
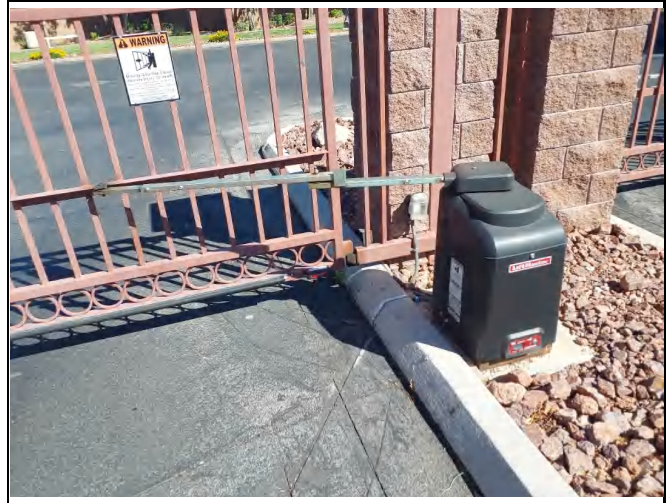
Comp #: 8.716 Vehicle Gate Operators - Repair

Quantity:	4 Gate Operators	Original Service Date:	2021
Unit Cost:	\$600.00	Useful Life:	4
% of Unit Cost:	100.0%	Rem. Useful Life Adjustment:	0
Total Cost:	\$2,400.00	Remaining Useful Life:	0
Cost Source:	GeoReserves Database	Next Scheduled Year:	2025
Description:	There are a variety of parts that are associated with the gate operators. These include the underground gate loops, the gate arms, battery backups, limit cams, photo eye sensors, motors, circuit boards and any other related parts. The useful life and cost estimate of these individual parts can be difficult to predict and usually will fall under the threshold cost that separates a reserve expense from an operating repair cost. However, when grouped together a typical reserve schedule is to have a budget for these types of repairs to occur every 3 to 5 years. A regular maintenance plan that includes frequent inspections is recommended.

Evaluation:	No operational problems noted. This site visit does not include any mechanical testing and maintenance plan with frequent inspections from a trained professional is recommended.		
General Notes:

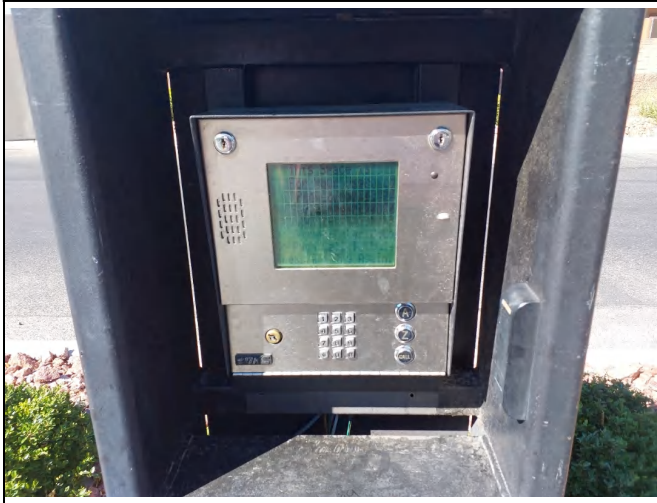
Comp #: 8.722 Vehicle Gate Entrance System - Replace

Quantity:	1 Entrance System	Original Service Date:	2019
Unit Cost:	\$6,000.00	Useful Life:	10
% of Unit Cost:	100.0%	Rem. Useful Life Adjustment:	0
Total Cost:	\$6,000.00	Remaining Useful Life:	4
Cost Source:	GeoReserves Database	Next Scheduled Year:	2029
Description:	This component includes replacing the phone entry system call box. These types of entry systems will be functional for approximately ten years. However, the screens will usually fade and the keypads will receive general wear and tear, sometimes within only three to five years. It may be cost prohibitive to replace individual parts for this type of electrical component. Therefore, some communities may decide to replace the entry system box more frequently to ensure this component is in top working order beyond basic functionality. This reserve study funds for a 10 year useful life but can be adjusted based on the association's specific needs.

Evaluation:	This component is functional with no major problems noted.		
General Notes:

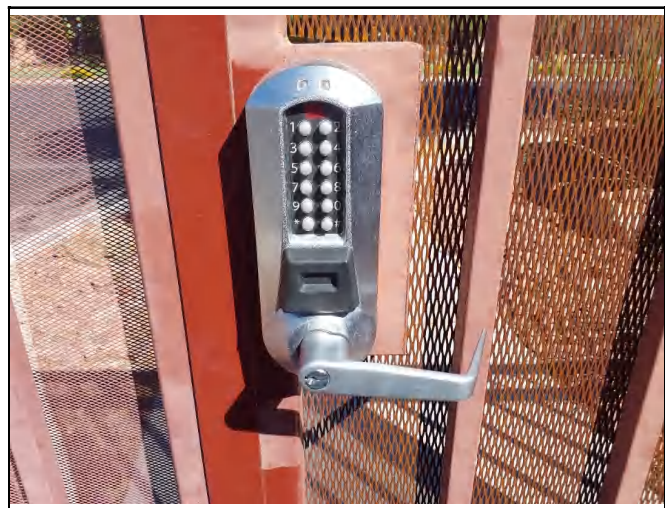
Comp #: 8.727 Pedestrian Gate Keypad Locks - Replace

Quantity:	3 Ped Gate Locks	Original Service Date:	2019
Unit Cost:	\$1,500.00	Useful Life:	10
% of Unit Cost:	100.0%	Rem. Useful Life Adjustment:	0
Total Cost:	\$4,500.00	Remaining Useful Life:	4
Cost Source:	GeoReserves Database	Next Scheduled Year:	2029
Description:	These pedestrian gate locks will have a useful life that varies widely by the amount of use and wear and tear they receive. We recommend budgeting to replace these keypad locks every 10 years but replacement should occur only when necessary.		
Evaluation:	No problems with these keypad locks noted. However this site visit does not open or perform any evasive test of mechanical equipment to determine condition beyond basic functionality.		
General Notes:
