# NOXON RAPIDS & CABINET GORGE RESERVOIRS SANDERS COUNTY, MONTANA

### 2019 Aquatic Invasive Species (AIS) Aquatic Pesticide Application Report (APAR)

Prepared For: Sanders County 1111 Main Street Thompson Falls, MT 59873

October 2019

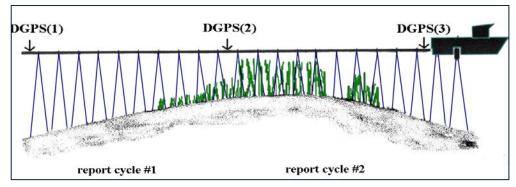
Treatment SAV coverage, height in the water column, and bio-volume to support post-treatment efficacy evaluations. An example of SAV conditions at time of treatment for Plot Nox-31, Noxon Reservoir, is pictured above.
