# HOME INSPECTION REPORT

*123 Main Street, Anytown , GA 30506*

*Inspection prepared for: Your Buyer*

*Date of Inspection: 1/1/2022 Time: 9:00*

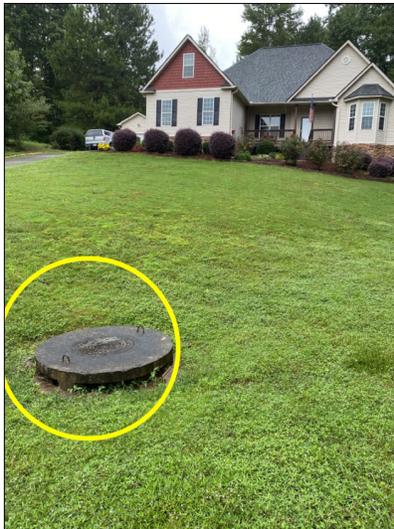
**IRRIGATION DRAINS** were observed in the yard, designed to properly control water flow around the property. This system is beyond the scope of this inspection.

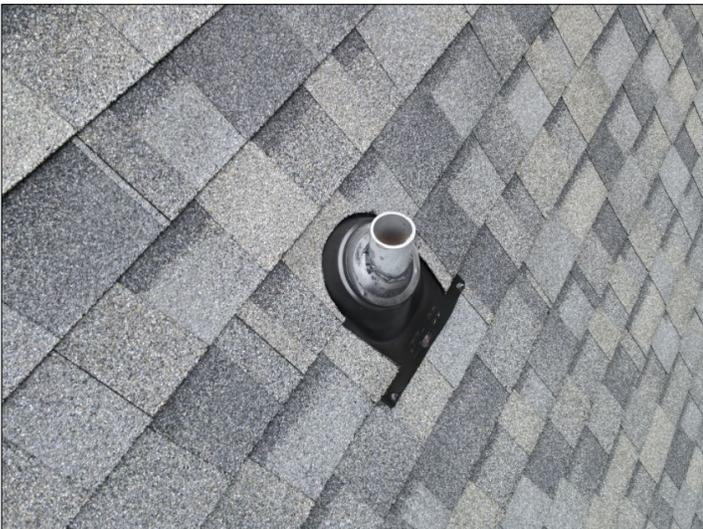
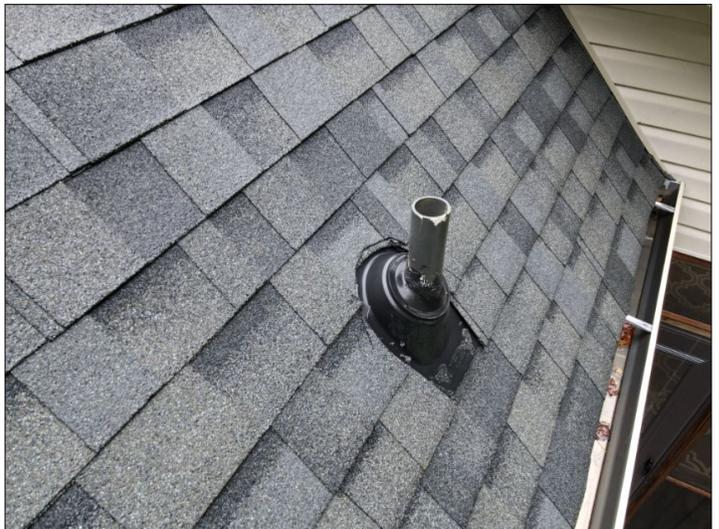
General Vent Photo

**VENTS - NO SUBSTANTIAL FLAWS** - Visible portions of the vents and vent flashing were inspected for obvious flaws, defects or installation damage that could be a point of moisture intrusion.

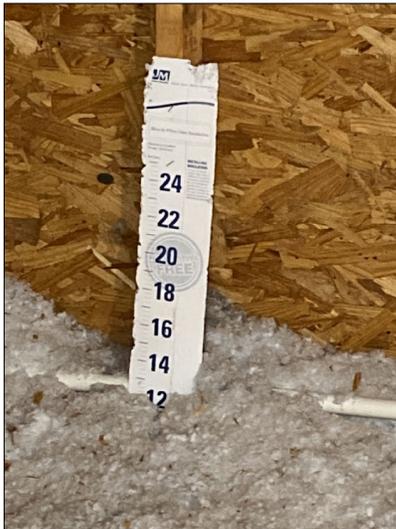
Approximately 10"-14" of insulation appeared to be installed.

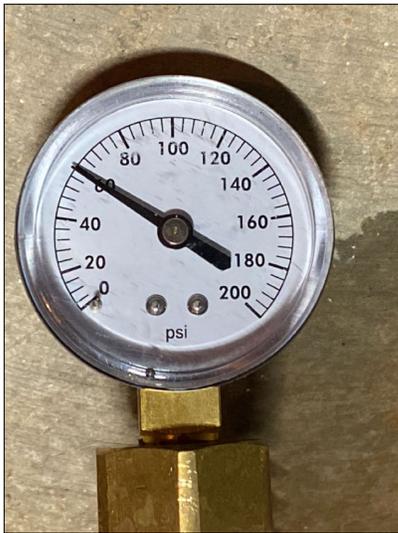
ACCEPTABLE WATER PRESSURE was measured at 60 psi with a pressure meter typically at the water heater or spigot. The generally accepted range of pressure is between 40-80 psi.

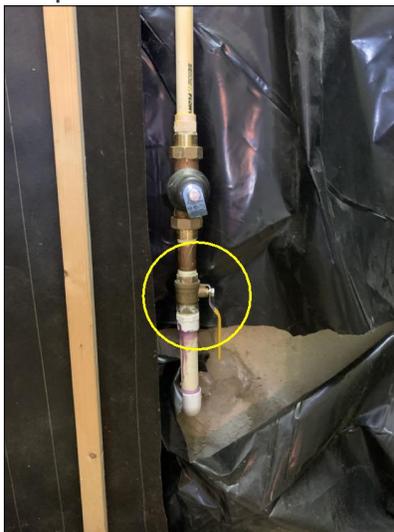
WATER SHUTOFF VALVE was located in the basement.

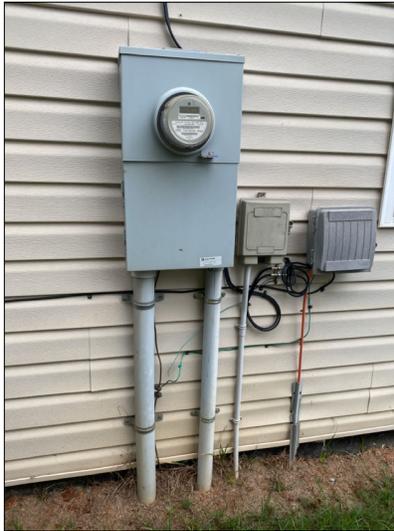
**ELECTRIC SERVICE - NO SUBSTANTIAL FLAWS** - Visible portions of the electric power service appeared to be in serviceable condition, including any meter, base, mast, conduit or disconnect breaker components.

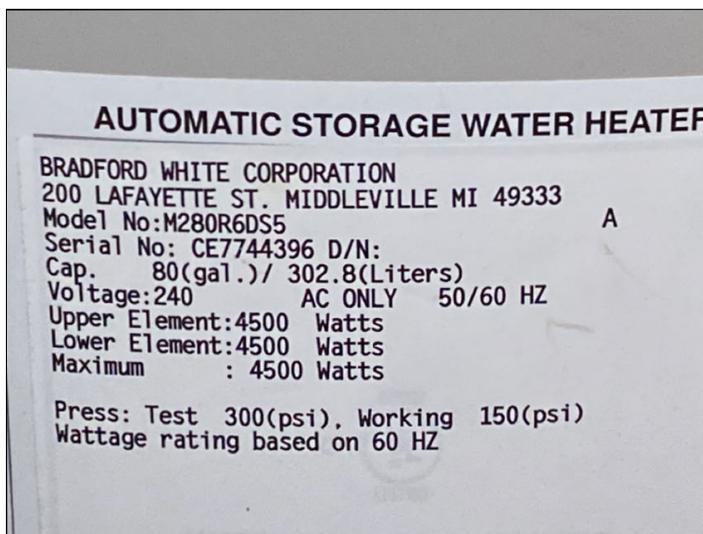
MANUFACTURE DATE of water heater 1 appeared to be -2007

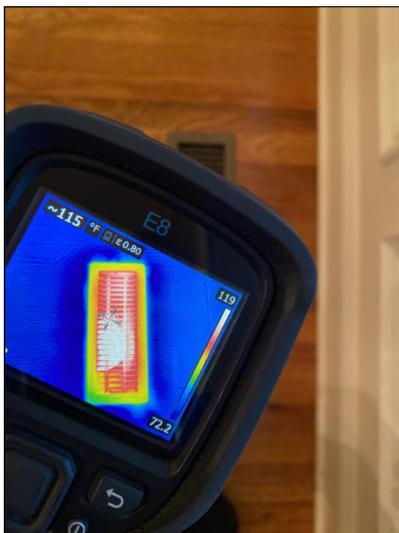
HEATING temperature was 115 degrees, measured at the vent taken from the floor with a thermal camera. Services main level.

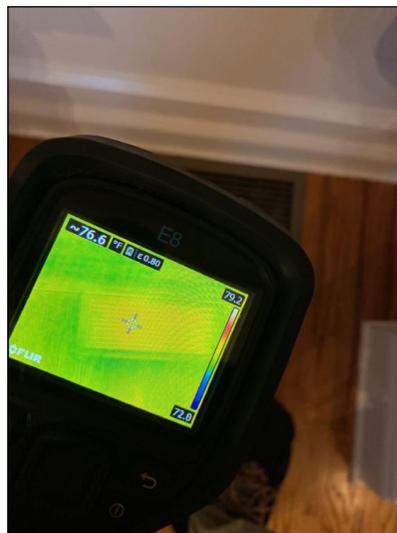
RETURN AIR temperature was 76 degrees, measured at the return air vent using a thermal camera. Services main level.

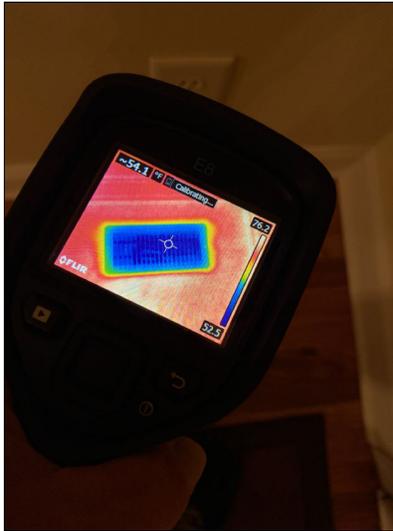
COOLING temperature was 54 degrees, measured at the vent taken from the floor with a thermal camera. Services main level.

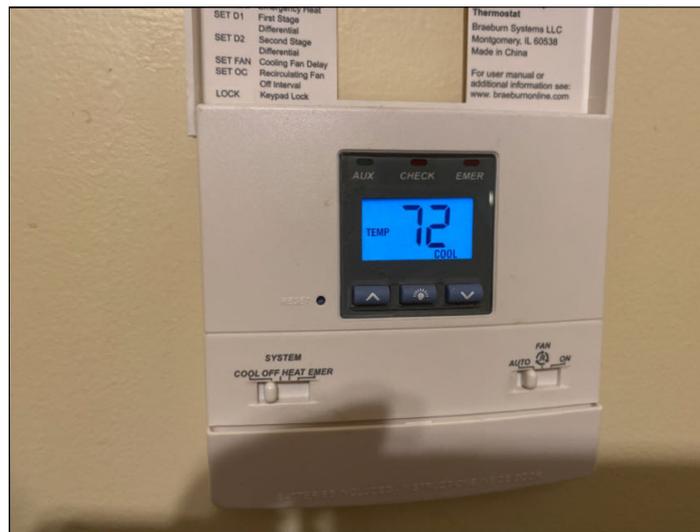
DIGITAL THERMOSTAT was installed and appeared to work properly.

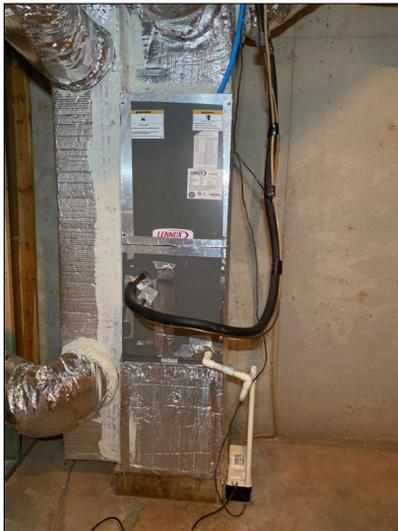
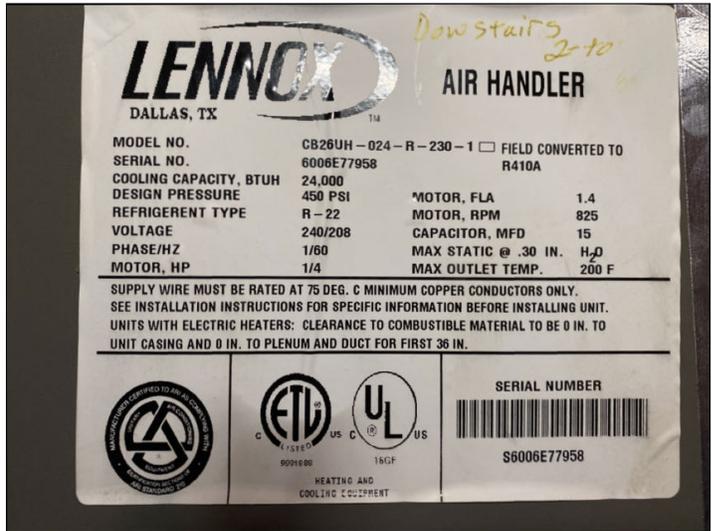
**MANUFACTURER DATE** of heater 1 appeared to be -2006

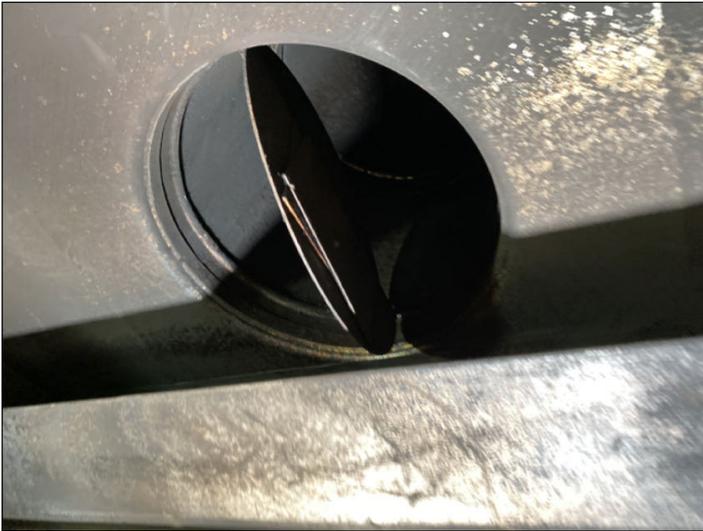
**CLEANING RECOMMENDED** - An annual chimney cleaning before the start of each heating season by a certified chimney sweep is recommended. Always maintain a Carbon Monoxide detector near the fireplace for safety.

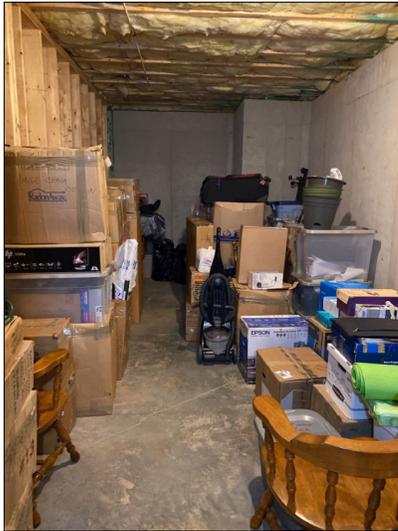
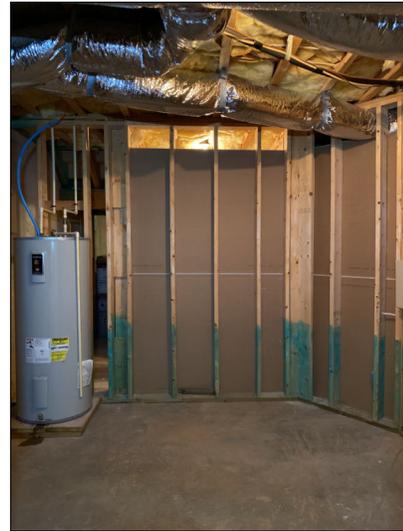
Basement Photos

- PERSONAL BELONGINGS limited the inspection of the basement including access to foundation walls. Recommend review of basement area before final walkthrough prior to closing.
- 75% finished basement.
- PORTABLE DEHUMIDIFIER recommended be used to maintain proper humidity levels in the unfinished basement that does not have an air conditioning source. High humidity can result in organic growth, mildew.
- MINOR SLAB CRACKS were observed in the concrete slab and are typical for most homes in this area. Maintenance should include sealing against moisture and monitoring. Cracks could be access points for moisture and insect intrusion into the home.

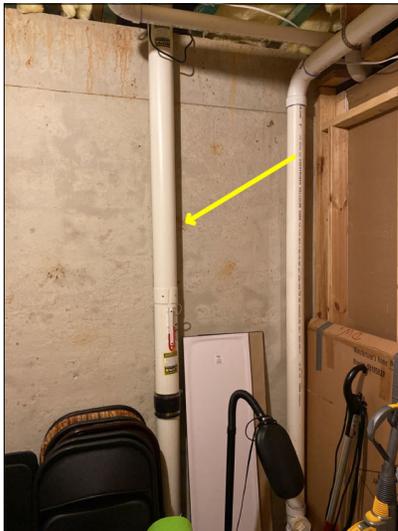
RADON MITIGATION system was installed at the time of inspection but was not tested for performance. The government recommendation, (EPA) is to test for Radon levels every 2 years to assure the mitigation system is working properly.

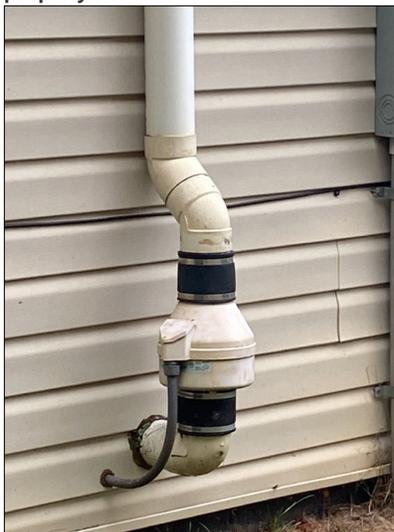
RADON MITIGATION system was installed at the time of inspection but was not tested for performance. The government recommendation, (EPA) is to test for Radon levels every 2 years to assure the mitigation system is working properly.
